FORD:

2011-2015 Explorer

This article supersedes TSB **12-12-4** to update the vehicle model years and Service Procedure.

ISSUE

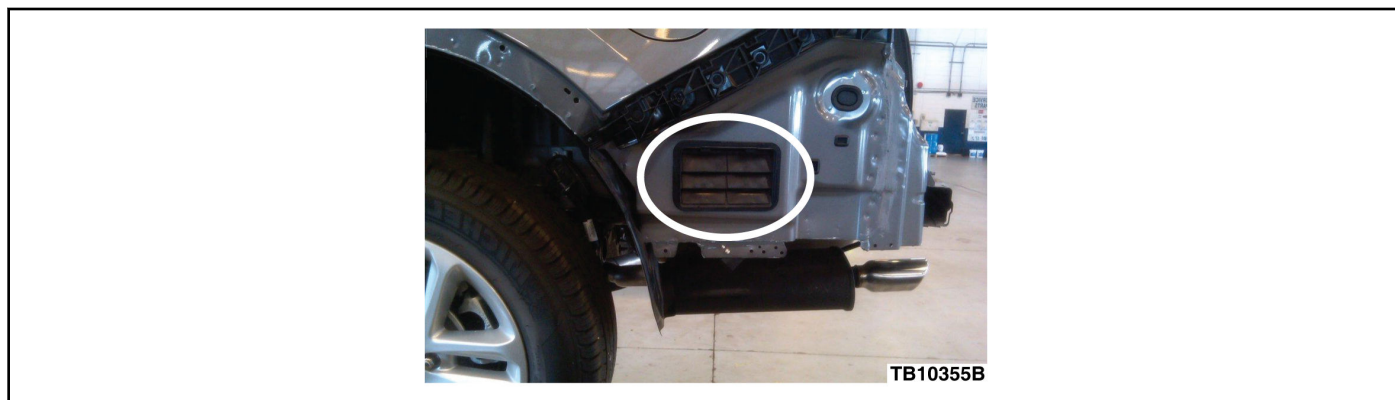
Figure 1 - Article 14-0130

Some 2011-2015 Explorer vehicles may exhibit an exhaust odor in the vehicle with the auxiliary climate control system on. Customers may indicate the odor smells like sulfur.

1. Reprogram the Heating Ventilation Air Conditioning (HVAC) module to the latest calibration using IDS release 91.02 or higher. Calibration files may also be obtained at www.motorcraftservice.com.
 - a. When reprogramming the HVAC, IDS will have additional questions that require a yes response to reprogram the module.
2. Remove the rear bumper cover. Refer to Workshop Manual (WSM), Section 501-19.
3. Replace the left side rear air extractor. (Figure 1)
