**National Highway
Traffic Safety
Administration**

DOT-HS-807-367
DOT-TSC-NHTSA-89-1
Final Report

An Examination of Sudden Acceleration

John Pollard
E. Donald Sussman

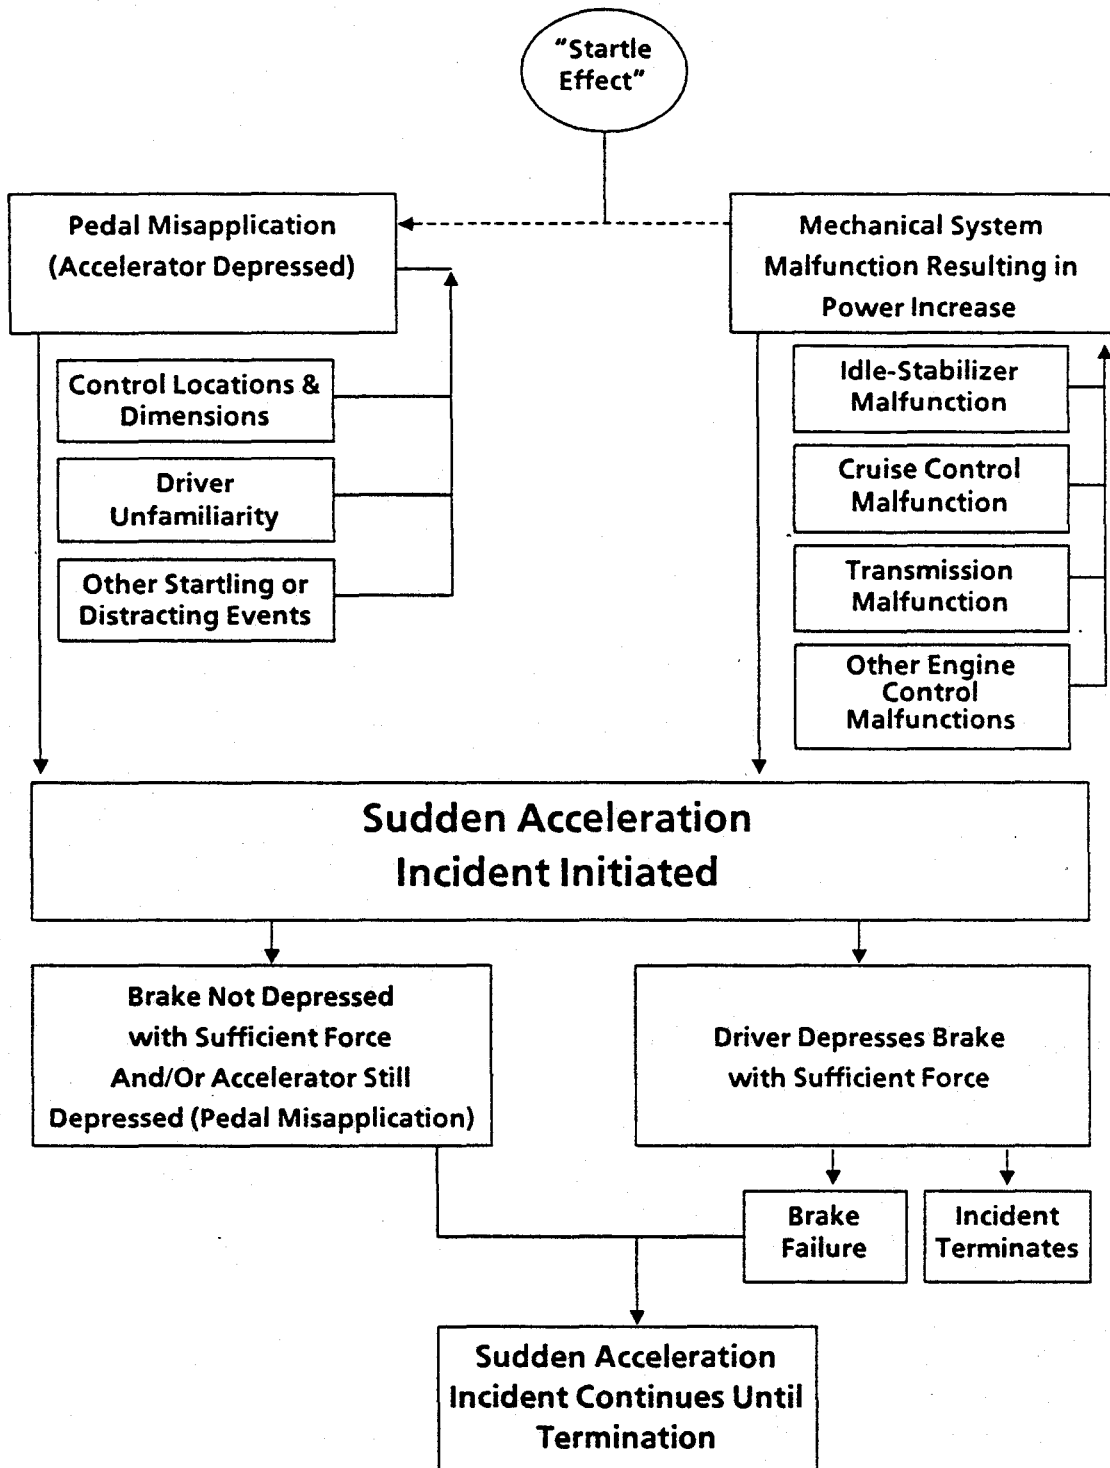
Figure 3.0-1: Sudden Acceleration Incident Scenario

Figure 3.0-1 presents a fault-tree analysis showing all of the possible events involved in an SAI. A large increase in engine power must occur by definition. This can be caused by a vehicle malfunction (a failure of one or more of the engine systems shown in Figure 3.0-1) or a pedal misapplication on the part of the driver.

If a vehicle malfunction is the initiating factor, loss of control can occur if the brakes fail or if the driver inadvertently presses the accelerator rather than, or in addition to, the brake or fails to apply sufficient force to the brake pedal. Should the initial event have been a pedal misapplication, loss of control may ensue if the driver fails to recognize it and continues to press the accelerator.

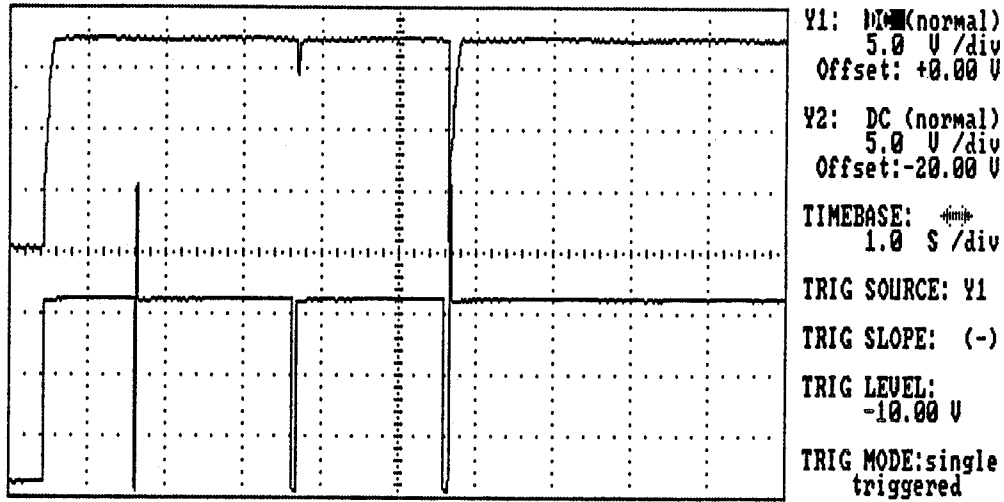
2. Simulated and spurious EMI caused occasional momentary actuation of the vacuum pump when an external signal was being applied to the speed sensor input. Most of these incidents lasted for less than 0.1 seconds and none exceeded half a second. Because of their brevity, no significant throttle opening could occur and they would have been imperceptible to a driver had they occurred in a vehicle in use. Figure 3.1.2-1 shows an oscillogram of a typical incident while Figure 3.1.2-2 shows an oscillogram of what the output would look like if the cruise control were accelerating the car continuously for 10 seconds.

Figure 3.1.2-1: Oscillogram of typical RFI-induced cruise-control transient. The vacuum pump (upper trace) is energized only when this waveform is low. The vent (lower trace) is sealed only when its waveform is low. In this incident, a speed signal is being supplied from an external generator. Without such a signal present, the duration of the spike would be only a few milliseconds rather than a few hundred milliseconds and would be difficult to see at a scale of one division per second.

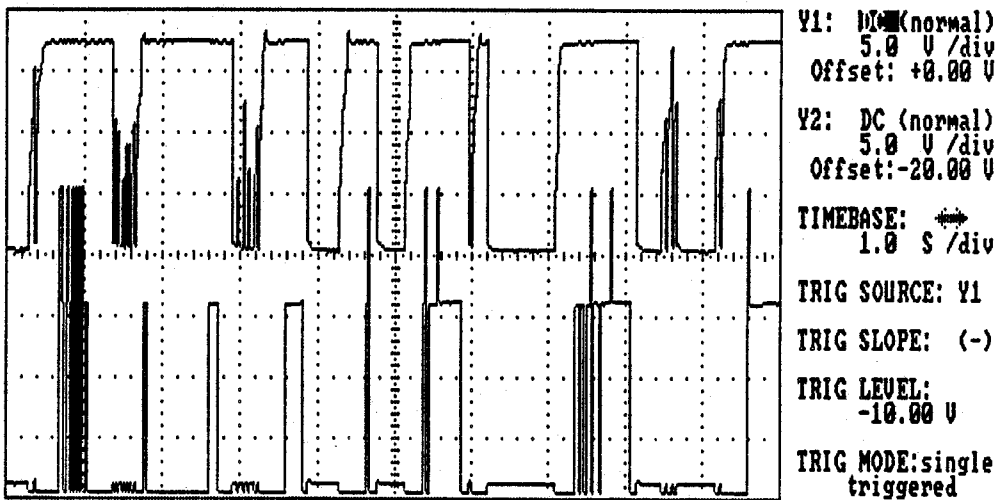
Figure 3.1.2-2: Oscillogram of cruise-control output which produces wide-open throttle in about five seconds. Current flows through the vacuum pump and the vent-sealing solenoid only when their waveforms are low. In this example the duty cycle is about 40%.

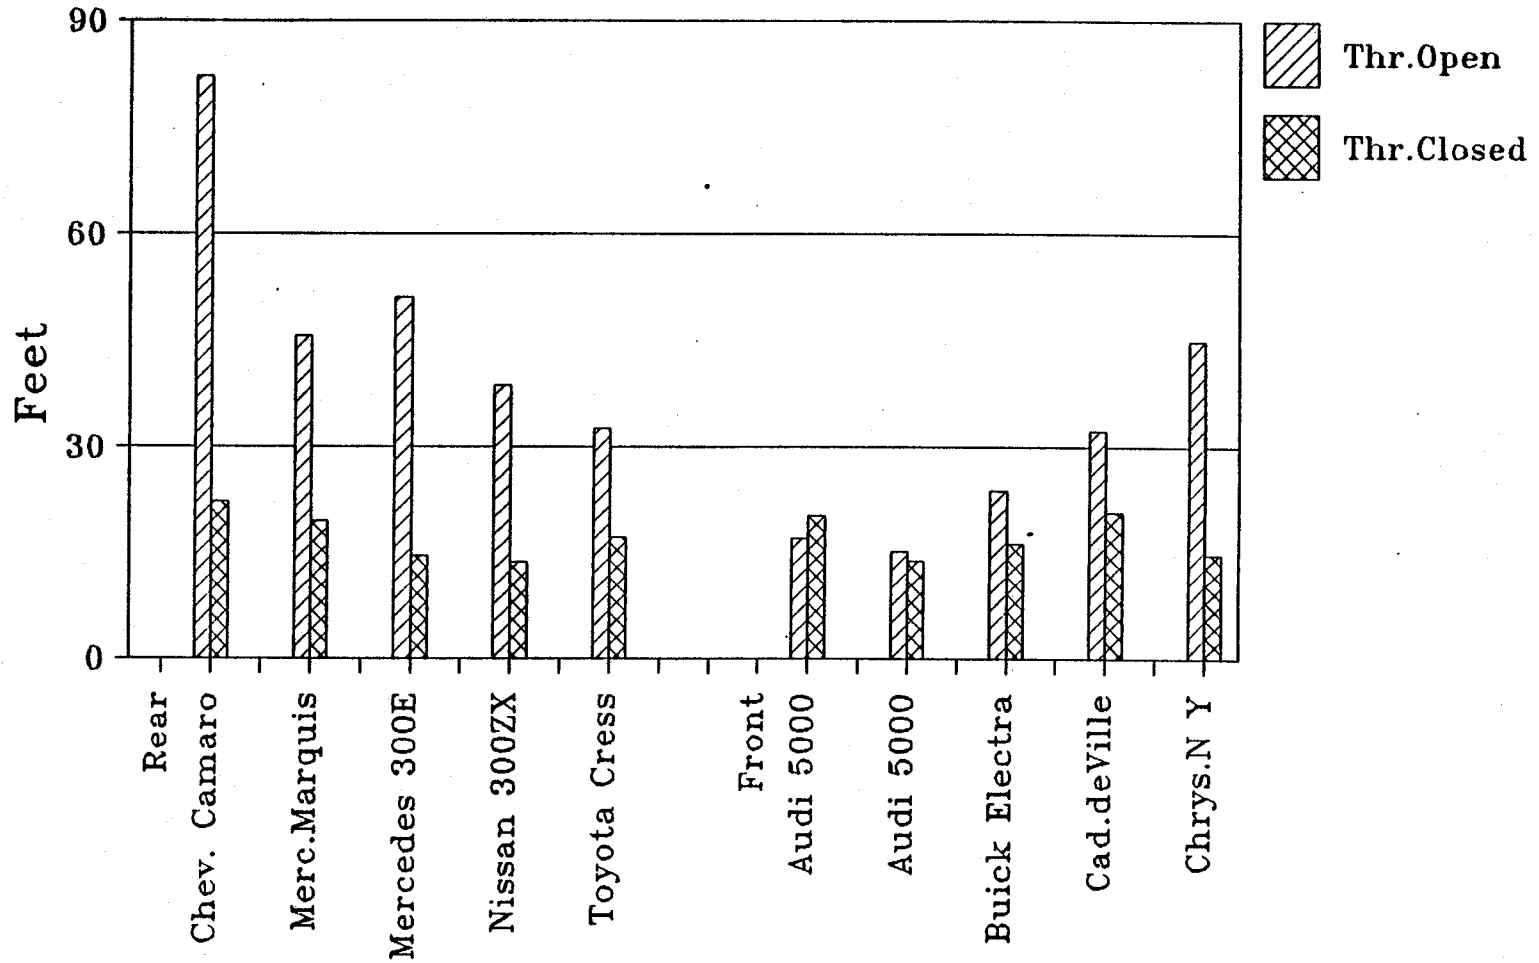
Figure 3.1.5-1: Graphic comparison of stopping distances for WOT versus closed throttle for various cars from speed reached after two seconds when 60 pounds of brake-pedal force were applied. Source: Appendix E, Series 4 and 5 tests. The disparity in stopping distances for the Chrysler New Yorker compared with other front-wheel-drive cars did not occur at the higher brake-pedal forces of 100 and 150 pounds.

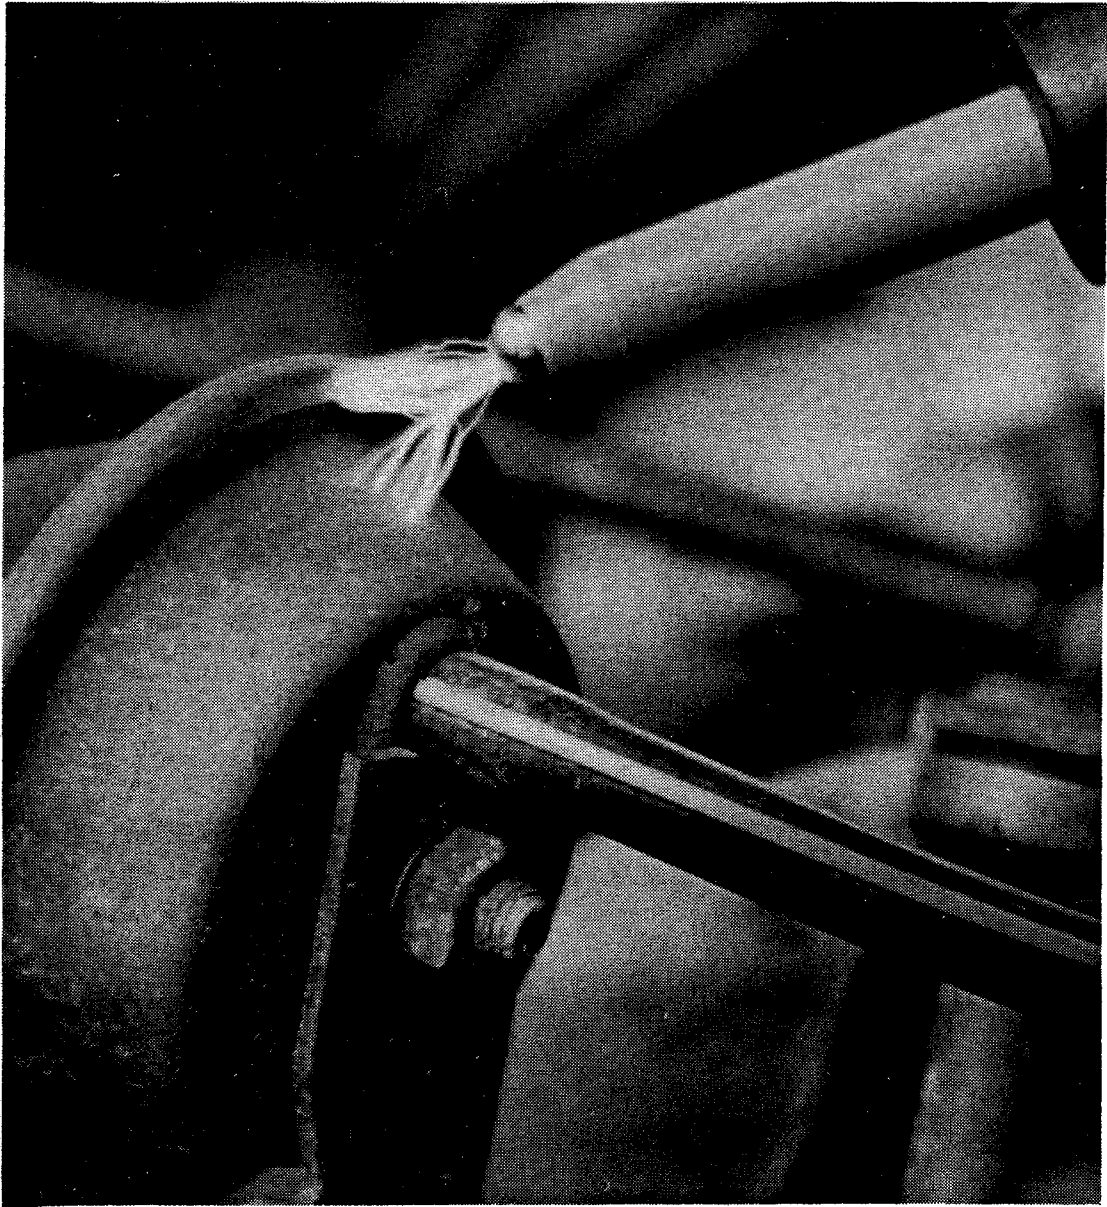
None of the tested vehicles showed any sign of throttle opening at any time. One of the cruise controls ceased functioning when 25 kV sparks were applied directly to its case and wiring. As a result of these tests, it may be concluded that engine controls of recent design, and cruise controls in particular, are not likely to experience throttle-opening failure modes as a result of exposure to very strong electric or magnetic fields.

Figure 3.2.3-1: Cruise-control actuator subjected to 25 kV sparks from an electrostatic discharge gun. (Photo: VRTC)

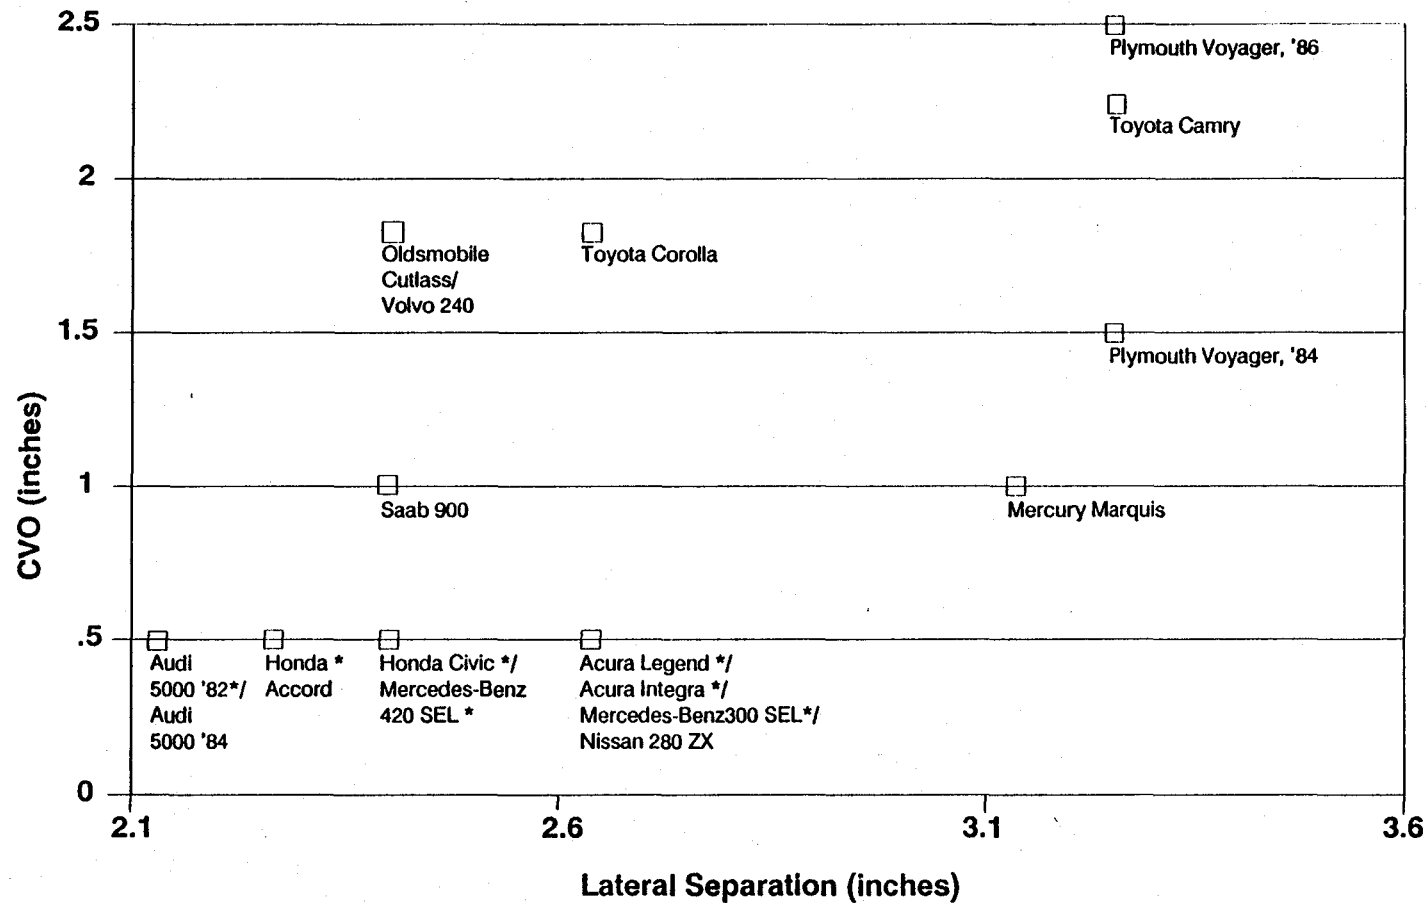
Figure 3.3.1-2: Scatter plot of pedal separation measures for various vehicles. All of the vehicles with vertical offset measurements of less than one inch have above-average rates of RSAI except the Honda Civic. The Mercury Marquis does have an above-average rate, which is not true of the other vehicles with offsets of an inch or more.

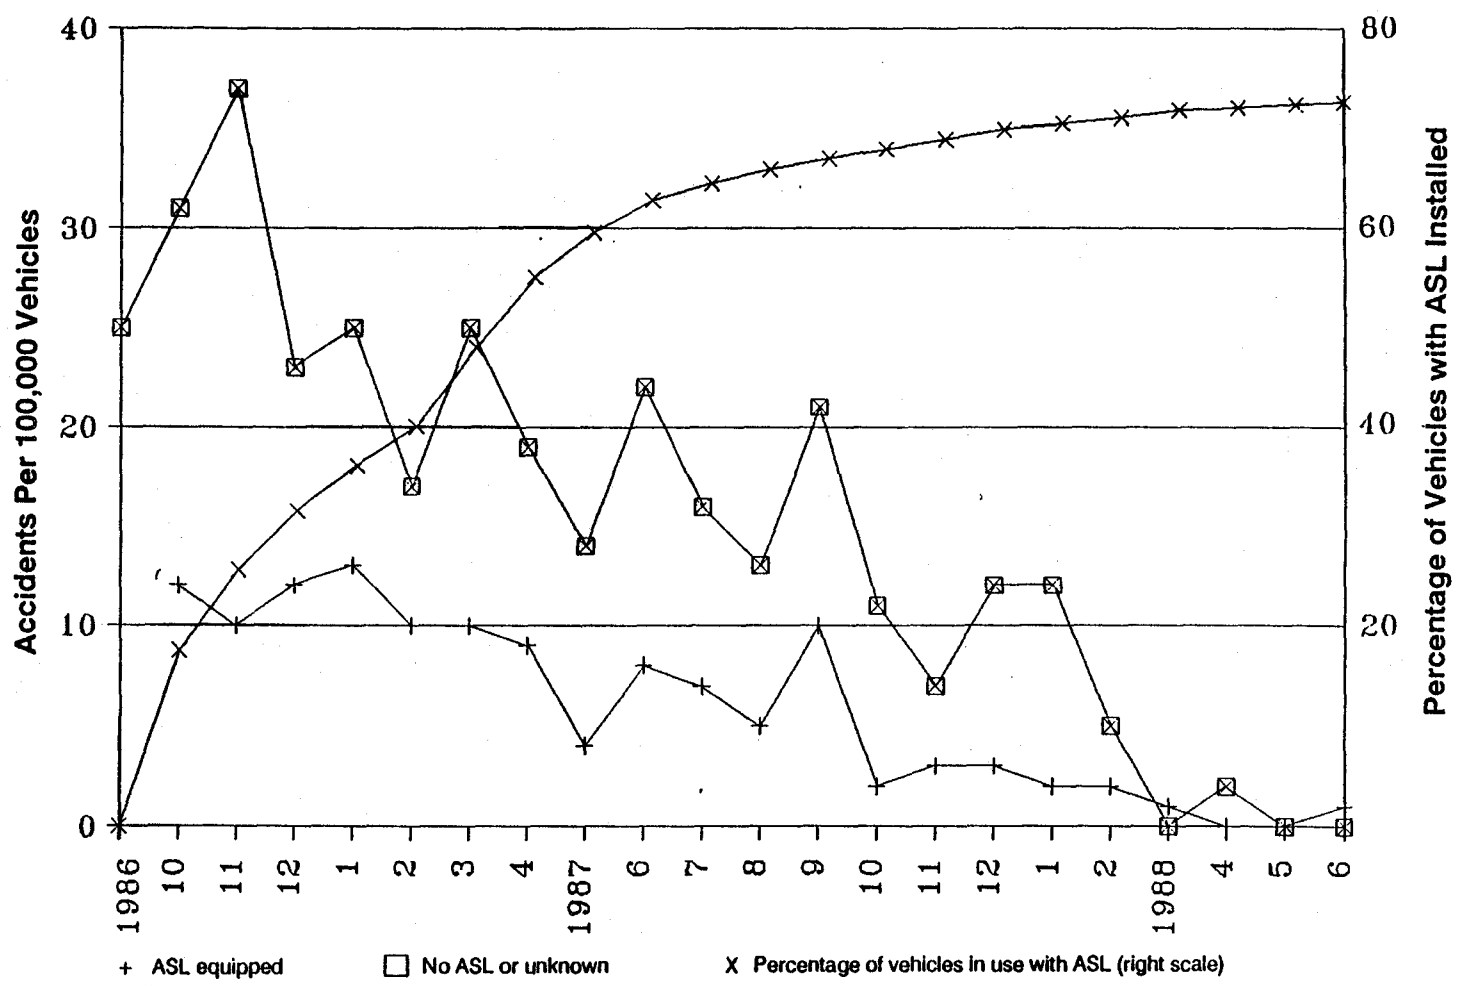
Figure 3.3.2-1: Comparison of RSAI for Audi 5000 cars with and without the ASL installed.

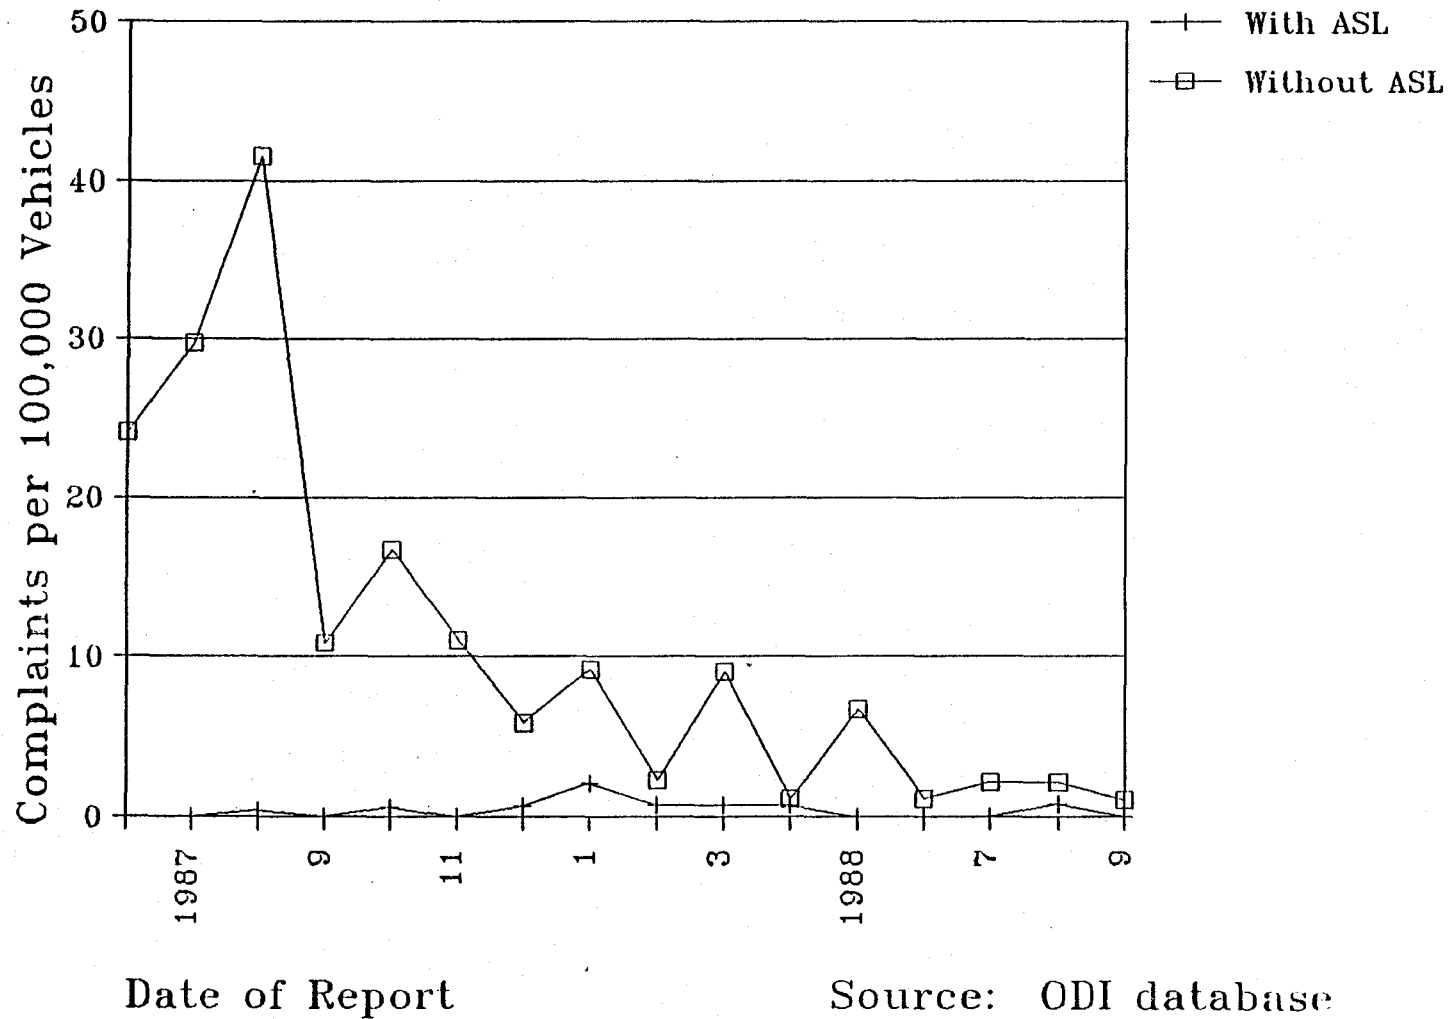
Figure 3.3.2-2: RSAI for the Nissan ZX models with and without the ASL installed.

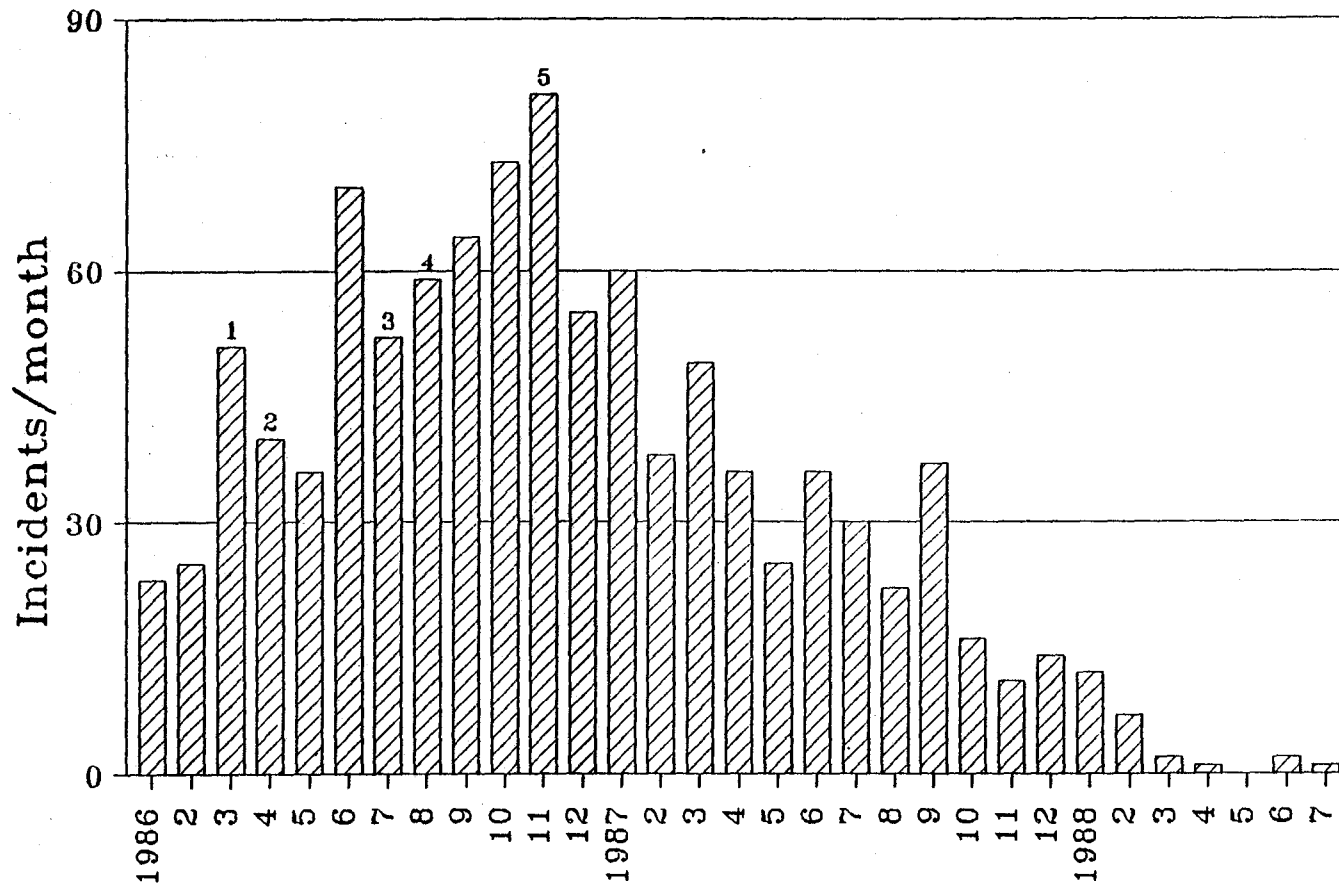
Figure 3.3.3-1: RSAI by month for the Audi 5000 with major media coverage events noted.

1. CAS, NYPIRG et al petition NHTSA. Petition receives wide media coverage in New York.
2. Audi Victims Network formed.
3. Audi shift-lock recall announced.
4. NHTSA opens formal investigation of SAI in Audi 5000
5. CBS's "60 Minutes" episode on SAI in the Audi 5000.
