CALSPAN ON-SITE AIR BAG NON-DEPLOYMENT INVESTIGATION

CASE NO: CA05-049

VEHICLE: 2005 CHEVROLET COBALT

CRASH DATE: JULY 2005

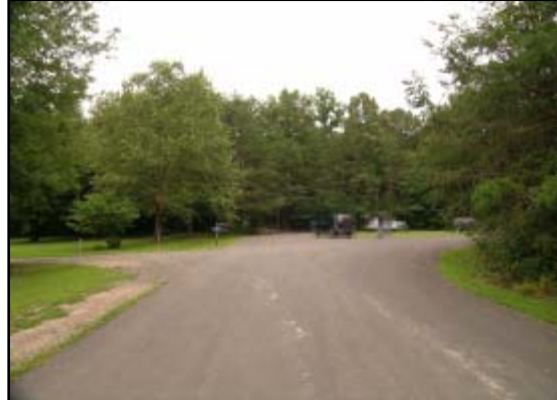
The 16-year old female driver was attending a house party at a residence located at the mouth of the cul-de-sac. She was under the influence of alcohol with a toxicology reported BAC of .17. The driver was not restrained by the manual 3-point lap and shoulder belt safety system. The lack of belt usage was determined from the vehicle inspection and EDR data. She left the party alone during the nighttime hours and attempted to exit the rural subdivision. For an unknown reason, the driver returned toward the cul-de-sac, traveling in a southerly direction on the left side of the two lane non-delineated roadway (**Figure 2**).

Figure 2. Pre-crash travel direction and overall view of the crash site.

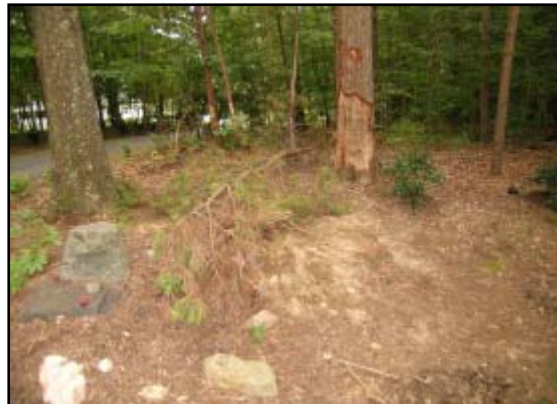
As the Cobalt traversed the mouth of the driveway, the undercarriage overrode the landscaping, which consisted of flush mounted rocks within the dirt and mulch. The front left area of the vehicle narrowly missed a large rock that was positioned vertically within the landscaped area. The Cobalt continued forward in a tracking mode and impacted a 13 cm (5") diameter pine tree with the front left area of the vehicle. The resultant direction of force for this impact event was 12 o'clock. The impact uprooted the tree, but did not fracture the 13 cm (5") trunk. The Cobalt carried the tree forward as this impact produced a minimal velocity change to the vehicle. (The delta V could not be calculated due to the masking of damage by the subsequent impact). **Figure 3** is an overall view of the crash site.

Figure 3. Overall view of the crash site.

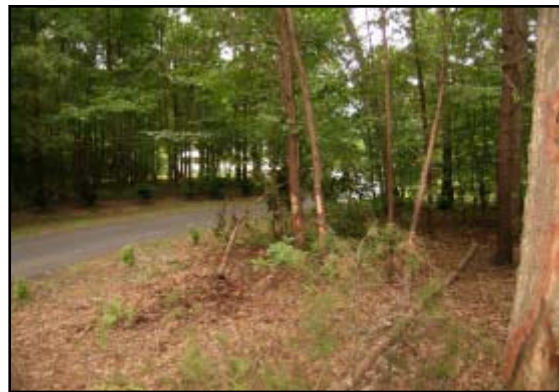
Figure 5. Area of impact with the four small diameter trees and final rest.

As the Cobalt rotated CW, the left side area impacted four small diameter trees that were located 2.8-4.6 m (9-15') south of the 51 cm (20'') diameter tree (**Figure 5**). The lateral impact deflected the trees, which resulted in a ramping effect as the undercarriage of the Cobalt rode up the trees. This ramping effect resulted in an overturn (flip-over) of the Cobalt as it rolled one-quarter turn onto its right side. The Cobalt continued to rotate approximately 40 degrees about its longitudinal axis prior to coming to rest on its side.

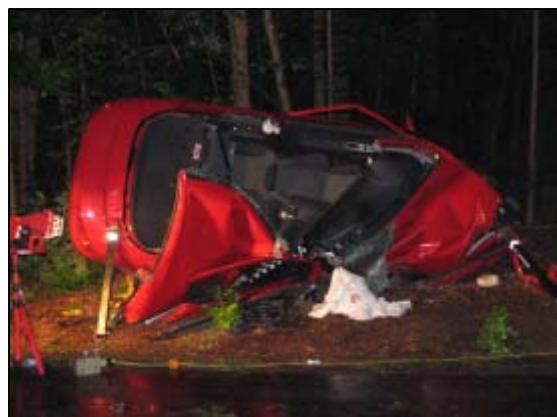
The Cobalt came to rest on its right side, facing in a northeasterly direction (**Figure 6**). At rest, the vehicle was facing in a direction that was nearly opposite of its initial travel direction. Volunteer fire

Figure 6. On-scene image of the Cobalt at final rest.

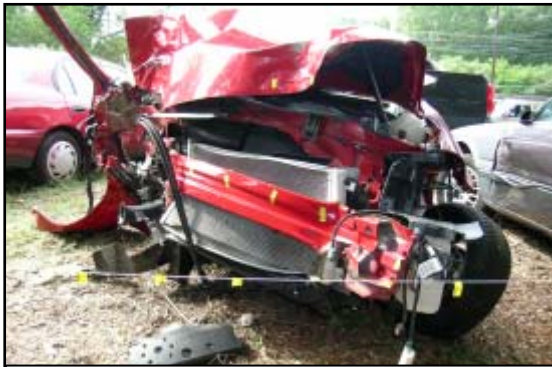
The initial impact with the 13 cm (5") diameter tree was located on the front left area of the vehicle (**Figure 7**). The direct contact damage began 29 cm (11.4") left of center and extended 11 cm (4.25") to the left. The impact dented the hood face to a maximum depth of 10 cm (4.0"). The damage and resulting crush to the bumper system was masked by the subsequent impact with the large diameter tree. The Collision Deformation

Classification for the impact was 12-FLEN-1.

Figure 7. Damage from the 13 cm (5") tree.

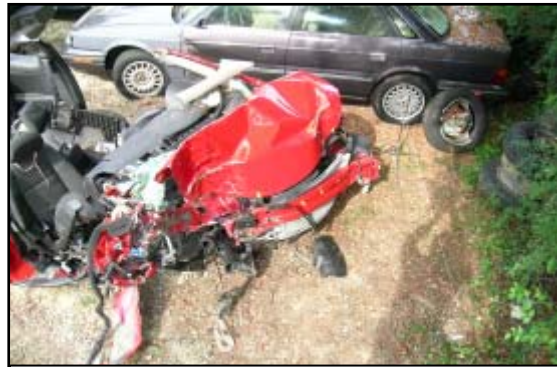
Figure 8. Overhead view of the damage from the 51 cm (20") tree.

The Cobalt uprooted and overrode the small diameter tree as it continued 2.3 m (7.5') forward and impacted the 51 cm (20") hardwood tree with the front right area (**Figure 8**). The direct contact damage began 41 cm (16.25") right of center and extended 33 cm (13") to the front right corner. The damage was concentrated outboard of the right frame rail and initially involved the corner of the bumper beam and sheet metal components. As the vehicle crushed, the right front tire/wheel and axle assembly engaged the tree followed by the right A-pillar area. The right corner impact deformed the full width of the frontal structure. The combined induced and direct contact damage at the bumper level measured 67 cm (26.5"), extending from corner-to-corner of the bumper beam. Maximum crush was measured at 110 cm (43.4"), located at the front right corner of the bumper beam. The crush profile at the level of the bumper beam was as follows: C1 = 12

cm (7.6”), C2 = 48 cm (18.75”), C3 = 56 cm (21.9”), C4 = 67 cm (26.5”), C5 = 80 cm (31.4”), C6 = 110 cm (43.4”).

As the Cobalt continued forward and began to rotate in a clockwise direction, the right front tire and wheel engaged the tree. This contact fractured the inner aspect of the alloy wheel rim and fractured the right front axle and suspension. The tire/wheel and brake assembly separated from the Cobalt. The right A-pillar engaged the tree and crushed the base of the pillar approximately 67 cm (26.5”) rearward. (It should be noted that the investigating officer stated that this area of the vehicle was pulled forward using hydraulic equipment as the officer interrogated the vehicle in search of the air bag control module.) The welded section of the right A-pillar, toe/floor pan, and the right sill separated due to the extensive crush and induced deformation. The CDC for this event was 12-FREE-7.

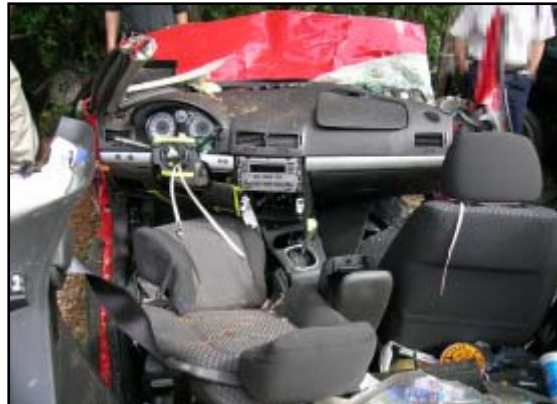
The steering wheel rotated upward as the cowl of the vehicle intruded rearward. The driver’s abdominal region loaded the lower aspect of the steering wheel rim. Her loading force fractured the mounting flange of the alloy wheel, thus resulting in complete separation of the steering wheel and air bag module from the column. This assembly was not with the vehicle at the time of the SCI inspection. The separated steering wheel was noted in an on-scene police image of the crash site. In addition to the flange fracture, the driver compressed the energy absorbing steering column as evidenced by 0.6 cm (0.25”) of left shear capsule separation and 2 cm (0.75”) of right capsule compression. **Figure 9** is overall view of the driver’s trajectory and contact points.

Figure 9. Driver trajectory and contact points.

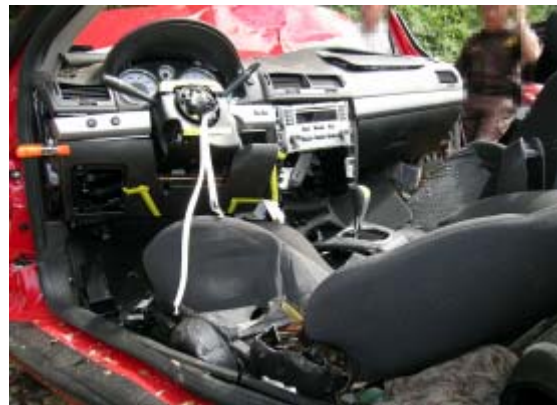
The driver’s knees and lower legs impacted the knee bolster (**Figure 10**). Her left knee scuffed the bolster 15-22 cm (5.75-8.75”) inboard of the left edge of the bolster panel and 15-23 cm (5.75-9.25”) below the top edge of the plastic panel. The right knee contact was located 44-50 cm (17.25-19.75”) inboard of the left edge and 20-24 cm (8-9.5”) below the top edge. A fabric scuff from her right leg was noted to the left side of the mid instrument panel at its juncture with the center console. This triangular fabric transfer was 13 cm (5”) in

Figure 10. Driver contact to the knee bolster.

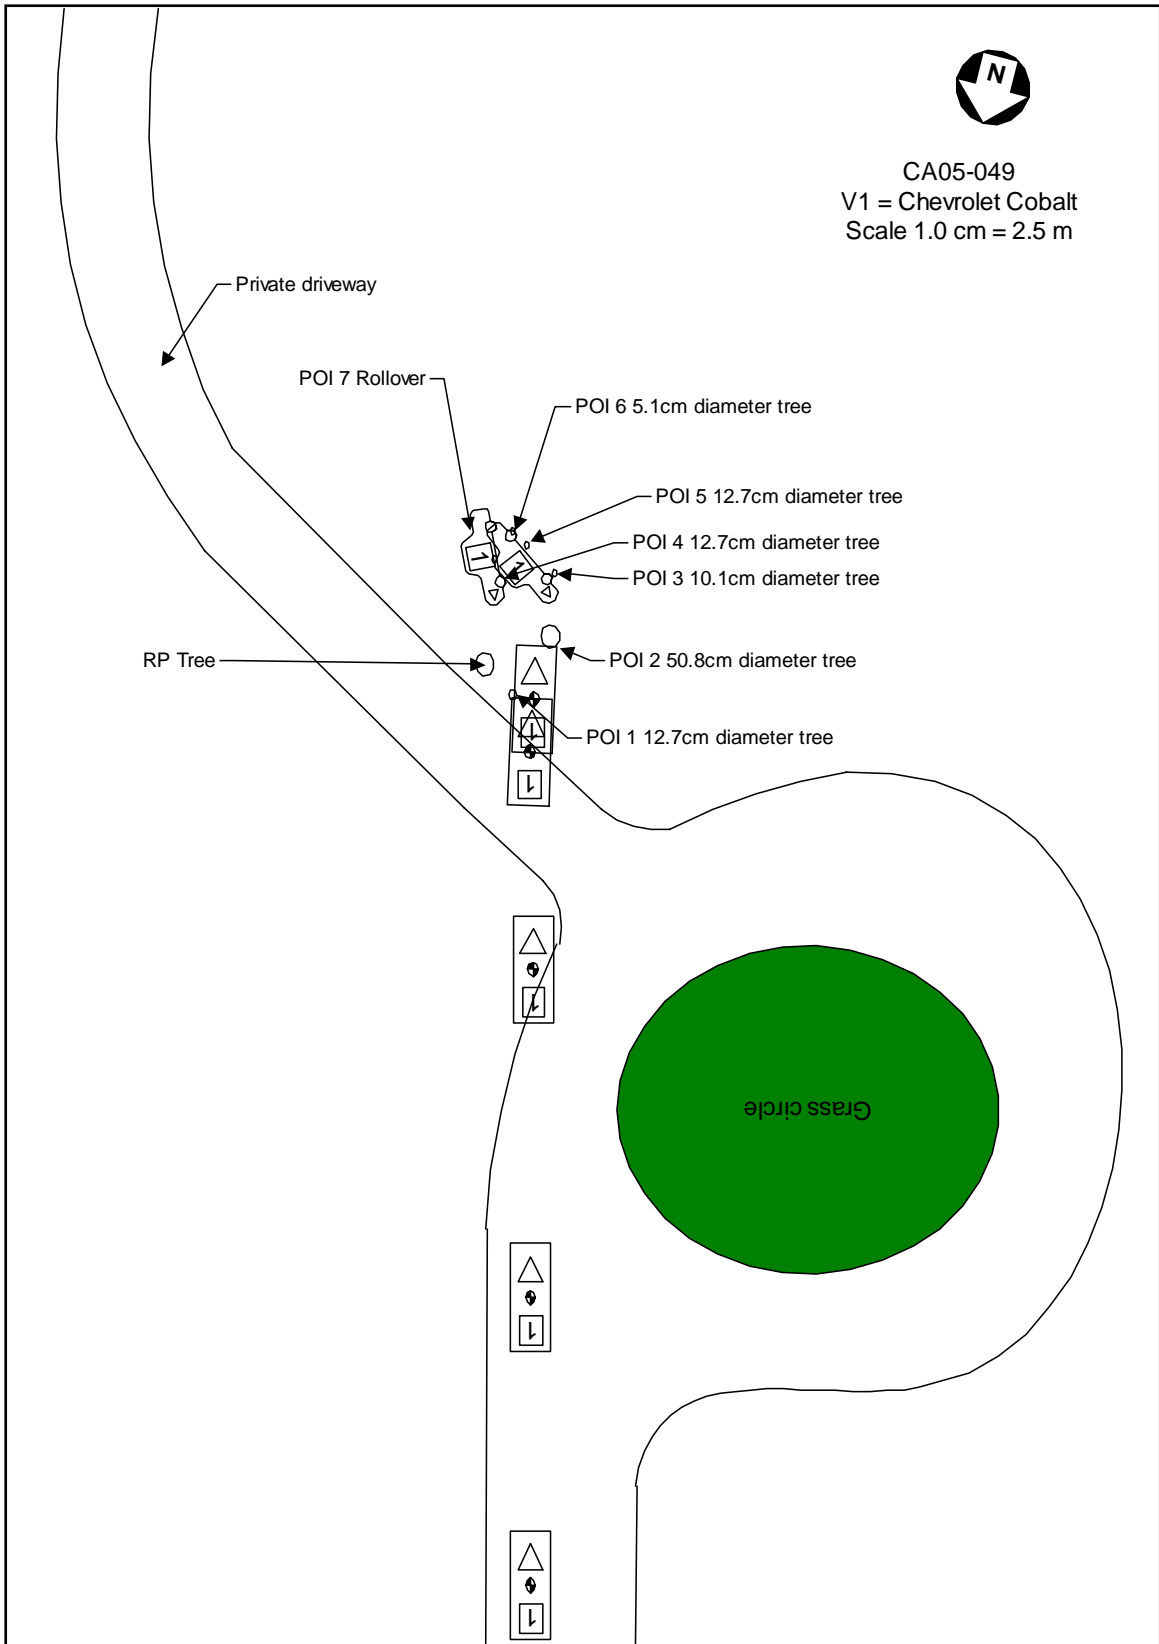
Figure 11: Scene Schematic

The crash occurred in a remote, rural residential area at the end of a cul-de-sac roadway during dark, nighttime hours. At the time of the crash, the weather conditions were police reported as overcast with wet environmental surfaces from a previous rainfall. A two-lane asphalt surfaced roadway terminated at a 29.8 m (98') diameter cul-de-sac, which formed a circular loop to the right of the approach roadway. The roadway was 6.4 m (21') in width and was bordered by grass/vegetation with no stabilized shoulders. A 17 m (55.8') diameter grass circle was centered within the cul-de-sac. The posted speed limit for the area was 40 km/h (25 mph). There were no lane lines or edge line markings on the road. A residential driveway intersected the cul-de-sac at the top, left aspect of the circle, with respect to vehicle travel. Numerous trees and a rock-landscaped area bordered the edges of the driveway and the cul-de-sac. At the crash site, the initial impact involved a 13 cm (5") diameter (soft wood) tree, a 51 cm (20") diameter oak tree, and four small trees that ranged in diameters of 5-13 cm (2-5"). The scene schematic is included as **Figure 11**.
