**OFFICE OF DEFECTS INVESTIGATION
CALSPAN ON-SITE AIR BAG NON-DEPLOYMENT FATAL CRASH INVESTIGATION
SCI CASE NO: CA09022**

**VEHICLE: 2005 CHEVROLET COBALT
LOCATION: PENNSYLVANIA
CRASH DATE: APRIL, 2009**

Contract No. DTNH22-07-C-00043

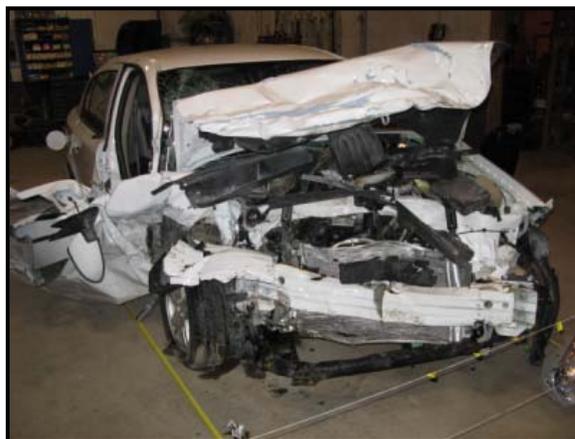
This on-site investigation focused on the fatal air bag non-deployment crash of a 2005 Chevrolet Cobalt (**Figure 1**). The Chevrolet was involved in a severe head-on collision with a 2001 Hyundai Sonata that resulted in three fatalities. The 2005 Chevrolet Cobalt was equipped with dual-stage air bags for the driver and front right passenger positions that did not deploy in the crash. The vehicle's Event Data Recorder (EDR) was imaged during the SCI investigation and a non-deployment event was recovered. The driver air bag in the Hyundai Sonata deployed during the impact. The 73-year old unrestrained driver and the 13-year old unrestrained front right passenger of the Chevrolet and the 47-year old unrestrained driver of the Hyundai were all pronounced deceased at the crash site. A 12-month-old male was restrained in a forward facing convertible Child Restraint System (CRS) in the center rear position of the Cobalt. The child sustained a critical cervical spine injury and was transported from the crash site to a pediatric trauma center via air ambulance.

Figure 1: Front right oblique view of the Chevrolet.

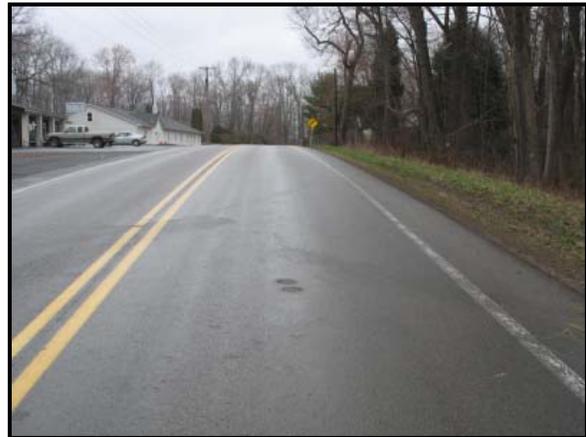
Figure 2: Eastbound trajectory view at the point of impact.

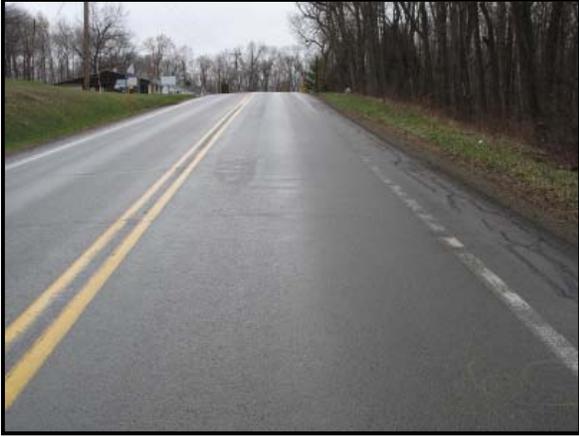
Figure 3: Eastbound approach view 90 m (300 ft) from the point of impact.

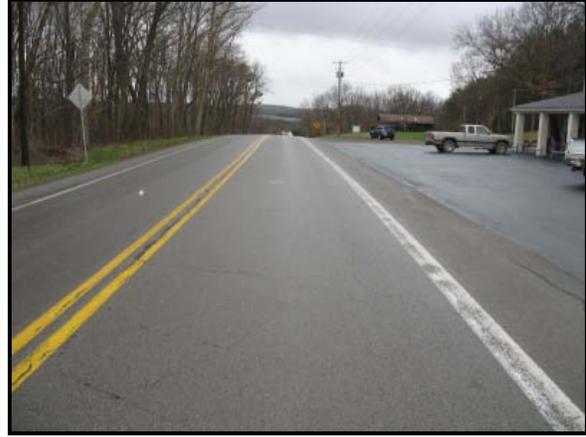
Figure 4: Westbound approach view 60 m (200 ft) from the point of impact.

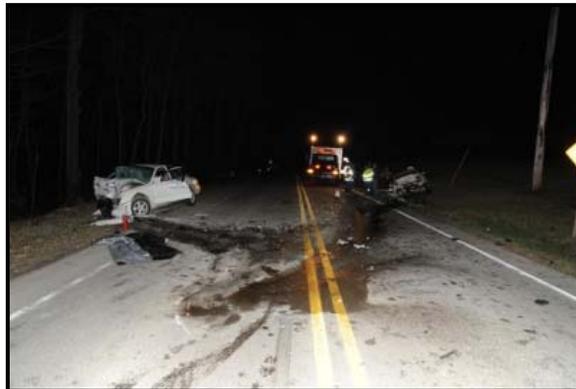
Figure 5: On-scene police image of the crash site.

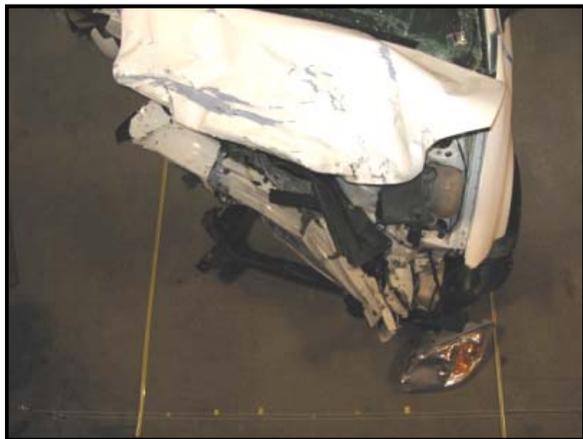
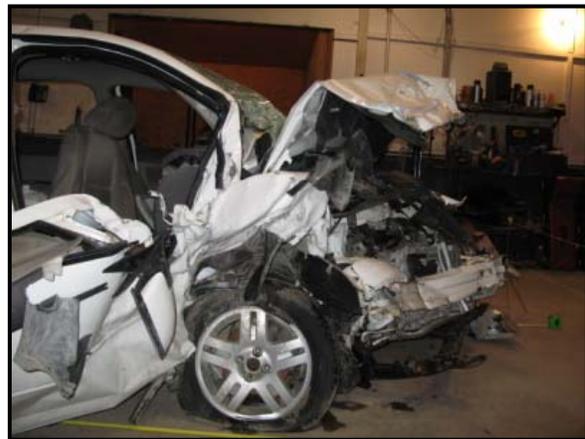
The 2005 Chevrolet Cobalt sustained severe damage from the off-set frontal collision with the Hyundai. **Figures 6 and 7** are an overhead and right side view of the deformation. The width of the direct contact damage measured 117 cm (46.1 in). The direct contact began 51 cm (20.1 in) left of center and extended to the right corner. The combined direct and induced damage extended across the entire 132 cm (52.0 in) end width. The damage pattern was biased to the right indicative of the offset impact configuration and the evasive left steering by the Chevrolet's driver. The damaged components included but were not limited to the front bumper fascia, bumper reinforcement beam, upper and lower radiator supports, headlight assemblies, fenders, right A-pillar, and the right front suspension components. As the vehicles crushed, the right wheel was displaced rearward into the wheelhouse and right cowl. The wheel rim fractured.

The right A-pillar was deformed rearward 40 cm (15.8 in) and the lower third of the pillar deformed to a vertical orientation. The front right door was compressed 19 cm (7.5 in) and buckled outboard. The right roof side rail was buckled to the right B-pillar location. The upper aspect of right front shock absorber tower deformed rearward 53 cm (21.0 in). The right wheelbase was reduced 41 cm (16.1 in). The left wheelbase lengthened by 8 cm (3.1 in) due to body distortion of the Cobalt. The residual crush profile documented along the bumper reinforcement was as follows: C1 = 7 cm (2.8 in), C2 = 40 cm (15.7 in), C3 = 73 cm (28.7 in), C4 = 81 cm (31.9 in), C5 = 89 cm (35.0 in), C6 = 79 cm (31.1 in). The maximum crush was 89 cm (35.0 in) at C5. The left front and right side doors were jammed closed by the impact. The left front and right front doors were opened by rescue personnel evidenced by extrication damage to the respective B-pillar areas. The right rear door compressed rearward and overlapped the quarter panel and C-pillar. The maximum overlap measured 2 cm (1 in). The windshield was fractured and the right front door glazing disintegrated during the crash. The left side, backlight, and right rear door glazing were intact. The Collision Deformation Classification (CDC) of the Cobalt was 12-FDEW5.

Figure 6: Overhead view of the Cobalt's frontal damage.

Figure 7: Right lateral view of the frontal damage.

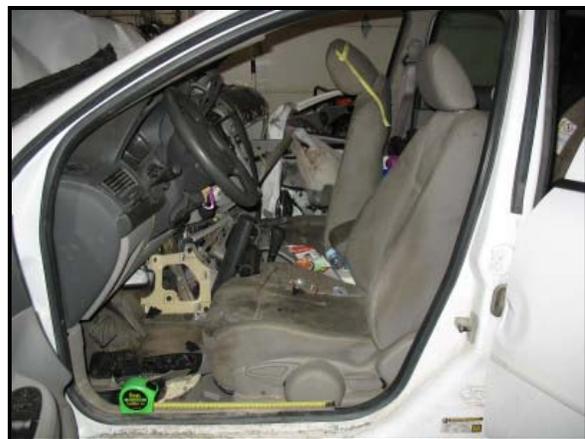
The interior of the Chevrolet sustained severe center and right frontal intrusion as a result of the exterior crash force. The unrestrained Row 1 occupants translated forward and contacted the vehicle's interior forward of their respective seat positions in response to the frontal impact force. This pattern was evidenced by multiple occupant contact points. **Figure 8** is a left lateral view of the front interior.

Figure 8: Left lateral view of the front interior.

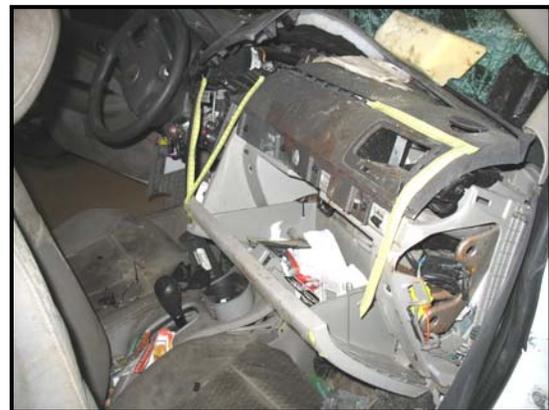
The unrestrained front right occupant responded to the frontal impact with a forward trajectory and contacted the right instrument panel with her chest. The outboard aspect of the panel was fractured. Body fluid transfers were noted over a 48 cm x 30 cm (19 in x 12 in) contact area. Refer to **Figure 9**. Her lower extremities contacted the glove box door. A 10 cm (4 in) wide head contact was identified on the inboard aspect on the right sun visor.

Figure 9: Right instrument panel contact evidence and the non-deployed passenger air bag.

The frontal air bag system in the Chevrolet Cobalt consisted of dual-stage driver and front right passenger air bags that did not deploy as a result of the crash. The cause of the non-deployment could not be determined. The driver air bag was located in the center hub of the steering wheel rim. The front right air bag module was a top-mount design located in the right aspect of the instrument panel. The vehicle was not equipped with side impact air bags. The frontal air bag system was controlled by a Sensing Diagnostic Module (SDM) that was located under the center console between the front seats. The SDM had Event Data Recorder (EDR) capabilities that could capture data at the time of a crash. The SDM was removed by the police investigator and was imaged by the SCI investigator at the time of the inspection.

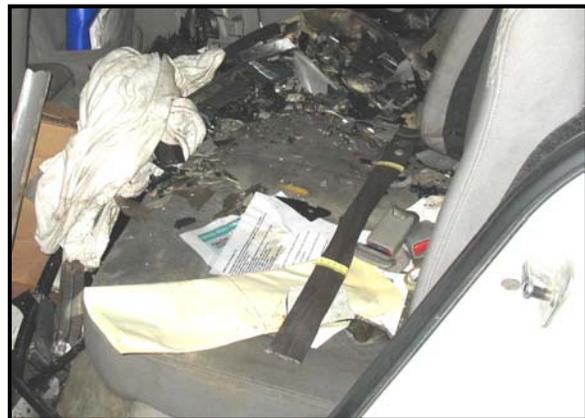
The three rear belt systems utilized switchable ELR/ALR retractors. The rear center safety belt was used to install the convertible CRS in the forward facing mode. The lap and shoulder belt webbing was routed through the forward facing belt path of the child safety seat. The webbing was cut post-crash by rescue personnel in order to remove the seat. The cut section of the belt webbing measured 77 cm (30.3 in), **Figure 10**. The balance of the webbing had spooled back into the retractor. The cut webbing contained a 45 cm (17.7 in) section that was loaded from its interaction with the belt path of the CRS. The loading began 13 cm (5.1 in) above the seat bight. The latch plate was found fastened in the center rear buckle. Extensive frictional abrasions were noted to both sides of the latch plate friction surface. These abrasions occurred as a result of the CRS loading of the webbing during the crash event. Refer to the *Child Restraint System* section of this report regarding further information regarding the use of the CRS.

Figure 10: View of the center rear safety belt.

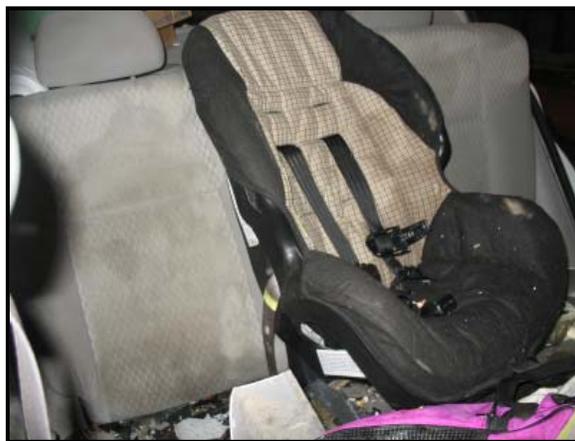
The 12-month-old male child was restrained by the five-point harness system of a Cosco Scenera S convertible CRS in the second row center position of the Cobalt, **Figure 11**. The CRS was restrained to the vehicle by the center three-point belt webbing routed through the forward facing belt path. The adjustable foot was in the extended position for forward facing use.

Figure 11: View of the Cosco CRS.

The shell was designed with four slots for adjustment of the harness straps. The straps were positioned in the second row from the top. The left strap was twisted one turn and the strap was roped in the chest retainer clip and left buckle. There was no residual evidence of loading to the harness. The chest retainer clip and buckle were operational. Examination of the upper shell was unremarkable for damage. Minor abrasions from interaction with the vehicle's safety belt were noted adjacent to the slot of the forward facing belt path.

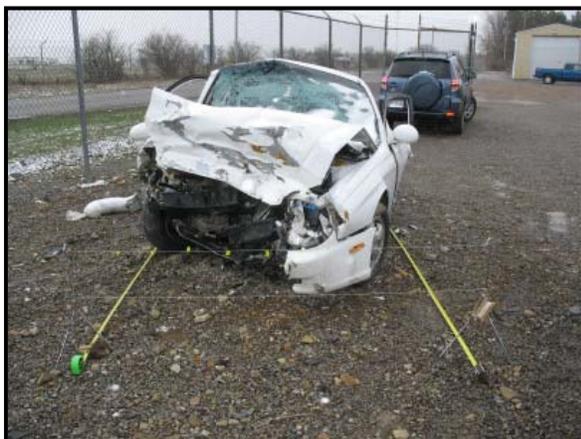
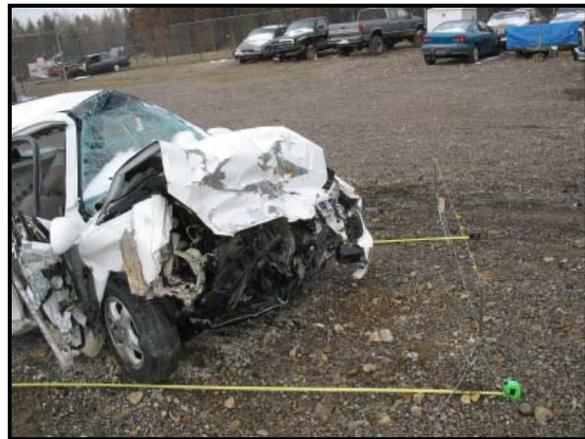
The 2001 Hyundai Sonata sustained severe frontal damage as a result of the impact with the Chevrolet (**Figures 12 and 13**). The width of the direct damage extended across the entire 147 cm (58 in) frontal end width of the Sonata. The right bias of the impact and extent of crush deformed the left front corner 23 cm (9 in) to the right. The bumper reinforcement and forward components deformed into the engine compartment. The front right wheel assembly crushed rearward into the lower A-pillar. The upper aspect of the A-pillar deformed and was near vertical. The rake angle measured 80 degrees from horizontal. The roof was buckled vertically above the front right position. The rake angle of the undeformed left upper A-pillar measured 35 degrees. The rearward displacement of the right upper shock absorber tower measured 65 cm (25.6 in). The left upper shock tower was displaced 10 cm (4.1 in). The residual frontal crush documented along the bumper reinforcement was as follows: C1 = 46 cm (18.1 in), C2 = 86 cm (33.9 in), C3 = 94 cm (37.0 in), C4 = 104 cm (40.9 in), C5 = 117 cm (46.1 in), C6 = 110 cm (43.3 in). The maximum crush was 117 cm (46.1 in) at C5. The right wheelbase was reduced 86 cm (33.8 in). The left wheelbase was reduced 12 cm (4.7 in). The front right door crushed 48 cm (19 in), bowed outboard and was jammed closed. The right rear door and the left doors remained closed during the impact. These were opened by the first responders and could not be relatched due to body deformation. The windshield was fractured. The front left and front right glazings disintegrated. The rear left, backlight and rear right glazings were intact. The CDC of the Hyundai was 12-FDEW5.

Figure 12: Front view of the Hyundai.

Figure 13: Right lateral view of the frontal deformation.

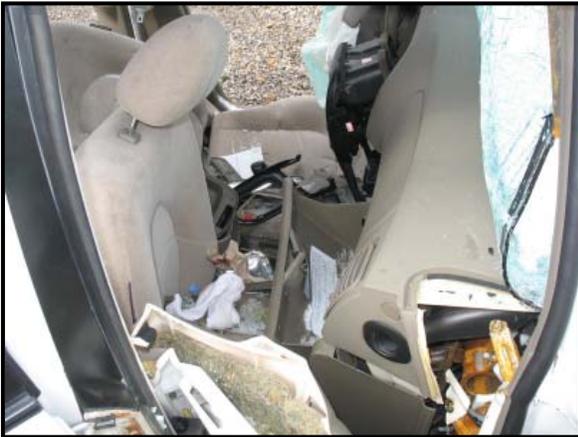
The interior of the Hyundai sustained severe right side intrusion. **Figure 14** is a right lateral view across Row 1. The right floor pan deformed and buckled vertically. The tow pan was crushed rearward to the leading edge of the front right seat cushion. The intrusion of the right instrument panel measured 51 cm (20 in). The horizontal distance from the front right seat back to the face of the instrument panel measured (17 in). The right floor pan deformed due to the extent of frontal crush. The floor pan deformation resulted in the inboard displacement of the front right seat relative to its original location. The upper aspect of the front right seat back and head restraint rotated inboard approximately 30 cm (12 in). The front right head restraint was raised at the time of the crash. The outboard aspect of the head restraint was raised 5 cm (2 in). However, the inboard aspect of the head was raised approximately 4 cm (1.5 in). The inboard aspect was lower due to a possible rebound head contact by the driver (**Figure 15**).

Figure 14: Hyundai front right interior.

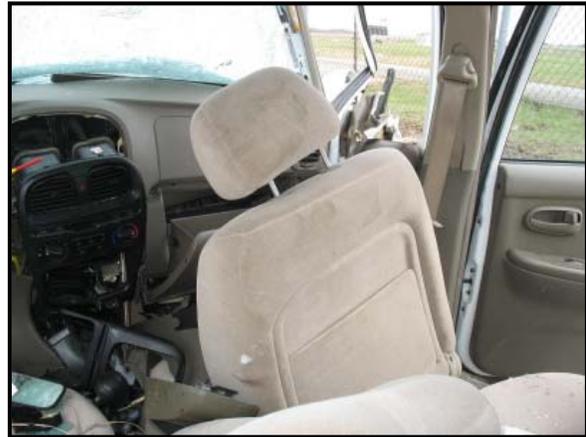
Figure 15: View of the Hyundai's front right head restraint.

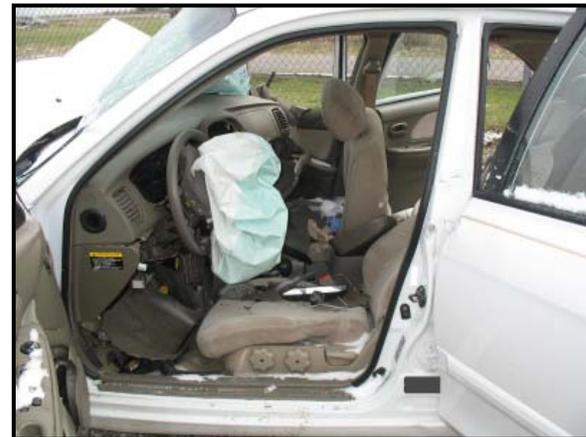
Figure 16 is a left lateral view of the driver compartment. The driver seat was adjusted to a full rear track position. The seat cushion was deformed vertically downward from driver loading. The seat back was reclined 45 degrees at the time of the SCI inspection and appeared to have been moved to that position by the first responders. The center aspect of the toe pan intruded to the brake pedal, an estimated 10 cm (4 in). There was no left instrument panel intrusion.

Figure 16: Left lateral view of the Hyundai's intrusion.

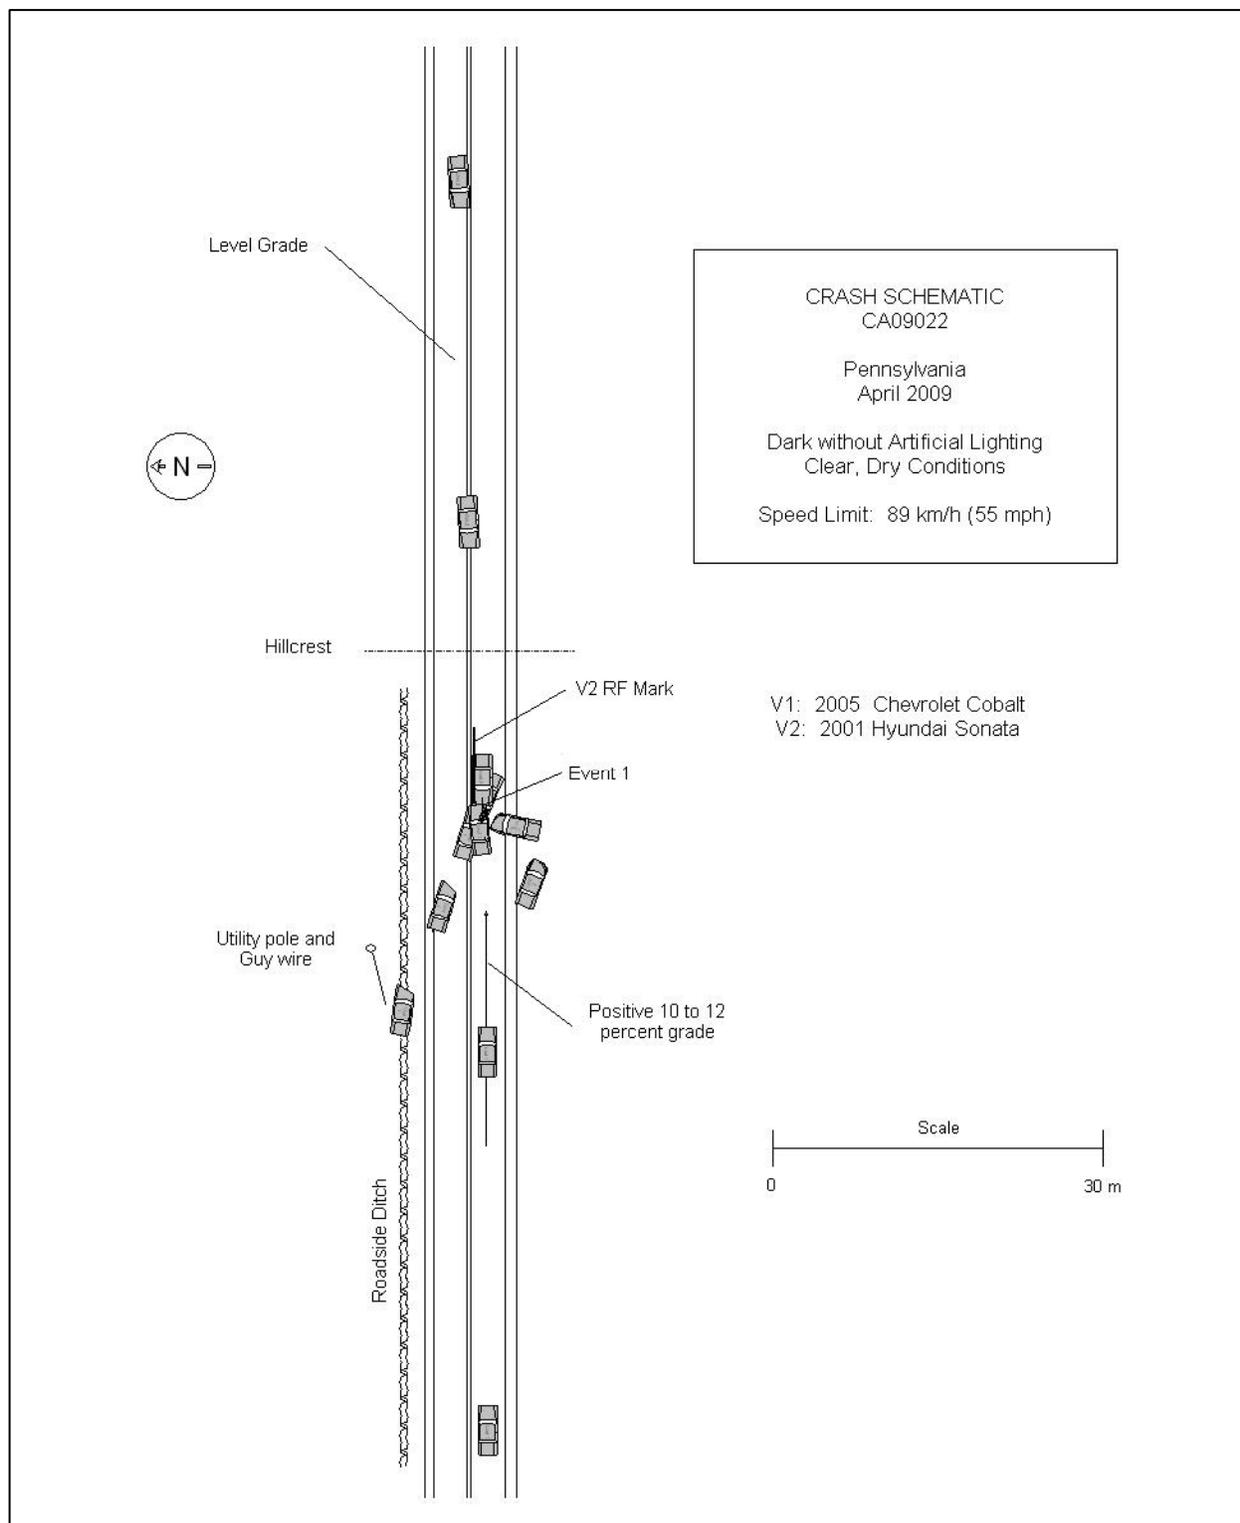
Figure 17: Crash schematic.

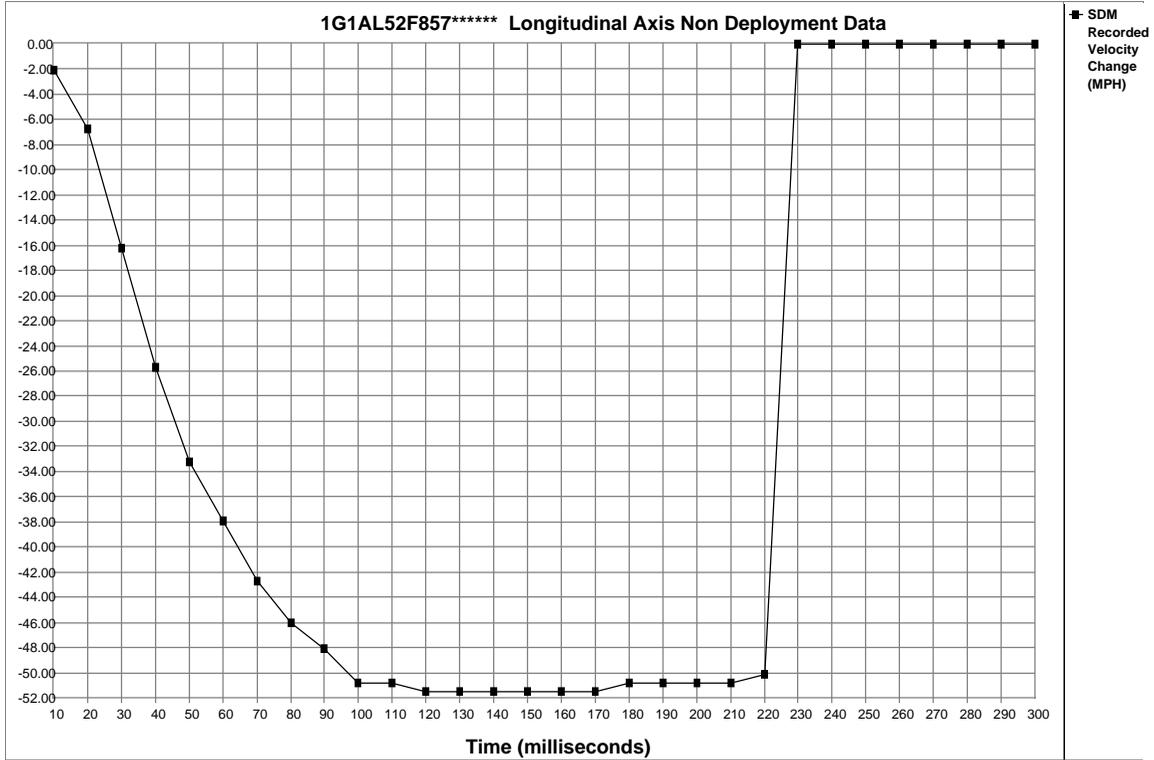
Time (milliseconds)	10	20	30	40	50	60	70	80	90	100	110	120	130	140	150
SDM Longitudinal Axis Recorded Velocity Change (MPH)	-2.03	-6.78	-16.26	-25.75	-33.21	-37.95	-42.69	-46.08	-48.12	-50.83	-50.83	-51.50	-51.50	-51.50	-51.50
Time (milliseconds)	160	170	180	190	200	210	220	230	240	250	260	270	280	290	300
SDM Longitudinal Axis Recorded Velocity Change (MPH)	-51.50	-51.50	-50.83	-50.83	-50.83	-50.83	-50.15	0.00	0.00	0.00	0.00	0.00	0.00	0.00	0.00

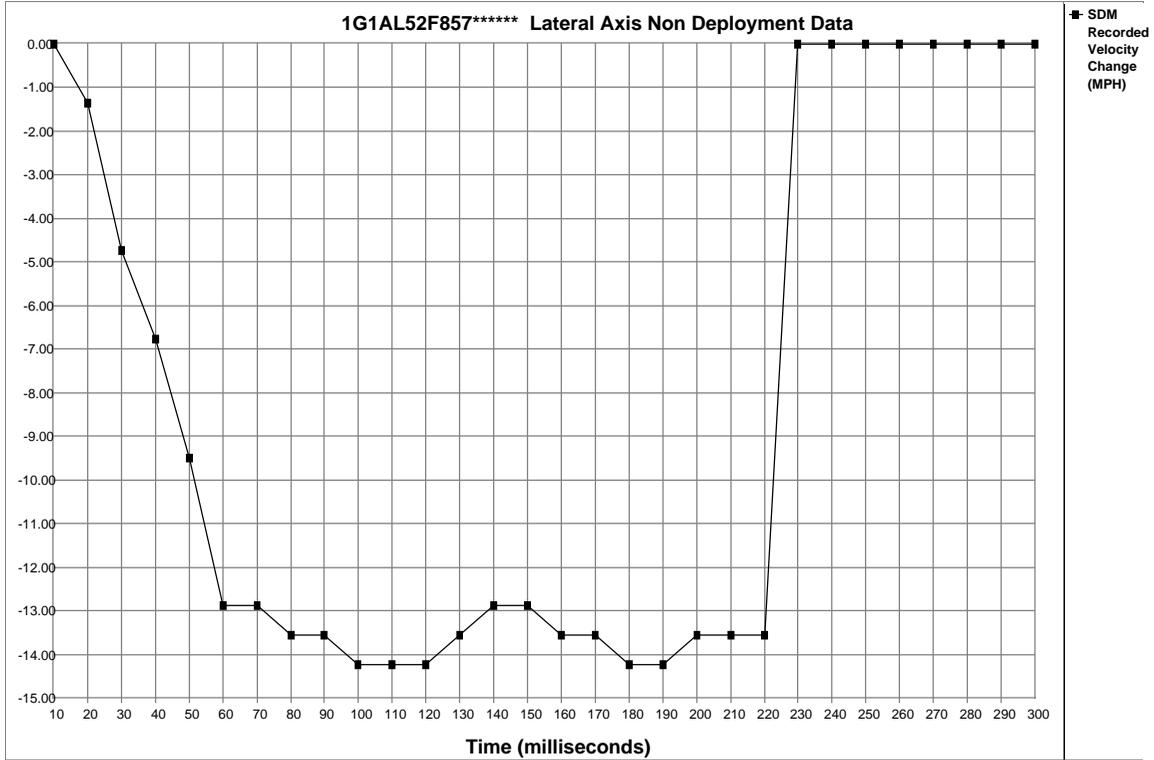
Time (milliseconds)	10	20	30	40	50	60	70	80	90	100	110	120	130	140	150
SDM Lateral Axis Recorded Velocity Change (MPH)	0.00	-1.36	-4.74	-6.78	-9.49	-12.88	-12.88	-13.55	-13.55	-14.23	-14.23	-14.23	-13.55	-12.88	-12.88
Time (milliseconds)	160	170	180	190	200	210	220	230	240	250	260	270	280	290	300
SDM Lateral Axis Recorded Velocity Change (MPH)	-13.55	-13.55	-14.23	-14.23	-13.55	-13.55	-13.55	0.00	0.00	0.00	0.00	0.00	0.00	0.00	0.00
