# CENTER FOR AUTO SAFETY

**Massachusetts State Police**  
**Collision Analysis and Reconstruction Section**  
**Collision Reconstruction Report**

<b>CASE #</b>	2013-CAR-000404
<b>Related Case#</b>	2013-0B3-006595

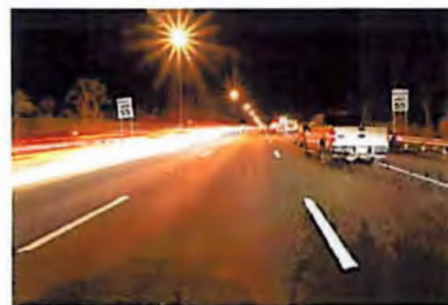
***Photograph One***

The posted speed limit for Interstate Route 91 northbound approaching the crash scene is 65 miles per hour, decreasing to 55 miles per hour at the crash scene with signs posted within the scene. This scene is fairly and accurately depicted in *Exhibit One, Image One,* and *Photograph One*. Interstate Route 91 in Longmeadow, Massachusetts is designated a public way by Massachusetts General Law C. 90 § 1. It is maintained by the Massachusetts Department of Transportation. It is patrolled by the primary agency of jurisdiction, the Massachusetts State Police – Springfield substation.

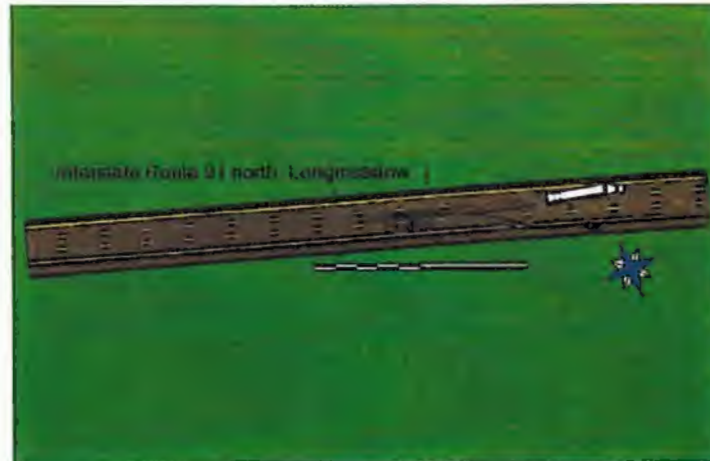
#### *Exhibit Two*

**Post impact:** Vehicle #1 left skidmarks beyond the area of impact and scraping from the area of impact toward its position of final rest. Vehicle #2 left scrapes from its left rear damage, a scuff mark with striations from its left front tire in the right lane, and scraping along the guardrail. Both vehicles remained at their positions of uncontrolled final rest. Operator #2 was found in the breakdown lane outside of his vehicle.

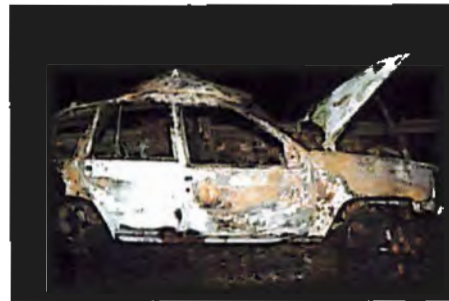
*Photograph Three*

Vehicle # 2 received the following damage, as depicted in *Photograph Three*, during the crash:

- Left front door
- Roof
- Left rear door
- Left quarter panel
- Right quarter panel
- Left and right C pillars
- Right rear door
- Right front door
- Rear floor
- Rear seats
- Driver's seat

On Monday, 25 November 2013 Trooper Mazza of the State Fire Marshall's Office assisted me in examining vehicle #2 for evidence of fuel tank failure. Vehicle #2 had a fissure in the sheet metal beneath the left rear seat. This fissure may have permitted gasoline from the ruptured fuel tank to enter the passenger compartment. Tpr Mazza is preparing a report.

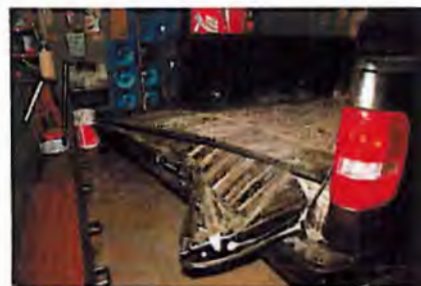
*Photograph Five*

Vehicle # 3 received the following damage, as depicted in *Photograph Five*, during the crash:

- Rear tailgate
