A Detailed Electronic Mechanism for Sudden Unintended Acceleration

Ronald A. Belt
Plymouth, MN 55447
2 August 2012

Abstract: An electronic cause for sudden unintended acceleration was discussed in a previous paper. The cause was attributed to a negative voltage spike on the battery supply line leading to a brownout error that causes faulty operation of the CPUs, keep-alive memory, and/or EEPROM memory, resulting in a data error that causes unpredictable engine operation, such as sudden acceleration. While this cause explained many observations associated with sudden acceleration, the theory was incomplete because it never identified the precise hardware or software fault producing the data error. In this paper a mechanism for this data error is presented. The mechanism involves a sudden change in the correction value that is used to adjust the PWM duty cycle applied to the throttle motor to compensate for variations in the battery voltage. The evidence for and against this mechanism is discussed.

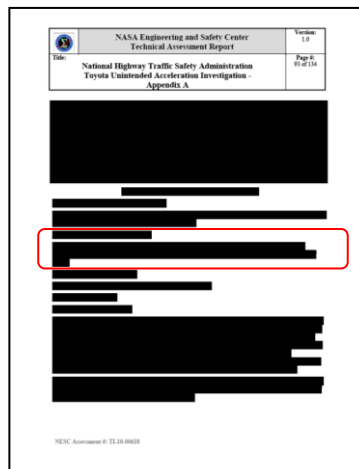
Fig 2. Page 93 of the NASA final report, Appendix A – Software⁴

The duty cycle conversion modifies scales the command based on the battery voltage and converts the signal to a duty cycle percentage. The duty cycle conversion operates at a rate of 16ms.

At first glance, this statement seems innocent enough given that the PID controller output must be converted into a duty cycle in order to control the throttle motor. However, the reference to “scaling the command based on battery voltage” immediately raises a red flag. This means that the PID output is multiplied by a constant which, if its value is incorrect, can cause the throttle to increase or decrease suddenly without an input from the driver. This constant is determined from a sensor output (voltage sensor) that is not redundant and that might have negative voltage spikes on it according to the author’s previous paper. Moreover, the multiplication operation occurs at a point in the system where it constitutes a single point of failure, has no diagnostics associated with it, and has no fail-safe mode identified. This operation required a closer look to understand its purpose and to see if it can produce sudden acceleration.

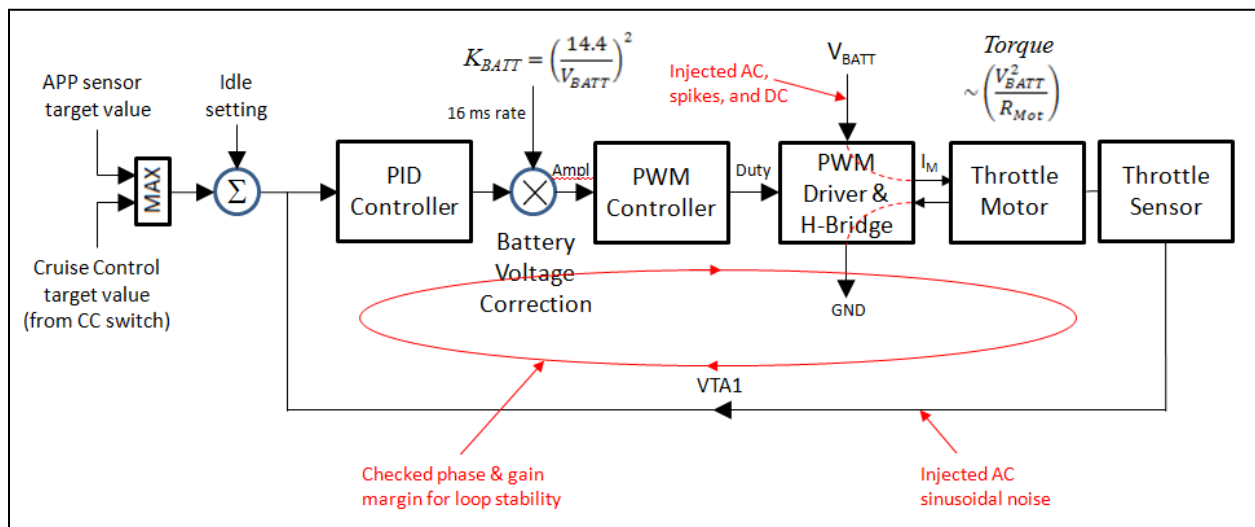
Purpose of Duty Cycle Voltage Compensation. Figure 3 shows a more detailed block diagram of the functions in an electronic throttle system. The throttle motor operates against the force of a spring which pulls it back to the limp home position when power to the motor is turned off. The throttle motor is a permanent magnet DC motor with brushes that is powered by battery current applied through an H-bridge. The battery current is turned on and off (i.e., modulated) by the PWM controller, which controls the duty cycle of the current through the motor. A higher duty cycle produces a larger motor torque, causing the throttle motor to open the throttle further and produce a higher engine speed. The motor torque is proportional to the motor current, which is given by $I = V_{BATT}/R_{mot}$, where V_{BATT} is the applied voltage and R_{mot} is the motor resistance. The motor speed is proportional to the applied voltage, V_{BATT} . The motor power P is given by $P = IV = V_{BATT}^2/R_{mot}$. Therefore, the throttle motor power varies with the square of the battery voltage. The throttle motor power determines how fast the throttle will open in response to the driver’s command. This means the throttle will open more slowly at lower battery voltages because there is less power to oppose the return spring. This has the undesirable effect of causing the engine to lag under acceleration when the battery voltage is low. To prevent this change in accelerator response from occurring, the output of the PID controller is multiplied by a constant $K_M = (14.4V/V_{BATT})^2$, which cancels out the battery voltage dependence by normalizing the throttle motor current to a constant 14.4 volts. Figure 4 shows that this duty cycle correction factor can vary from 1 at a battery voltage of 14.4V to as much as 3.2 at a battery voltage of 8.0V.

Fig 3. Detailed block diagram of the throttle motor control loop showing the battery voltage correction function.

3. Constitutes a single point of failure. Fig 3 shows that the output of the PID controller is a single amplitude value which gets converted into a PWM duty cycle that is used to control the on-time of the transistors in an H-bridge, which thereby control the duty cycle of the current in the throttle motor. Therefore, the single amplitude value produced by the PID controller is a single point of failure that can produce a throttle opening fault as a result of just one error in amplitude value. There is no need to have multiple faults, as is necessary with tin whiskers causing errors in the accelerator pedal sensor.

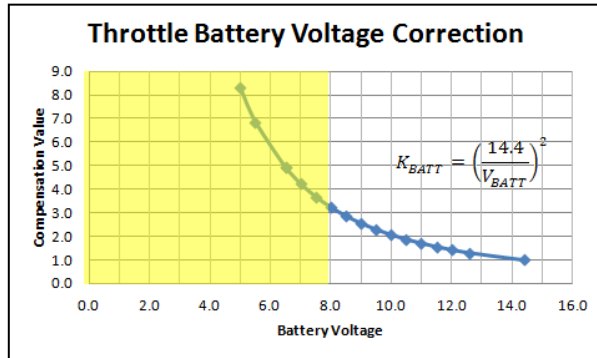
Fig 4. Example duty correction calculated using the formula shown (normalized to 1 at 14.4V).

4. Increases PID gain by $\leq 3x$ at idle for spikes $\leq 8V$. Fig 4 shows that the battery voltage correction factor is 3.2 at a battery voltage of 8V. This means that the PID gain can be multiplied by 3.2x for voltage spikes as low as 8V. If there is a lack of coincidence between the increase in PID gain and the decrease in throttle motor gain, then there will be a net increase in the PID loop gain by a factor of 3.2x. Voltage spikes between 12.6V and 8.0V will produce smaller increases in PID gain.

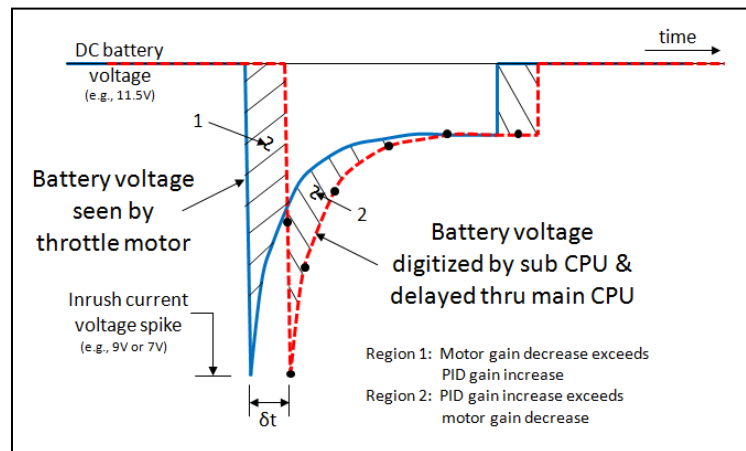
Duty Cycle Voltage Correction with Spikes on the Battery Supply Line. Let’s now look at what happens to the duty cycle voltage correction process when a negative voltage spike is encountered on the battery supply line. This case is shown in Figure 6. The negative voltage spike very quickly affects the throttle motor and lowers its gain due to the lower battery voltage seen by the throttle motor, as shown by the blue line in Fig 6. The same spike is also digitized by the sub-CPU at some random point on the spike because the spike is not synchronous with the A/D conversion interval, as shown by the red line in Fig 6.

Fig 6. Conceptual diagram showing how a delay in applying the battery correction value can cause the PID gain increase to exceed the throttle motor gain decrease causing the PID controller to increase the throttle setting⁵

The digitized spike voltage is then converted into a gain correction value that is used to increase the gain of the PID controller, which produces an increase in the PWM duty cycle by the same gain factor. If there is no delay in calculating the duty cycle correction value, then the duty cycle increase applied to the motor coincides with the battery voltage decrease at the motor, and the two gain changes cancel, leaving the motor torque unchanged. This corresponds to the two curves in Fig 6 being superimposed on one another. However, if there is any delay in calculating the duty cycle correction value, then the two gain changes will not coincide, producing a decrease in the throttle motor gain followed by an increase in the PID controller gain as shown by the two oppositely shaded areas in Fig 6. This is equivalent to a net decrease in the control loop gain followed by a net increase in the control loop gain, which can amount to a factor of three gain change in each direction as we saw in Fig 4. This will produce a sudden decrease in throttle motor torque followed by a sudden increase in torque, which corresponds to a sudden increase in engine RPM. Large voltage spikes will produce large duty cycle correction values that, if they are not coincident with the drop in motor gain, can lead to large increases in engine RPM as found in some sudden acceleration incidents. Smaller voltage spikes will produce smaller duty cycle correction values that, if they are not coincident with the drop in motor gain, can lead to smaller increases in engine RPM as found in most other sudden acceleration incidents. If a large voltage spike causes the throttle increase to exceed about 88% of full throttle, then there is a chance that the throttle will stay above 88%, leading to a long term sudden acceleration incident. Smaller voltage spikes produce less of a throttle increase which may last only a short time. These are frequently interpreted as surging or lunging incidents.

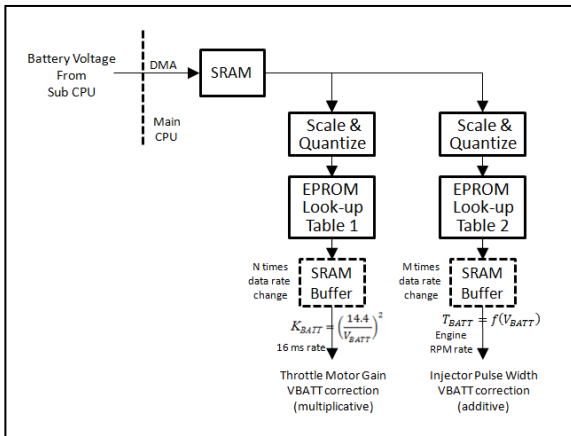
Fig 7. Algorithm flow for one way of calculating the duty cycle battery voltage correction value. The SRAM buffers save ALU throughput.

The duty cycle correction value may be calculated in the same way by using a different look-up table as shown in Figure 7. It is also possible to calculate the duty cycle correction value directly using arithmetic operations inside the ALU as shown in Figure 8 because its functional dependence on the battery voltage is known. In either case the duty cycle correction value may be used directly to modify the PID controller output as shown in Fig 3, or it may be stored in an SRAM buffer temporarily from which it can be extracted repeatedly and used each PID loop cycle (every 16 milliseconds). As with the other correction value, temporarily storing the duty correction value in an SRAM buffer has the advantage of eliminating repetitive look-up table or ALU operations that can occupy ALU throughput that may be better applied to other engine control applications.

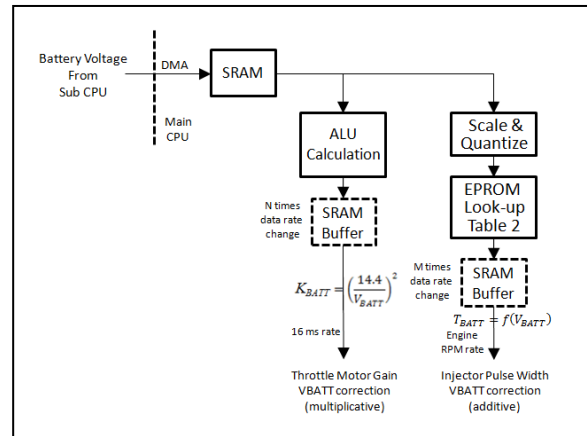
Fig 8. Algorithm flow for a second way of calculating the duty cycle battery voltage correction value. The SRAM buffers save ALU throughput.
