U.S. Department
of Transportation
National Highway
Traffic Safety
Administration

Subject: Engineering Analysis E80-074: 1975 through 1978 Toyota Throttle Sticking Problem, All Models Date: SEP 28 1983

From: John A. Dunsmoor *John A. Dunsmoor*
Safety Defects Engineer

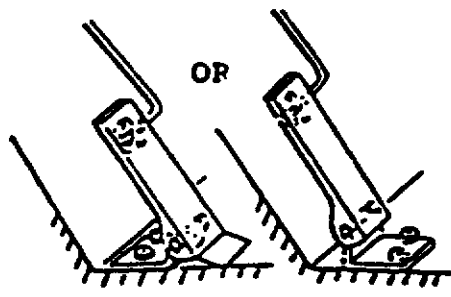
TYPE	MECHANISM	MODEL	PART NUMBER
ORGAN PEDAL TYPE (Pin Hinge)

The pin hinge organ pedal type is used in the majority of the subject vehicles. The stainless steel hinge pin and the return spring wound around the hinge pin are located at the base of the pedal. A nylon bushing is used to reduce friction. This, of the three designs used, is most susceptible to increased friction due to build-up of and corrosion in the area of the hinge pin.

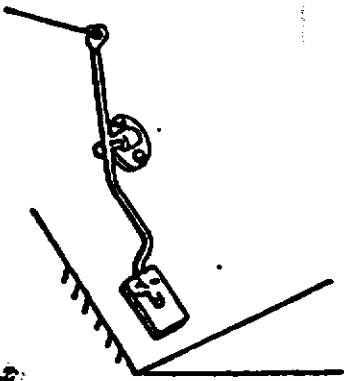
PENDANT TYPE

The pendant type pedal is not fastened to the floor. It rotates about a dash-mounted pivot bracket up and away from the floor board. This configuration prevents moisture and dirt from contacting the pivot bracket bearing.

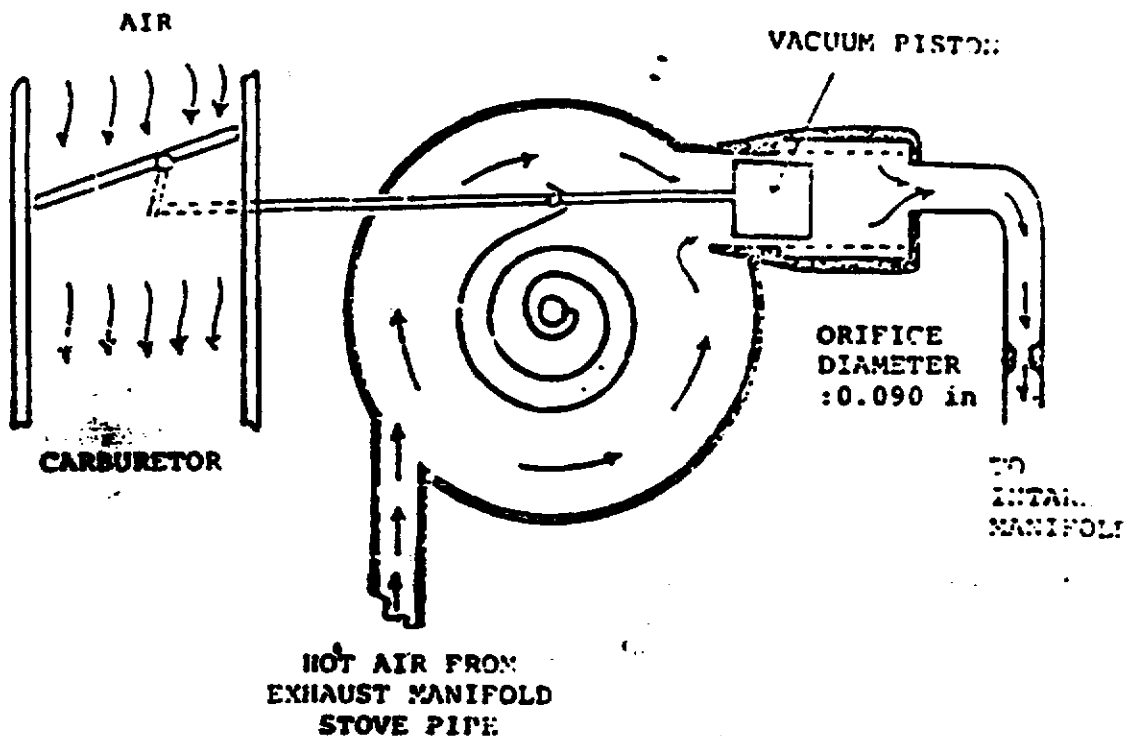
Fig. 1 Toyota Automatic Choke System

The Office of Defects Investigation computerized complaint data may be misleading due to the influence of a previous Environmental Protection Agency recall and a related ODI investigation, Case No. C5-08. That case involved poor engine performance because of a heat tube-choke problem. Fresh air passes through and is heated in a heat tube in the exhaust manifold. It is directed to the choke where it causes the bi-metallic spring to release the choke (See Figure 1). Cracking of the heat tube allows exhaust contaminants to clog the choke mechanism with resultant

effect on engine speed and performance. This condition could have resulted in a complaint of a stuck accelerator or throttle.
