July 13, 2012

RECALL REMEDY & DEFECT PETITION

The Center for Auto Safety (“CAS”) files this petition on recall 04V-583 under 49 CFR Parts 552 and 557.¹ Recall 04V-583 (Mazda Recall 2704L) covers 2002-04 Mazda Tributes, and involves a safety defect in which the accelerator cable liner migrates out of position at the dash panel and contacts the accelerator pedal arm, preventing the pedal from returning, and also preventing the throttle body from returning to the idle position. The other end of the accelerator cable is attached to the throttle body cam in the engine alongside a speed (cruise) control cable which may be damaged by the 04V-583 recall repair or the cruise cable may fail on its own. Either can result in sudden unintended acceleration (SUA). Mazda initiated this recall based on Ford Recall 04V-574, which involved identical failures in the Ford Escape, the Mazda Tribute’s twin. CAS filed a recall remedy and defect petition on the Escape on July 8 incorporated herein by reference.²

SUBJECT: Safety Recall 04S25: *Update*
All 2002 through 2004 Model Year Left Hand Drive (LHD) Escape Vehicles Equipped
with 3.0L Engines
Accelerator Cable Replacement

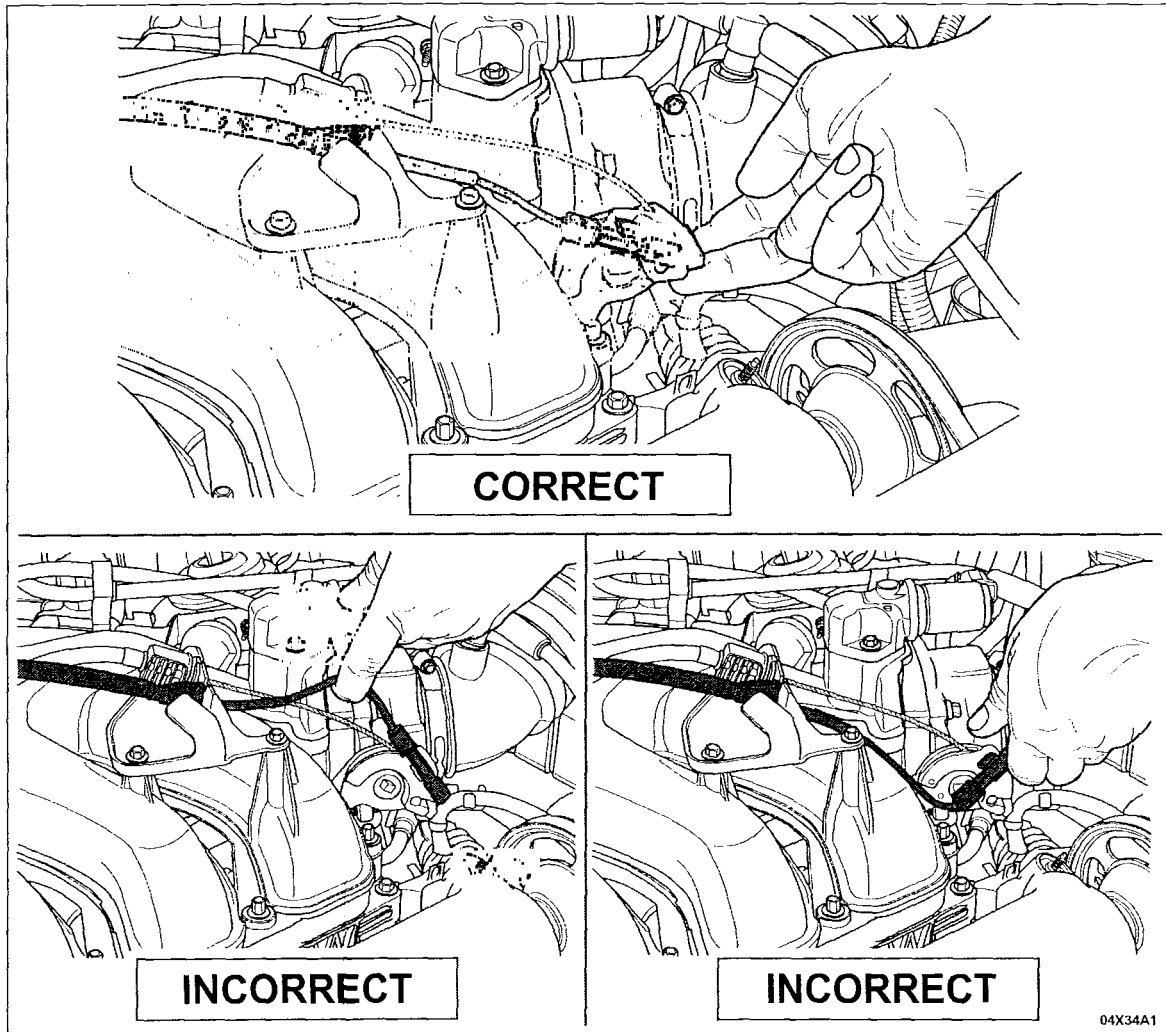
FIGURE 1

CAUTION: Damage to the speed control cable may result if the throttle body cam is rotated by lifting up on the speed control cable or the speed control cable connector end. When disconnecting the accelerator cable from the throttle body, rotate the throttle body cam only by lifting up on the cam itself. See Figure 1.
