#### FOIA REQUEST

FINAL REPORT: "2007 Lexus ES-350 Unintended

#### VRTC MEMORANDUM REPORT EA07-010 VRTC-DCD-7113

#### 2007 Lexus ES-350 Unintended Acceleration

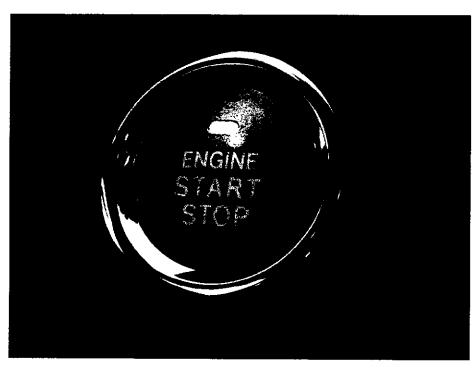
- 3.3.2 Turning off the ignition In place of an ignition key, the ES-350 uses an ignition button that removes the ability to instantaneously shut off the engine in the event of an emergency while the vehicle is in motion (see Figure 6). It was found that depressing and holding the button will eventually turn off the engine after three seconds. Through the survey it was learned that the button delay operation is not widely known by owners and because of this, drivers found themselves unable to turn off the engine when the vehicle was in motion. The owner's manual makes general mention of the operation, but there is no indication of the three second hold requirement.

- The owner survey indicated the 3 second delay in the operation of the ignition button is not widely known by owners and because of this, drivers found themselves unable to turn off the engine when the vehicle was in motion.

Figure 6 - Push Button Ignition Replaces Conventional Key

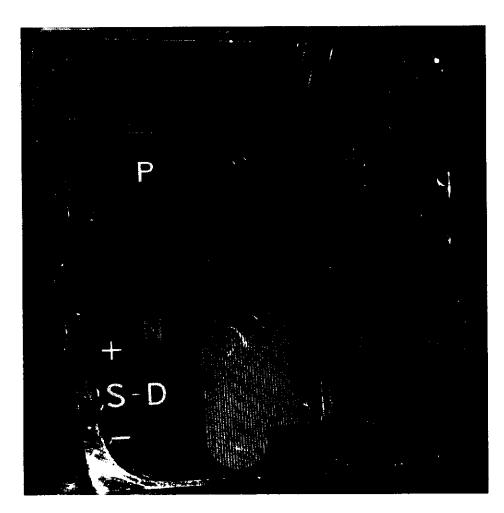
- 3.3.3 Placing the vehicle in Neutral Many owners complained that the neutral gear position in the gated shift pattern was not immediately obvious, leading to unsuccessful attempts to disengage the engine from the drive wheels. On the labeled shift diagram located on the console, the Neutral "N" marking is in closest proximity to the "Sport" mode upshift gate (see Figure 7).

- Many owners complained that the neutral gear position in the gated shift pattern was not immediately obvious, leading to unsuccessful attempts to disengage the engine from the drive wheels.

Figure 7 – Shift Gate with Diagram

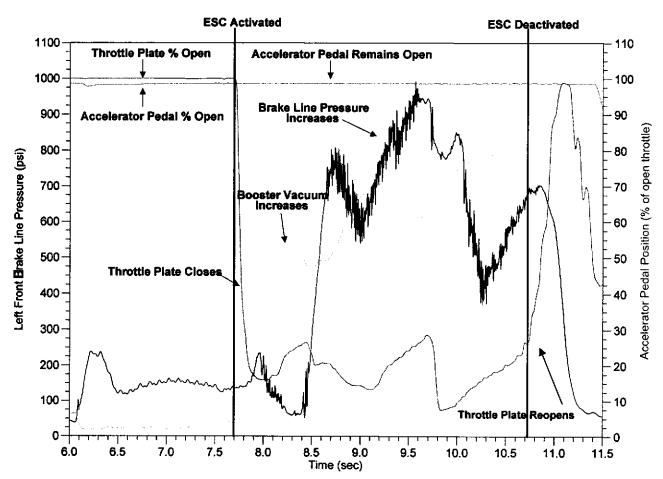
- 3.3.4 Activation of Electronic Stability Control (ESC) It was discovered that if an emergency maneuver is executed that activates the Electronic Stability Control, such as steering around a sharp curve while traveling at an excessive speed, the electronic throttle is temporarily electronically closed by the vehicle control module regardless of the accelerator pedal position. With the throttle plate closed, vacuum quickly returns to the brake booster and provides a significant increase in braking capability (see Figure 8). Additionally, ESC has the capability to automatically apply hydraulic pressure to the service brakes to aid in slowing the vehicle. When the emergency maneuver is concluded however, the ESC system returns to a passive state, and the throttle again returns to an open condition leading to further unwanted acceleration.

- o ESC activation may restore vacuum to the brake booster, providing a significant increase in braking capability, but only until ESC activity ceases.

Figure 8 - Data Acquired from Lexus During Testing Indicates Engine Throttle is Overridden During ESC
