Subject: FINAL REPORT: "2007 Lexus ES-350 Unintended  
Acceleration"

**VRTC MEMORANDUM REPORT EA07-010  
VRTC-DCD-7113**

**2007 Lexus ES-350 Unintended Acceleration**

This program was performed at the Vehicle Research and Test Center (VRTC) at the request of the Office of Defects Investigation (ODI) of the National Highway Traffic Safety Administration. ODI opened an Engineering Analysis (EA07-010) on 2007 Lexus ES-350 vehicles to investigate reports of unintended acceleration.

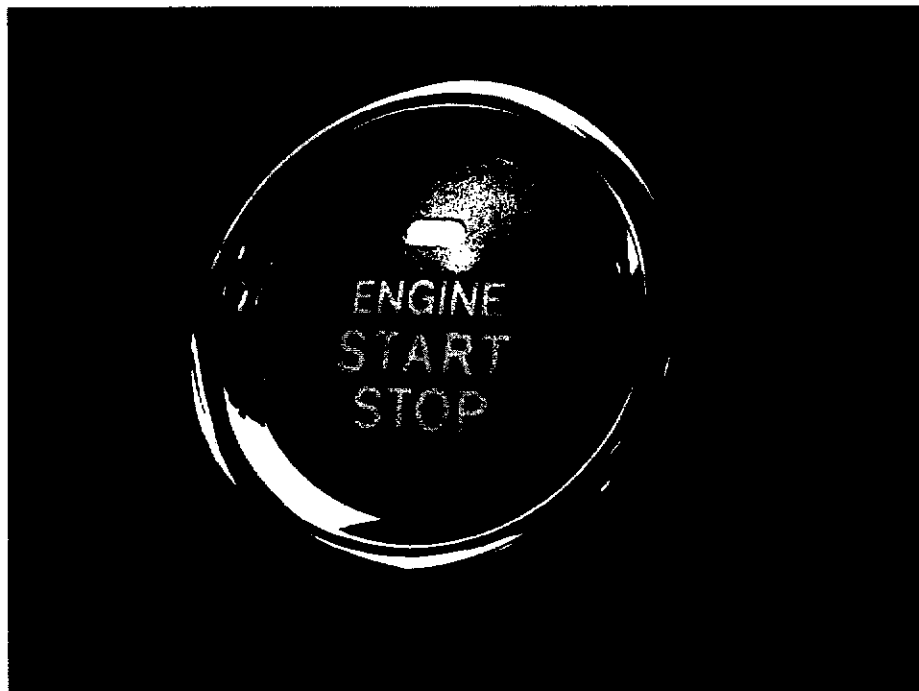
- 3.3.2 Turning off the ignition - In place of an ignition key, the ES-350 uses an ignition button that removes the ability to instantaneously shut off the engine in the event of an emergency while the vehicle is in motion (see Figure 6). It was found that depressing and holding the button will eventually turn off the engine after three seconds. Through the survey it was learned that the button delay operation is not widely known by owners and because of this, drivers found themselves unable to turn off the engine when the vehicle was in motion. The owner's manual makes general mention of the operation, but there is no indication of the three second hold requirement.

- The owner survey indicated the 3 second delay in the operation of the ignition button is not widely known by owners and because of this, drivers found themselves unable to turn off the engine when the vehicle was in motion.

**Figure 6 - Push Button Ignition Replaces Conventional Key**

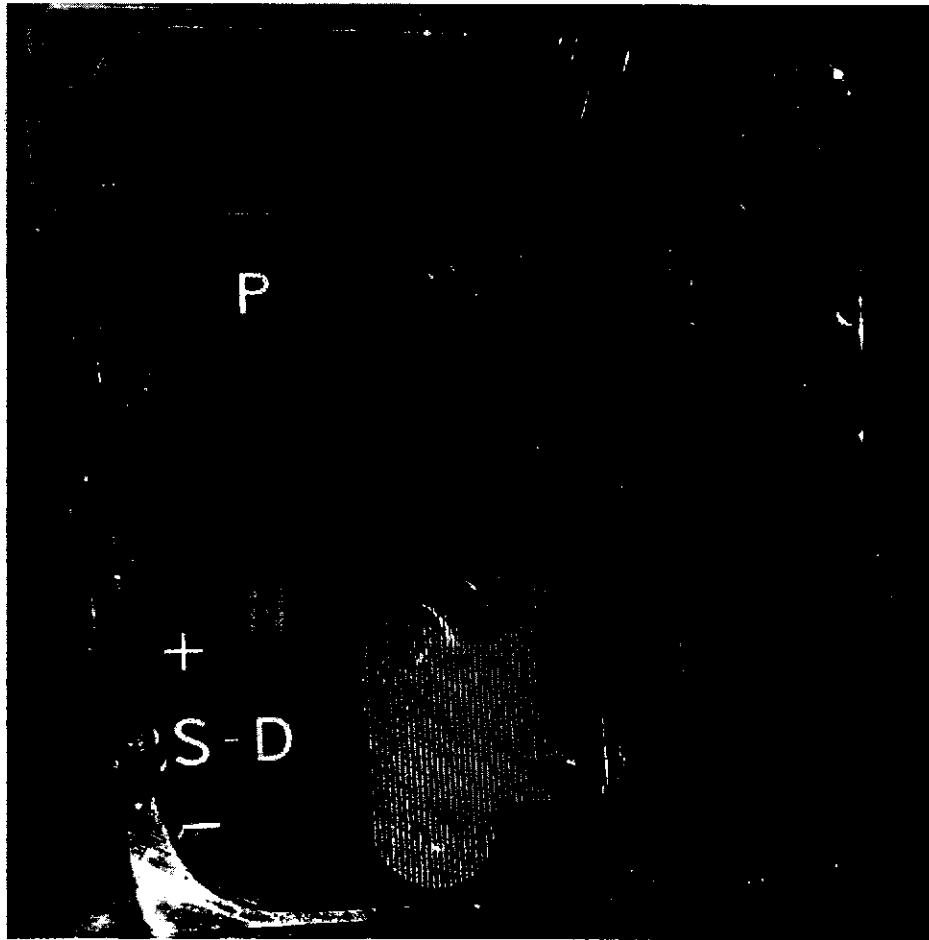
- 3.3.3 Placing the vehicle in Neutral - Many owners complained that the neutral gear position in the gated shift pattern was not immediately obvious, leading to unsuccessful attempts to disengage the engine from the drive wheels. On the labeled shift diagram located on the console, the Neutral "N" marking is in closest proximity to the "Sport" mode upshift gate (see Figure 7).

- Many owners complained that the neutral gear position in the gated shift pattern was not immediately obvious, leading to unsuccessful attempts to disengage the engine from the drive wheels.

**Figure 7 - Shift Gate with Diagram**

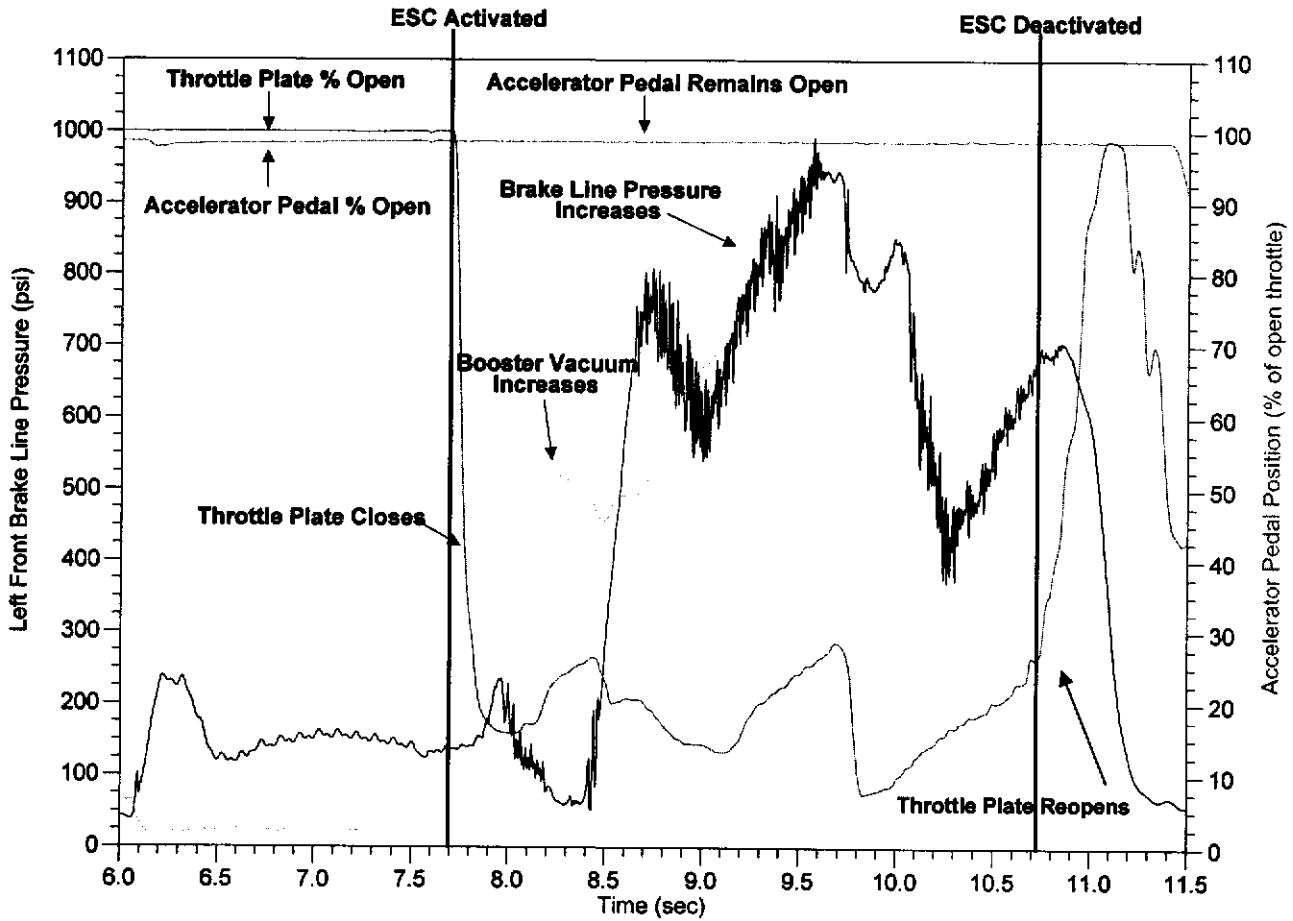
- 3.3.4 Activation of Electronic Stability Control (ESC) - It was discovered that if an emergency maneuver is executed that activates the Electronic Stability Control, such as steering around a sharp curve while traveling at an excessive speed, the electronic throttle is temporarily electronically closed by the vehicle control module regardless of the accelerator pedal position. With the throttle plate closed, vacuum quickly returns to the brake booster and provides a significant increase in braking capability (see Figure 8). Additionally, ESC has the capability to automatically apply hydraulic pressure to the service brakes to aid in slowing the vehicle. When the emergency maneuver is concluded however, the ESC system returns to a passive state, and the throttle again returns to an open condition leading to further unwanted acceleration.

- Brake pedal force in excess of 150 pounds was required to stop the vehicle, compared to 30 pounds required when the vehicle is operating normally.
  - ESC activation may restore vacuum to the brake booster, providing a significant increase in braking capability, but only until ESC activity ceases.

Figure 8 – Data Acquired from Lexus During Testing Indicates Engine Throttle is Overridden During ESC
