Sudden Unintended Acceleration in an All-Electric Vehicle

Ronald A. Belt
Plymouth, MN 55447
27 February 2015

Abstract: Six sudden unintended acceleration incidents have been reported with Tesla's Model S all-electric vehicle following its introduction in 2012. The cause of these incidents is explained by a runaway condition in the traction motor controller that is precipitated by a negative voltage spike on the battery supply line. This explanation is very similar to the author's explanation for a runaway condition in the electronic throttle controller of gasoline engines, which explains the cause of sudden unintended acceleration in vehicles having electronic throttles. The root cause of the problem is explained, and potential solutions are discussed.

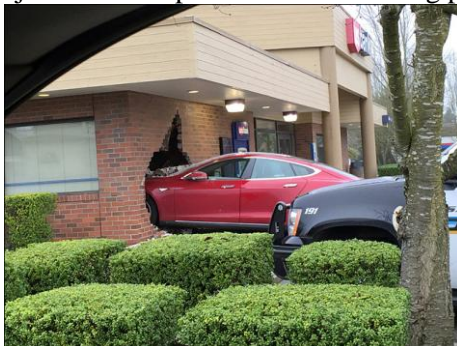
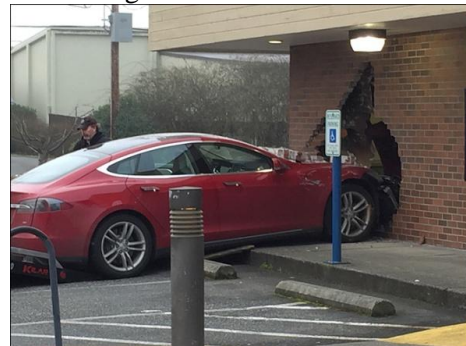
1. Incident #1. February 15, 2015. Crash into an Issaquah, Washington, bank building. The crash occurred at 9:00 a.m. while the driver was parking his car in front of the bank so he could use an ATM machine. The car jumped the curb and crashed through the brick wall of the bank building. No injuries were reported. The following photos show the damage done.³

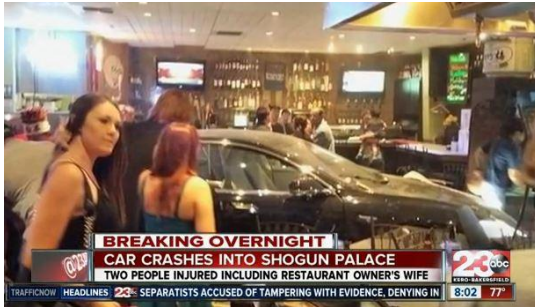
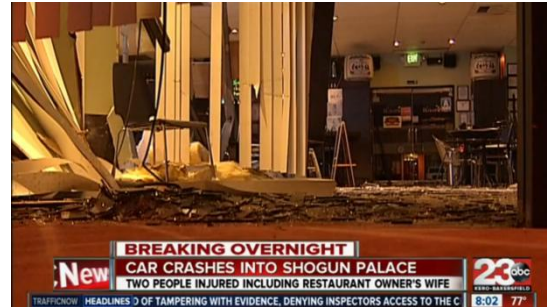
2. Incident #2. August 2014. Crash into a Bakersfield, California, sushi restaurant. The crash occurred at 9:30 p.m. on a Saturday evening, when there were about thirty customers in the restaurant. Two injuries were reported requiring hospital care, but no deaths occurred. The driver was not arrested or charged with a driving offense because police found that neither drugs nor alcohol were involved. Police speculated that the driver mistakenly hit the accelerator while trying to apply the brakes. The following photos show the restaurant and the vehicle in the restaurant.⁴

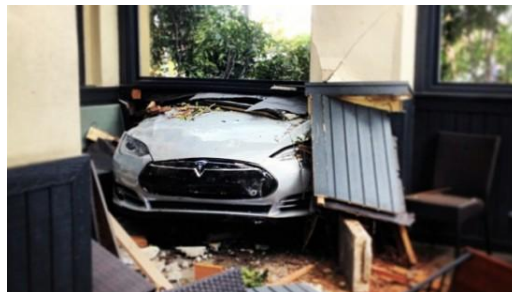
3. Incident #3. August 2013. Crash into a Camarillo (Ventura county), California, fish restaurant. The crash occurred at 11:11 a.m. when the vehicle jumped the curb and crashed into the restaurant. The driver, a 71-year old woman, claimed to have applied the brake, but the car lurched forward despite her efforts. There were four passengers in the car with the driver. The restaurant area involved was unoccupied at the time, so no injuries were reported. The following photo shows the vehicle in the restaurant.⁵

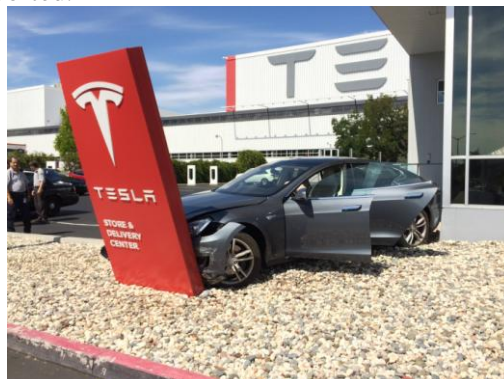
4. Incident #4. July 14, 2014. Crash into a Tesla sign in Fremont, California. The crash occurred at Tesla's supercharger battery charging station in Fremont, California. The vehicle first hit the Tesla store building, and then the Tesla sign. The following photo shows the vehicle after the crash. No injuries were reported.⁶

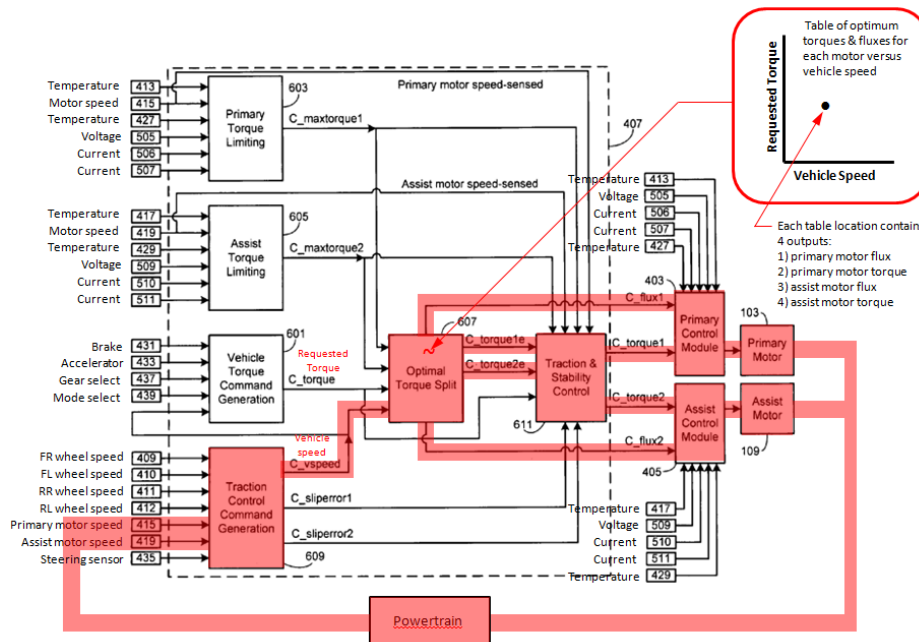
Figure 2. The Tesla Model S torque and traction controller from Tesla patent No. 7747363¹¹.

All four variations of the Tesla S vehicle use the same motor controller. A block diagram of this motor controller is shown in Figure 2. One can see that there is a control loop through the controller which uses both engine speed and wheel speed as feedback terms from the traction motors to the controller inputs, and that the loop contains a look-up table or map which has the vehicle speed as one of its inputs. The table contains torque and flux commands for both motors if two traction motors are used, but torque and flux commands for one only motor if just one traction motor is used. Since the Tesla vehicles have no torque converter, the vehicle speed is always proportional to the traction motor speed.

The controller contains a loop with a map that has vehicle speed as an input variable.

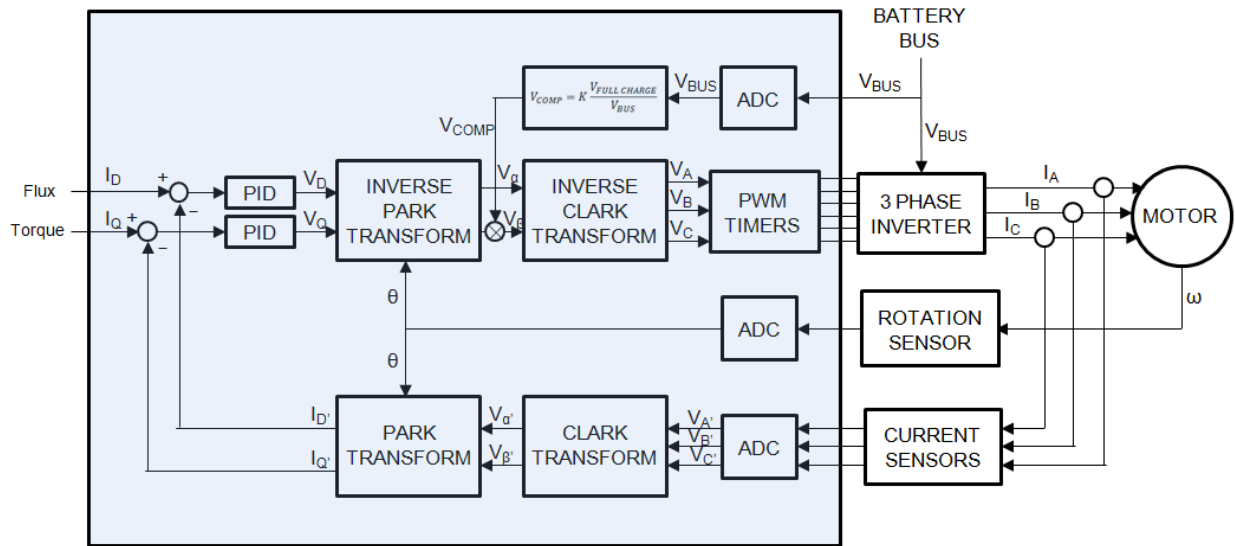
Figure 3. The Tesla S primary and assist control modules use a flux vector control algorithm to switch the three-phase inverter transistors.

transformations are used to transform coordinates between two-space and three-space. All of the flux vector control operations are carried out by a single programmable DSP chip as shown by the shaded box of Figure 3. The PWM outputs of the DSP chip are then used to switch the bipolar inverter transistors. It is assumed in Figure 3 that a rotation sensor is used to determine the motor's angle of rotation. This provides finer control at low motor speeds and at motor start-up than sensorless flux vector control units, which determine the motor's rotation angle by estimating the flux vector angle from the measured inverter currents.

The flux vector control scheme makes three-phase motor operation behave like that of a simpler DC permanent magnet motor in which the input torque command is independent of the motor flux. In both cases, the motor current is proportional to the DC battery supply voltage, making the output motor torque rise or fall with the DC battery supply voltage. In order to keep the motor torque constant while the battery supply voltage changes as the battery discharges with use, the DC supply voltage is sampled periodically and used to create a compensation coefficient that is inversely proportional to the supply voltage. This inverse compensation term is then used to multiply the input torque command on the DSP controller chip, which stabilizes the output motor torque with respect to supply voltage changes^{15,16}.

This all works correctly as long as the sampled battery bus voltage corresponds to the DC value of the supply voltage powering the inverter. But if a negative voltage spike occurs while the DC voltage is being sampled, then the sampled voltage no longer corresponds to the DC supply voltage. Instead, an incorrect voltage compensation coefficient is created which gets applied to the input torque command, causing the output motor torque to increase above the value associated with the normal supply voltage. This leads to the output motor torque being greater than the value specified by input torque command. This incrementing of the input torque command occurs each time the outer control loop in the torque and traction controller is being traversed. If the output motor torque causes the map in the control loop to issue a new torque command that is larger than the previous one because the vehicle speed is higher, then this new motor torque command will also be incremented to give an even larger output motor torque. The result will be a runaway of the motor torque to the highest possible torque value achievable by the traction motor. This can be substantial from a stopped position because the maximum torque of an electric traction motor is constant with speed down to a stopped position.

Sudden acceleration can be prevented in the Tesla Model S vehicle either by preventing negative voltage spikes from occurring during the sampling of the battery bus voltage, or by rejecting the sampled bus voltage if it has been corrupted by a negative voltage spike, and then re-sampling the battery bus voltage to get the true DC voltage value. The use of a capacitor to stabilize the bus voltage during a negative voltage spike is ineffective because the required current is too large for most capacitors of practical size. Also, the use of a separate battery bus for powering the electric traction motor is not possible as it might be with an electronic throttle motor because it requires a second battery. Therefore, rejecting corrupted samples is probably the most attractive solution. This can be done by taking multiple voltage samples at times far enough apart so that the negative voltage spikes will affect at most one sample. Then the multiple samples can be compared by various means, and the corrupted sample rejected. The remaining samples can then be used to create the DC voltage value required. There may be other techniques to determine the battery bus voltage based on monitoring the state of charge of the traction battery. These techniques could be used if they are not susceptible to corruption by negative voltage spikes.
