Unintended Acceleration/Hybrid ODI Vehicle Investigation / Vehicle to Object
Dynamic Science, Inc. / Case Number: DS07010
2005 Toyota Prius
Washington
March 2007

1. Report No. DS07010	2. Government Accession No.		3. Recipient Catalog No.	
4. Title and Subtitle Unintended Acceleration/Hybrid ODI Vehicle Investigation			5. Report Date September 24, 2007

This on-site investigation focused on the reported unintended acceleration of a 2005 Toyota Prius four-door sedan, as well as this hybrid vehicle's conformance to Federal Motor Vehicle Safety Standard, Section 571.305, Standard No.305 (Electric-powered vehicles: electrolyte spillage and electrical shock protection).

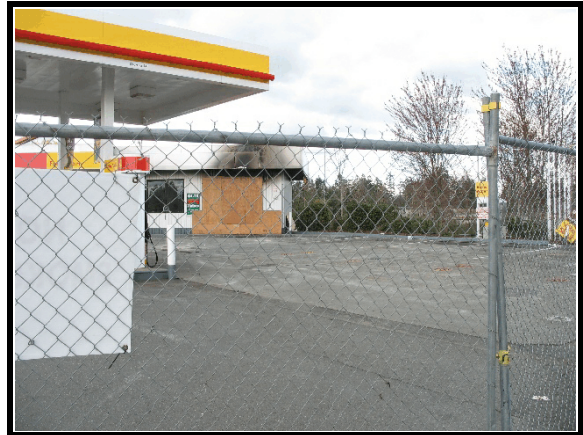
Figure 5. Impact with convenience store (fencing not present at time of crash)

The vehicle continued on and struck the convenience mart with its front end. The vehicle penetrated the store. A clerk was temporarily pinned behind a counter.

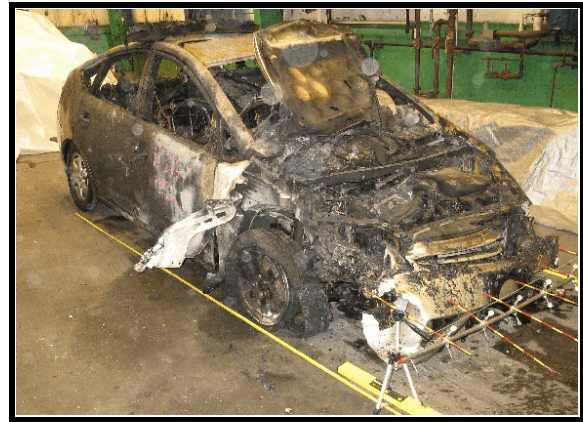
The 2005 Toyota Prius sustained moderate front end damage from the impact with the convenience store and major damage from the post-crash fire. For the frontal impact, the direct damage began at the right front bumper corner and extended across the entire end width. There was also contact damage to the right side, left side and roof that occurred as the Prius penetrated the building.

Six crush measurements were documented at the bumper level as follows: C1 = 0 cm (0 in), C2 = 1.0 cm (0.4 in), C3 = 1.0 cm (0.4 in), C4 = 2.0 cm (0.8 in), C5 = 3.0 cm (1.2 in), C6 = 27.0 cm (10.6 in). The Collision Deformation Classification (CDC) for the impact with the building was 12FDEW2. The barrier option of the WinSmash Program calculated a barrier equivalent speed of 15.3 km/h (9.5 mph). This is a borderline reconstruction since the vehicle struck a yielding object.

Figure 7. Front right, Toyota Prius

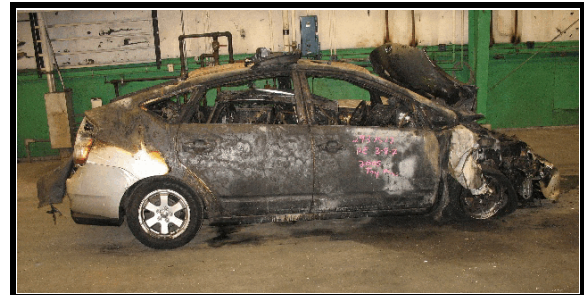
The Prius sustained burn damage on all planes. It appears likely that the heat generated by the continual brake application may have been the source of the fire. All the glazing on the vehicle was gone. All the doors were closed. They could not be opened because all the handles/grips had been carbonized in the fire and were totally frangible and broke away when any pressure was applied. The doors were later pried open by this investigator.

Figure 8. Right side view, Toyota Prius

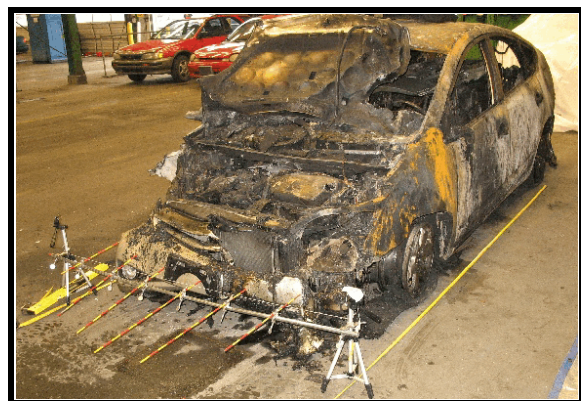
Figure 9. Front left, Toyota Prius

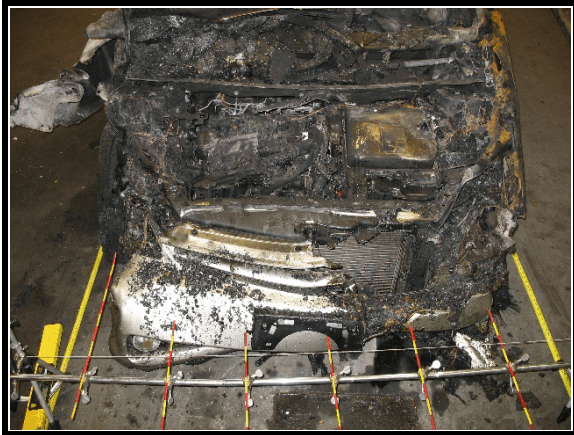
Figure 10. Overview of engine compartment

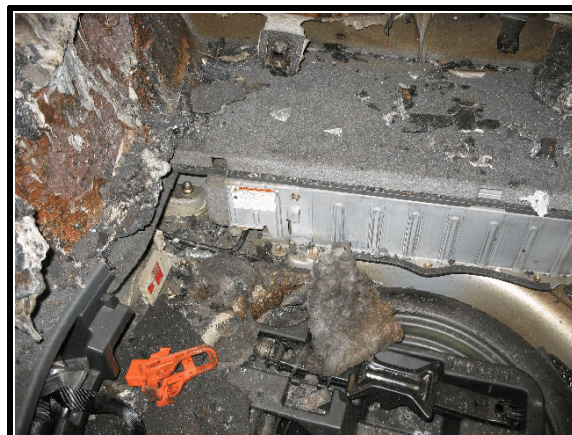
The vehicle's service plug was pulled after the crash. The service plug shuts off the high voltage circuit of the high voltage battery when this plug is removed for vehicle inspection or maintenance. Overviews of the service plug and high voltage battery location are shown on the following page. The service plug is accessed through the deck behind the rear seats. It is necessary to remove the spare tire tool package to access the plug.

Figure 15. Service plug location on case vehicle

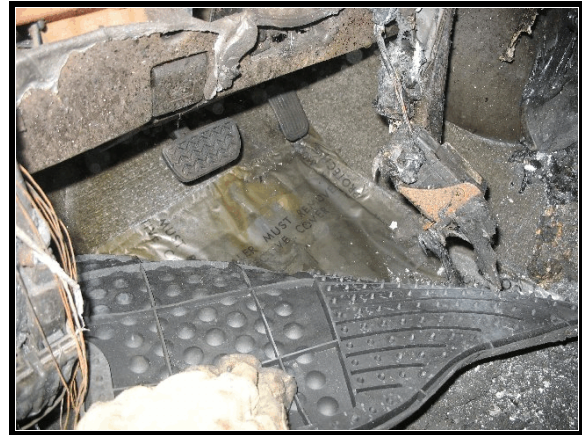
The driver of the Prius stated that the vehicle began accelerating on its own. He also stated that he could not stop the vehicle using either the parking brake or the service brakes. A rubberized all weather mat had been installed on top of the floor carpeting. The floor carpeting was covered by plastic sheeting with a printed message that stated: Dealer must remove protective cover. The rubberized floor mat was designed to be secured to the floorboard by plastic retention devices near the front of the driver's seat. The retention devices were destroyed by the vehicle fire. The interaction between the rubber mat and the accelerator pedal was examined. As the pedal was pressed down the bottom edge of the pedal became trapped by the leading edge of the rubber mat. The pedal remained trapped by the mat until freed by the investigator.

Figure 16. Plastic sheet on top of floor carpeting

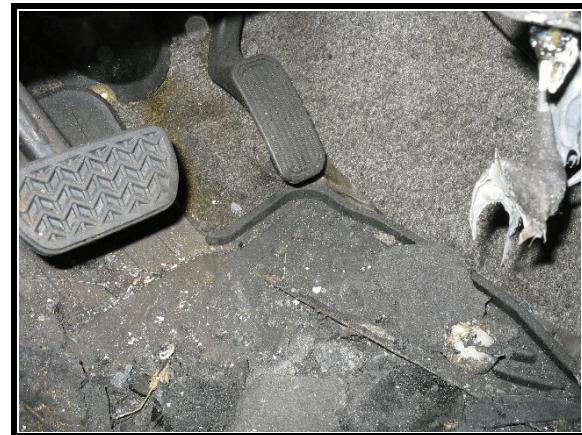
Figure 17. Pedal/mat before pressing pedal

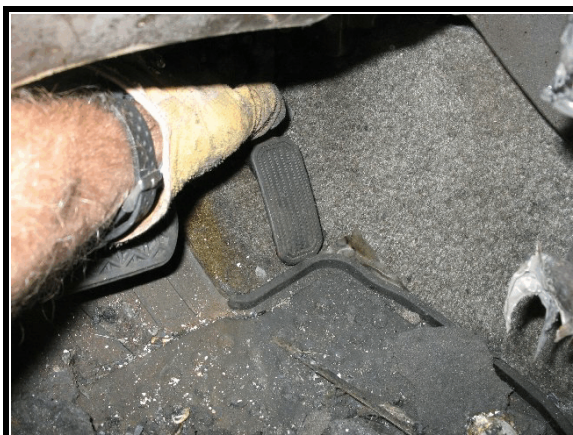
Figure 18. Pedal pressed down, trapped by mat

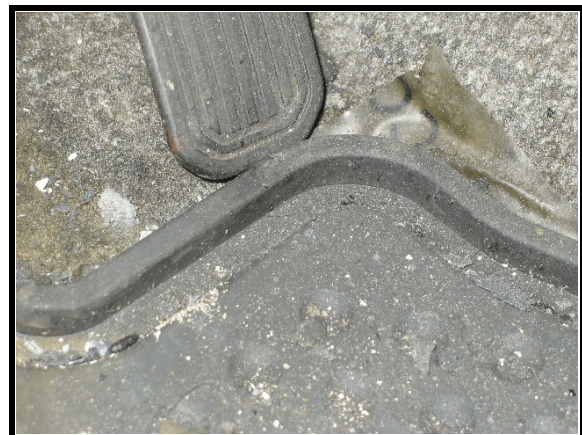
Figure 19. Close up. Pedal pressed down, trapped by mat

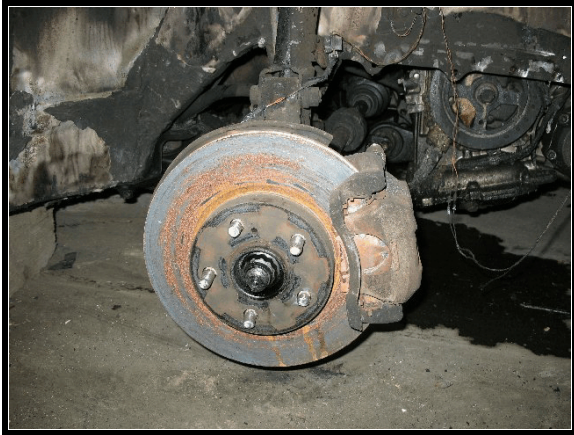
Figure 20. Right front rotor

The front brakes were removed and examined by the DSI investigator. All the brake pads exhibited wear that was consistent with the brakes being applied for a long period of time while the vehicle was at speed. The brake pads were worn down to the metal. There were also indications of excessive temperature.

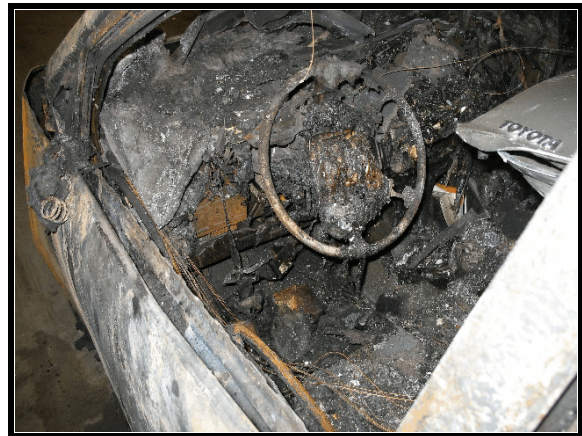
Figure 26. Driver's air bag

The 2005 Toyota Prius was equipped with dual-stage frontal air bags for the driver and front right passenger positions. The Prius was also equipped with seat back mounted side air bags. According to the driver, there were no air bag deployments as a result of the impact with the building.

Driver
Age/Sex:	66/Male
Seated Position:	Front left
Seat Type:	Bucket
Height:	183 cm (72 in)
Weight:	86 kg (190 lbs)
Occupation:	Retired
Pre-existing Medical Condition:	None noted
Alcohol/Drug Involvement:	None
Driving Experience:	>20 years
Body Posture:	Normal, upright
Hand Position:	Both hands on steering wheel, 10/2 o'clock position
Foot Position:	Right foot on brake, left on floor board
Restraint Usage:	Lap and shoulder belt available, used
Air bag:	Did not deploy in crash, deployed later during fire
