**National Highway
Traffic Safety
Administration**

Subject: FINAL REPORT: "2007 Lexus ES-350 Unintended
Acceleration"

**VRTC MEMORANDUM REPORT EA07-010
VRTC-DCD-7113**

2007 Lexus ES-350 Unintended Acceleration

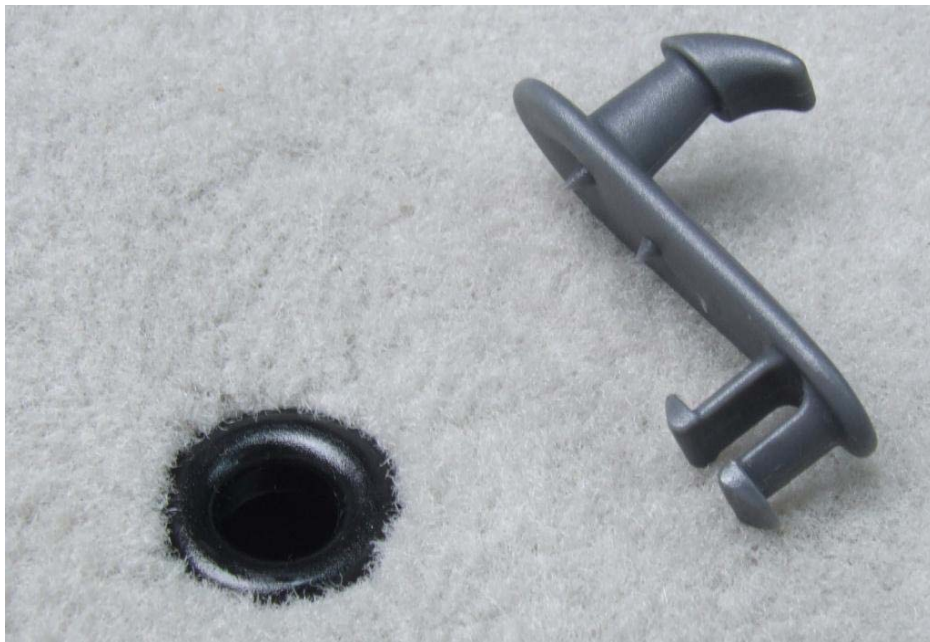
pedal revealed that the one-piece, non-articulating accelerator pedal assembly was easily entrapped in the groove of the rubber all-weather floor mat (Figures 2 and 3) if the rubber mat was not properly secured with at least one of the two retaining hooks (Figure 4). In many observed ES-350's, the rubber mats were stacked on top of the existing carpeted floor mats, which prevented attachment of the rubber mats and facilitated the interference failure mode. A warning is embossed on the front of the floor mat that reads "Do not place on top of existing floor mats". Very few owners interviewed were able to find or read this warning (see Figure 5).

Figure 4 –Floor Mat Retaining Clip and Carpet Receiving Eyelet

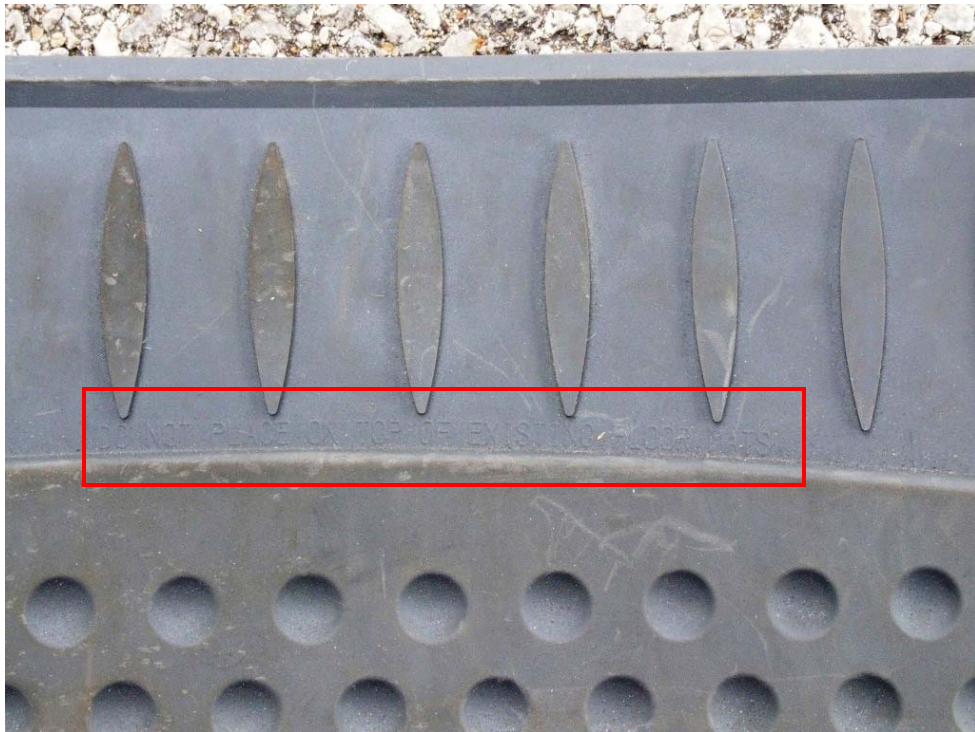
Figure 5 – Embossed Warning On Floor Mat States “Do Not Place On Top of Existing Floor Mats”

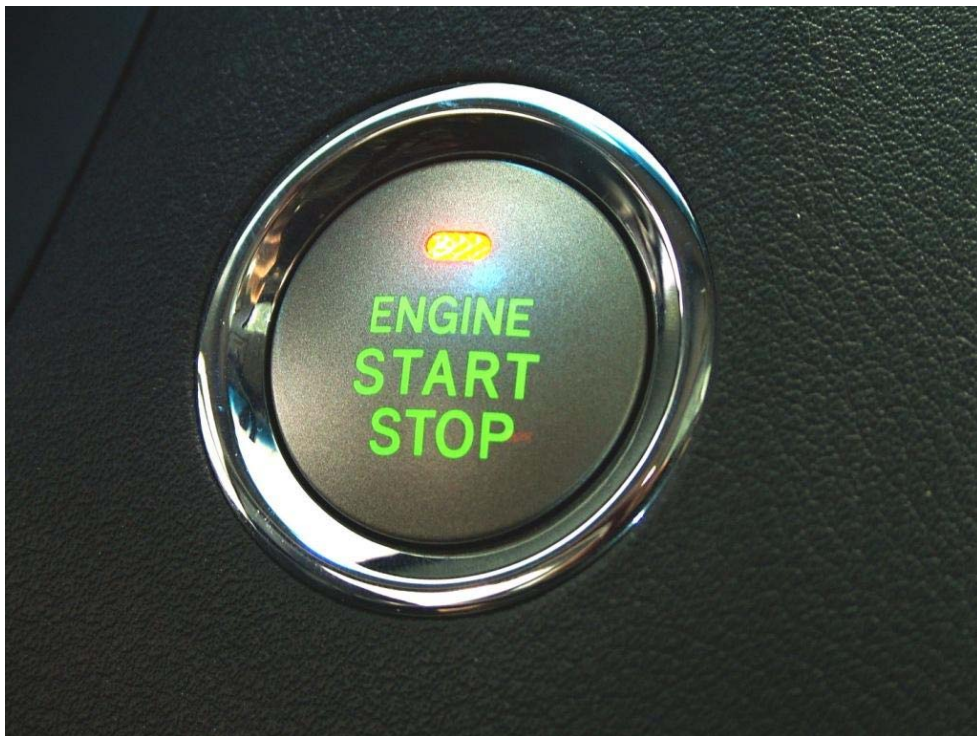
- 3.3.2** Turning off the ignition - In place of an ignition key, the ES-350 uses an ignition button that removes the ability to instantaneously shut off the engine in the event of an emergency while the vehicle is in motion (see Figure 6). It was found that depressing and holding the button will eventually turn off the engine after three seconds. Through the survey it was learned that the button delay operation is not widely known by owners and because of this, drivers found themselves unable to turn off the engine when the vehicle was in motion. The owner's manual makes general mention of the operation, but there is no indication of the three second hold requirement.

- The owner survey indicated the 3 second delay in the operation of the ignition button is not widely known by owners and because of this, drivers found themselves unable to turn off the engine when the vehicle was in motion.

Figure 6 - Push Button Ignition Replaces Conventional Key

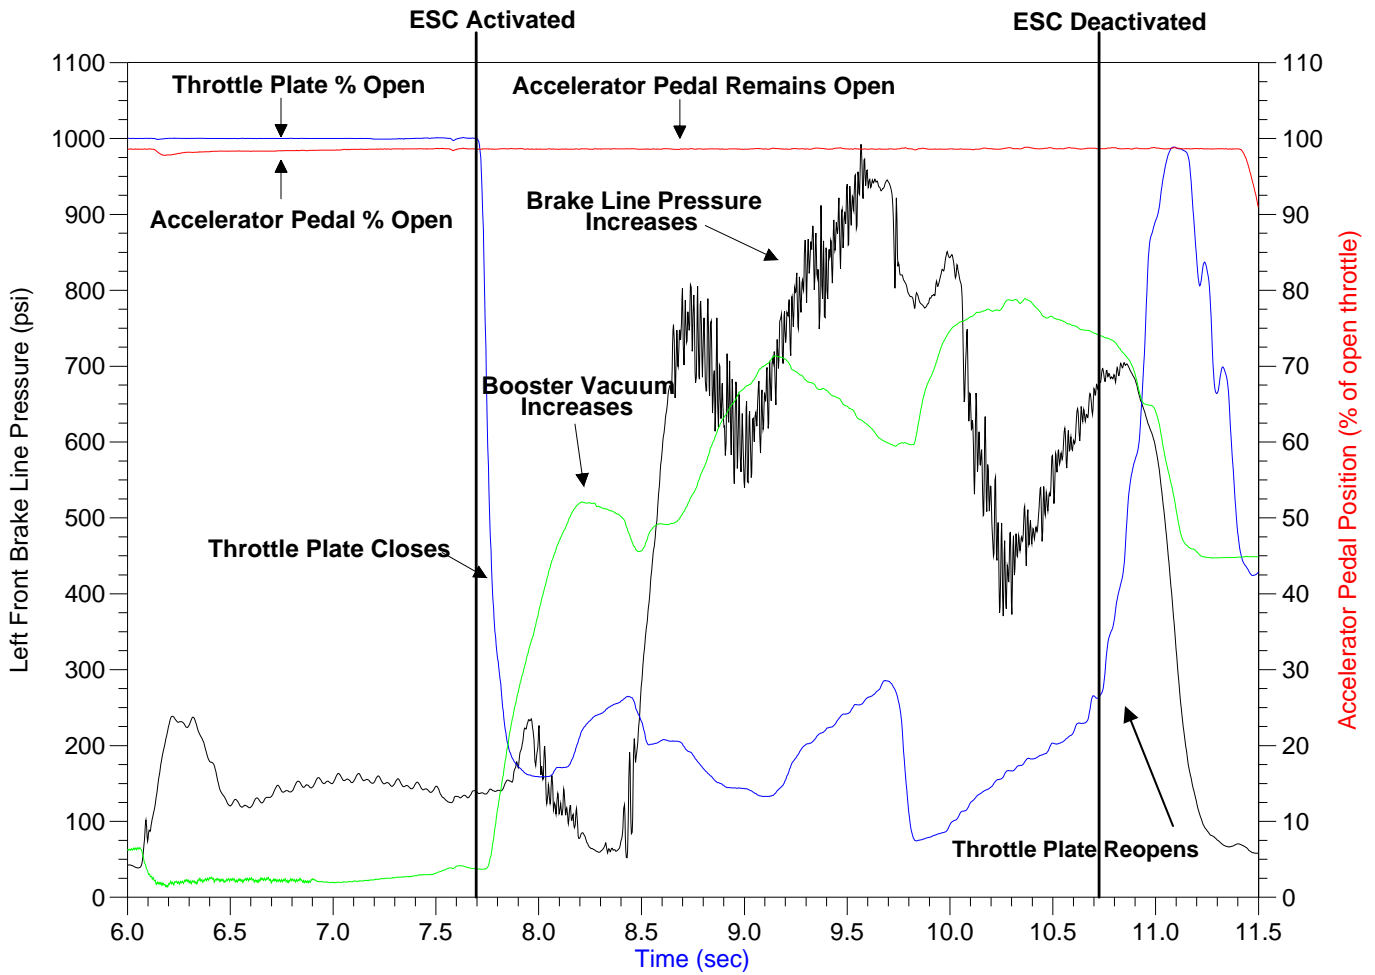
- 3.3.4** Activation of Electronic Stability Control (ESC) - It was discovered that if an emergency maneuver is executed that activates the Electronic Stability Control, such as steering around a sharp curve while traveling at an excessive speed, the electronic throttle is temporarily electronically closed by the vehicle control module regardless of the accelerator pedal position. With the throttle plate closed, vacuum quickly returns to the brake booster and provides a significant increase in braking capability (see Figure 8). Additionally, ESC has the capability to automatically apply hydraulic pressure to the service brakes to aid in slowing the vehicle. When the emergency maneuver is concluded however, the ESC system returns to a passive state, and the throttle again returns to an open condition leading to further unwanted acceleration.

Figure 8 – Data Acquired from Lexus During Testing Indicates Engine Throttle is Overridden During ESC
