SUMMARY REPORT:
CENTRE MOUNTED TANK SYSTEM
FOR GM 1500 PICKUP TRUCKS

Prepared for: Dr. Ken Digges
Automotive Safety
Research Institute

Date: March 8, 2001

Report No.: R01-02

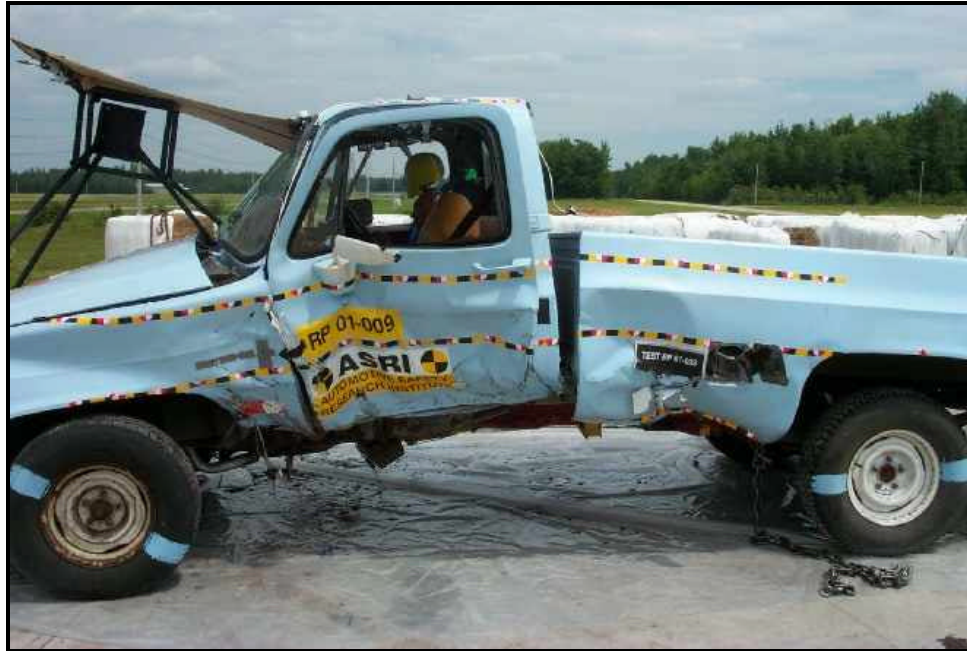
Overall, the tank system was well protected by the structure of the truck cab and by the frame rail. However, the empty space created by removing the tank allowed the bullet vehicle to penetrate deep into the side of the truck, resulting in significant damage to the body of the truck, as shown in Figure 18.

Figure 18: Damage to the truck (test RP 01-009).

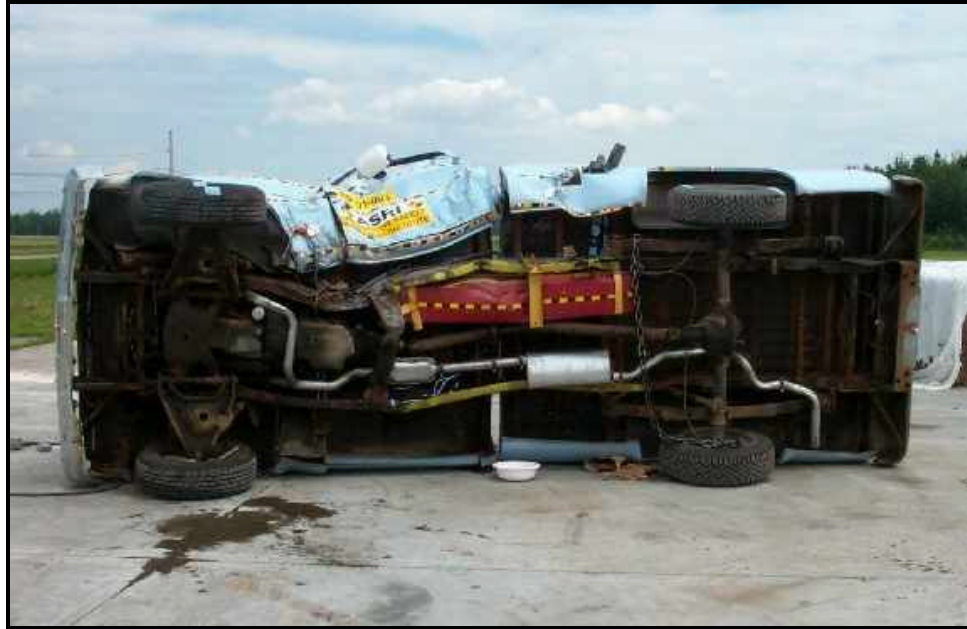
The truck was lifted off the ground during the impact and was flipped onto its side, damaging the anti-rollover bar that was affixed to the passenger side of the vehicle. The final resting position of the truck is shown in Figure 19. If the anti-rollover bar, which resists the moment created by the bullet vehicle travelling under the truck, did not fail then the loading on the tank may have been higher possibly resulting in more damage to the tank.

Figure 19: Final resting position of the truck (test RP 01-009).

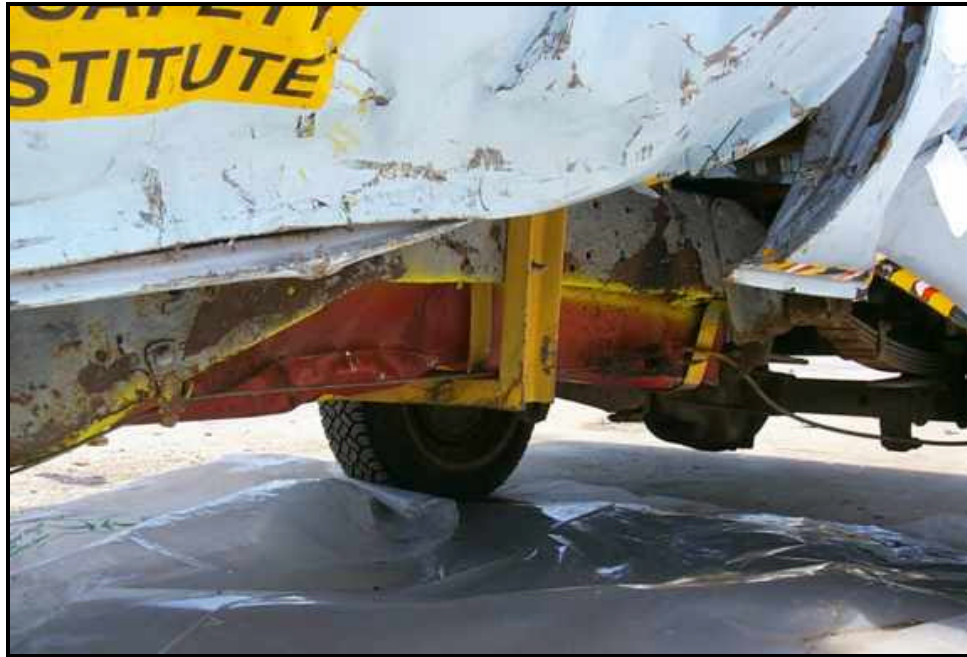
The tank support brackets had minor bending but were still securely fastened to the truck (see Figure 21 and Figure 22).

Figure 21: Tank mounting brackets following the test (test RP 01-009).

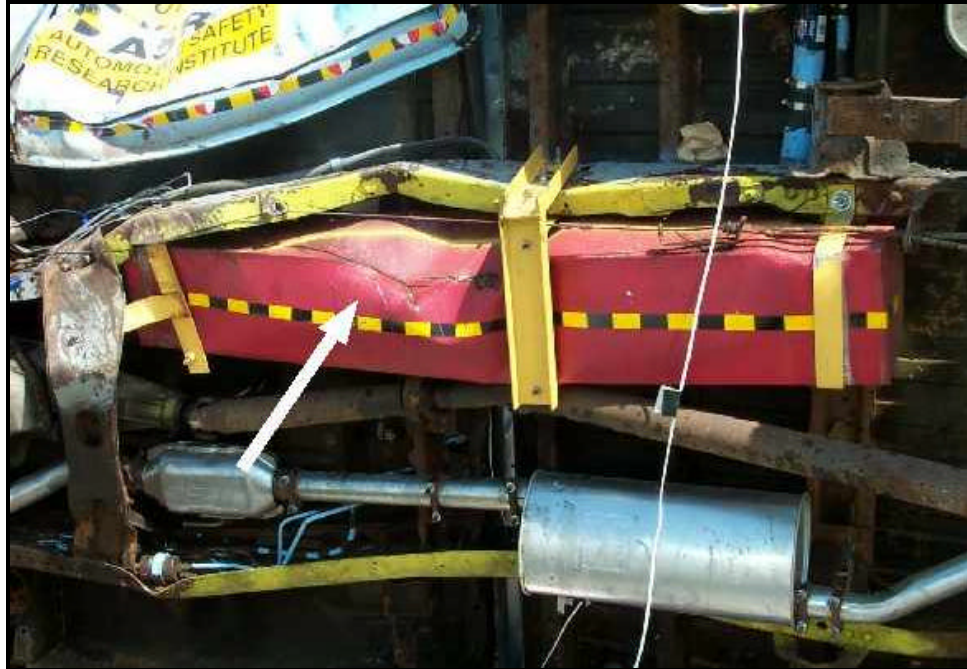
Despite some large denting on the exposed face the fuel tank, as shown in Figure 22, only minor damage to the tank was observed.

Figure 22: Denting to the fuel tank and damage to the tank mounting brackets (test RP 01-009).

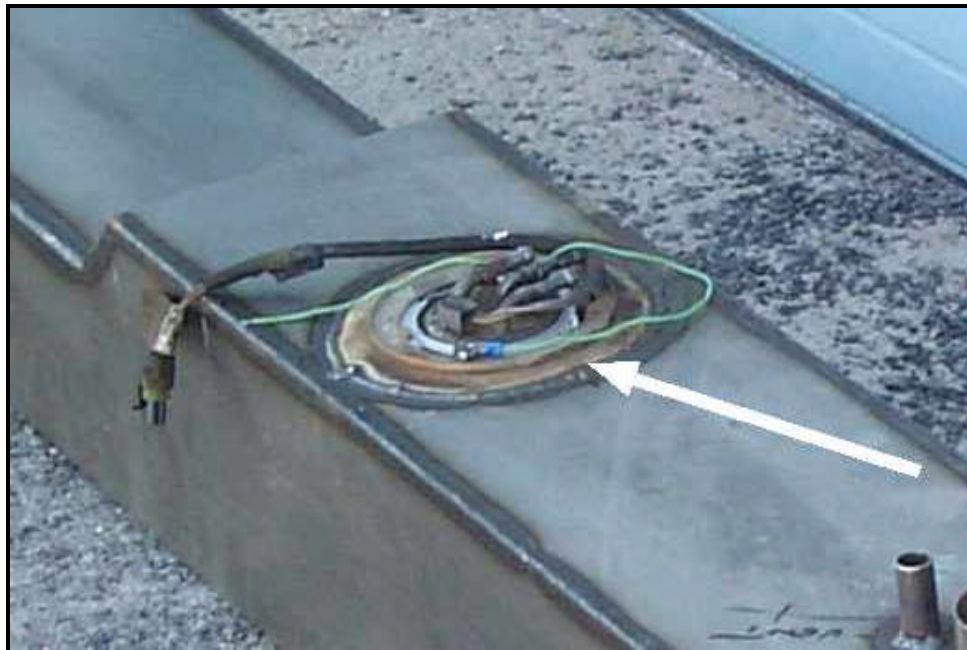
Fuel leakage stemmed from a poor seal between the sending unit and the sending unit receptacle that was welded to the tank (see Figure 23). The sending unit and its receptacle are standard GM parts that were fitted to the centre tank. As already mentioned the leak was not enough to result in failure of the system.

Figure 23: Sending unit seal where leakage occurred (test RP 01-009).

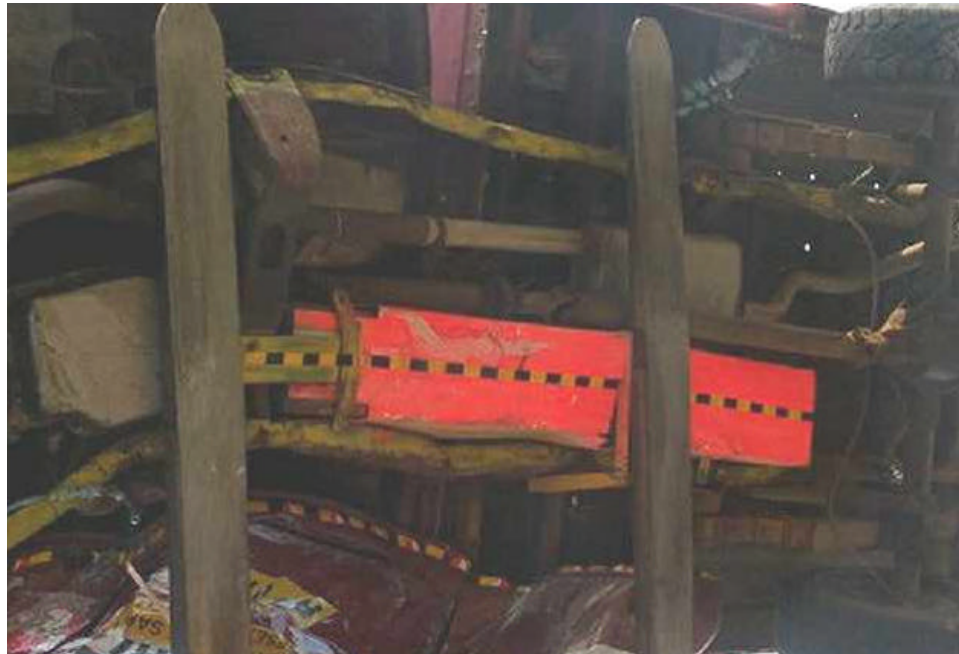
The tank with the plastic shield and the mounting brackets survived the collision with very little damage as can be seen in Figure 27 and Figure 28.

Figure 27: Centre tank and plastic shield following after the collision (test RP 01-036).

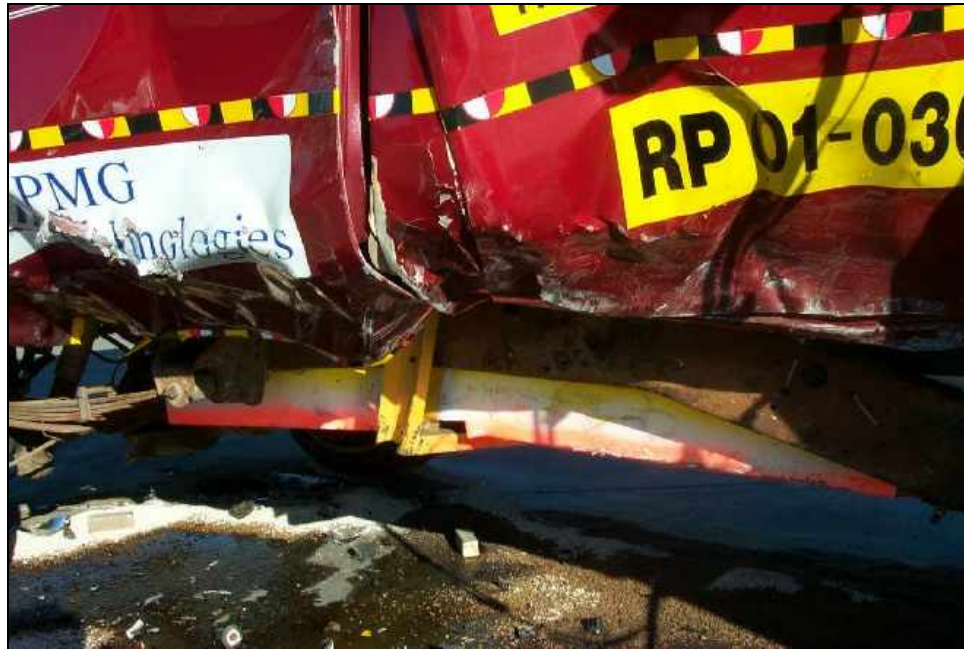
Figure 28: Plastic shield and centre mounting bracket. (Note: the rear bracket is concealed under the plastic shield.)

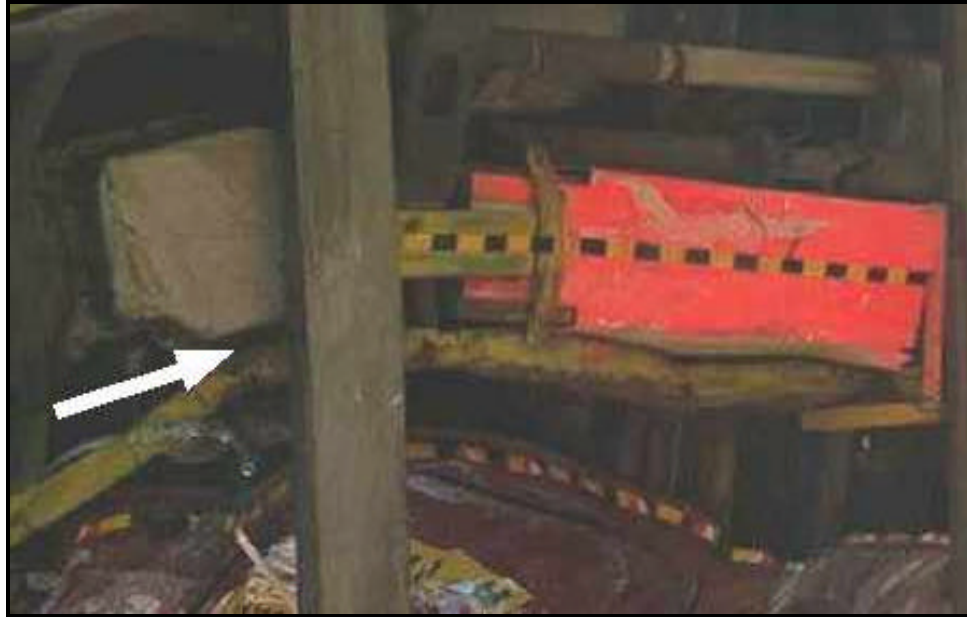
Figure 29: The location of the switching valve identified by the arrow. (test RP 01-0036)

If a truck is to be fitted with two tanks, thereby necessitating a switching valve, the valve must be better located or additional protection must be incorporated into the fuel system design to prevent similar damage to switching valve from occurring.

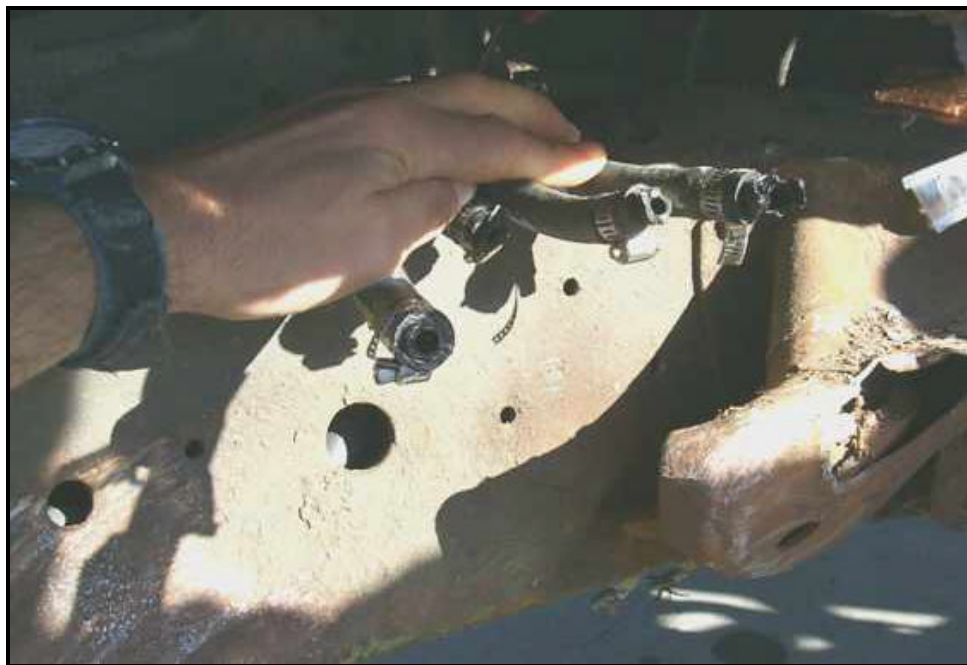
Figure 30: Fuel lines that were torn from the tank switching valve (test RP 01-036).

Although technically this test would have failed the requirements of FMVSS 301 it is worthy to note that had only the centre tank been installed and thus a switching would not have been required, the tank would have passed the test. With this in mind the fuel lines were plugged and the tank was refilled with fluid

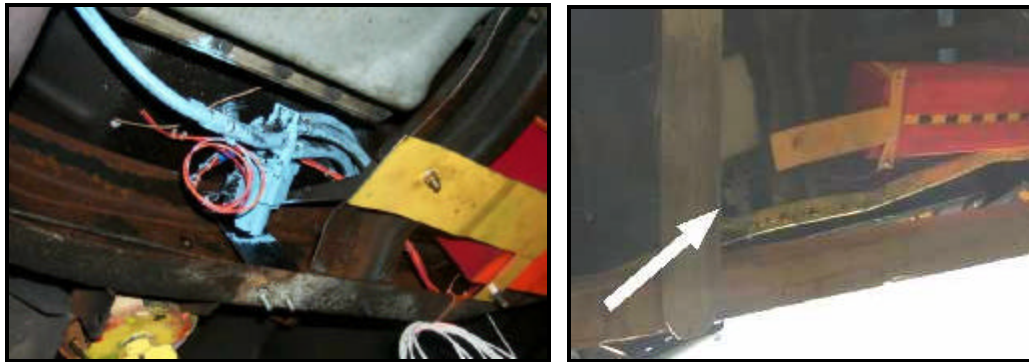
Figure 36: View of the switching valve before and after the test.

As seen in Figure 36 the spacing between the frame rail and the transfer case is relatively intact compare to the that observed in test RP 01-036 where the frame rail was almost in contact with the transfer case (refer back to Figure 29).

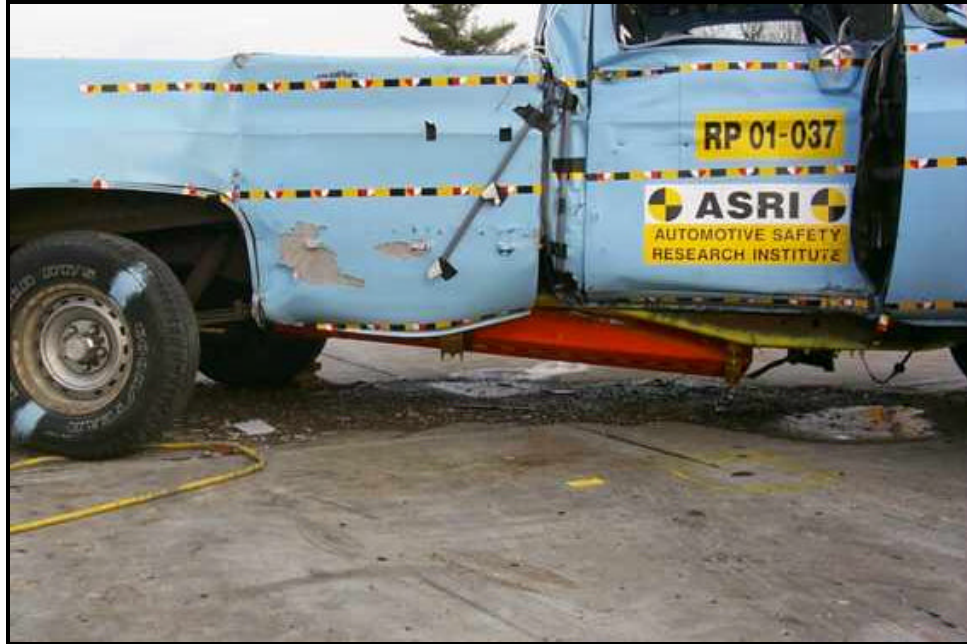
The centre tank and the bracket sustained minor damage. However, because of bending of the vehicle frame rail the tank was hanging down lower to the ground, as shown in Figure 37.

Figure 37: That hanging down low to the ground (test RP 01-037).

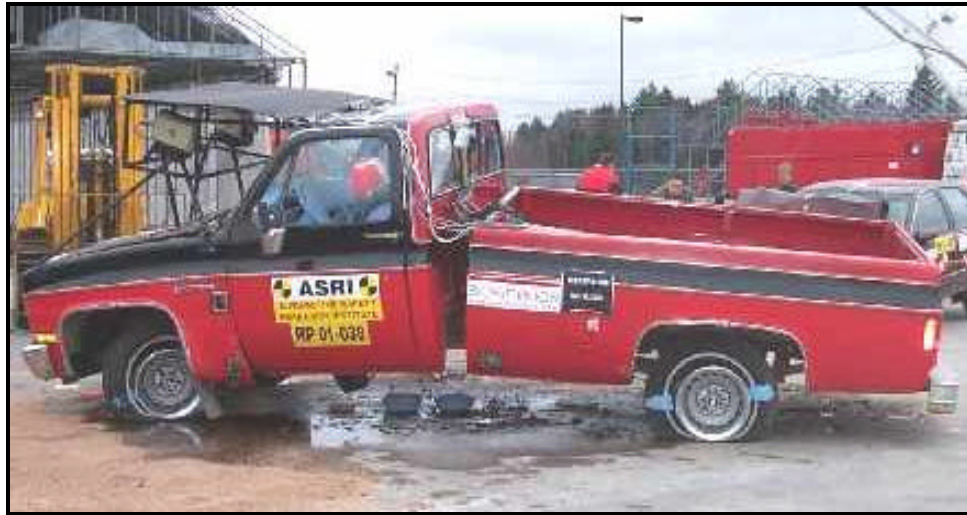
Figure 41: Far side tires were torn from their rims during the collision (test RP 01-038)

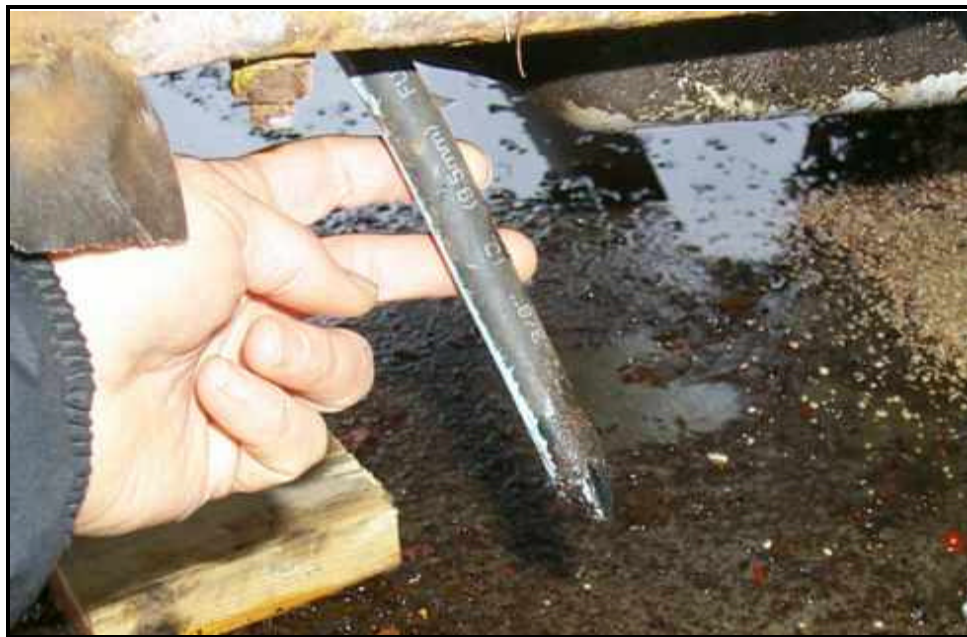
The fuel line leading to the engine was severed during the test (see Figure 42), resulting in a substantial gravity fed fluid leak. All leaking stopped when the fuel lines were cut near the sending unit with a pair of shears.

Figure 42: Severed fuel line (test RP 01-038).

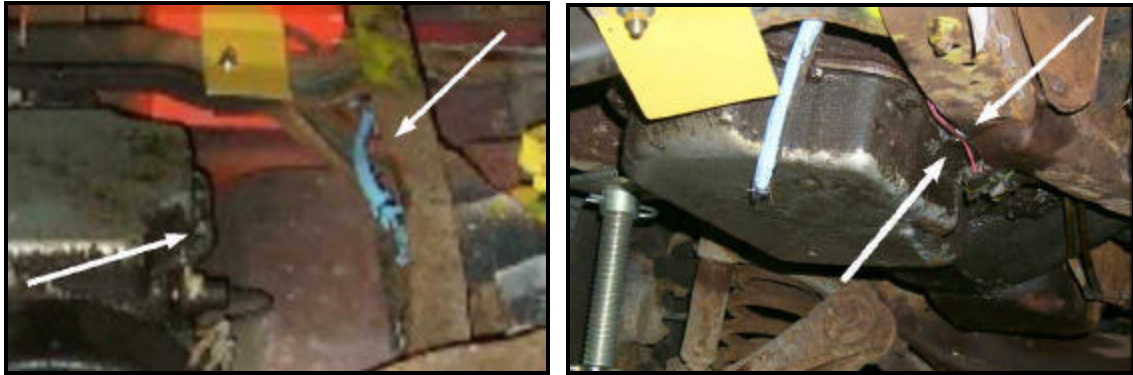
Figure 43: Spacing between the frame rail and the transmission housing that severed the fuel line (test RP 01-038).

The complete exhaust system, including the manifold, was removed from the truck to achieve a target truck weight of 4400 lb. One of the tubes from the manifold normally runs down between the frame rail and the transmission and its presence may have prevented the damage to the fuel line by acting as a somewhat rigid spacer between the rail and transmission providing clearance for the fuel line. A typical manifold on the GM truck is shown in Figure 44.

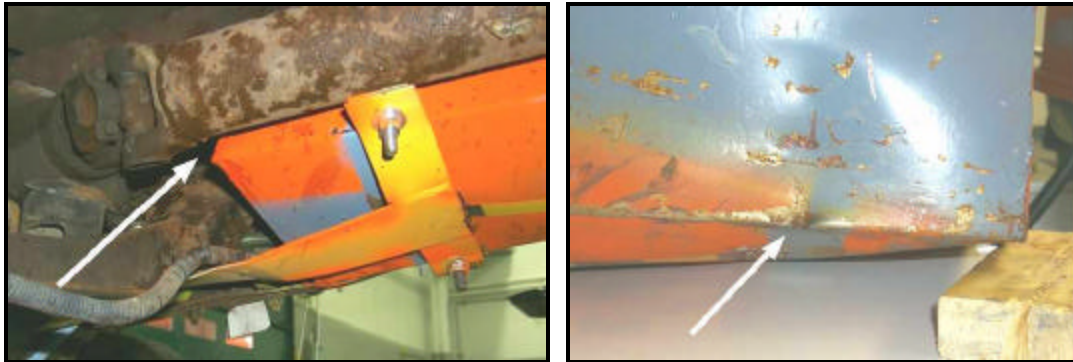
The centre tank sustained substantial denting from various sources. The side of the tank near the front was damaged by the drive shaft. On the opposite side at the front, the threaded end of the bracket strap created a small dent. The middle of the tank was pushed in and upward by the bullet vehicle and the middle mounting bracket, and was dented on the inside by the drive shaft. An additional small dent was created on lower rear edge of the tank by the rear bracket strap. The damage to the tank is shown in Figure 45 to Figure 48.

Figure 45: Damage to the front end of the tank front the drive shaft (left photo) and from the front mounting strap (right photo) (test RP 01-038).

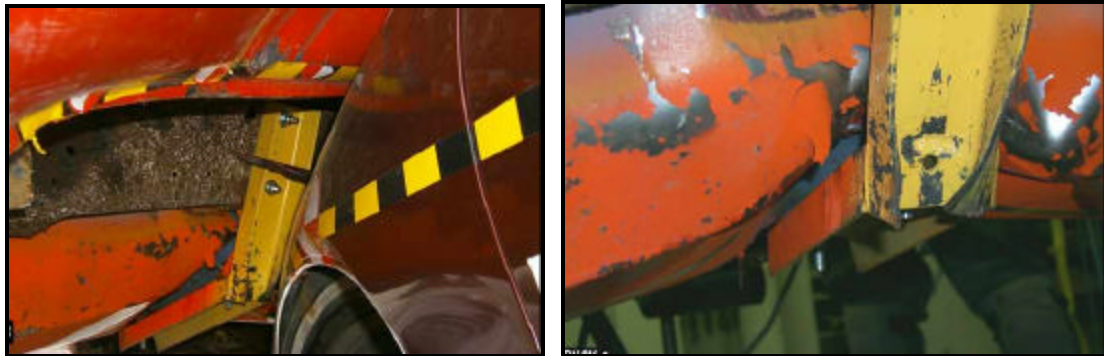
Figure 46: Damage caused by the bullet vehicle loading the centre bracket (test RP 01-038).

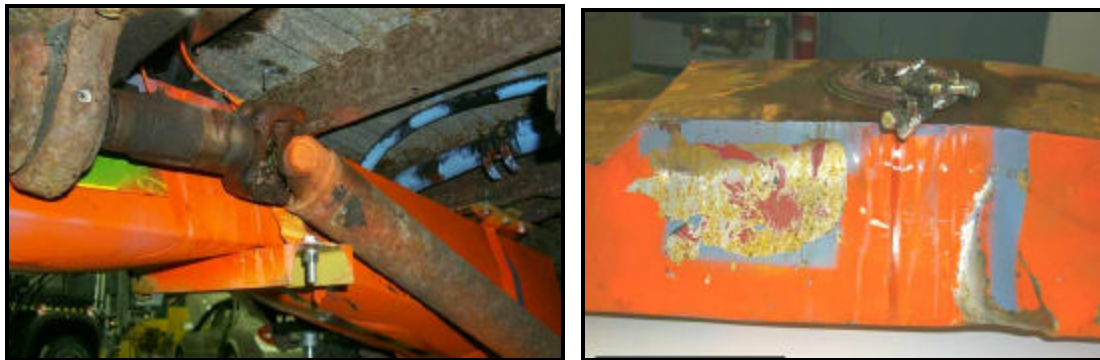
Figure 47: Denting caused by the drive shaft (test RP 01-038).

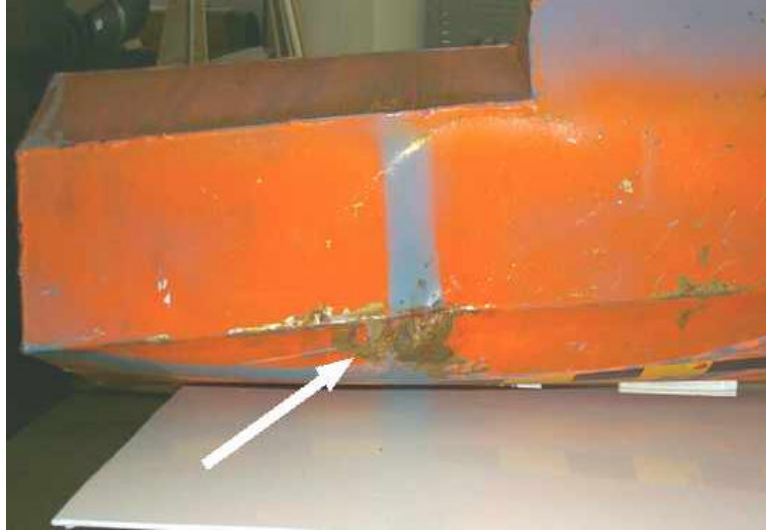
Figure 48: Minor denting caused by the rear mounting strap (test RP 01-038).

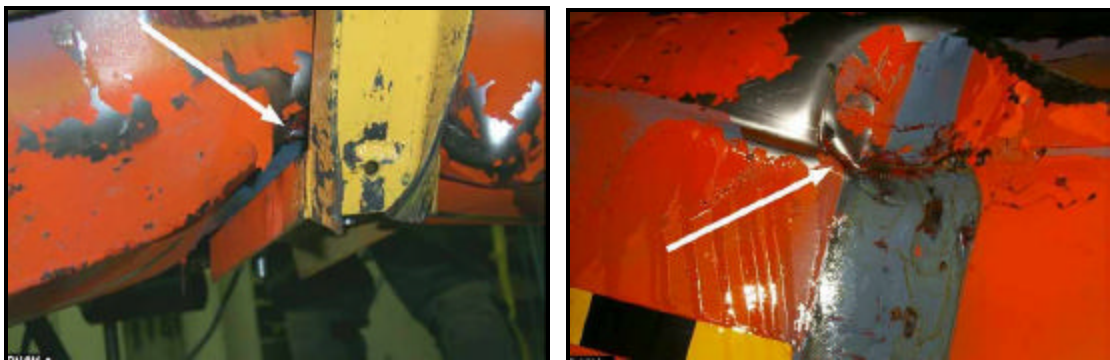
Irrespective of the leakage from the fuel line, the tank itself initially appeared to be intact despite the substantial amount of deformation. To verify the tank's integrity, the tank was refilled with fluids and a rollover test was to be performed. However, during the refilling a hole was discovered in the side of the tank and the fluid flow rate from the hole exceeded the allowable limits of the of the FMVSS 301 requirement (the actual rate was not reported in the PMG report). The hole in the tank was created by the creasing of the lower edge of the tank at the centre bracket (see Figure 49).

Figure 49: Hole in the tank behind the centre bracket (test RP 01-038).

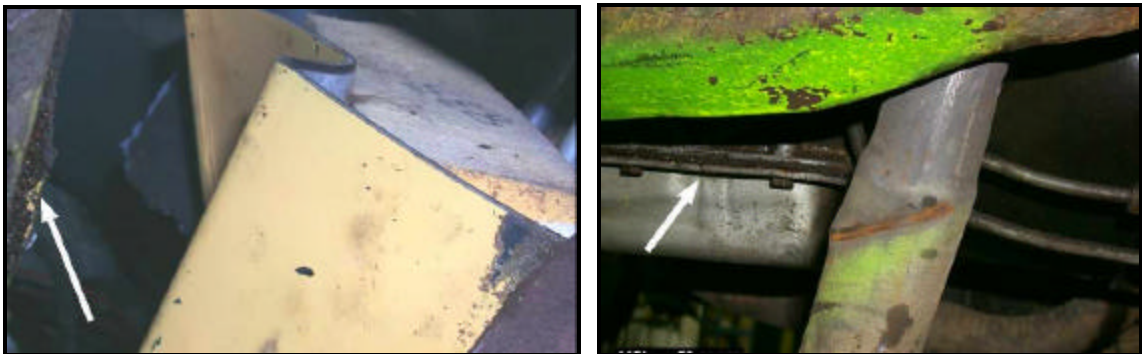
The shield placed over the fuel lines, which ran along the inside of the frame rail, to prevent damage from the transmission housing, was deformed from contact with the transmission. Additionally, the exhaust manifold, which was not removed from the truck as it was in the previous test, impeded relative translation of the frame rail towards the transmission. The lower flange of the frame rail imprinted itself in the right manifold pipe indicating substantial loading of that component. The fuel lines, however, were not damaged. Figure 55 shows the deformed shield with the arrow highlighting the side of the transmission and the dented manifold pipe.

Figure 55: Damaged fuel line shield and exhaust manifold. The arrow is pointing to the edge of the transmission (test RP 01-039).

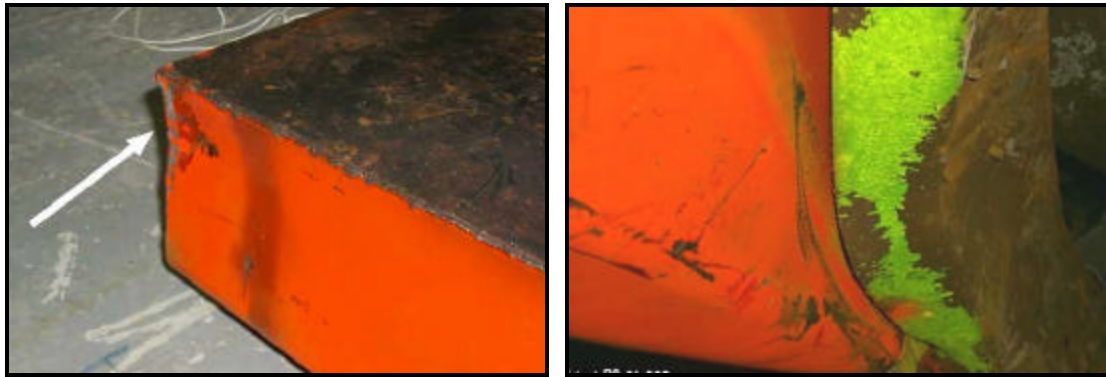
The tank sustained damage on both sides and along its length from various sources. The left front side of the tank contacted the drive shaft with minor denting while the flange of the frame rail indented the forward portion of the

Figure 56: Damage tot the front of the tank was caused by the drive shaft on the left side and by the frame rail on the right of the tank (test RP 01-039).

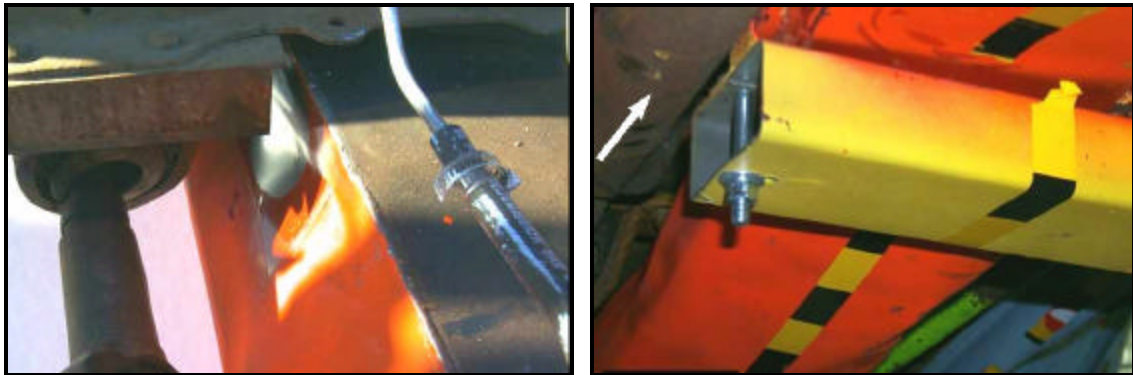
Figure 57: Deformation of the tank caused by the drive shaft bearing housing (left) and contact of middle bracket with the drive shaft (right) (test RP 01-039).

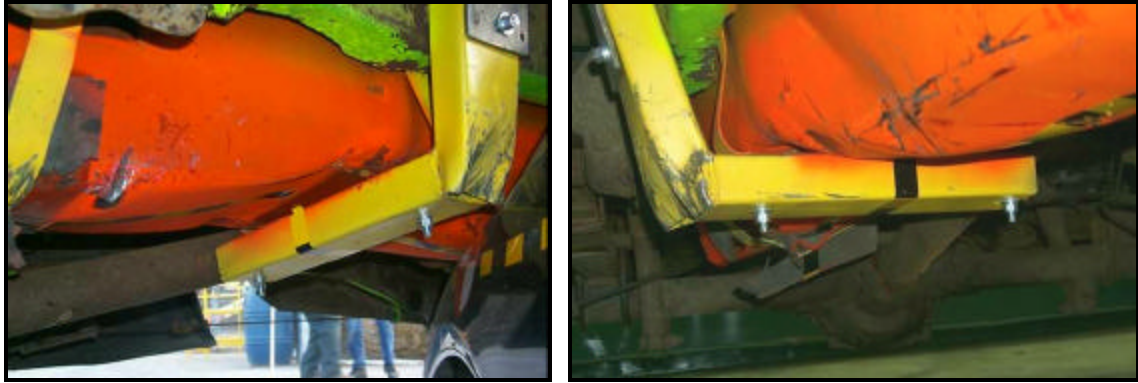
Figure 58: Deformations of the centre portion of the tank (test RP 01-039).

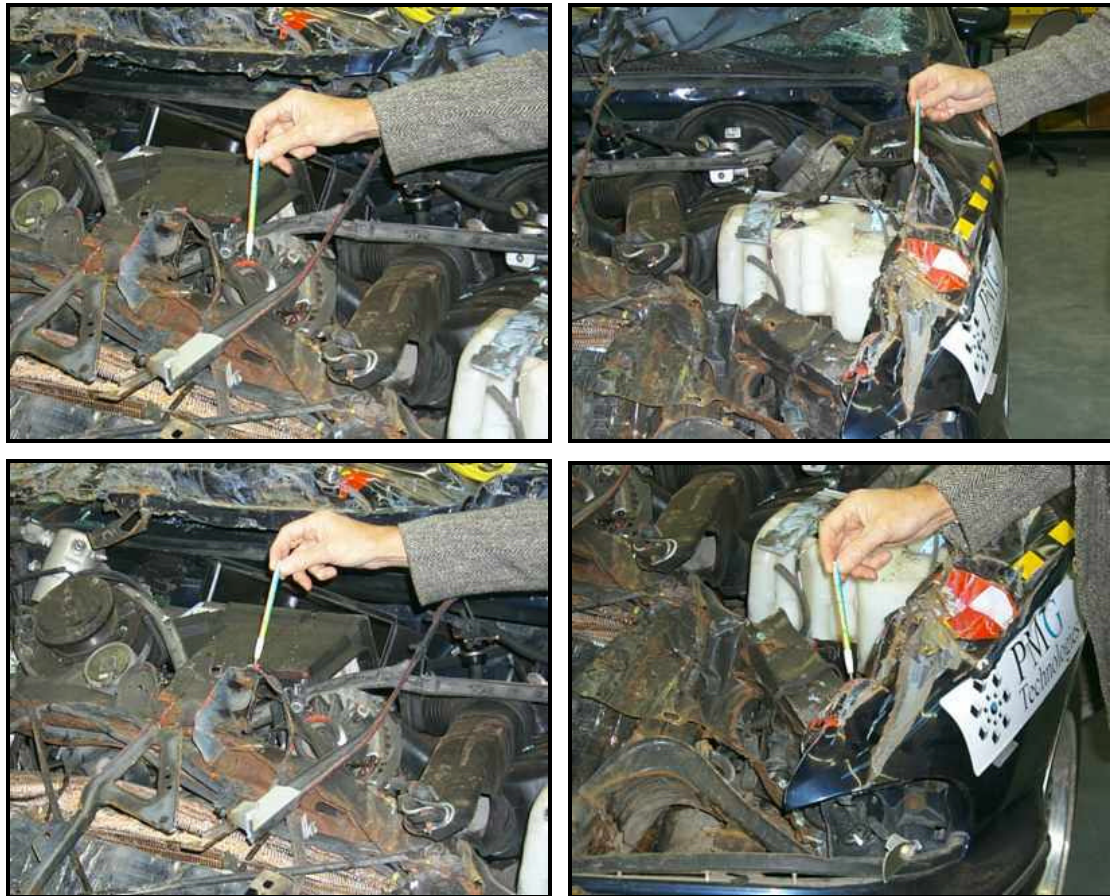
Figure 59: Hard points on the bullet vehicle that caused minor scuffing and gouging to the tank (test RP 01-039).

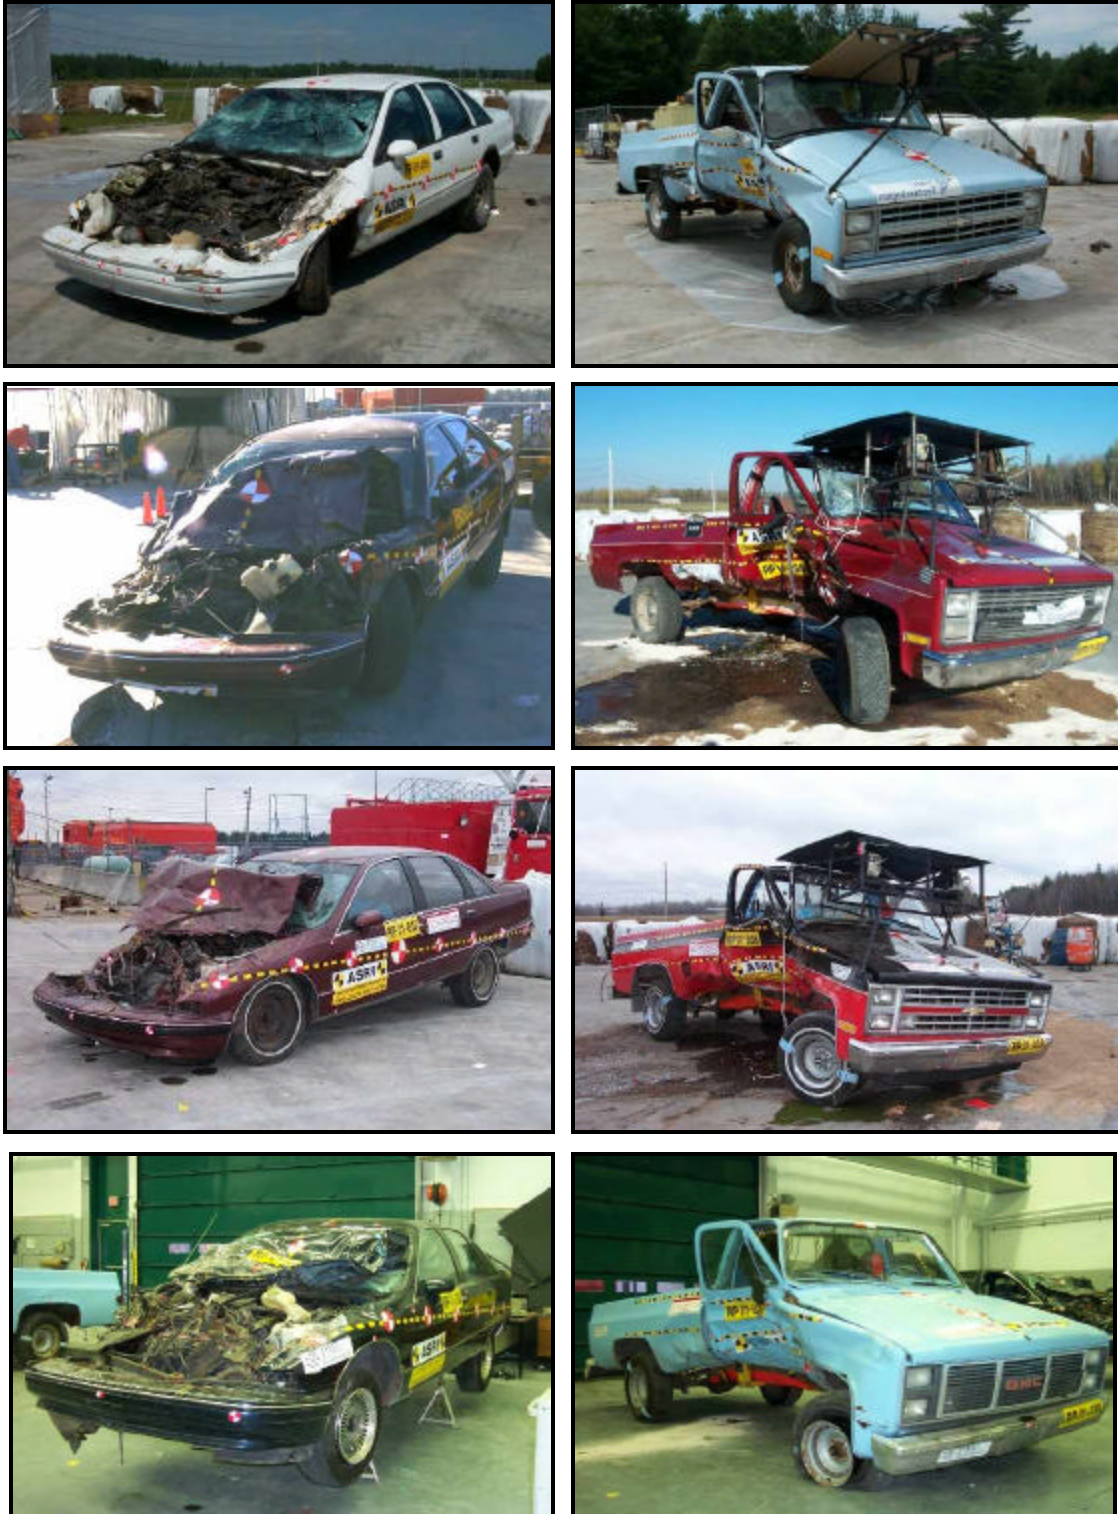
Considering the similarity in the test set-up and input conditions, it is not surprising that the kinematics of each test were very similar. Following contact with the truck the front end of the bullet vehicle was pushed downwards and as it travelled under the truck it lifted the truck up and carried it in the direction of impact. The resulting damage to the vehicles, from test to test, was, for all intents and purpose, similar. A comparison of the damage to the vehicles is shown in Figure 62.

Figure 62: Comparison of damage to tested vehicles. From top to bottom: test RP 01-009, RP 01-036, RP 01-038 and test RP 01-039. (note the truck in RP 01-009 was impacted on the drivers side, the photo was reversed for ease of comparison.
