# ODI RESUME

Investigation: PE04-028  
 Prompted By: IE04-013 (Steve Chan)  
 Date Opened: 03/15/2004 Date Closed: 06/18/2004  
 Principal Investigator: Cheryl Tuosto  
 Subject: Engine Compartment Fires

Manufacturer: DaimlerChrysler Corporation  
 Products: 2001-2003 Chrysler PT Cruiser  
 Population: 463,830

## **Safety Recall #18** **Power Steering Pressure Hose**

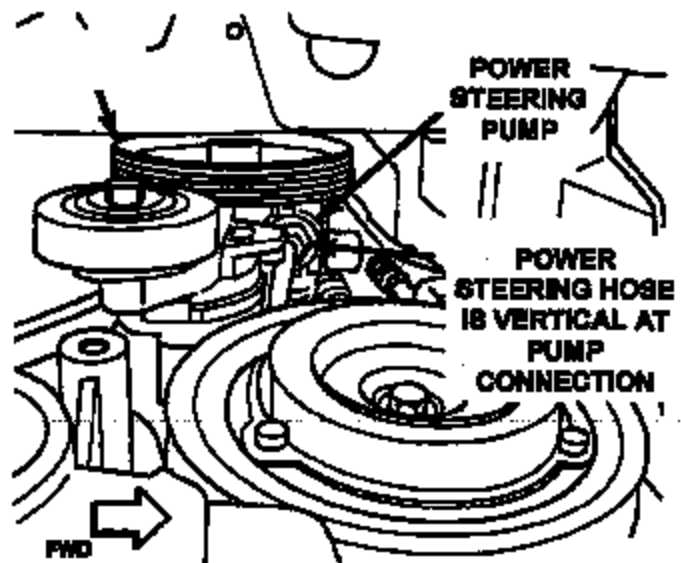
Figure 1 – As viewed from below

**IMPORTANT:** The power steering hose to pump connection orientation changed late in the 2002 model year. For 2002 model year vehicles, inspect the hose connection orientation to determine the proper replacement hose. For hoses with a vertical orientation, order P/N CBTKD182 (Figure 1). For hoses with an angled orientation, order P/N CBTBD181. The two hoses are not interchangeable.
