**Product Update: Front Balancer Shaft Oil Seal**

(Supersedes 00-073, dated November 2000)

Product Update Campaign: Engine Oil Leak

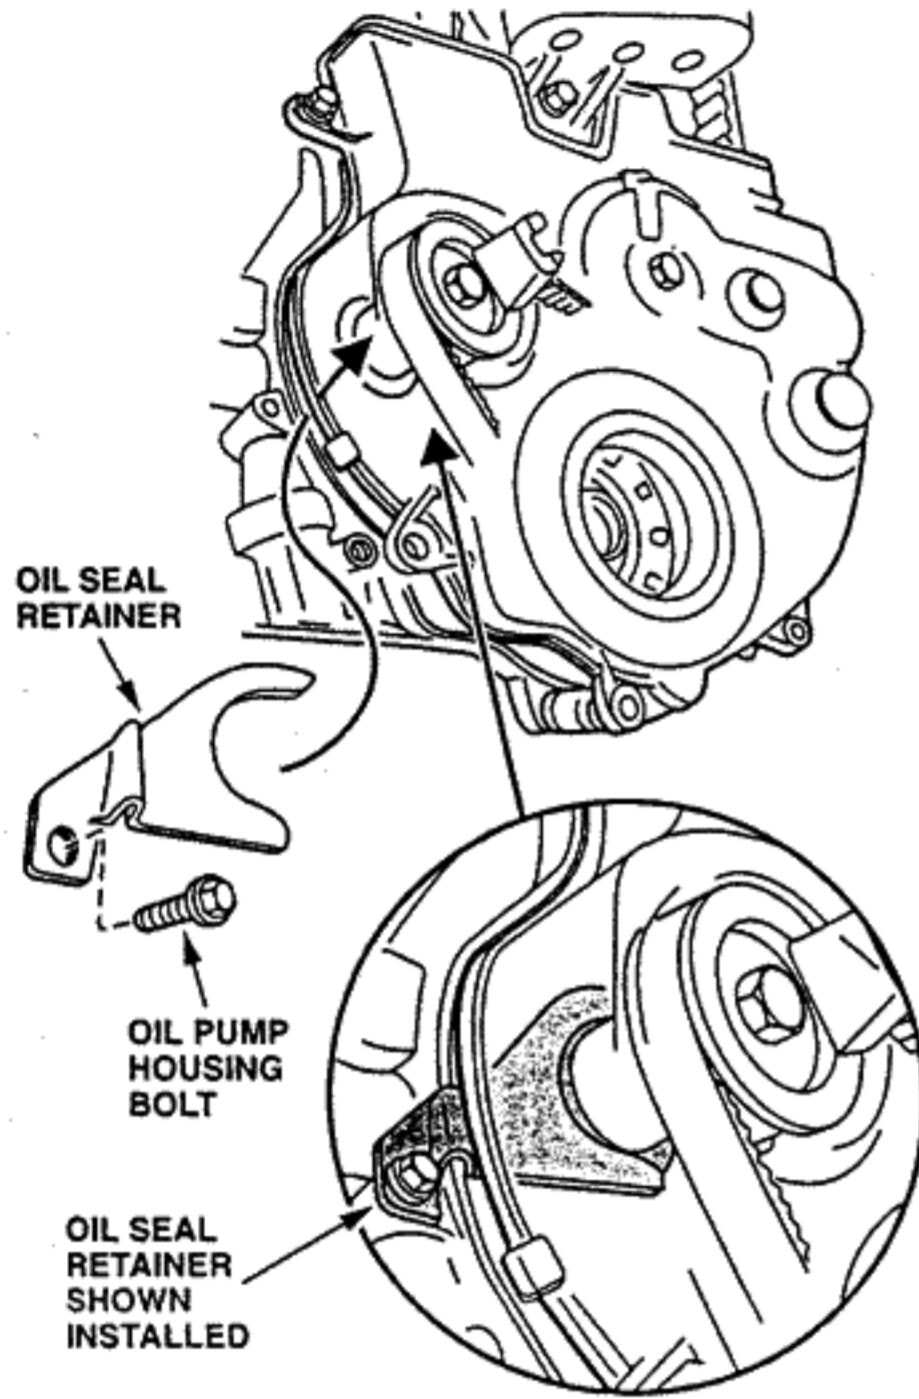
The front balancer shaft oil seal may slowly come out of the oil pump housing. If it comes out completely, the oil can be pumped out of the engine rapidly without warning, causing serious engine damage if you continue to drive.

12. Remove the oil pump housing bolt to the left and below the front balancer shaft.

13. Install the oil seal retainer from the kit on the pump housing with the bolt you just removed. Torque the bolt to 12 N·m.
14. Reinstall the lower cover bolts, making sure the rubber seal seats properly in the cover. Torque the bolts to 12 N·m.
15. Reinstall the crankshaft pulley. Use the special tools and a torque wrench to torque the pulley bolt to 245 N·m. Make sure you use a torque wrench; do *not* use an impact wrench.
16. Reinstall the splash shield mounting bolts. Torque the bolts to 12 N·m.
17. Reinstall the left front wheel. Torque the wheel nuts to 108 N·m.
18. Reinstall the dipstick tube with the new O-ring from the kit. Torque the bolt to 12 N·m. Reinstall the dipstick.
19. *DOHC Prelude only:* Reinstall the power steering reservoir and the power steering pump.
20. Reinstall the alternator belt and the power steering pump belt.
