A Second Possible Cause of SUA In Mitsubishi Montero Sport Vehicles

Ronald A. Belt
Plymouth, MN 55447
22 September 2018

Abstract: A new cause of sudden unintended acceleration (SUA) has been found in Mitsubishi Montero Sport vehicles. The new cause arises from a known sticking defect in the Denso suction control valve used to meter fuel to the common rail and from a known ECU learning operation used on the Mitsubishi vehicle assembly line to correct for manufacturing variations in the fuel system components. These known vehicle features cause sudden unintended acceleration during engine idling in much the same manner as a negative voltage spike affects the battery voltage compensation function, leading to the same vehicle behavior relative to the idle and cruise engine controllers and the shifting of the transmission out of PARK and into DRIVE. Therefore, everything discussed to date about how the battery voltage compensation function causes sudden unintended acceleration during engine idling applies as well to this new cause of SUA. However, the two causes of sudden acceleration are independent, leading to an increase in the incident rate for sudden unintended acceleration. This

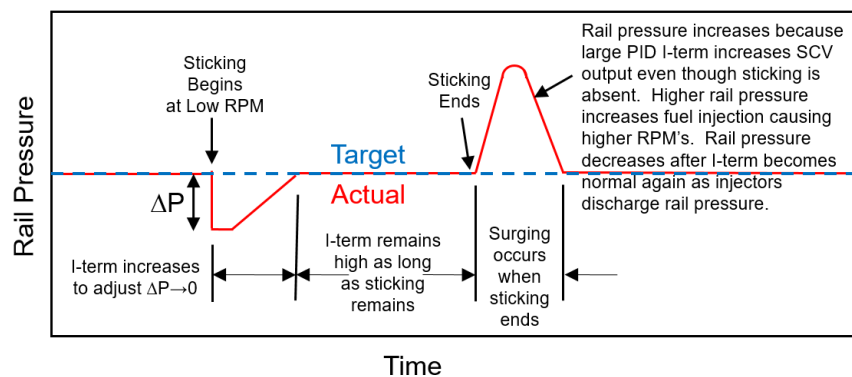
To understand how sticking can cause sub-par engine performance followed by surging, take a look at Figure 9. At some point in time, while the engine RPM is low, sticking of the SCV valve occurs, causing the actual rail pressure to drop below the target value. This causes sub-par engine performance with lower engine RPMs. It also causes the SCV PID controller to increase its integral I-term in order to adjust for the inability of the actual rail pressure to reach the target pressure. This can take several

seconds. With an increased I-term, the controller increases the SCV valve opening, causing the actual rail pressure to increase to compensate for the perceived mismatch between the actual rail pressure and the target pressure caused by the sticking. This causes the sub-par engine performance to disappear. Then, when sticking ends as the SCV is opened in response to either an engine idle-up or the driver nudging the accelerator pedal, the actual rail pressure suddenly exceeds the target value because the integral I-term overcompensates the actual rail pressure as a result of the sticking being absent. The result is a temporary increase in the actual rail pressure that exceeds the amount normally associated with the small increase in SCV opening caused by either an engine idle-up or the accelerator pedal being pressed slightly by the driver. This increase in actual rail pressure causes more fuel to be injected into the engine, causing a temporary surge in the engine RPMs. The surge ends after a second or two because the I-term decreases again as the actual rail pressure falls back to the target value as the injectors deplete the excess fuel in the rail. But sometimes the rail pressure can become so high that it exceeds the maximum pressure that the rail can withstand, triggering the opening of a pressure relief valve and the switching of the engine to the limp home mode in which the engine RPM's are limited to a very low value. Drivers rarely refer to this surging in RPMs as sudden unintended acceleration because it is usually short in duration and is usually not accompanied by a higher engine torque, or acceleration.

Figure 9. Rail pressure time behavior during surging¹⁷

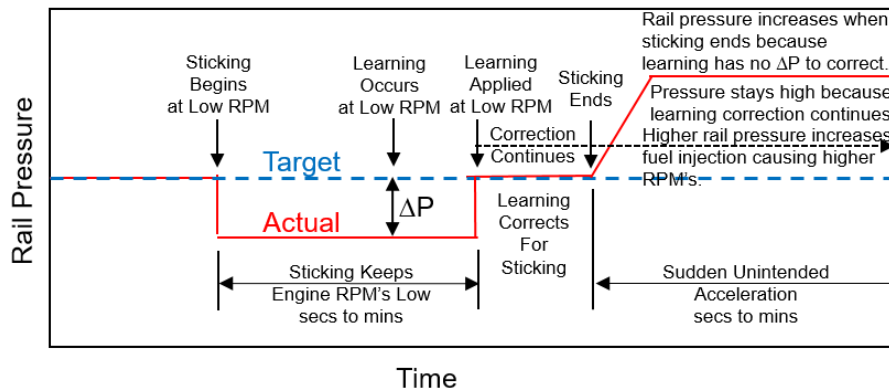
Figure 11. Sticking during learning can cause sudden unintended acceleration when the sticking ceases and the learning correction is applied to the normal target pressure without sticking being present.²³

Figure 11 shows that SCV sticking can cause the rail pressure to become lower than the target pressure by an amount ΔP when it occurs at a low engine RPM such as when the engine is idling. At some time after SCV sticking occurs, learning happens after the engine is warmed up and while the sticking is still

present. The learning corrects for the pressure difference ΔP and makes the actual rail pressure equal to the compensated target pressure while the sticking is still present. Then, the sticking ends because perhaps an increase in SCV opening occurs to cause an engine idle-up, as a result of either the air conditioner turning on or the radiator fan turning on. When the sticking ends, the actual rail pressure increases because the learning correction is still being applied while the cause of the learned compensation value has disappeared. When the actual rail pressure increases, more fuel is injected into the engine even though the target rail pressure, the injector opening time, and the injector opening duration do not change. The result is sudden unintended acceleration without the driver pressing on the accelerator pedal. And no diagnostic code is produced because nothing in the engine is working incorrectly, except that the learning function has obtained an incorrect value, which it continues to apply as designed.

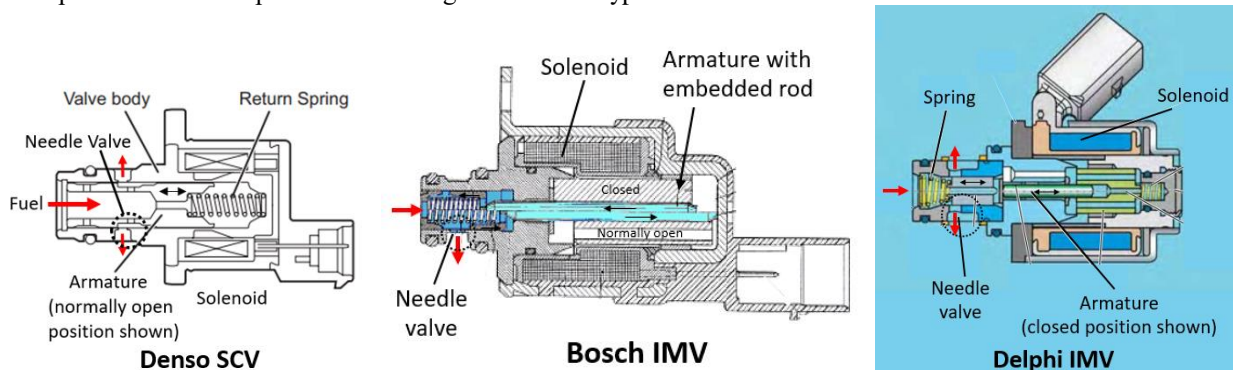
¹³ Denso’s SCV’s have a much greater sliding area in contact with the fuel containing particles than Bosch and Delphi’s IMV’s. Compare these drawings of the three types of flow control valves:
