Tesla Regen, Brakes and Sudden Acceleration

Ronald A. Belt
Plymouth, MN 55447

1 June 2020

Abstract: EDR log data from a Tesla sudden acceleration incident is presented. To explain the EDR data, the operation of Tesla's drive motor control system and braking system are examined. As expected, friction braking and regen are completely separate with no blending. The braking system, however, includes several vehicle stability control functions that have a profound effect on regen operation in the presence of wheel slip, such as stopping regen when going over bumps and while turning corners. One of these slip control functions can cause the drive motor to speed up if regen is causing slip in the rear drive wheels that can lead to an oversteer or understeer. This same slip control function can be misled by a defective brake light switch to confuse a brake-induced deceleration for a regen-induced deceleration, in which case the harder a driver presses on the brake pedal, the larger a positive motor torque is produced. This is believed to be the cause of sudden acceleration in over 70% of Tesla vehicles.

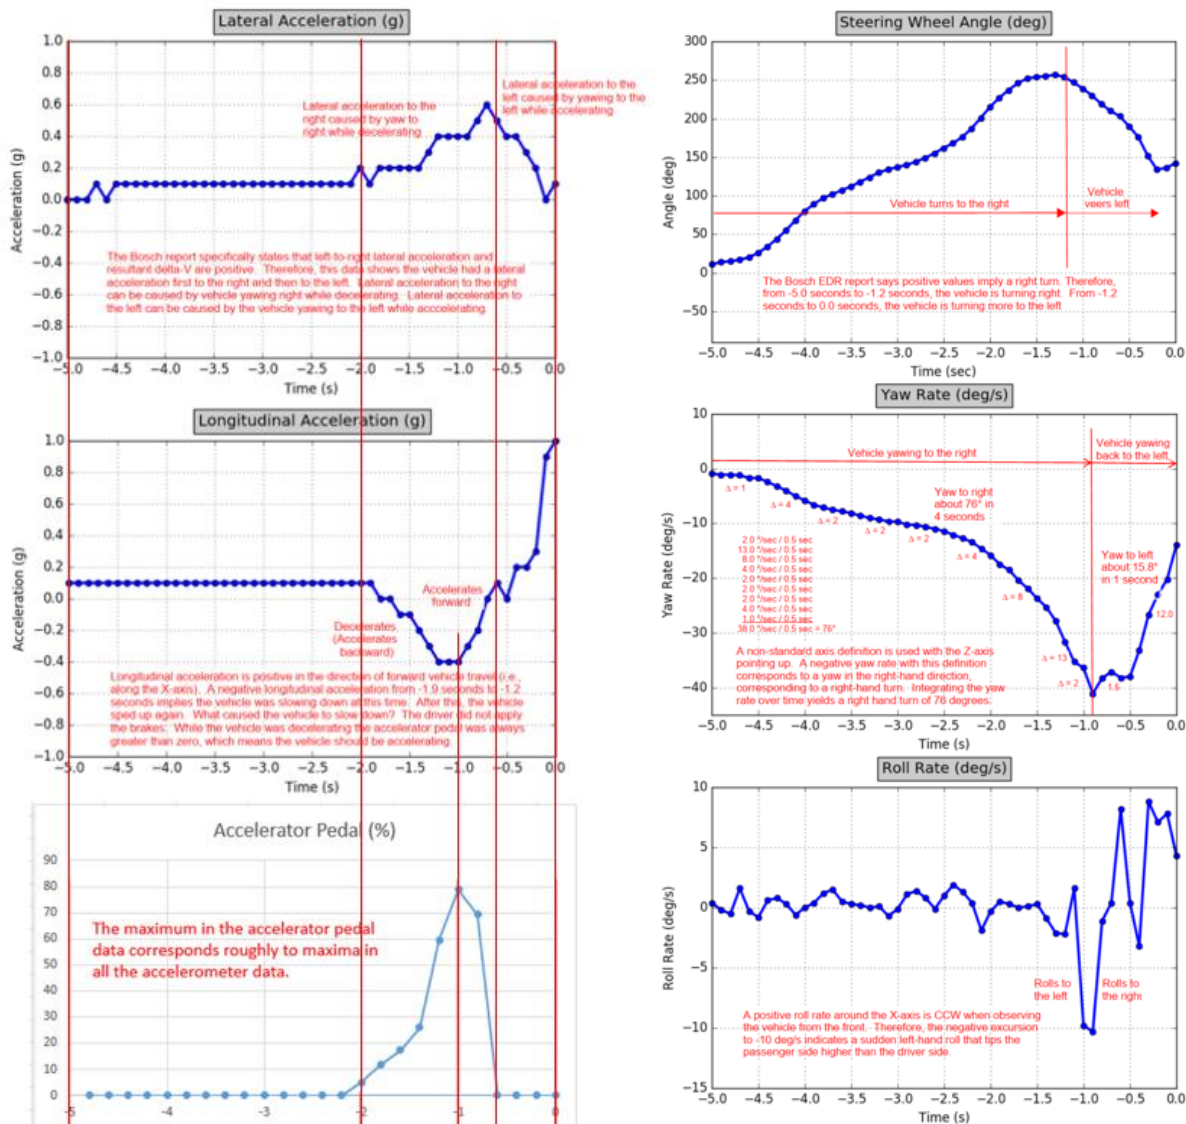
Figure 4 shows the pre-crash accelerometer data. The longitudinal accelerometer data show that the vehicle had a rapid deceleration of -5 g's from +1 g to -4 g one second before the crash. Since the Model 3's regeneration is limited to -2 g's (increased to -3 g's by software update 2018.42 v9 on October 25, 2018), this higher -5 g deceleration could not have been caused by the vehicle's regen system. Instead, it can only have been caused by the vehicle's braking system. This conclusion is supported by the high resolution log data described by Tesla which shows that the brakes were applied even though the EDR data says they were not (Fig 5). Therefore, the driver was pressing on the brake pedal at the time the drive motor revved up, exactly as she described.

Comparison of the accelerator pedal data to the longitudinal acceleration data shows that the increase and decrease in the accelerator pedal data are coincident with the decrease and increase in the longitudinal acceleration data, which is determined by the depression of the brake pedal. This suggests the possibility that the accelerator pedal may have been pressed at

Figure 4. Pre-crash accelerometer data. An ISO 8855 coordinate system is used in which the longitudinal x-axis points forward, the y-axis points to the driver's left, and the z-axis points up. The steering wheel angle is positive when turned to the right.

The longitudinal acceleration data in Figure 4 also shows no evidence that regen is occurring as the vehicle is turning into the driveway before the drive motor revs up. This observation is supported by the vehicle speed data of Figure 3, which shows that the vehicle speed remains constant at 6 MPH before the drive motor revs up. Yet, the driver maintains that the vehicle was in the HOLD mode with STANDARD regen throughout the incident. If the driver is correct, then why isn't regen apparent in the data of these two sensors?

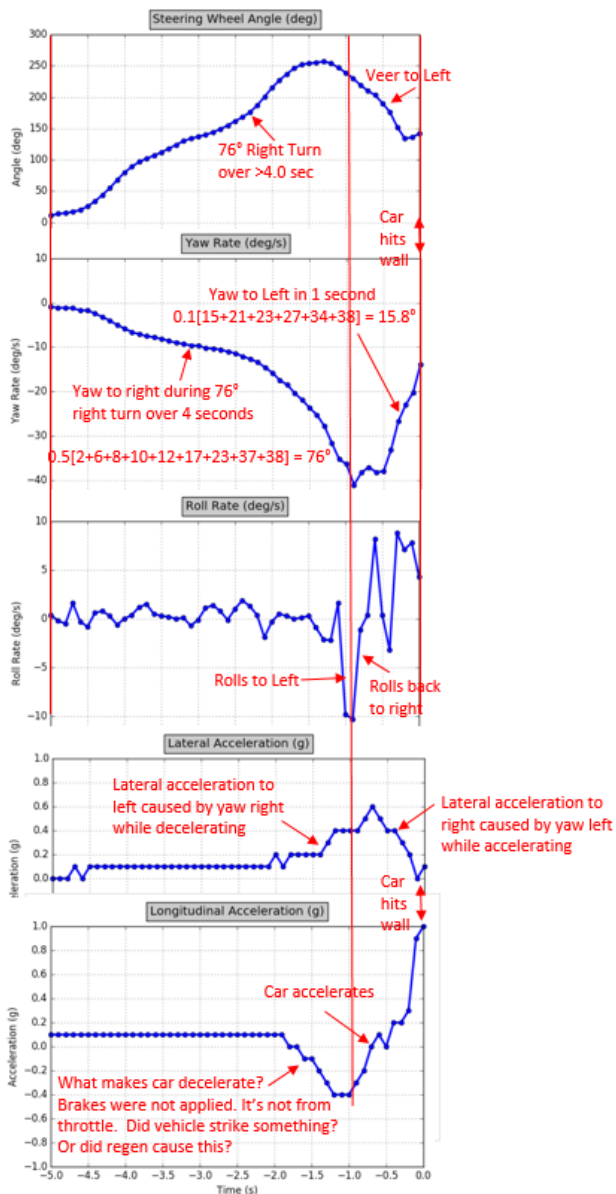
More inconsistencies become apparent if we compare the accelerometer data while aligned in time, as shown in Figure 6. Both the steering wheel data and the yaw rate data agree with each other and show that the vehicle was turning to the right into the driveway. At about 76° into the 90° turn, as the drive motor revs up to cause the vehicle to accelerator forward, both the steering wheel data and the yaw rate data change direction, indicating a veer to the left. The acceleration in the forward direction appears to be causing the veer to the left. This change of direction in the yaw data reconciles the difference between the driver's testimony and the EDR data and Tesla's letter as shown in table of Figure 5.

A closer look at the steering wheel angle data and the yaw rate data reveals that the yaw rate is still increasing while the steering wheel angle is leveling off or even decreasing. This suggests that front wheel slip is occurring to cause an oversteer condition, which could activate the

Figure 6. Accelerometer plots aligned in time show that the peaks roughly align at -1.0 seconds

vehicle's stability control system. The normal response of a vehicle stability control system to an oversteer condition is to brake the outside front wheel to cause a yaw moment in the direction opposite to the oversteer direction. In this case, during an oversteer to the right, the left front wheel would be braked, causing the vehicle to yaw to the left. This is exactly what is observed. This appears to explain the driver's testimony that the vehicle "turned to the left" to cause damage to the right front corner of her vehicle.

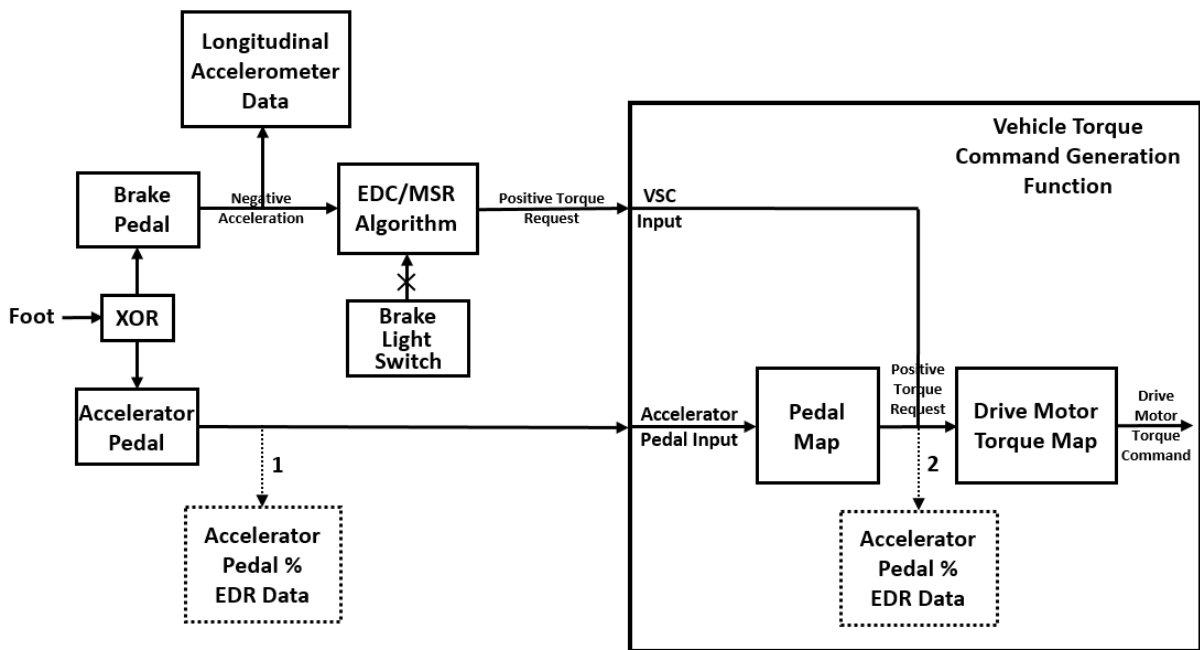
What likely happened in this incident is the brake switch was faulty. As a result, when the driver pressed on the brake pedal to cause a negative acceleration of 0.5 g's, the brake switch did not show that the brake pedal was being pressed. Therefore, when the EDC/MSR function detected the negative acceleration, it checked the brake switch to find the cause and got a false reading showing that the brake pedal was not being applied. As a result, it concluded that the negative 0.5 g acceleration was caused by a regen torque from the drive motor, instead of the brake system as was truly the case. This caused it to send a request to the drive motor to reduce the negative torque by increasing the drive motor torque. Since the drive motor torque was already zero because regen had been cut by the ESP hev II module early in the turn, this request to increase the drive motor torque caused the drive motor torque to increase from 0 to an RPM corresponding to 0.5 g's of positive torque. This is what we see in the longitudinal acceleration data, with a slight time delay of a few hundred milliseconds caused by the command latency over the CAN bus. What has happened in this case is that the faulty brake light switch has caused the brake pedal to behave like an accelerator pedal. The harder the brake pedal is pressed, the more positive drive motor torque is produced.

To answer this question, let's first clarify what was happening in greater detail. Figure 30 shows the sequence of events involved in this incident. The driver's foot could either be on the brake pedal or the accelerator pedal, and not on both at the same time. This explains the exclusive-OR (XOR) function in Figure 30. Pressing on the brake pedal produced a negative acceleration of 0.5 g's which was recorded by the longitudinal accelerometer. The EDC/MSR algorithm in the brake modulator also detected this negative acceleration, and after checking the defective brake light switch, it interpreted the negative acceleration as a drive motor drag torque. Therefore, it issued a request to the drive motor for a positive motor torque to offset the negative drag torque. This request went via a CAN bus to the VSC input of the Vehicle Torque Command Generation Function in the drive motor control system (Figure 16), where it became a positive torque request to the drive motor torque map.

Figure 30. Sequence of events involved in this incident

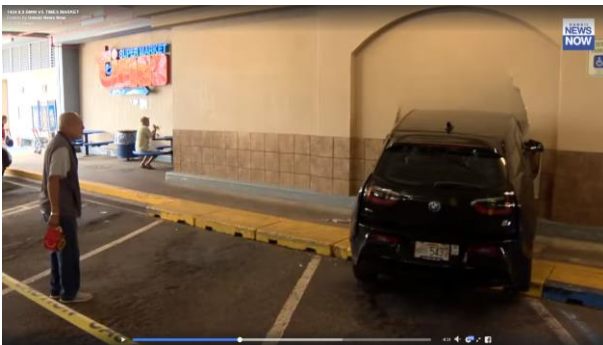
Figures 31 and 32 show a BMW i3 that has run into a wall.⁴⁷ This incident took place in the Kiamuki Shopping Center in an inner suburb of Honolulu on August 11, 2019. Although no driver's testimony is provided about the incident, it is clear from the photos what happened. The driver was trying to park in a perpendicular parking space in preparation for shopping in the Times supermarket. The parking space was near the entrance of the supermarket. As the driver was pulling into the parking space after making a 90° turn, the vehicle's drive motor revved up. The BMW i3 has a single rear drive motor just like many Tesla's. This incident is exactly like the 70 Tesla sudden acceleration incidents of Category A in Section 9, for which our explanation is valid.

Figure 31. BMW i3 after suddenly accelerating while pulling into a perpendicular parking space.⁴⁷

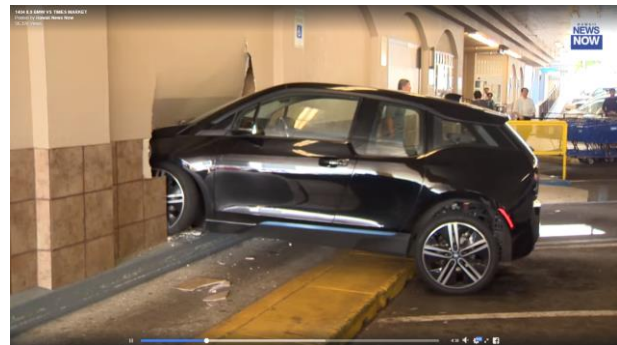
Figure 32. Side view showing damage to the wall behind the parking space. Store entrance is in the background.⁴⁷
