Tesla's Sudden Acceleration Log Data – What It Shows

Ronald A. Belt
Plymouth, MN 55447
1 May 2018

Abstract: Accelerator pedal sensor data from the log file of a Tesla S sudden acceleration incident is provided, and a Tesla circuit diagram is used to explain how the data is obtained from the two accelerator pedal position sensors. Examination of the data shows that the accelerator pedal sensor output increased to cause the sudden acceleration. But the increase in the accelerator pedal sensor output could not have been caused by the driver. Instead, the increase in the accelerator pedal sensor output appears to have been caused by a fault in the motor speed sensor, with which it shares a common+ 5V power and ground. This increase in pedal sensor output occurs without the driver pressing on the accelerator pedal. An explanation of how this increase can occur is provided, yielding a testable theory of sudden acceleration in Tesla vehicles. The theory applies to all Tesla S and Tesla X vehicles as a result of commonality in the design of their traction motor/inverter assemblies.

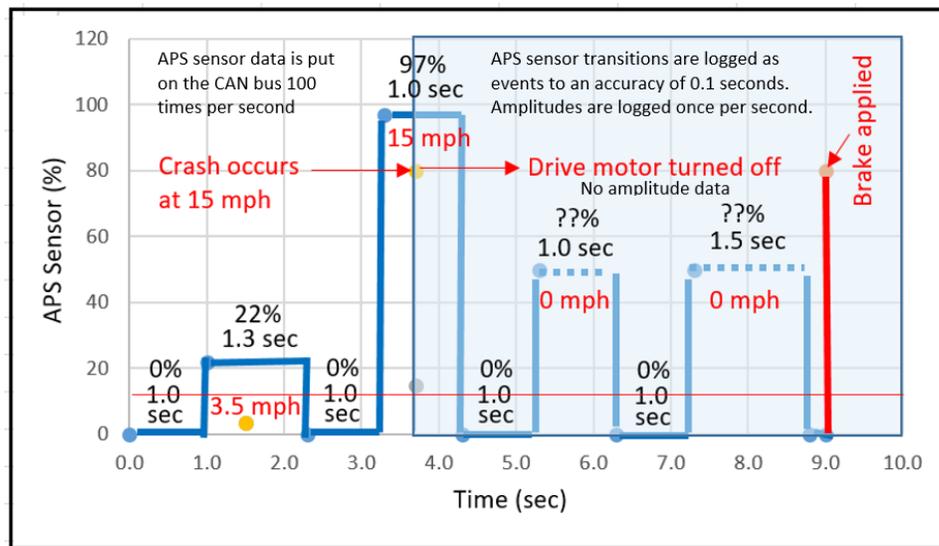
Figure 1 shows the accelerator pedal sensor data logged during a Tesla S sudden unintended acceleration incident. The driver maintained that her foot was not on the accelerator pedal at any time during the incident. Above each peak and valley are the amounts that the accelerator pedal is being pressed in percent of maximum travel, where maximum travel means pedal floored. The durations of the pressing are shown in seconds. Beneath the peaks the vehicle speed is shown in red in miles per hour. At $t = 3.5$ seconds when the crash occurred, the power to the drive motor was turned off as the vehicle was going at 15 miles per hour. It can be inferred from the data that the inverter logic and sensors continue to operate as before the crash. Amplitude data was not provided for the two peaks after the crash. After the crash the vehicle was stationary for five seconds before the brake pedal was applied.

Figure 1. Accelerator pedal sensor data for a sudden unintended acceleration incident

Tesla engineers interpreted the peaks in the data as the driver causing the sudden acceleration incident by pressing on the accelerator pedal. But this does not explain the zero-amplitude periods of one second duration between the periods of higher amplitude. These zero-amplitude periods were explained by Tesla engineers as the driver alternately pressing on the accelerator pedal and releasing the accelerator pedal; i.e., “stabbing” at the accelerator pedal. Note that the time periods of the peaks and valleys are accurate to 0.1 second. There is no way that a human driver can produce four time periods of exactly one second duration accurate to 0.1 second by alternately pressing and releasing the accelerator pedal. Therefore, the author began to look for an alternative way to explain these periods of zero amplitude by some malfunction of the electronic circuitry. One suspicion was that the four time periods of zero amplitude are caused by some integrated circuit component going into reset.

- a. The anomalous increase in APP sensor output voltage is caused by a voltage drop in the APP sensor ground line as a result of the temperature-dependent speed sensor leakage current passing through the parasitic ground resistance. As the temperature of the drive motor increases, the motor speed sensor leakage current increases, causing the output of the accelerator pedal sensor to rise. This creates the peaks in the accelerator sensor output shown in Figure 1.

- b. As the leakage current continues to increase, at some point the reverse biased isolation junctions in the Hall effect switches become forward biased, causing a huge increase in the Hall encoder leakage current. At this point the +5V regulator powering the APP sensor and the motor speed sensor goes into reset, causing the APP sensor output to fall to zero as shown by the transitions at $t = 2.3$ sec, 4.3 sec, and 6.3 sec in Figure 1.

- c. The +5V regulator stays in reset for a fixed amount of time, creating the four periods of zero sensor output lasting for exactly 1.0 seconds accurate to 0.1 second as shown by the peaks in Figure 1.

- d. After the 1.0 second reset time is over, the +5V regulator turns on again, causing the motor speed sensor to turn on again. The leakage current of the motor speed sensor starts to rise again, making the APP sensor output rise again. This is shown by the upward transitions in Figure 1 at $t = 3.3$ sec, $t = 5.3$ sec, and $t = 7.3$ sec.

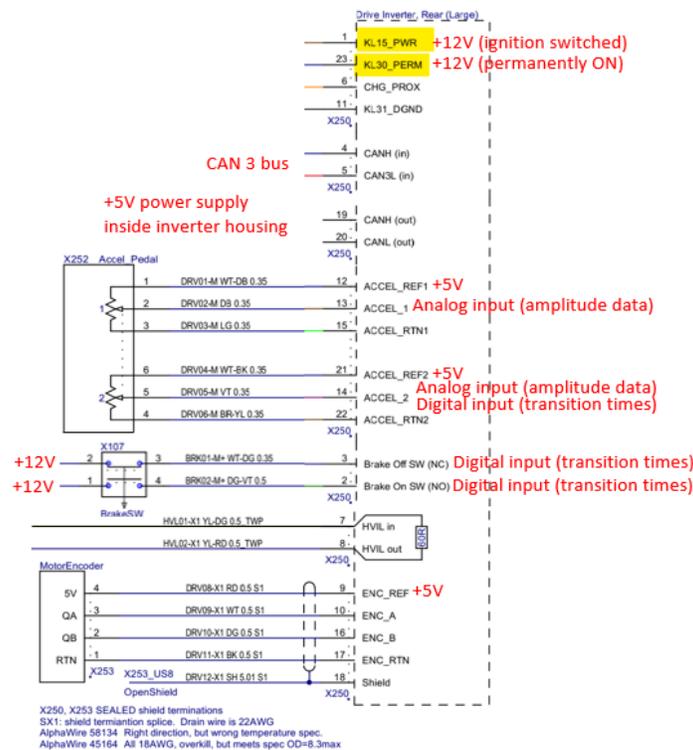
Since the 0.1 second accuracy of these accelerator sensor transitions is important to interpreting the data as not being caused by a human driver, we will take a look at how these transitions and amplitudes are measured. This is done with the help of the wiring diagram for a Model S motor drive inverter obtained from Tesla as shown in Figure 2. Figure 2 shows that two accelerator pedal position (APP) sensors are used by the inverter. The outputs of both sensors go to analog CPU inputs where they are sampled by an A/D converter at a rate of 100 samples per second. The amplitudes of the two sensors are then compared and, if they differ by more than a specified tolerance, the vehicle drive power is disabled and a diagnostic trouble code (DTC) is set. If the amplitudes of the two sensors agree, then the common amplitude is used by the inverter's control system to adjust the torque of the drive motor. This high speed amplitude data is then down-sampled or averaged at a rate of one sample per second for logging by the vehicle's data logging system. The analog output from one of the APP sensors is also converted into a fast rise-time digital signal and inserted into a digital CPU input, where it punches a time clock that provides the time of the transition. The transition times are measured to an accuracy of 0.1 second. The transition data is used only as a check on the amplitude data to declare the amplitude data as valid while the accelerator pedal is being pressed down. It is not used by the control system of the motor drive inverter.

Figure 2. Wiring diagram a Tesla S motor drive inverter. Author's notations are shown in red.

Figure 2 shows that a motor speed encoder is also used by the inverter, having a +5V supply and GND input and two digital outputs giving the speed. There is also a brake switch having a +12V input and two digital outputs. One of the outputs is normally ON while the brake pedal is released and transitions to OFF when the brake pedal is pressed down. The other output is normally OFF and transitions to ON when the brake pedal is being pressed down. This action provides an exclusive OR function that can be used by the control system as a redundancy check to tell that the brake is being applied.

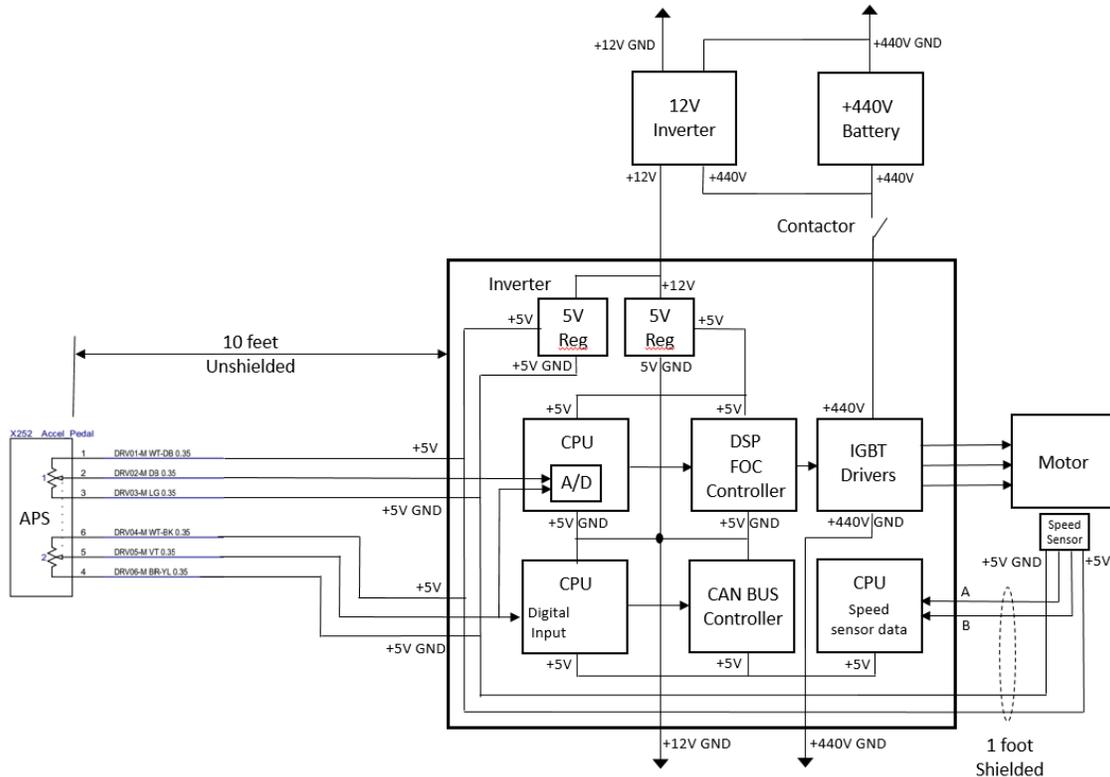
From a basic understanding of how the electronic control circuitry is designed in other automobiles, it is possible to draw a block diagram of the major inverter functions as shown in Figure 3. Figure 3 shows that the major inverter functions are a CPU controller, a DSP FOC motor drive controller, IGBT drivers, a CAN bus controller, and one or more +5V regulators. To the inverter block one can then add the external accelerator pedal sensors, motor speed sensor, 12V inverter, and 440 volt drive battery with contactor as shown in Figure 3. In creating Figure 3 it was assumed that the two accelerator pedal sensors and the motor speed sensor share the same +5V regulator and GND. This is standard practice on all modern automobiles even though it compromises the fault tolerance of the dual accelerator pedal sensors. The CPU, DSP, and CAN bus controller were given a separate +5V inverter and GND.

Figure 3. Block diagram of the major functions inside the motor drive inverter

After creating this figure, the author began to consider how one might explain the logged accelerator sensor data. After mulling over the figure, it became apparent that the peaks in the logged accelerator data might be explained by a rise in the APP sensor GND voltage. The valleys, on the other hand, might be explained by the +5V APP sensor voltage regulator going into reset with a 1.0 sec reset time. The fall in the APP sensor signal after the +5V sensor regulator goes into reset can be detected because the CPU remains functional as a result of its separate +5V power supply. A quick check of +5V regulator specifications showed that +5V regulators can have widely varying reset times that are either fixed by design or adjustable by the user via external capacitors. The rise in the APP sensor GND voltage may be explained by an increase in the APP sensor GND current acting on the parasitic resistance in the APP sensor GND line. But the cause of the increase in the APP sensor GND current must still be found.

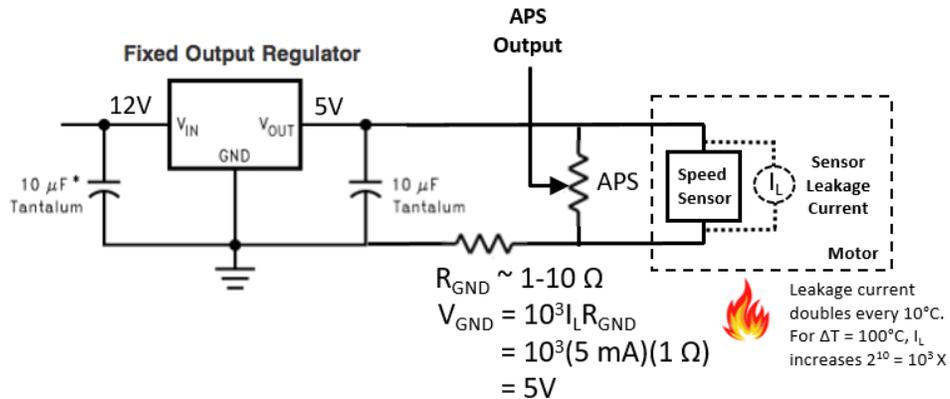
A detailed circuit diagram of the essential components is shown in Figure 4. Figure 4 shows that when the temperature of the motor speed sensor increases, the increased sensor leakage current I_L through the parasitic R_{GND} causes the ground voltage to rise due to the voltage drop across R_{GND} . This, in turn, causes the APP sensor output signal to rise without the accelerator pedal being pressed. A rise of 100°C in the motor speed sensor temperature can cause a rise of 10^3 times in the sensor leakage current, producing a rise in the APP sensor output voltage of up to 5 volts with a stray resistance of only a 1-10 ohms in the ground line. When the leakage current gets too high, the +5V regulator powering the APP and motor speed sensors is shut off for a fixed amount of time. Voltage regulators can have widely varying reset times that are either fixed by design or adjustable via external capacitors. The voltage drop across R_{GND} will not be noticeable (< 5 mV) when the current through the motor speed sensor is only a few milliamps at room temperature. The circuit of Figure 4 can therefore explain the increase in the APP sensor output without the driver pressing on the accelerator pedal. A closer look at the motor speed sensor will help to understand the source of the temperature-dependent leakage current.

Figure 4. Circuit diagram showing essential components affecting the output of the accelerator pedal sensor (APP)

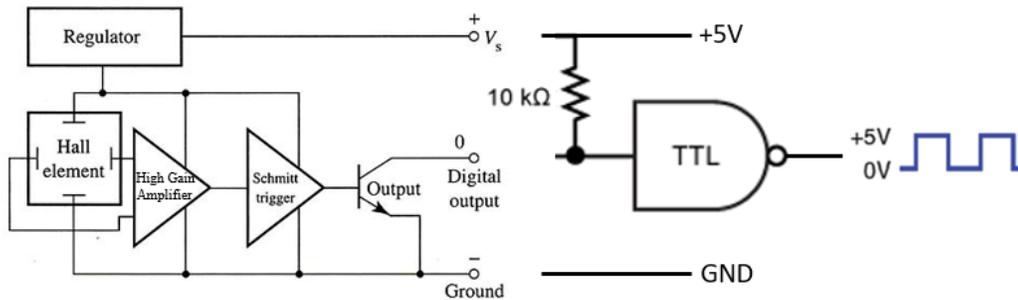
Figure 5. Hall effect switch with digital output

Figure 5 shows that the leakage current that increases with temperature is caused not only by a Hall effect sensor, which is essentially an isolated resistor, but also by a high gain amplifier, a Schmitt trigger circuit, an output transistor, and a voltage regulator, all of which are complex integrated circuit functions comprised of many active semiconductor components. All of these components must be electronically isolated from each other using reverse-biased semiconductor junctions, which can cause a leakage current that varies with the temperature. The leakage current will double with every 10°C rise in temperature. Therefore, a rise in temperature of 100°C can cause an increase in leakage current of $2^{10} = 10^3$ times, or enough to go from one milliamp to one amp. This increase of leakage current with temperature will occur even though the devices are specified to remain operable at temperatures of up to 150°C because the devices can remain functional even when the leakage current gets quite high. It is only when the leakage current gets so high that the isolation junctions become forward biased that the functionality of the device

ceases. At this point, the leakage current will suddenly increase to an even higher value that is not limited by the device itself. This will cause the external +5V regulator to go into reset.

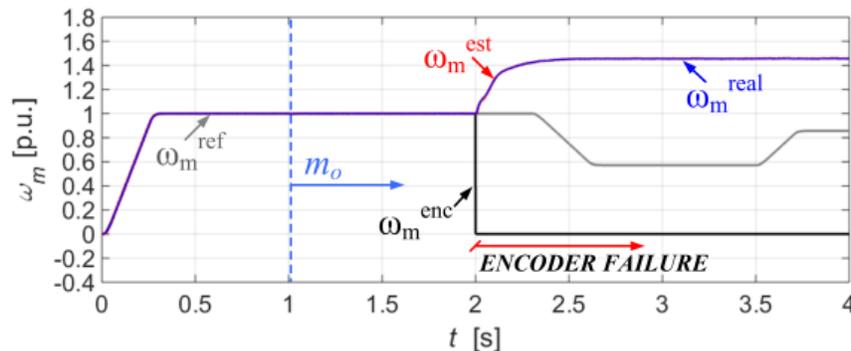
- c. The result is that during the valleys of the pedal sensor output shown in Figure 1, while the motor speed sensor is turned off, the FOC motor control algorithms become unstable, causing the motor speed to increase in an uncontrolled fashion. This increase in motor speed is not shown in Figure 1. But it is shown in Figure 8 below, which shows actual measured and estimated results for a speed sensor failure in real AC induction motor controlled by a DFOC algorithm as used by Tesla in all their vehicles.¹

Figure 8. Measured motor speed (ω_m^{real}) and estimated motor speed (ω_m^{est}) for a total failure of the speed sensor in a real ACIM motor controlled by a DFOC structure, as used by Tesla in all their vehicles. The drive is started from zero speed and brought up to the nominal speed of 1 power unit, then at $t = 1$ s a load m_o is placed on the motor. The speed sensor failure occurs at $t = 2$ s, when the motor speed sensed by the motor speed encoder (ω_m^{enc}) changes from $\omega_m^{\text{ref}} = 1$ power unit to 0 power units. At this time the measured and estimated motor speeds increase from one power unit to 1.4 power units as a result of instability in the DFOC algorithm.¹

The authors of the paper in reference 1 propose a fault tolerant solution to the loss of a motor speed sensor in a situation similar to Tesla's. Their solution is to compare the speed sensed by the external motor speed sensor to the motor speed estimated by a speed-sensorless DFOC motor control algorithm. The motor power is then turned off when the two speed values differ by greater than some pre-determined value. This will cause the vehicle to lose power in much the same way an internal combustion engine does when the electronic throttle goes into the limp-home mode. The suddenness of losing drive torque due to turning off the motor power suddenly may cause a problem if done while driving at high speeds. But this suddenness may be an advantage in preventing damage in tight situations like parking lots with people and structures close by.
