Michael A. Berardi
Director
Service Engineering Operations
Ford Customer Service Division

October 26, 2017

SUBJECT: **Customer Satisfaction Program 17N03 – Supplement #1**
Certain 2011-2017 Model Year Explorer Vehicles
Carbon Monoxide Concerns

REF: **Customer Satisfaction Program 17N03**
Dated October 25, 2017

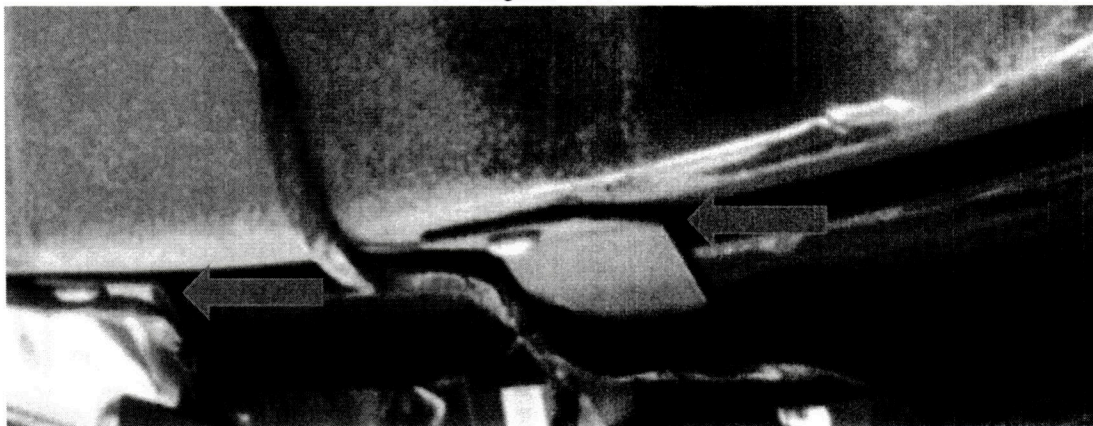
Figure 1

- Brackets positioned between the spoiler and the liftgate (See Figure 1)
- Lighting and/or equipment that forces the spoiler out of position creates a gap between the spoiler and the liftgate (See Figure 2)
- Unsealed holes drilled in the spoiler or liftgate (See Figures 3 and 4)
- Wiring for lighting and/or equipment routed from the spoiler to the vehicle in a manner that damages the seals between the spoiler and the vehicle (See Figures 5 and 6)
- When the spoiler is removed to install aftermarket lights and/or equipment, the spoiler attachment clips and seals may be damaged. If the spoiler was removed from the vehicle, the spoiler attachment clips and seals should be replaced. Use part number HB5Z-78442K03-A

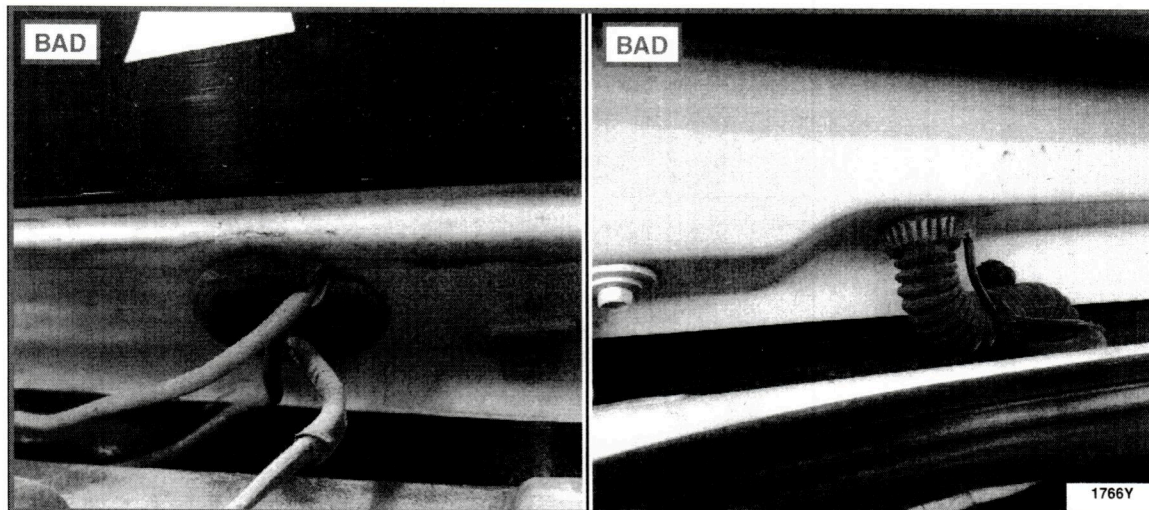
2. Inspect for any aftermarket wiring pass throughs/holes that could affect the sealing ability of the spoiler. See Figures 9a and 9b.

3. Seal any leak paths created by the aftermarket wiring pass throughs/holes in the spoiler area with Motorcraft® TA-2 seam sealer or equivalent.
4. Remove the liftgate spoiler tower foam seal. See Figure 10.
