KIA Sorento Fire Investigations

Prepared for:

January 11, 2019

Overview:

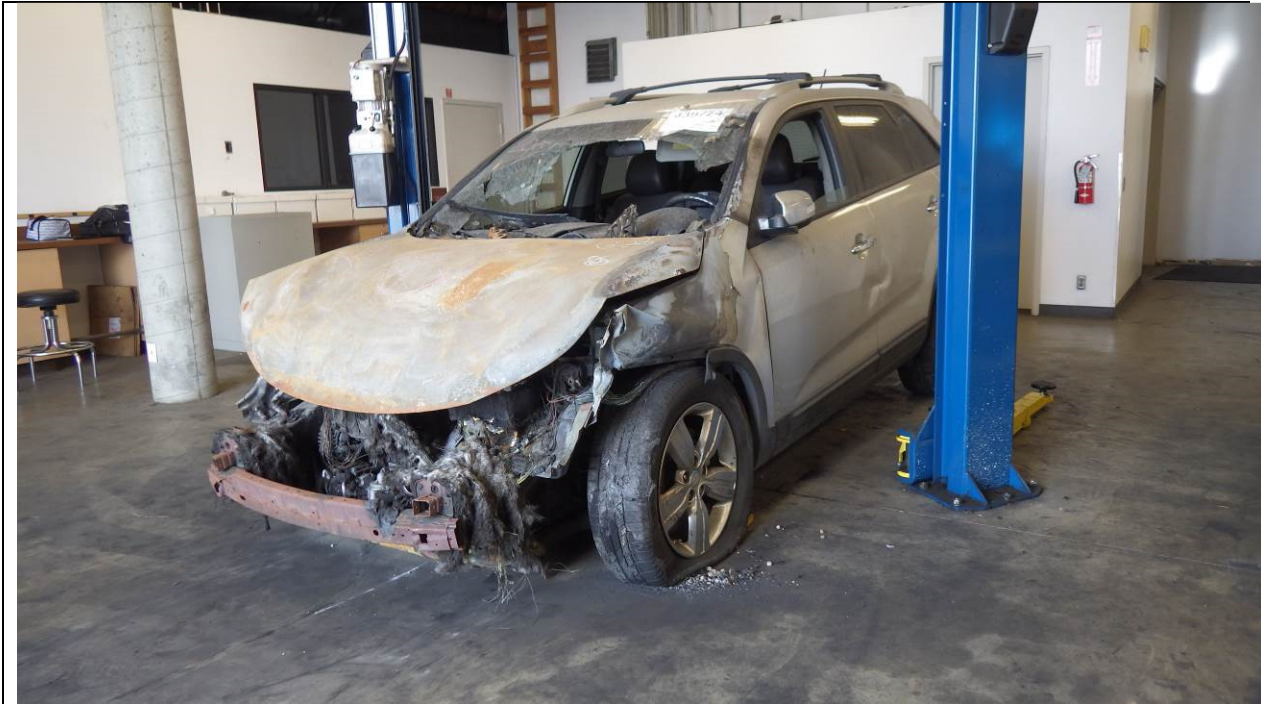
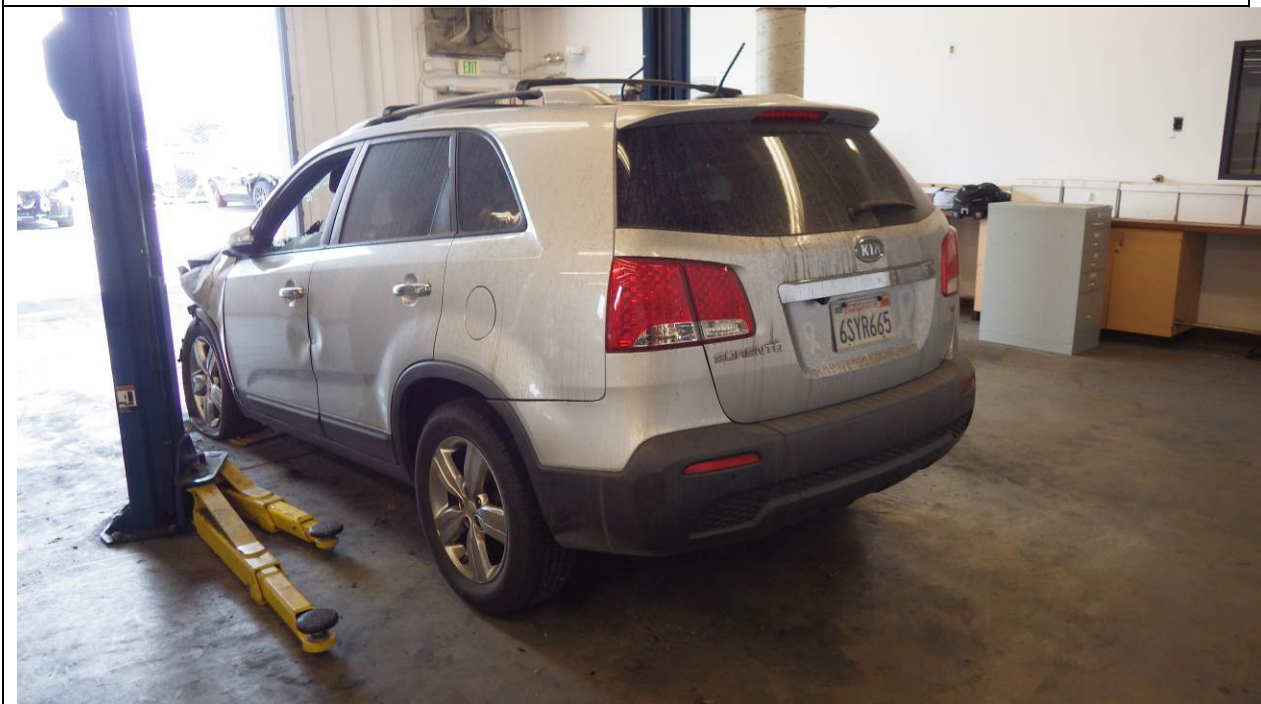
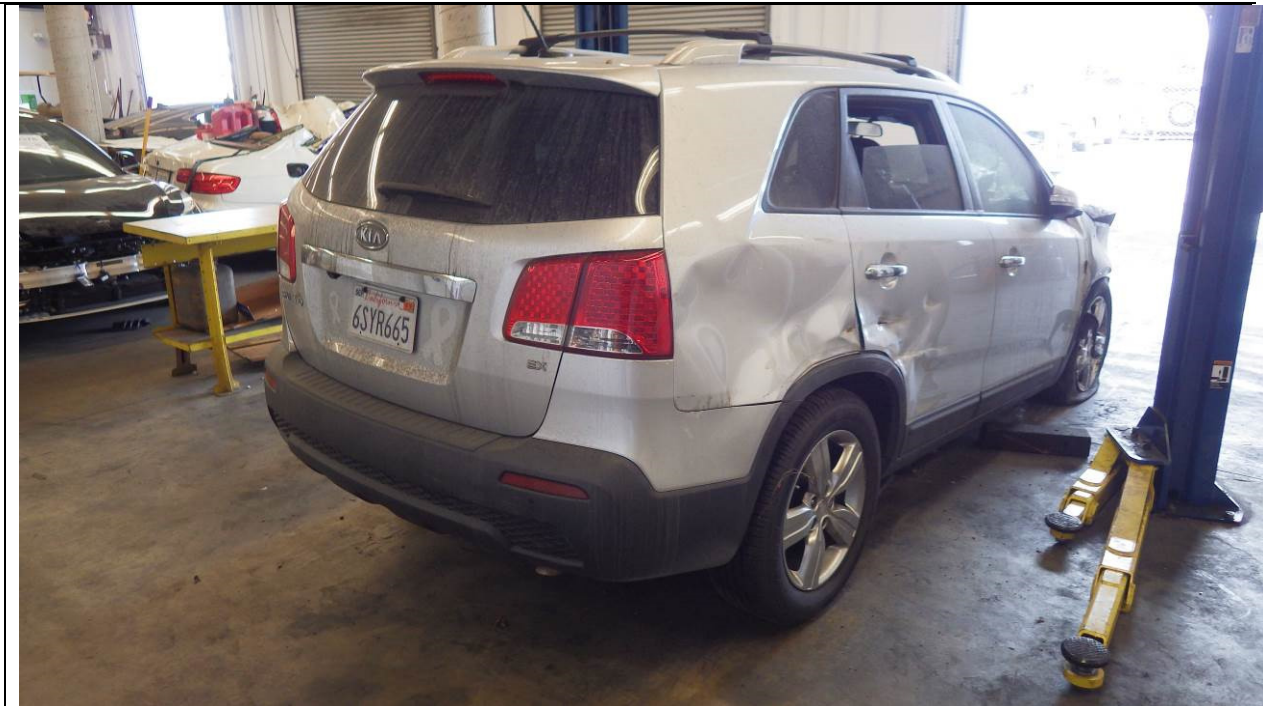
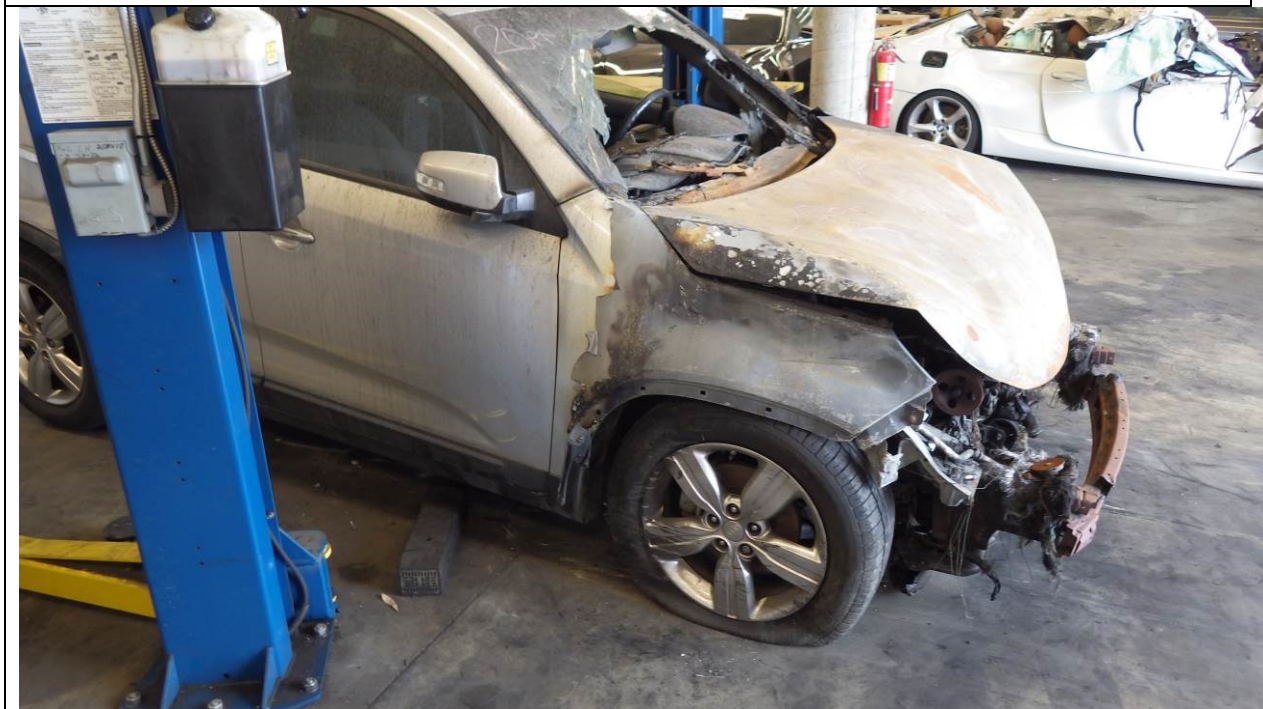
The subject vehicle was a 2012 Kia Sorento, manufactured in August of 2011. The vehicle identification number (VIN) was 5XYKU3A63CG242877 (See Figures 1 through 5). An exterior examination revealed extensive fire damage in the front of the vehicle, most significantly in the engine compartment and spreading into the front of the occupant compartment. The windshield

was partially fractured and melted along the lower aspect. Both front tires were deflated and showed heat damage. The hood and front quarter panels were distorted from the heat.

Figure 1: Hixon 2012 Kia Sorento, left front

Figure 2: Hixon 2012 Kia Sorento, left rear

Figure 3: Hixon 2012 Kia Sorento, right rear

Figure 4: Hixon 2012 Kia Sorento, right front

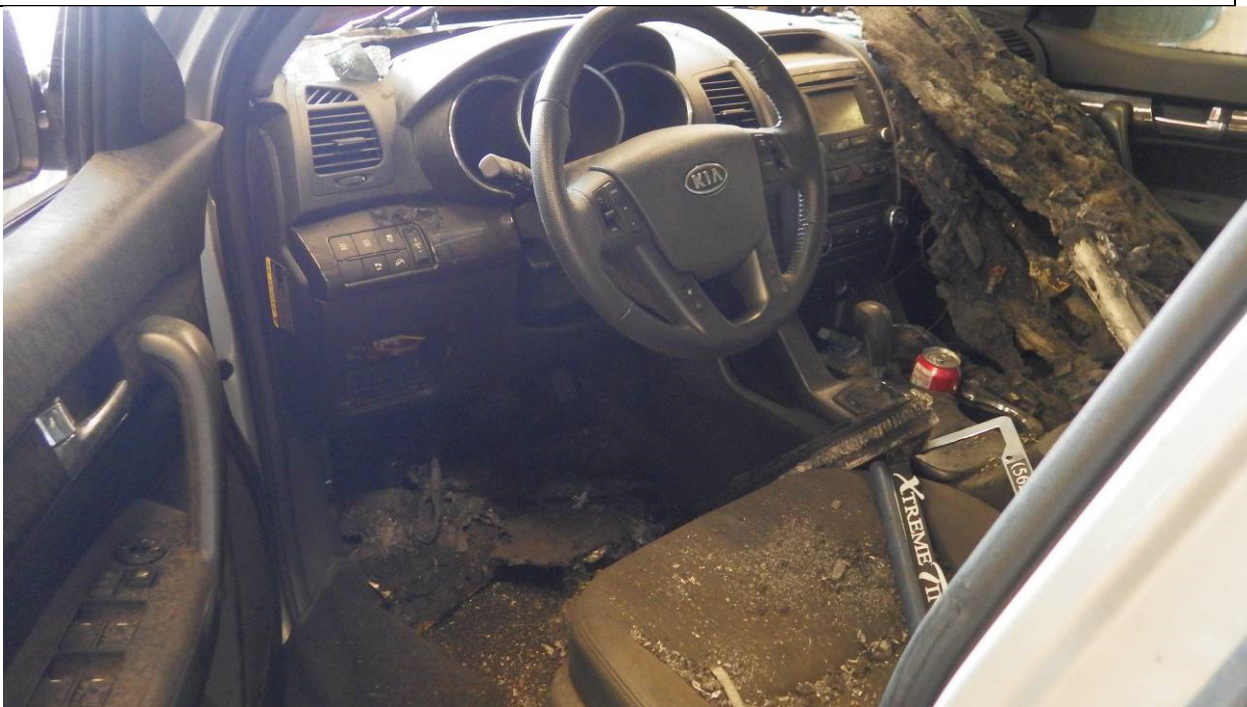
An interior examination revealed less extensive fire and smoke damage throughout the occupant compartment, mostly concentrated to the interior side of the bulkhead and internal dashboard area (See Figures 6 and 7). There was debris collected from the scene that was placed in the occupant compartment, and I was not permitted to disturb this debris. The headliner showed heat patterns, more significantly on the passenger side. Both front windows were intact, and the driver's side front window was partially opened.

Figure 6: Hixon 2012 Kia Sorento, interior driver's area

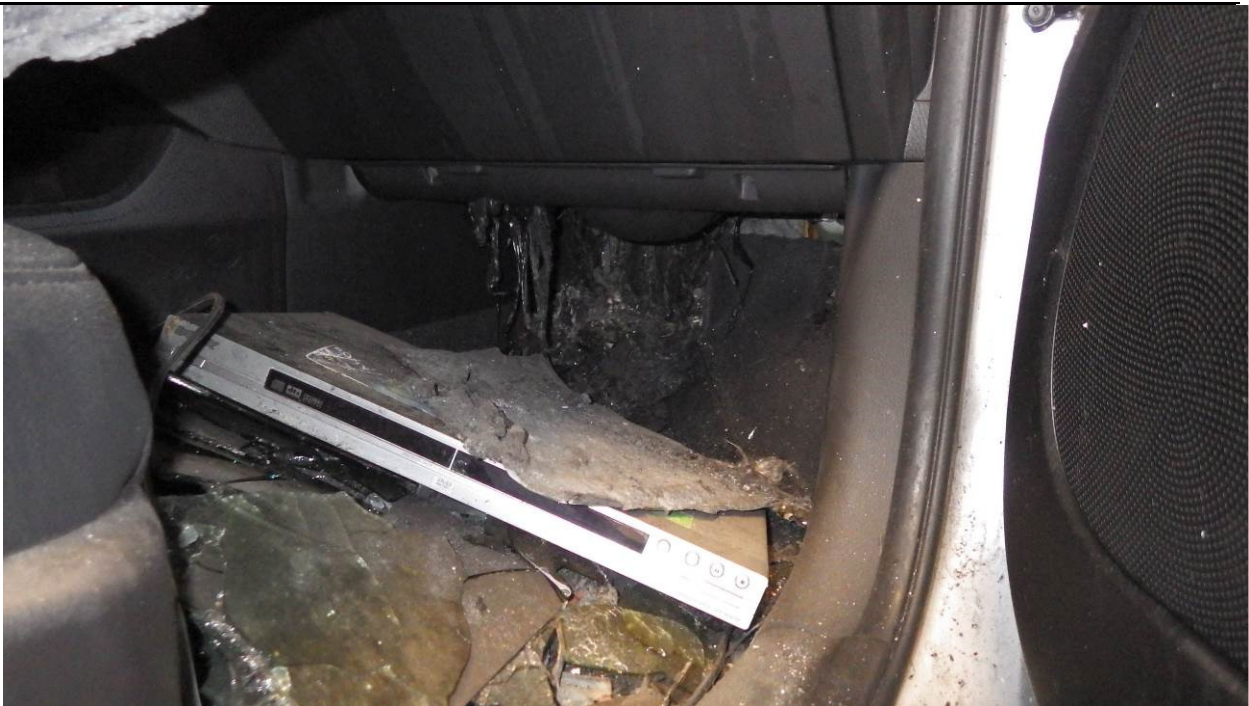
Figure 7: Hixon 2012 Kia Sorento, interior passenger's foot well area

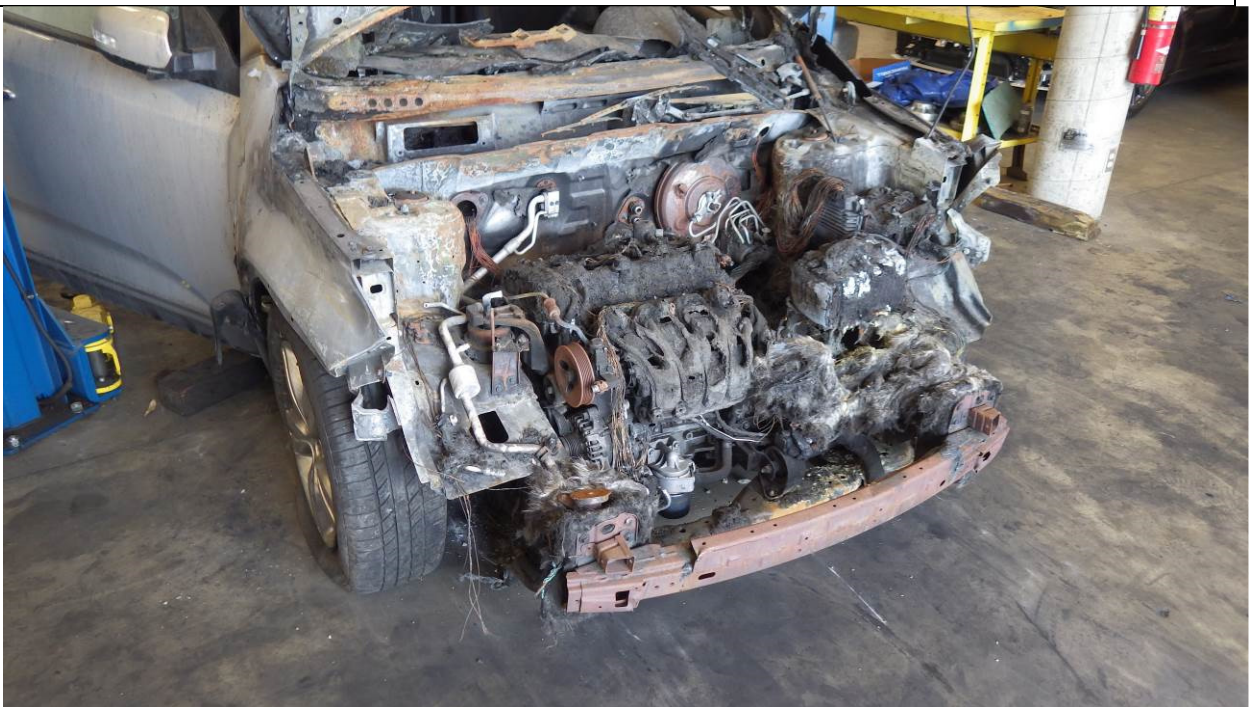
The engine compartment was inspected in more detail by raising the hood (See Figure 8). I was again limited to a visual inspection of the engine compartment only, so I took care not to disturb any of the electrical wiring or harness components. Most of the plastic components on the top and rear of the engine were consumed or melted. The battery was partially melted, with the terminals detached and buried in the debris. A visual examination of the battery wiring, starter, and alternator wiring, revealed no obvious signs of arc damage. The power distribution module and fuse panel was partially melted on the top. I traced the wiring bundle from this module to the interior of the vehicle, and many of the wires inside the loom still had insulation. The brake master cylinder and reservoir were missing. Many aluminum components on the rear of the engine were consumed. The area of most significant heat appeared to be the center rear area of the engine (See Figure 9). The front of the engine, especially the lower portion, had less damage and some plastic components that were not melted or consumed (See Figure 10).

Figure 8: Hixon 2012 Kia Sorento, engine compartment

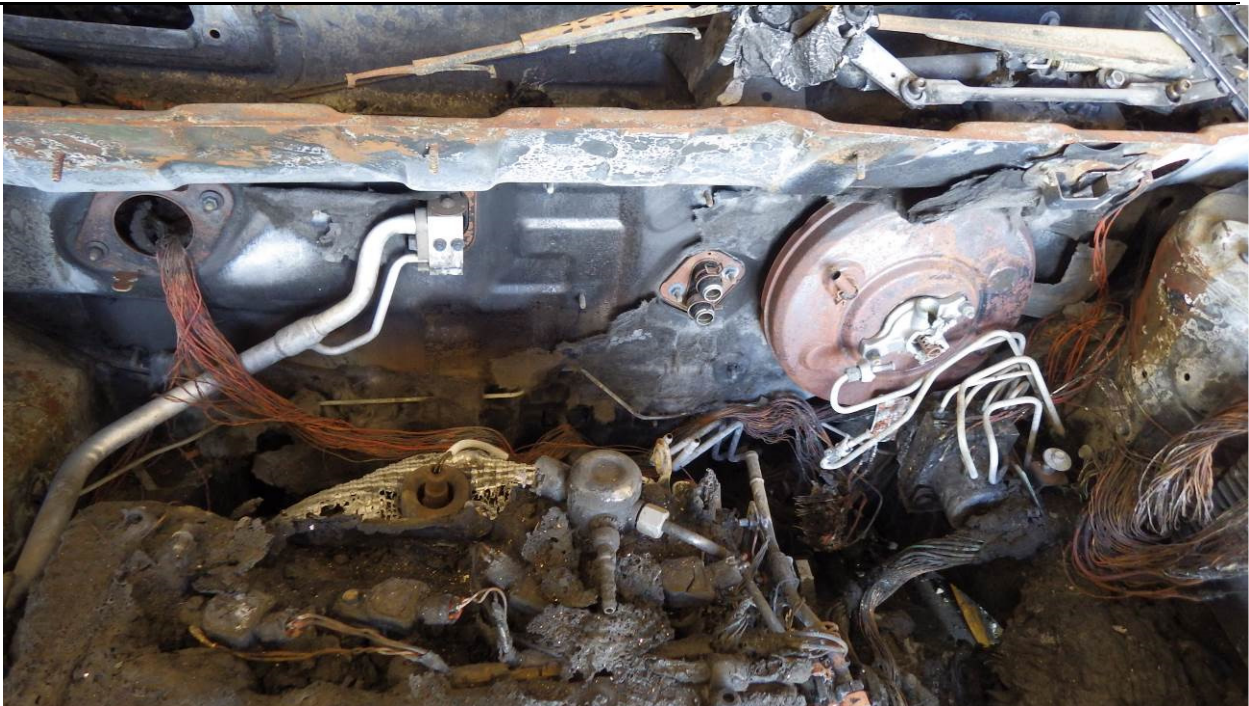
The fire damage on the subject Hixon Kia Sorento was localized to the engine compartment, with some extension into the dash area of the occupant compartment. All fire patterns are consistent with an area of origin in the engine compartment. More specifically, the heat patterns in the engine compartment indicate a point of origin and most significant damage as the center rear of the engine, between the block and the bulkhead.

Figure 9: Hixon 2012 Kia Sorento, engine compartment, center rear area

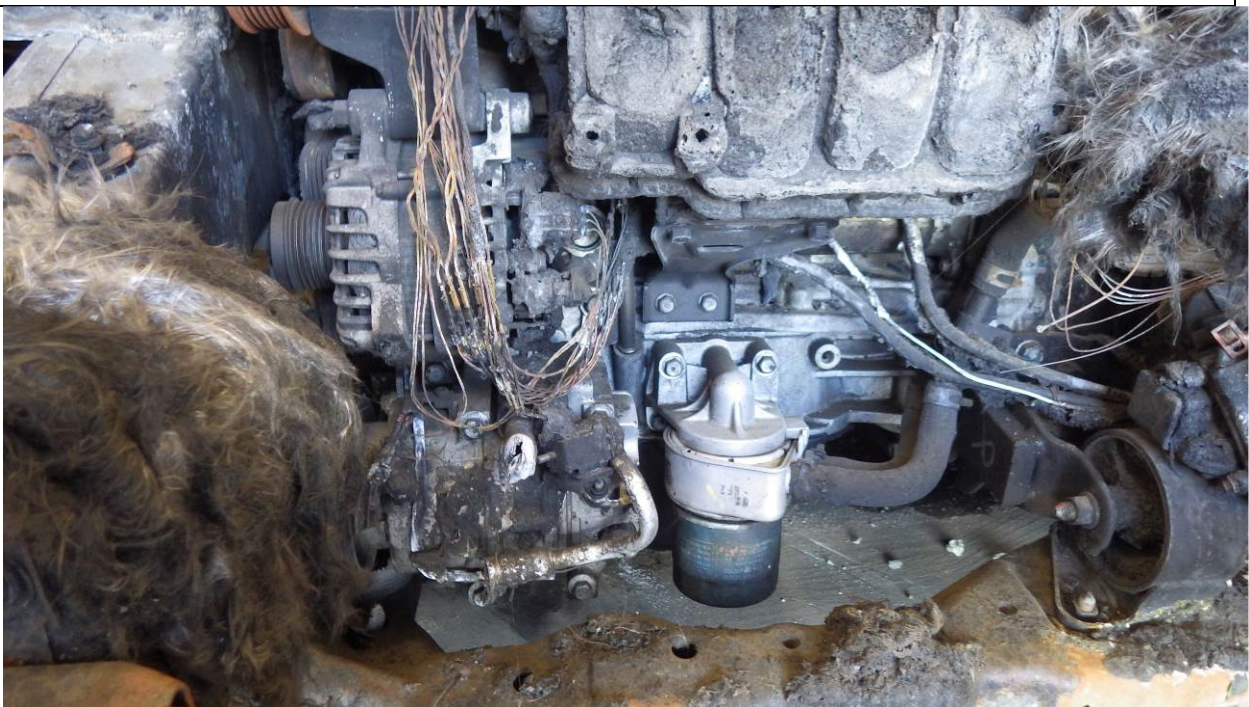
Figure 10: Hixon 2012 Kia Sorento, front of engine showing protected area

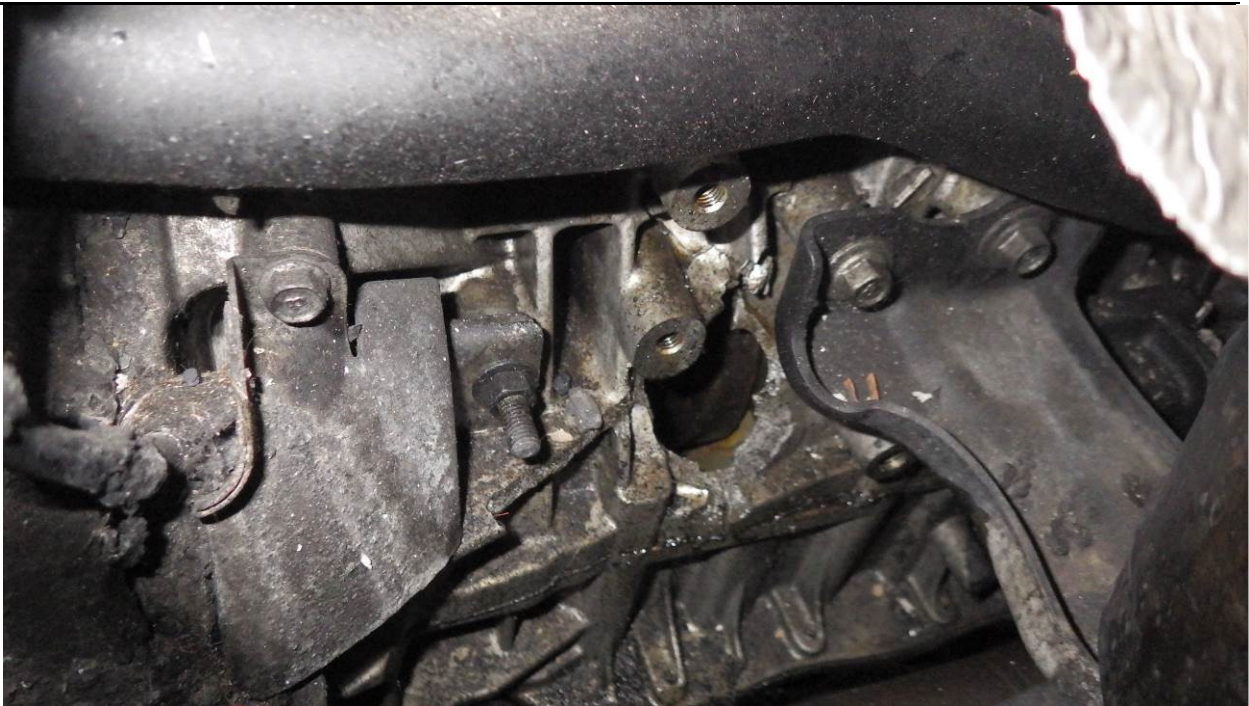
I further investigated the area in the center rear of the engine. The exhaust manifold and catalytic converter were located in this area. I discovered a hole in the sidewall of the engine block, between the engine and the bulkhead (See Figures 11 and 12). Heat patterns on the bottom of the exhaust manifold and down tube in this area are consistent with the presence of significant heat (See Figure 13).

Figure 11: Hixon 2012 Kia Sorento, rear of engine

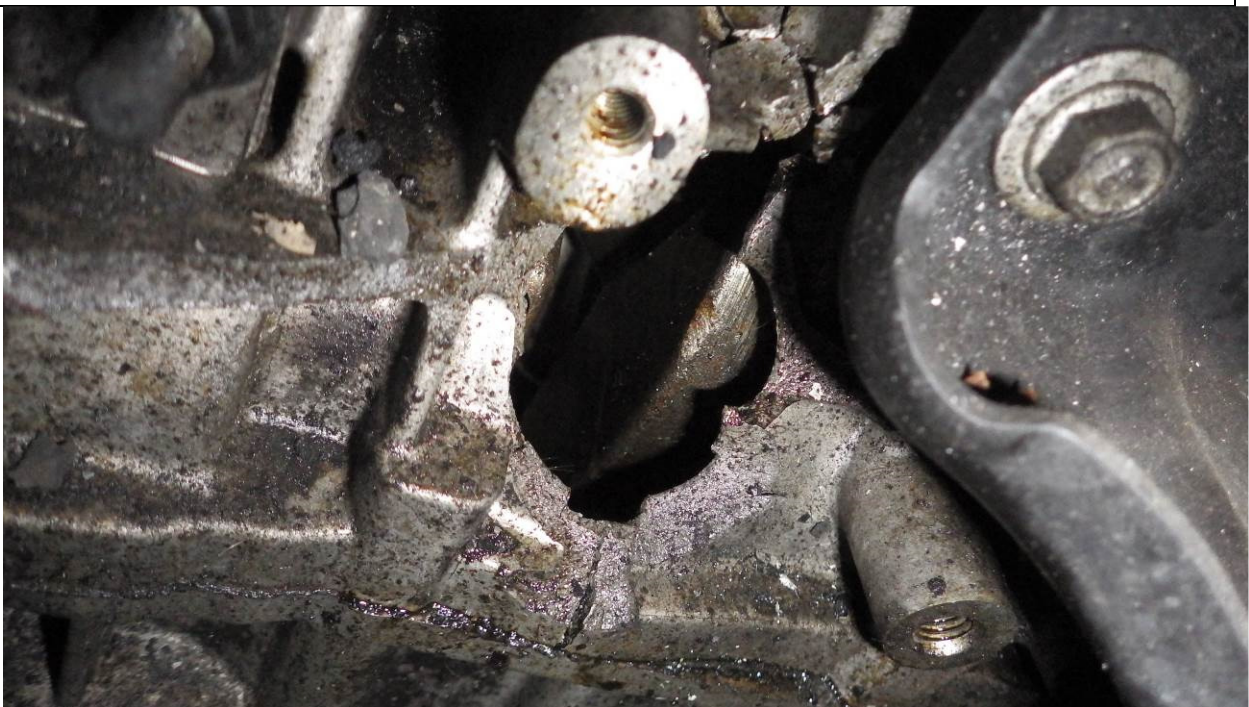
Once the origin has been established, the cause can be investigated. For a fire to occur, there must be a fuel source, as well as a mechanism of ignition whereby the fuel is ignited. Using the data gathered from the inspection, for the Hixon vehicle, there was a fuel source introduced into the area of origin when a catastrophic engine failure caused a hole in the rear sidewall of the engine block. The hot engine oil that would normally exist in the lower portion of the engine could escape through the hole. The oil would spray onto the adjacent surfaces. The exhaust manifold is located in this immediate area, which would provide a competent heat source. Surface temperatures of the exhaust components can easily be high enough to ignite sprayed oil. Although a thorough investigation of the electrical system could not be performed due to the limitations imposed by AAA, I saw no immediate visual indications of any potential electrical causes to the Hixon fire.

It is my opinion to a reasonable degree of engineering certainty that the origin of the fire in the subject 2012 Kia Sorento owned by Lorinda Hixon was the center rear of the engine compartment, between the engine and the bulkhead. The cause of the fire was likely ignition of the engine oil by the hot exhaust components after a catastrophic engine failure caused a breach in the side of the engine. The fire was related to a Kia Safety Recall Campaign SC147. The subject 2012 Kia Sorento was inspected according to the Kia Safety Recall Campaign SC147 remedy by Rally Auto Group, however, the vehicle still suffered catastrophic engine failure approximately 15,000 miles later.

Figure 12: Hixon 2012 Kia Sorento, hole in rear of engine

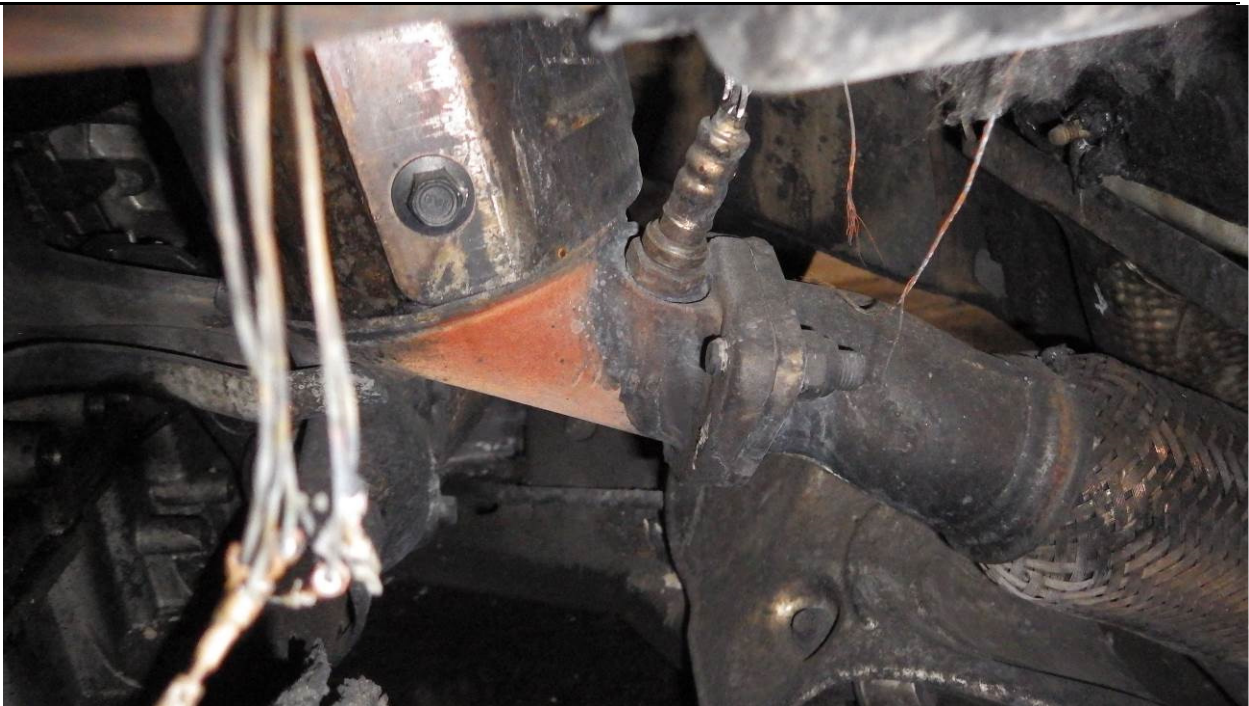
Figure 13: Hixon 2012 Kia Sorento, Exhaust near hole in rear of engine

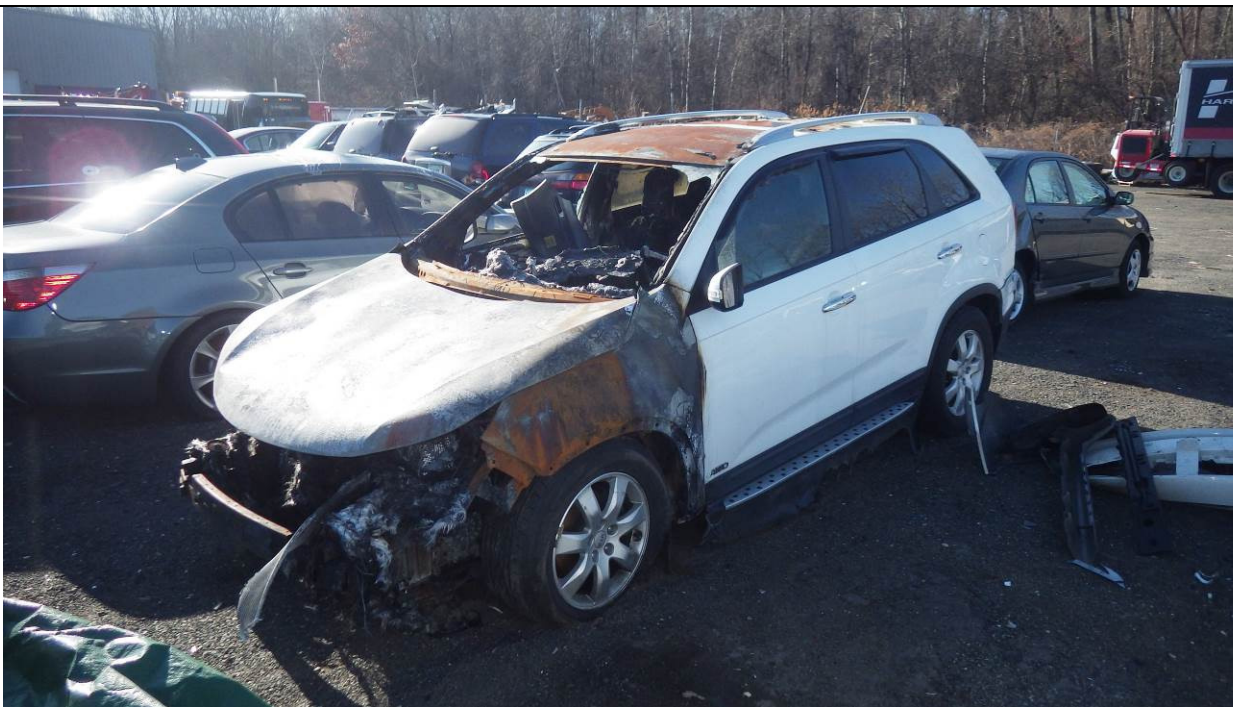
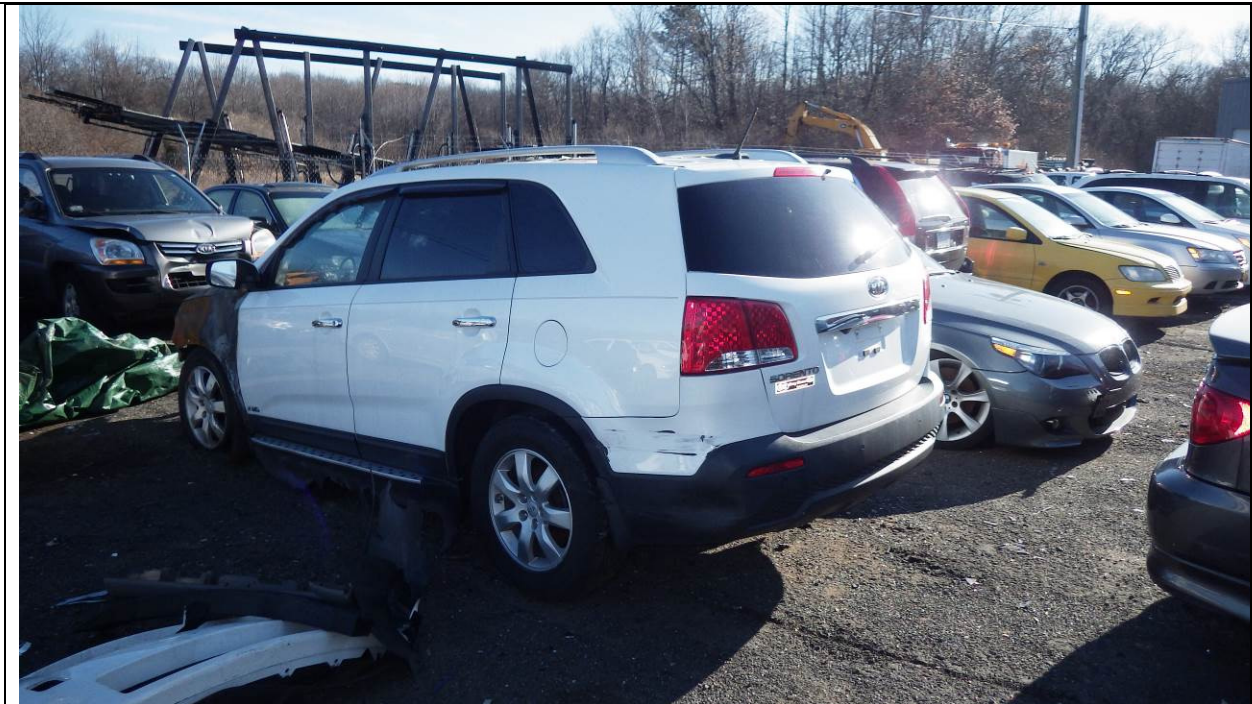
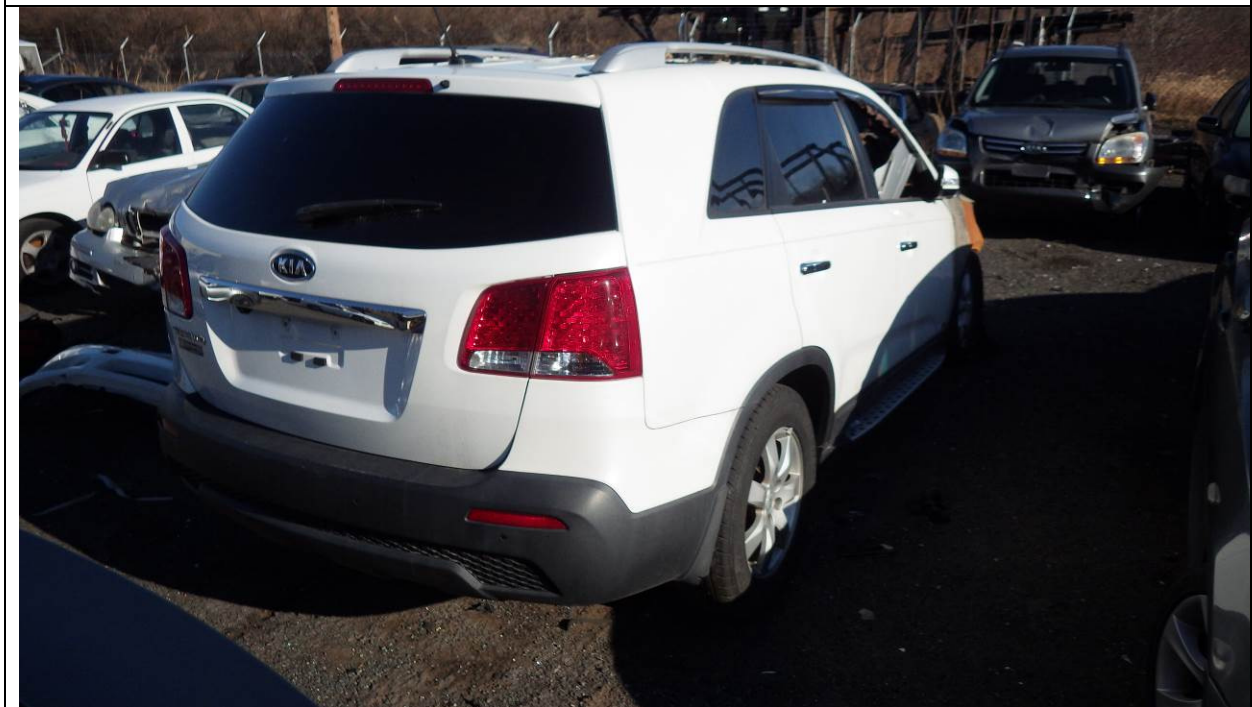
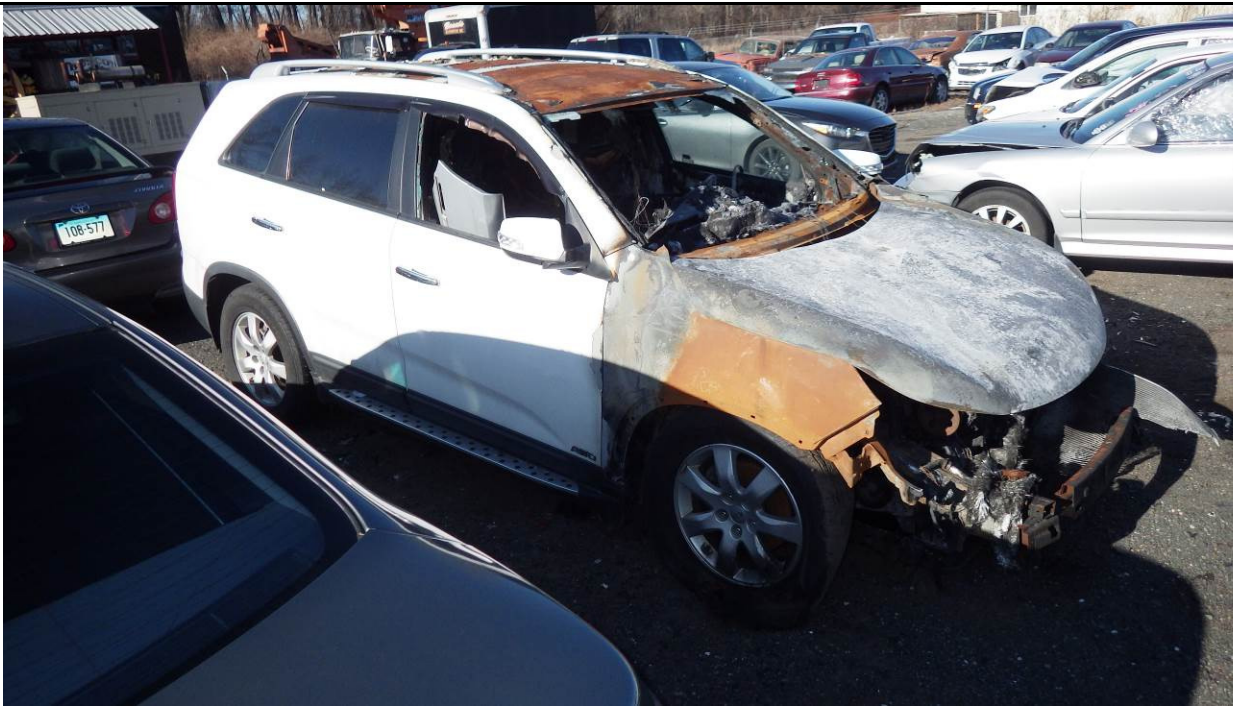
On December 18, 2018, I traveled to Bosco's Towing, located at 155 South Road, in Enfield, Connecticut. Prior to conducting the inspection, I received permission from Ms. Preste's attorney, Robert Elliott. The subject vehicle was a 2012 Kia Sorento, manufactured in September of 2011. The vehicle identification number (VIN) was 5XYKTDA61CG257628 (See Figures 14 through 18). The vehicle was sitting outside in a yard, uncovered and exposed to the elements. An exterior examination revealed extensive fire damage in the front of the vehicle, most significantly in the engine compartment and spreading into the front of the occupant compartment. The windshield was almost completely melted, with small remnants in the upper corners. Both front tires were deflated and showed heat damage. The hood, front quarter panels, and roof panel were distorted and discolored from the heat.

Figure 14: Preste 2012 Kia Sorento, left front

Figure 15: Preste 2012 Kia Sorento, left rear

Figure 16: Preste 2012 Kia Sorento, right rear

Figure 17: Prete 2012 Kia Sorento, right front

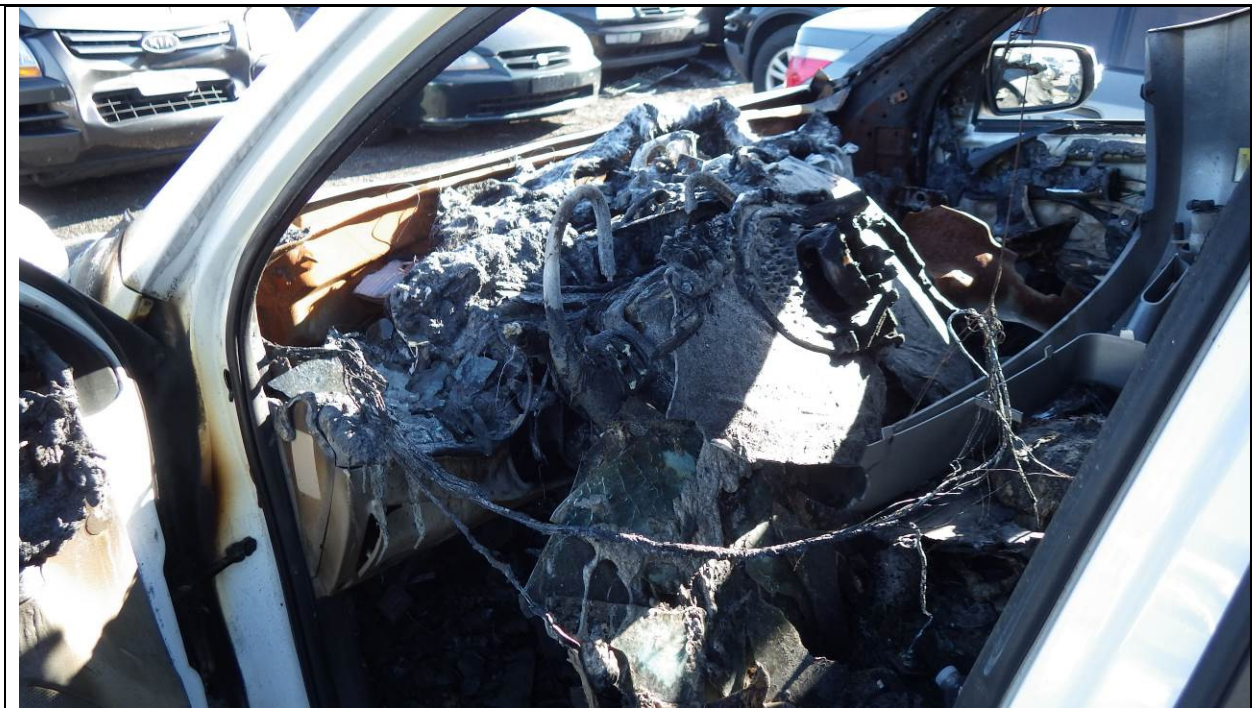
An interior examination revealed extensive fire and smoke damage throughout the occupant compartment, as the headliner was consumed and the upper portions of the front and rear seatbacks were damaged from the heat. (See Figures 19 and 20). The left front window was fractured, but other windows remained intact.

Figure 19: Preste 2012 Kia Sorento, interior driver's area

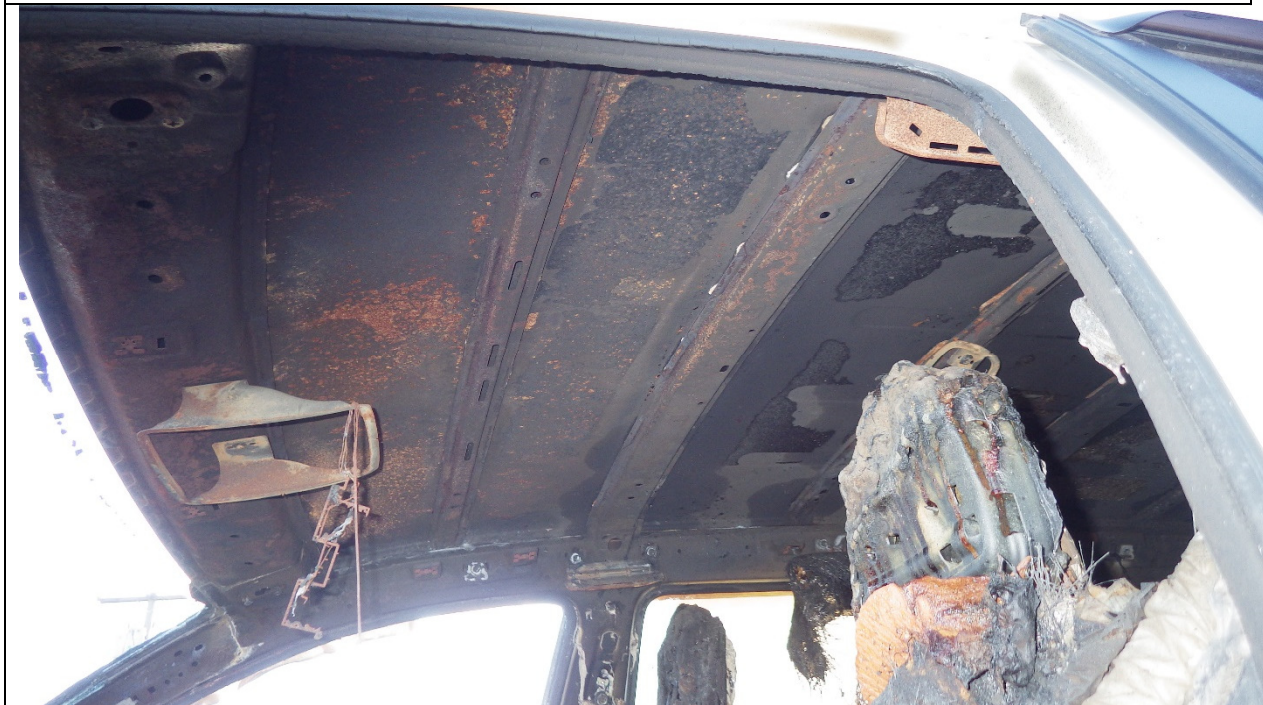
Figure 20: Preste 2012 Kia Sorento, interior headliner

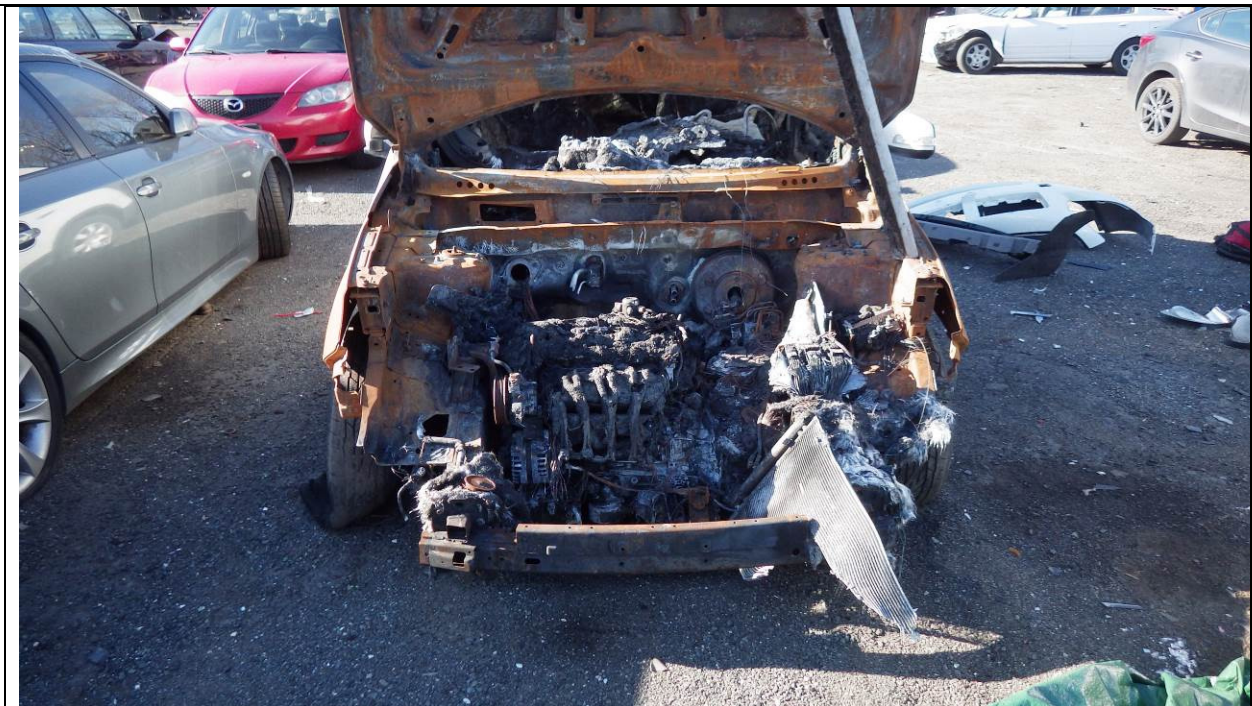
The engine compartment was inspected in more detail by raising the hood (See Figure 21). Most of the plastic components on the top and rear of the engine were consumed or melted. The battery was partially melted, with the terminals detached. A visual examination of the battery wiring, starter, and alternator wiring, revealed no obvious signs of arc damage to any of the high-current

Figure 21: Preste 2012 Kia Sorento, engine compartment

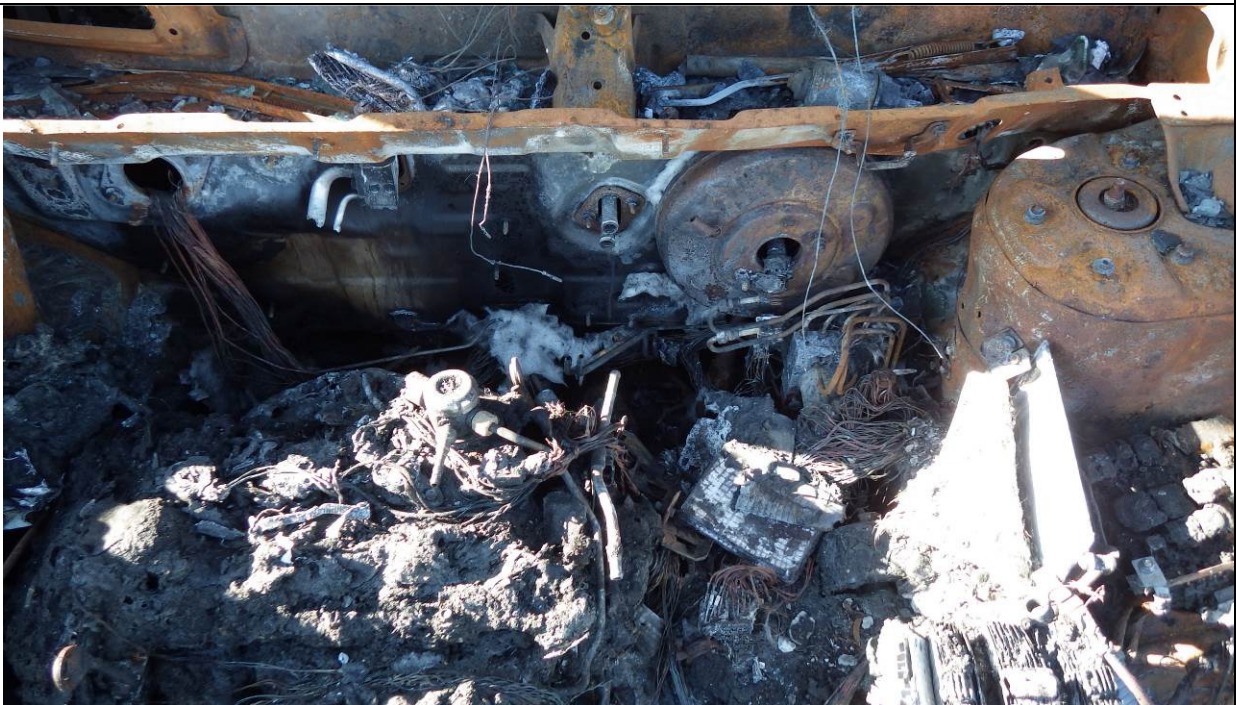
conductors. The power distribution module and fuse panel was melted and partially consumed. I traced the wiring bundle from this module to the interior of the vehicle, and found no indication of any arc damage. The brake master cylinder and reservoir were missing. Many aluminum components on the rear of the engine were consumed. The aluminum radiator was partially consumed. The area of most significant heat appeared to be the top of the engine, where the air intake and filter box would be located. (See Figure 22). The fuel lines would also enter the fuel rail in this location. The throttle body was found separate, and was distorted and partially consumed in the fire. The fuel rail and injectors would be on the front of the block, and they were likely encased in the melted plastic of the intake manifold. The front of the engine, especially the lower portion, had less damage and some hoses and wiring insulation was not consumed (See Figure 23). There was visible oil seeping from the engine in this area. A photograph of an undamaged exemplar was used for comparison purposes, to identify the location of the some of the engine components (See Figure 24).

The fire damage on the subject Preste Kia Sorento was also localized to the engine compartment, with more significant extension into the occupant compartment. It is likely that the Preste vehicle burned for a longer period of time than the Hixon vehicle. Due to the longer period of burn, the heat patterns in the Preste engine compartment are harder to establish, but the area of most significant damage appeared to be to the top of the engine, to the right of the block between the head and the electronic distribution. This area, based on the exemplar, is originally occupied by the airbox and air intake components, including the throttle body and incoming fuel lines.

Figure 22: Preste 2012 Kia Sorento, engine compartment, center rear area

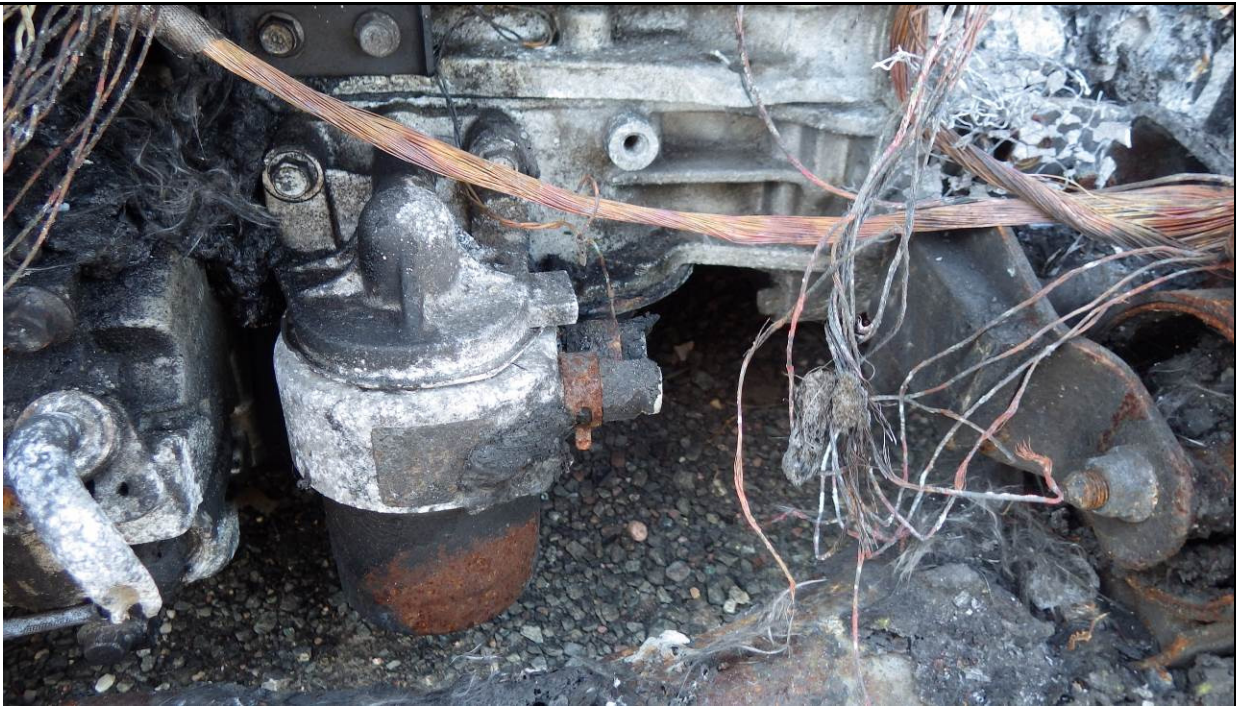
Figure 23: Preste 2012 Kia Sorento, front of engine showing protected area
