# NHTSA's 1989 Pollard and Sussman Report Concluding Pedal Confusion is the Cause of Audi 5000 SAI is Wrong

Ronald A. Belt  
Plymouth, MN 55447  
24 October 2025

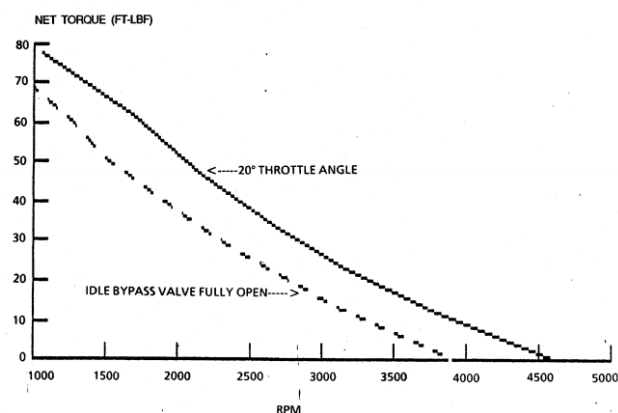
Figure 1. Engine torque versus engine RPM for a typical Audi 5000 vehicle without turbocharger as tested by Audi engineers and documented as Figure B-4 in the Pollard and Sussman report. The dashed curve applies when the engine is operating with air supplied only by a fully open idle stabilizer valve.

We will now consider the dashed curve in Figure 1, which shows the case when the idle stabilizer valve is fully open. This occurs when the control electronics gets overheated and causes a PNP drive transistor to fail suddenly, which sends a maximum current to the idle stabilizer valve. When this happens, the engine RPM suddenly increases from an idle value of 900 RPM to its maximum value and remains there, causing a high engine RPM of 2000 to 3000 RPM. In this case, the engine RPM remains high as the driver applies the brakes because the stabilizer valve opening remains at its maximum. When the driver applies the brakes, he expects to feel the normal deceleration of the vehicle as the brakes are applied. Engine RPM normally drops when the brakes are applied because the brakes add a load to the engine, which causes the engine RPM to drop. But with the engine continuing to operate in the negative slope region of the curve in Figure 1, a decrease in the engine RPM causes the engine output torque to increase. This increase in engine output torque causes an increase in the vehicle's acceleration that opposes the deceleration produced by the brakes being applied. The result felt by the driver is the algebraic sum of these positive and negative torques (or equivalently, positive and negative accelerations), which can be anywhere between a less-than-expected braking deceleration all the way up to a positive vehicle acceleration as the brakes are applied, depending on the magnitudes of the two accelerations. Either of these cases is interpreted by the driver as a lack of braking effectiveness, which explains the driver's testimonies in all these cases. In more everyday English some drivers may state that the brakes "didn't work". But the brakes did work. Their braking effectiveness just got diminished by the increased output torque of the engine as the engine RPM's decreased while the idle stabilizer valve remained completely open.

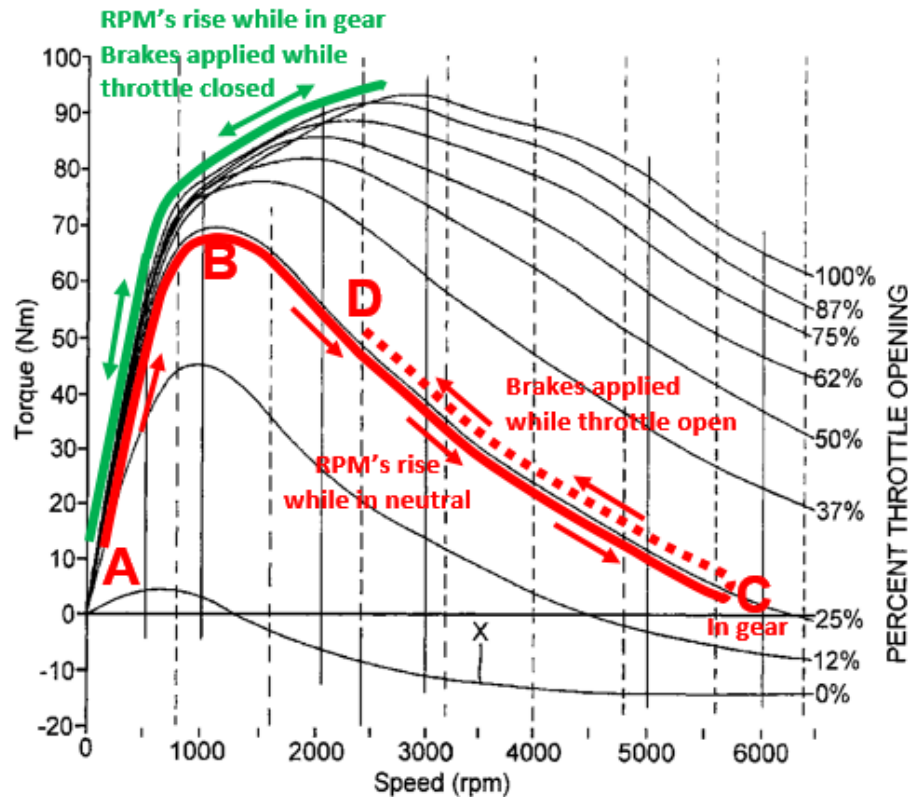
Figure 3. Engine torque versus engine speed for an ICE vehicle. During normal operation the engine follows the green curve to the left of the maximum points in the throttle opening curves. The engine torque increases as the engine RPM's increase and decreases as the engine RPM's decrease while braking with the accelerator pedal released and the throttle closed. During sudden acceleration, the engine RPM's increase rapidly following the red curve while the transmission remains in neutral due to delayed engagement. At point C the transmission drops into the lowest gear to begin vehicle motion. When the brakes are applied during sudden acceleration, the engine torque increases as the engine RPM's decrease because of the increased load on the engine produced by the brakes as a result of the engine operating to the right of the maximum torque position while the throttle remains open. The resulting increase in engine torque counters the braking torque, giving the driver the impression that the brakes are failing. In vehicles with engines that produce a lot of torque the driver may even perceive that the vehicle speeds up as the driver presses on the brake pedal during sudden acceleration.

The brake test that should have been done is to first operate the engine in the red region of Figure 3 where the engine torque increases with decreasing engine RPM by raising the engine speed above the RPM at which the maximum torque is produced while the transmission remains in the lowest gear in DRIVE. This can be done by raising the engine RPM's while in NEUTRAL to some RPM above the RPM at which the maximum torque occurs, after which the transmission is shifted into LOW gear. Then, while the throttle continues to be applied, the brakes should be applied and the brake pedal force measured. In this case, one will find that the engine torque increases as the brake pedal force is applied to stop the vehicle, which reduces the effectiveness of the brakes in stopping the vehicle. This is the cause of the perceived brake failure reported by many drivers during the Audi 5000 idle stabilizer incidents.

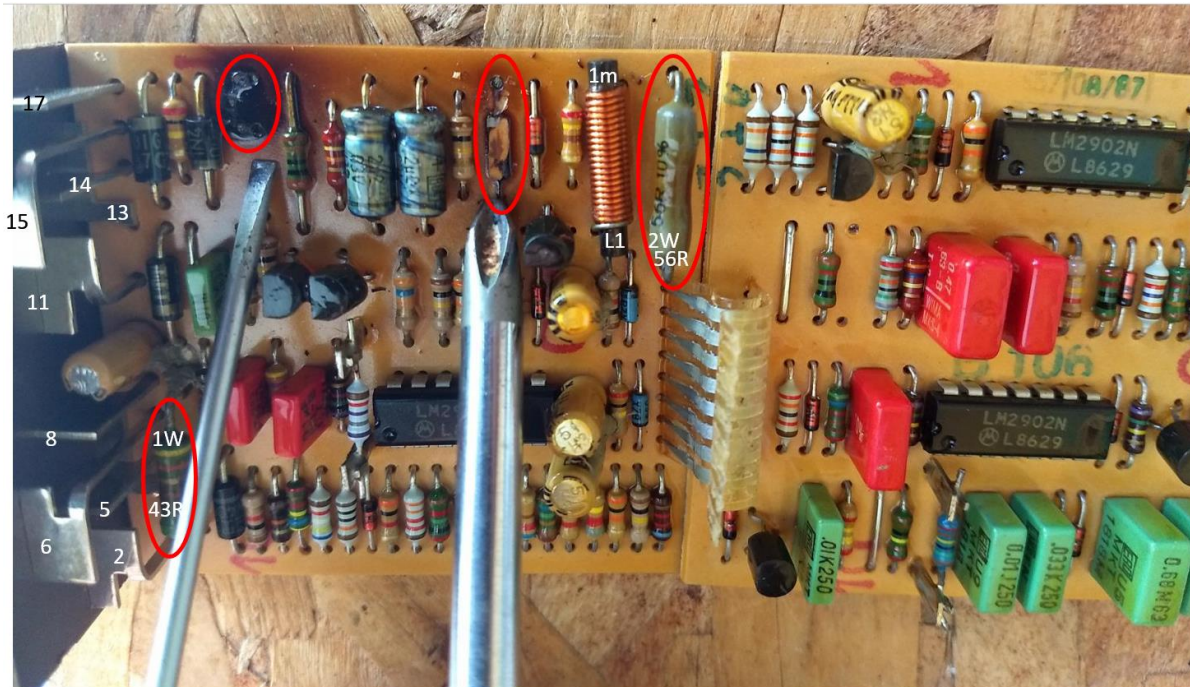
Figure A-2 shows a color photograph of the Audi idle stabilizer control electronics found on a slightly later Audi model. Although the number of pins has increased by two, the circuit design and components are believed to be essentially the same with only minor changes over time. Figure A-2 clearly shows a failed PNP drive transistor, failed diode, and two overheated resistors that caused a fully open idle stabilizer valve. The output current of this failed unit was 2.3 amps when the maximum current of a normally functioning unit was 1.3 amps. When the transistor and diode were replaced, complete functionality of the control electronics and idle stabilizer

valve was restored. This proves that the sudden opening of the idle stabilizer valve initiating the Audi 5000 SAI incidents was caused by the drive transistor and diode instantaneously losing their functionality by being overheated by a current higher than the normal 1.3 ampere current that fully opens the valve.

Figure A-2. Audi 5000 idle stabilizer control electronics taken from a slightly later Audi model, showing a failed transistor, failed diode, and two overheated resistors.

When the transistor and diode were replaced, full functionality was restored. <sup>[1]</sup>

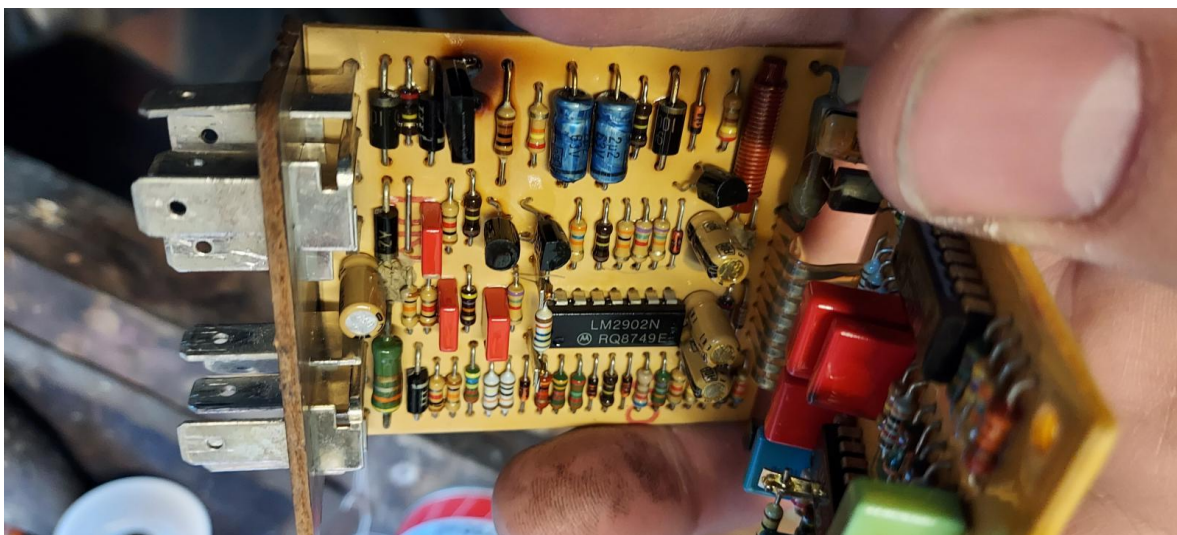
Figure A-3. Different view of the same electronics that shows more clearly the heat stress associated with the component failures. <sup>[2]</sup>

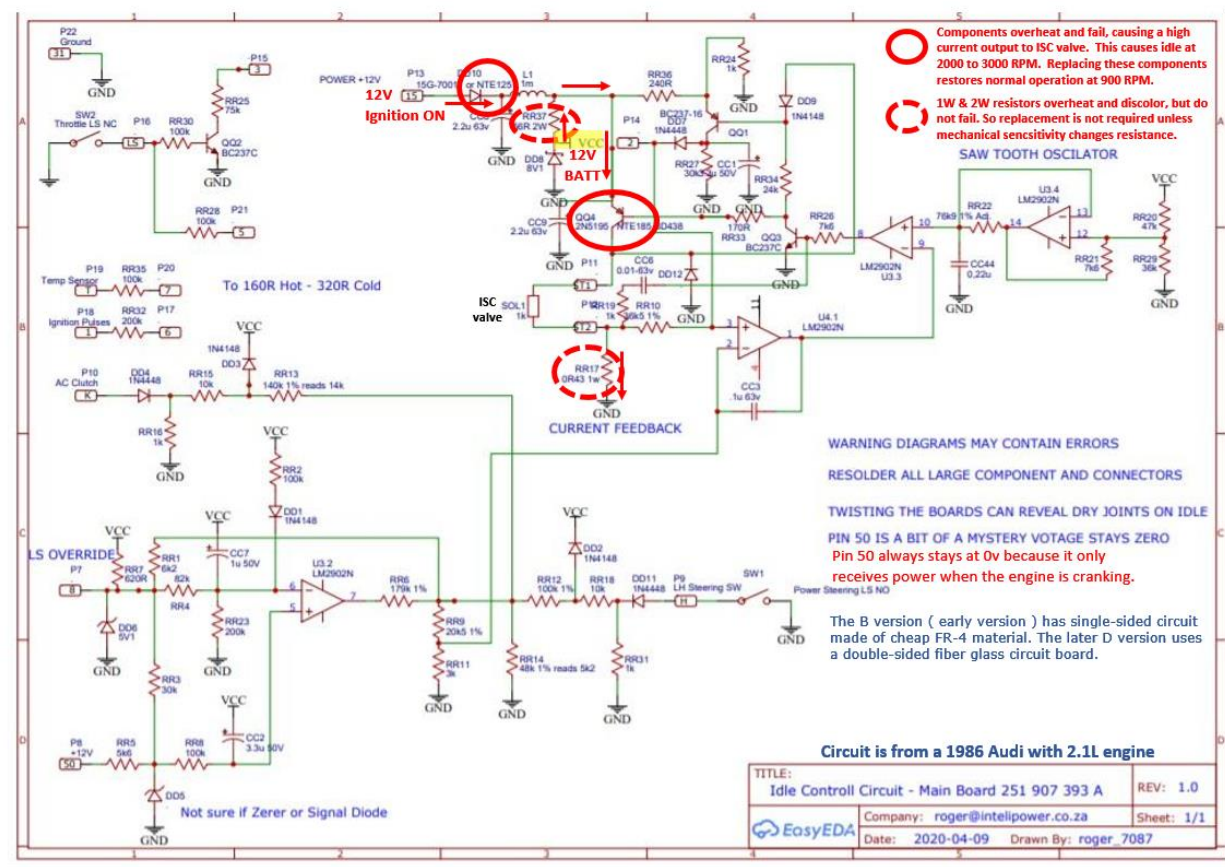
In Figure A-8 one can see that transistor QQ4, a PNP drive transistor with the part number NTE185, modulates the current between VCC and the ISC valve with a duty cycle that changes with engine RPM as provided by the saw tooth oscillator and the electronics in the lower left hand portion of the figure. When the ignition is ON, another 12V supply provides further current through diode DD10, with the part number NTE125. When the PNP drive transistor and diode fail, the output current to the ISC valve increases to cause a fully open idle control valve that does not close as the engine RPM changes. Replacing these two components with new components restores the idle control electronics to its normal operation. When the control electronics is inoperative, two resistors also become discolored due to the higher current through them. But these resistors do not need to be replaced to restore normal operation.

Figure A-8. Circuit diagram for the idle stabilizer control electronics of a 1986 Audi 2.7L engine on the PWB containing the I/O pins.<sup>[4]</sup>

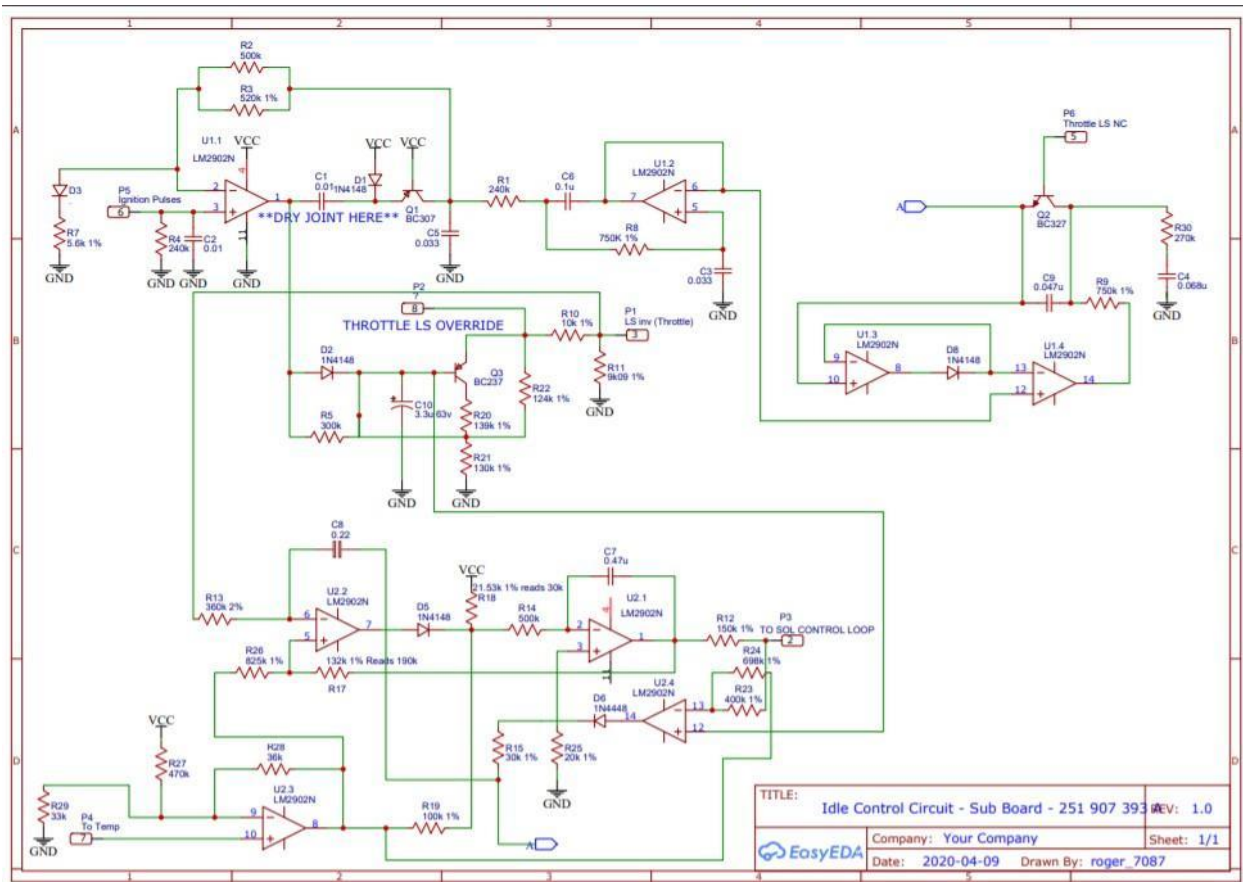
Figure A-8. Circuit diagram for the idle stabilizer control electronics of a 1986 Audi 2.7L engine on the PWB without the I/O pins. [5]
