**09V-023
(5 pages)**

Re: NHTSA EA08-014; Missing Retaining Clip on Floor Carpet Cover
in Early MY 2004 Toyota Sienna Vehicles

Early 2004 Sienna - Floor Carpet Cover and Retaining Clip Safety Recall Campaign 80_

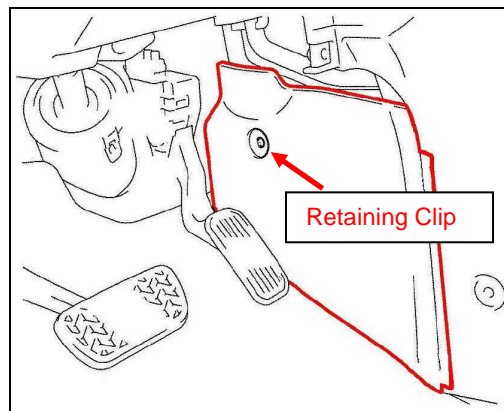
In recent months, Toyota has received reports that the Retaining Clip for the Driver's-side Center Console Trim Panel (Floor Carpet Cover) was missing in a handful of vehicles. If this Retaining Clip is missing, the Floor Carpet Cover may become loose. In the worst case, if the accelerator pedal is depressed to nearly full throttle, a loose floor carpet cover may interfere with the accelerator pedal. In this condition, if the driver releases the accelerator pedal, it may not return to idle position, and could result in a loss of vehicle control or a crash.

Until this repair is completed on your vehicle, you may verify the Retaining Clip is installed on your vehicle by inspecting for it as indicated below. If the clip is missing, please call your local Toyota dealership.

Any Toyota dealer will replace the Retaining Clip and Floor Carpet Cover with a newly designed one at **NO CHARGE** to you.
