1. Identify and describe the difference between the recalled cruise control computer and the improved design computer to be installed as a remedy.
2. Identify and describe the nature of the defect, its failure modes, and the specific components which can result in the malfunction or failure. The description should include an identification of the following:

Toyota will initiate a special service campaign to replace the factory installed cruise control computer with an improved design on certain 1983 and 1984 Toyota Camrys and 1984 Corollas.

Shutting off the cruise control after extensive continuous use followed by exposure to extremely cold ambient conditions may result in excessive thermal shock to the cruise control computer. Repetition of this cycle may lead to a cruise control computer malfunction.

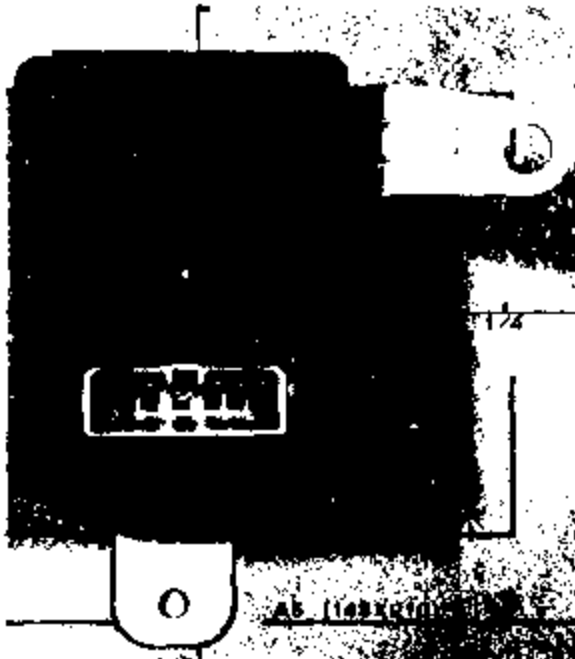
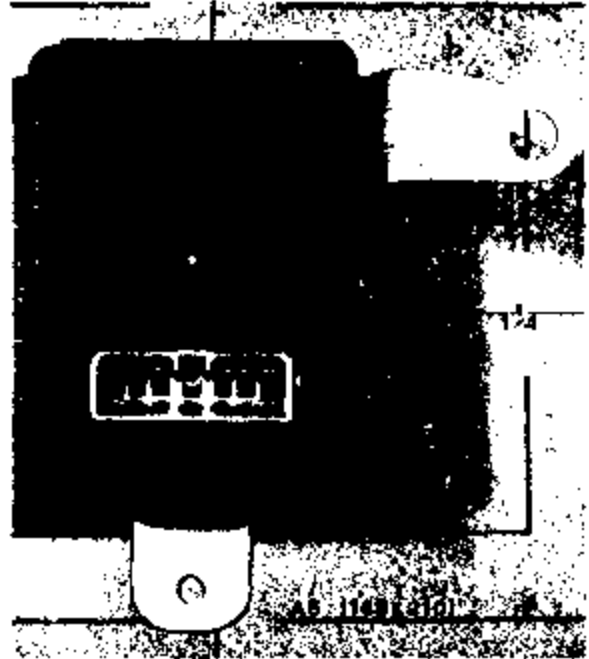
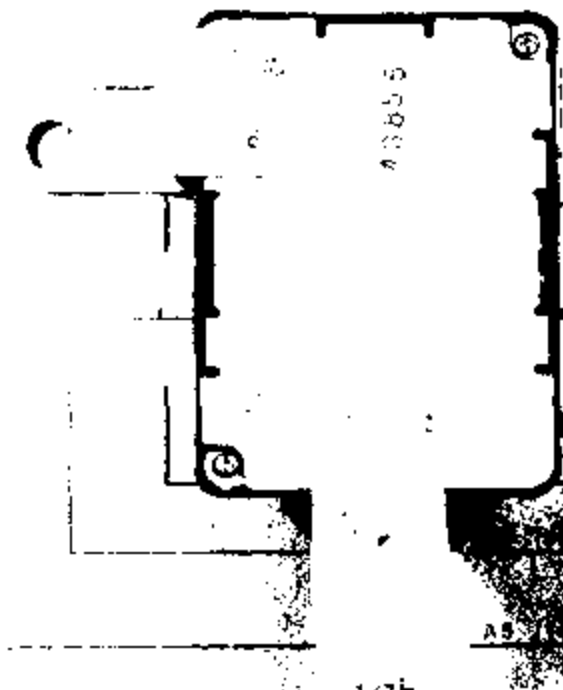
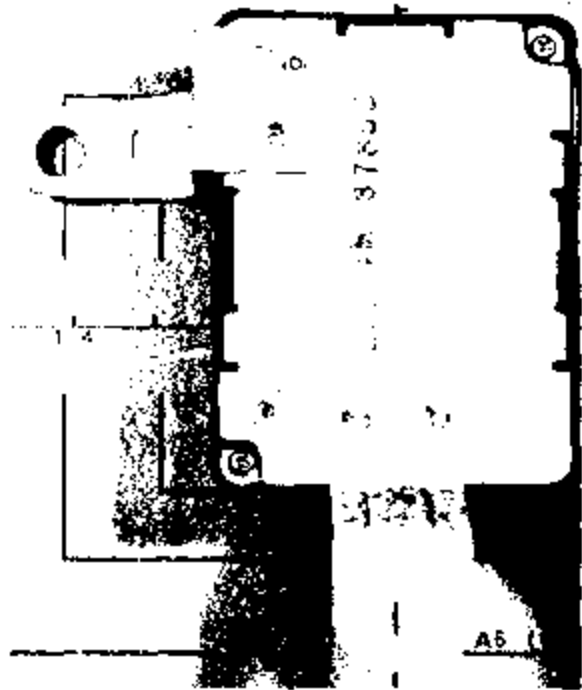
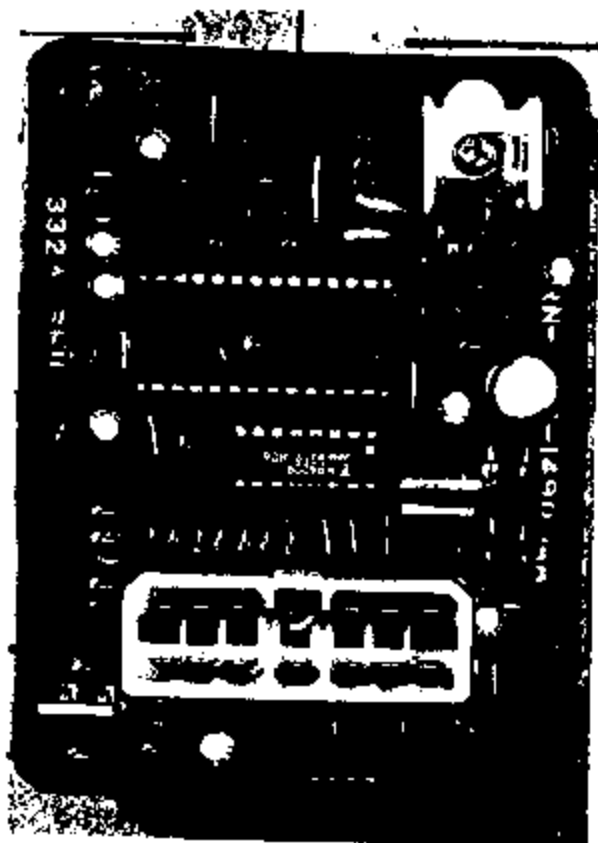
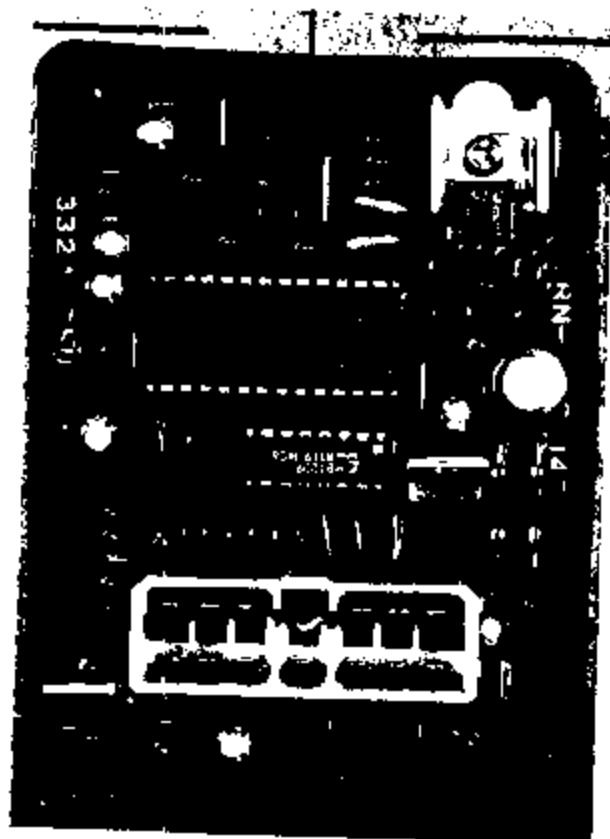
No abnormality was found on the outside or inside of the case for both computers.

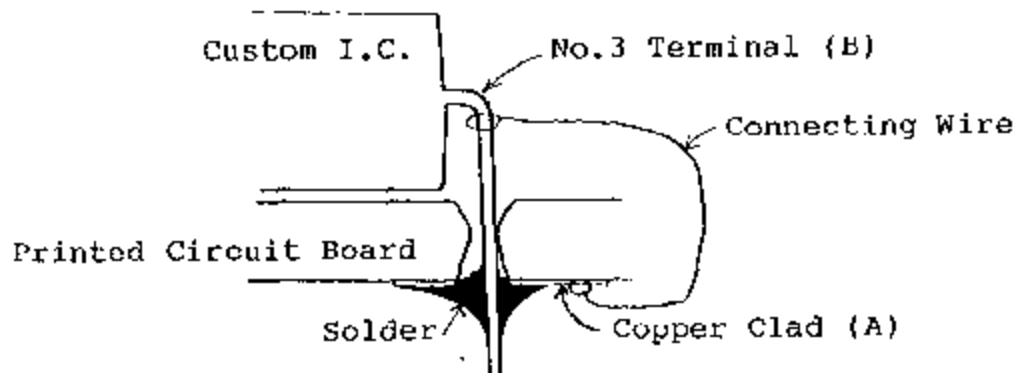
Fig 4 No.3 Terminal Repair

To confirm whether the cause of this failure mode is the open circuit on the No. 3 terminal or not, we measured the voltage level at each terminal by connecting the copper clad (A) and the No.3 terminal (B) using another wire as shown in Fig. 4.

Consequently, the voltage level at each terminal was the same as that of the normal part and the computer performed all functions properly. Test results are included in table 4 through 7.

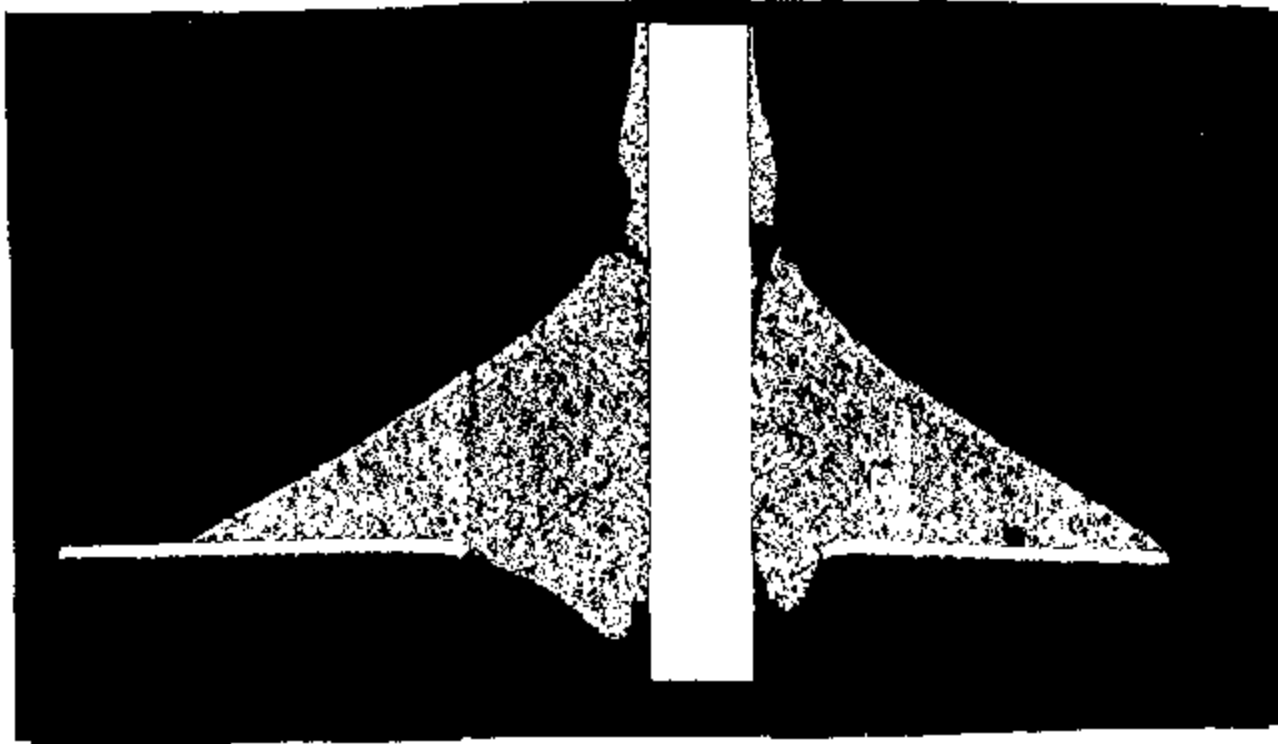
Photo 6 Cross Section Cut-Away of No.3 Terminal
(Yves Arcouet Case)

With microscopic observation of the soldering portion on the No.3 terminal of custom I.C., it was found that the solder was fractured along the terminal as shown in Photo 6 and 7.

Based on the aforementioned results, we have concluded that the failure mode for both computers was caused by the open circuit due to a solder fracture on the No.3 terminal of the custom I.C..

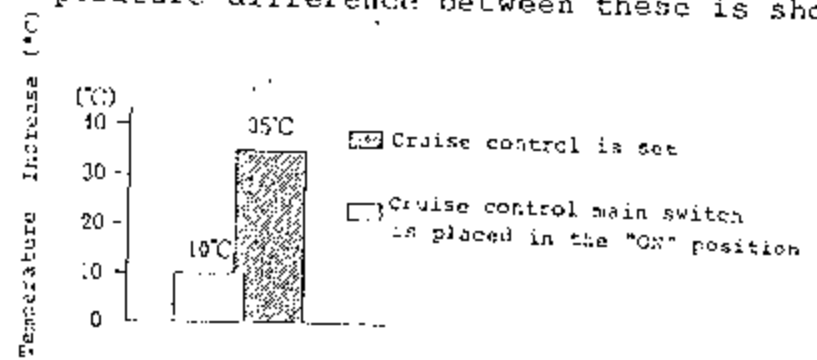
Fig.3 Temperature increase of Subject Computer

Thereupon, based on the fact that the cruise control computer failures occurred in Canadian vehicles only, we conducted a detailed investigation focusing on the temperature. As a result, we found that the surface temperature of the custom I.C. when the cruise control was set, is higher than when the cruise control main switch only is placed in the "ON" position, which is the test condition during development. The temperature difference between these is shown in Fig.3.

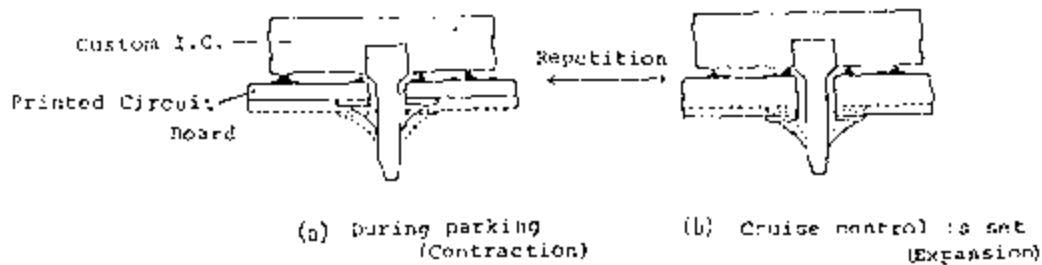
Fig. 6 Stress on the Soldered Portion

We found the temperature increase by self-generating heat from the custom I.C. is higher than that expected during development. The soldered terminal is stressed by contraction/expansion of the printed circuit board and custom I.C. due to repetition of excessive thermal shock (See Fig.6). It could cause the soldered terminals of the custom I.C. to develop cracks and finally may lead to a complete separation of the soldered terminals, resulting in non-conductivity of the circuit.

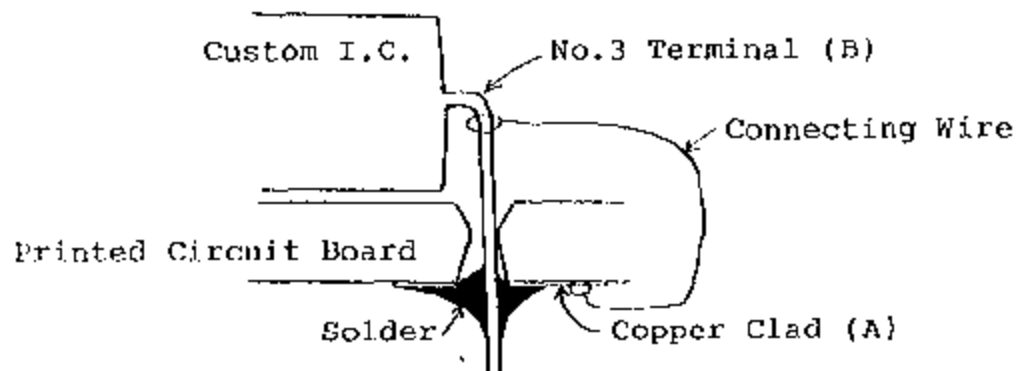
Fig 4 No.3 Terminal Repair

Consequently, the voltage level at each terminal was the same as that of the normal part and the computer performed all functions properly. Test results are included in table 4 through 7.

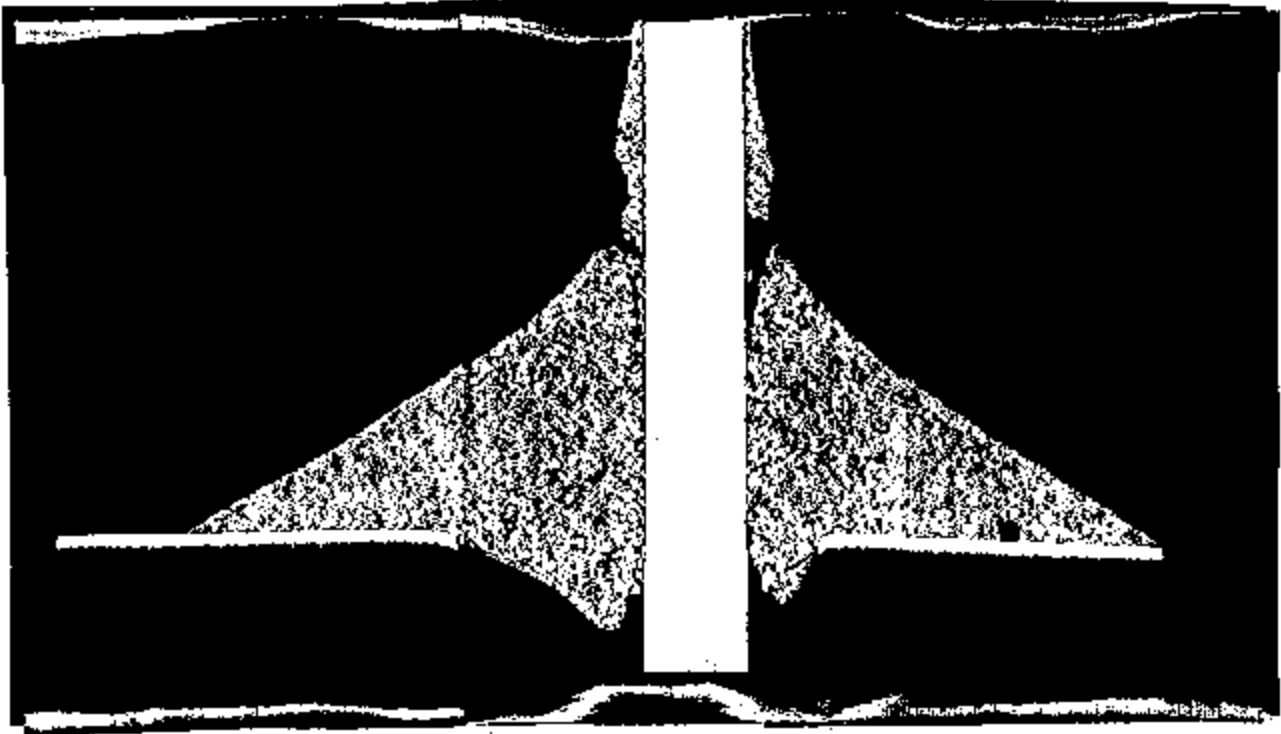
Photo 6 Cross Section Cut-Away of No.3 Terminal
(Yves Arcouet Case)

With microscopic observation of the soldering portion on the No.3 terminal of custom I.C., it was found that the solder was fractured along the terminal as shown in Photo 6 and 7.

Based on the aforementioned results, we have concluded that the failure mode for both computers was caused by the open circuit due to a solder fracture on the No.3 terminal of the custom I.C..
