U.S. Department
of Transportation

National Highway
Traffic Safety
Administration

NSA-111jdw
95V-103

SUBJECT: Seat Belt Buckle Failures in Vehicles Equipped with Takata Seat Belts

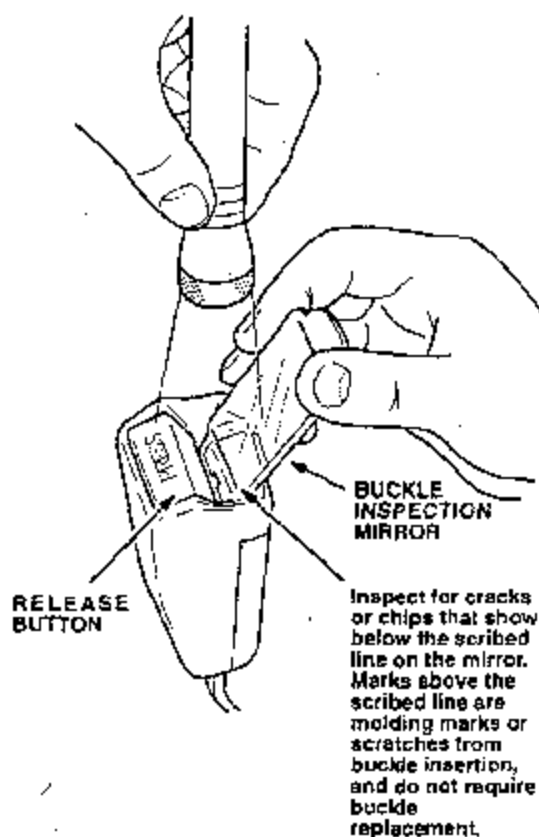
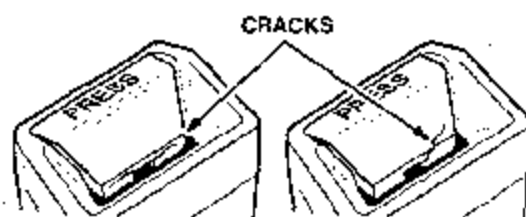
2. Using the Buckle Inspection Mirror (see TOOL INFORMATION) and a bright light, examine the release button for chips or cracks.

- If either front buckle assembly has a chipped or cracked release button, go to **Seat Belt Buckle Replacement.**
- If the front buckle assemblies are in good condition, go to **Seat Belt Buckle Guide Installation.**

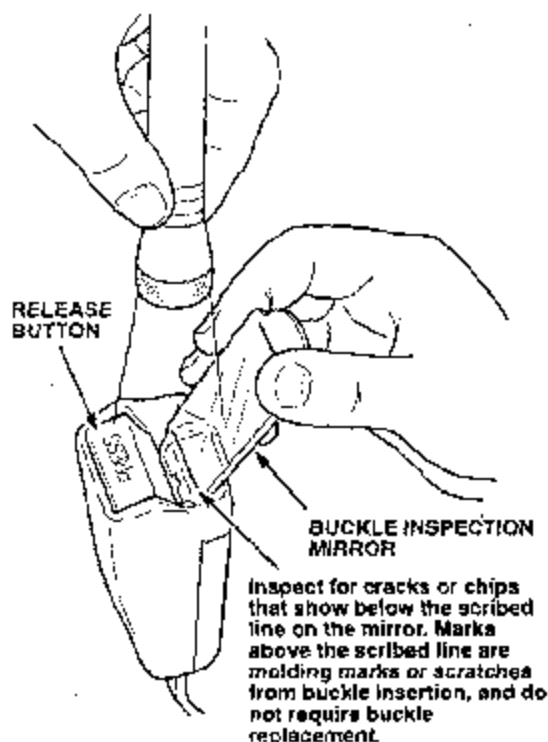
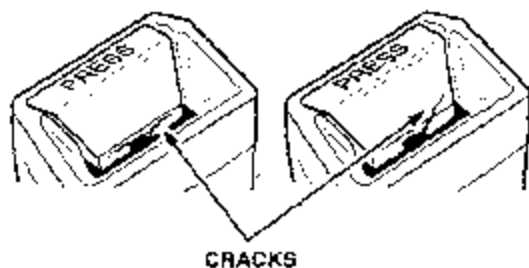
- Using the Buckle Inspection Mirror (see TOOL INFORMATION) and a bright light, examine the release button for chips or cracks.

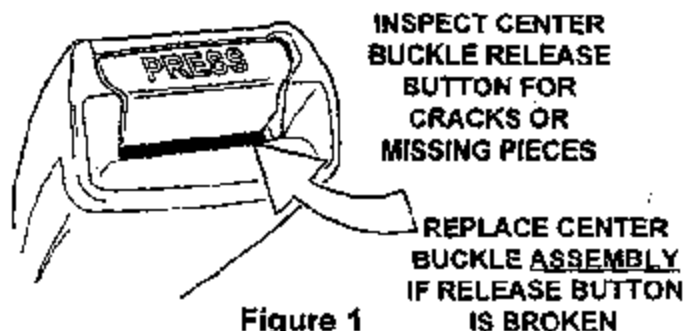
Figure 1

1. Verify that the center buckle assembly operates properly by inserting the center buckle tongue into the center buckle assembly until it latches. Make sure it is securely latched by pulling on the belt several times. Then press the release button to unlatch the tongue. Repeat several times.
2. Inspect the center buckle red release button for cracks or missing pieces (Figure 1).
