Center for Auto Safety White Paper on Concerns With
Chrysler Recall of the Jeep Grand Cherokee and Liberty
Presented to NHTSA July 1, 2013

Chrysler has responded to the National Highway Traffic Safety Administration's request that it recall the Jeep Grand Cherokee and Liberty that have fuel tanks installed behind the rear axle for defects in their fuel systems with several specious arguments

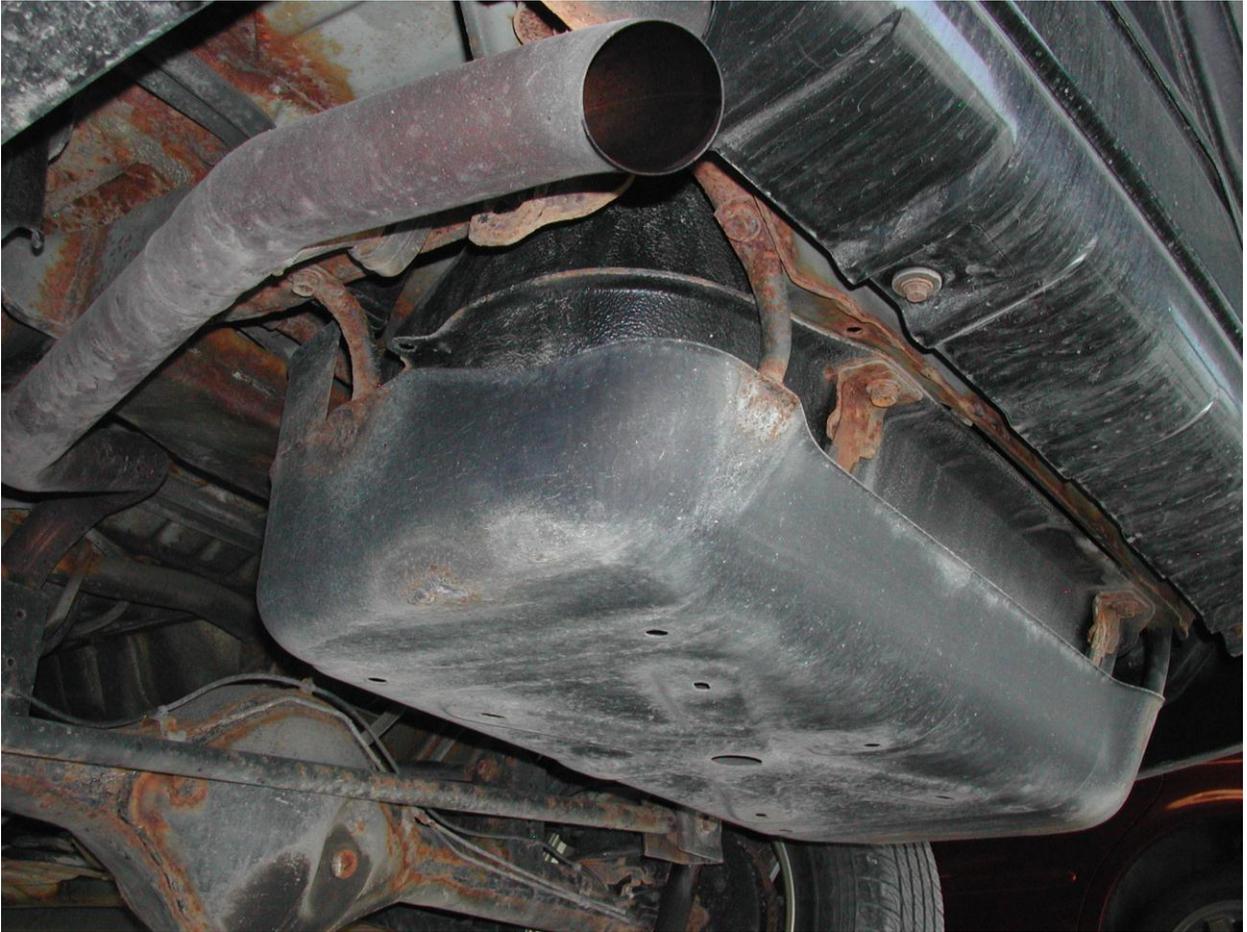
There is no significant production vehicle currently sold in the U.S. with the fuel tank located behind the rear axle. Even at the time the subject Jeeps were sold, only a few vehicle lines had fuel tanks in this location. And ones like the Suzuki XL-7 have a steel structure encapsulating the fuel tank. (Attachment A.)

Exhibit A – Encapsulated Suzuki SL-7 Fuel Tank

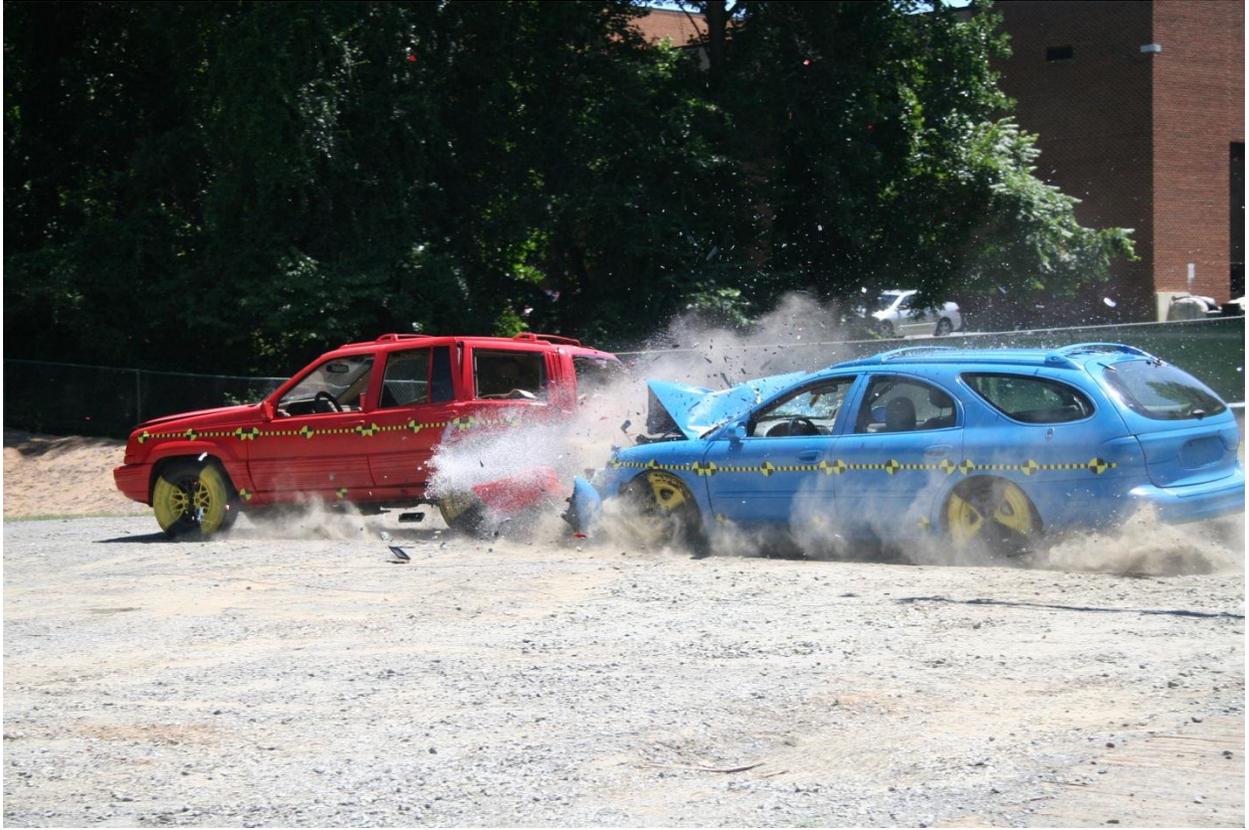
These deficiencies and failure modes were demonstrated in three crash tests in which Ford Taurus passenger cars struck the rear of Jeep Grand Cherokees. In an additional crash test conducted at the Federal Highway Administration's testing ground, a Ford Explorer with its fuel tank located ahead of the rear axle was struck in the rear by a Ford Taurus moving at 75 mph, and sustained no fuel leakage. The Explorer was fitted with an instrumented Hybrid II dummy that showed the driver would have survived this impact. This impact involved an impact energy more than three times that of the lowest speed Jeep Grand Cherokee impact conducted for the Center for Auto Safety in which there was major fuel leakage. Indeed, the energy level of the striking Taurus of 630,500 ft-lbs was higher than 29 of the 40 crashes cited by Chrysler without considering whether Chrysler inflated the speed of the bullet vehicle.

Exhibit B Fuel Spray from FHWA Due to Filler Hose Pulling Loose

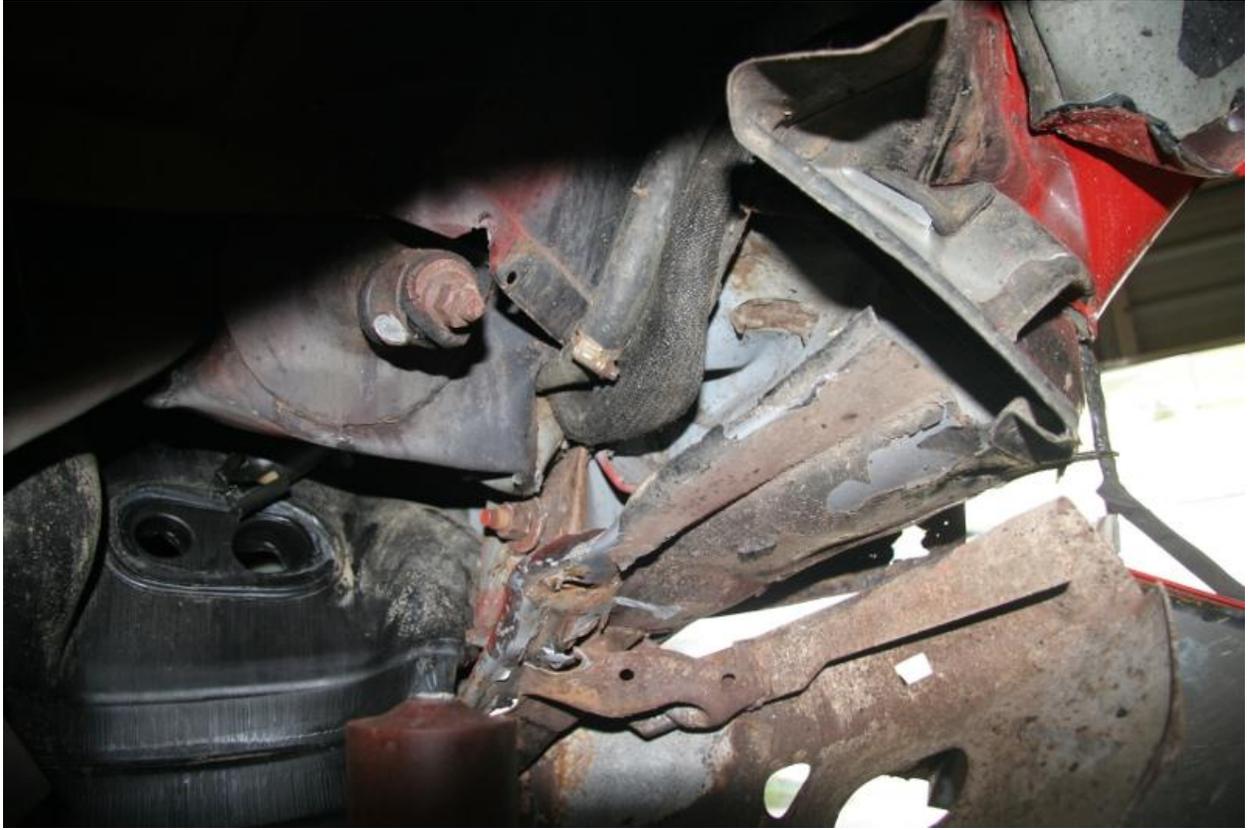
The Jeeps do have a check valve in the tank to preclude back flushing when the gas cap is removed on a hot day. However, this valve lacks a simple spring that would keep it closed under any circumstances where the pressure in the tank is equal to or greater than atmospheric pressure. Such a spring would ensure that the fuel in the tank remained there (assuming that the tank itself is not damaged) even when the filler tube is damaged.

Exhibit C – Fuel Tank Connection Where Filler Tube Pulled Loose

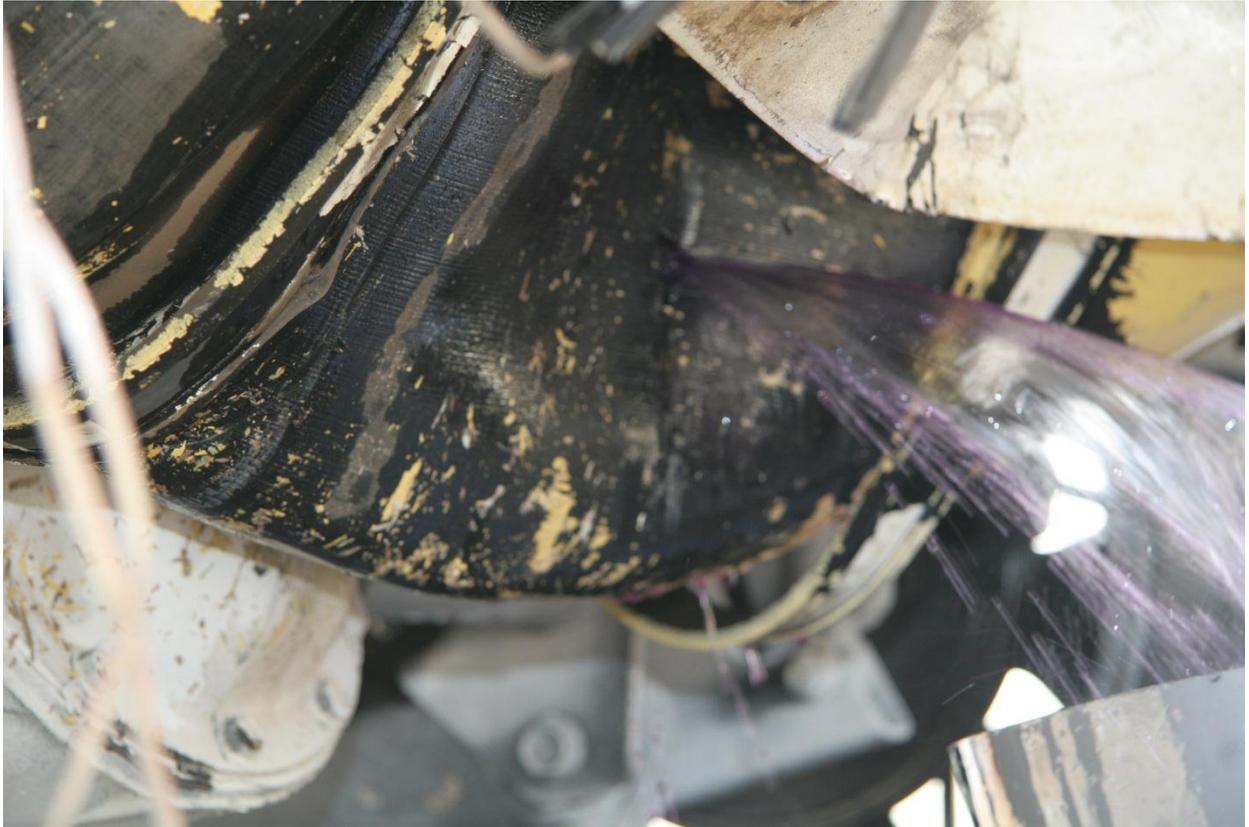
We are confident that the subject Jeeps could not pass the current FMVSS 301 despite Chrysler's claim that virtually all of the fatal fire crashes of Jeeps were more severe than this test. The last test conducted for the Center for Auto Safety was similar to the current fuel system integrity test except that it was conducted at 40 mph rather than 50 mph (about two-thirds of the energy). The tank failed in that test.

Exhibit D –Leak from Ruptured Grand Cherokee Fuel Tank in 40-mph Impact

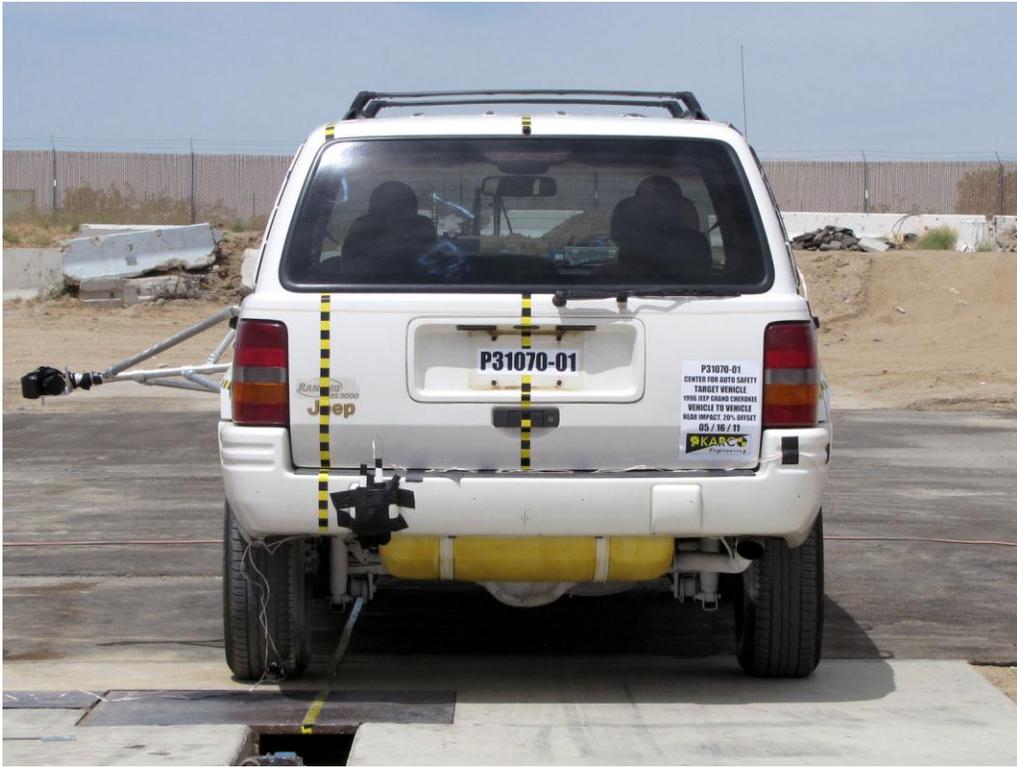
The trailer certainly provides no protection for rear impacts in which the nose of the striking vehicle goes under the Jeep's bumper which it will also go under the trailer hitch because the fuel tank extends downward 8.5" below the rear bumper. At best the trailer hitch extends downward only 1.2 inches below the bumper leaving more than 7" of the fuel tank exposed.

Exhibit E – Pre-Crash Photo Showing Exposed Fuel Tank
