engine mount recall

GENERAL MOTORS CORPORATION

December 10, 1971

Subject: ENGINE MOUNTS
Models: 1967 - 1970 1500-2500-3500 MODEL TRUCKS
WITH V-8 ENGINES

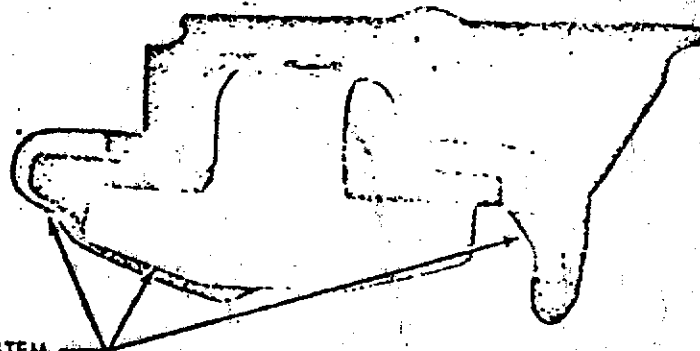
FIGURE 2

Presently, the only service replacement mount available from Chevrolet is the interlock type (Figure 2), and this is the only type that should be used for repair on any mount replacement on Chevrolet models, 1958 through 1971. The interlock feature is an important improvement, and use of engine mounts without the interlock feature or modification of the interlock for ease of installation, does not represent acceptable service procedures.
