ENGINEERING ANALYSIS EA92-041  
GENERAL MOTORS PICKUP TRUCK DEFECT INVESTIGATION

ENGINEERING ANALYSIS REPORT AND  
INITIAL DECISION THAT THE SUBJECT VEHICLES  
CONTAIN A SAFETY-RELATED DEFECT

October 17, 1994

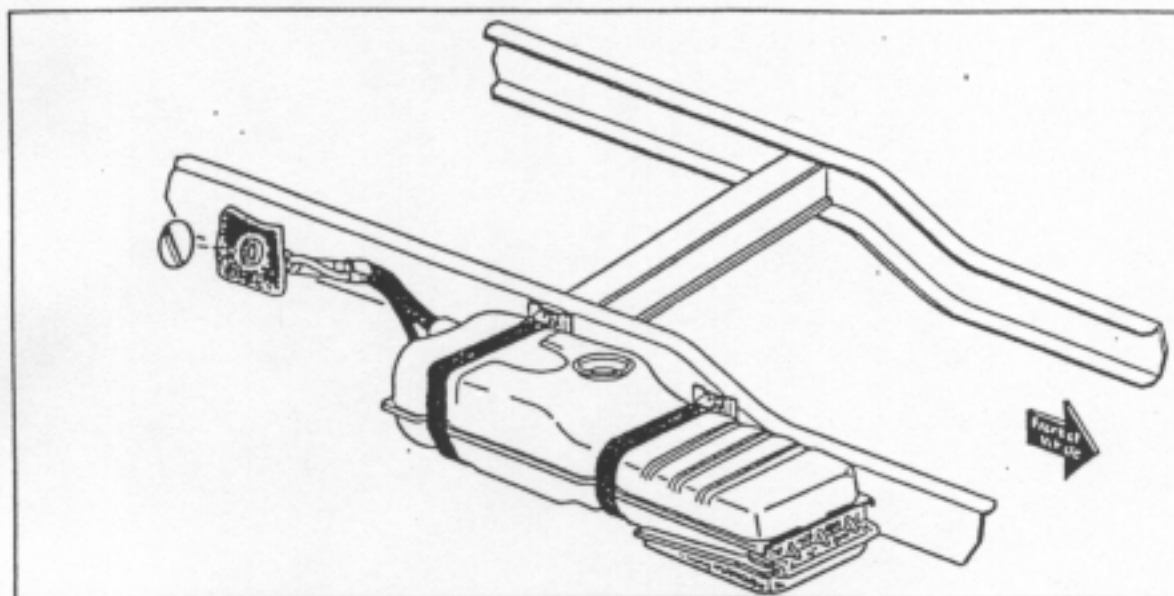
Figure 1. Location of Fuel Tank in Subject Vehicles (Outside Frame)

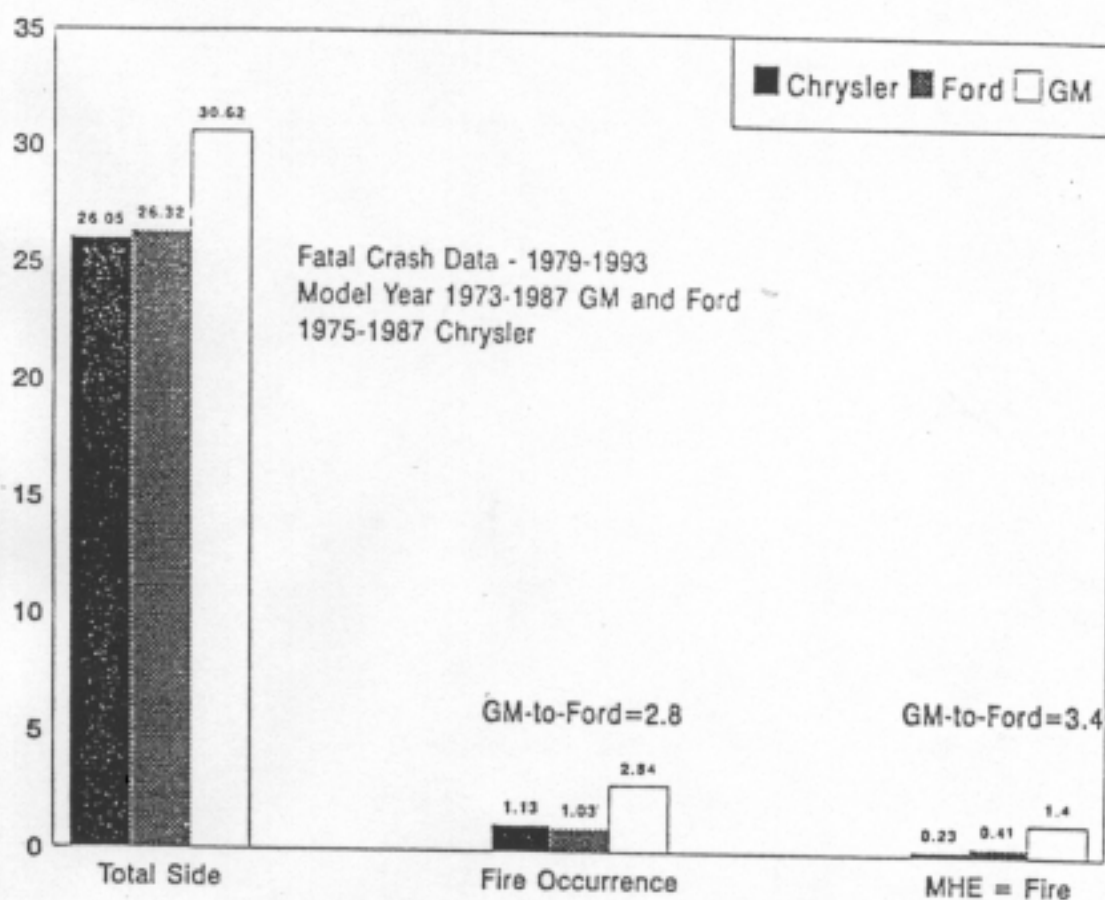
fatalities per million registered vehicle-years was 2.84 for GM, 1.03 for Ford, and 1.13 for Dodge. The ratio of the side-impact fire-related fatality rate for the GM pickup trucks to that of the Ford pickup trucks is 2.8 to 1. Finally, in those side-impact crashes in which fire was the MHE, comparative fatality rates were 1.40 for GM trucks, 0.41 for Ford trucks, and 0.23 for Dodge trucks. The difference in the side-impact MHE=fire occupant fatality rates between the GM and Ford trucks is 0.99 (1.40 - 0.41) occupant fatalities per million

Figure 3. Side-Impact Occupant Fatalities per Million Registered Vehicle-Years

registered vehicle-years. The ratio of GM to Ford rates for side-impact MHE=fire occupant fatalities is 3.4 to 1.<sup>8</sup>

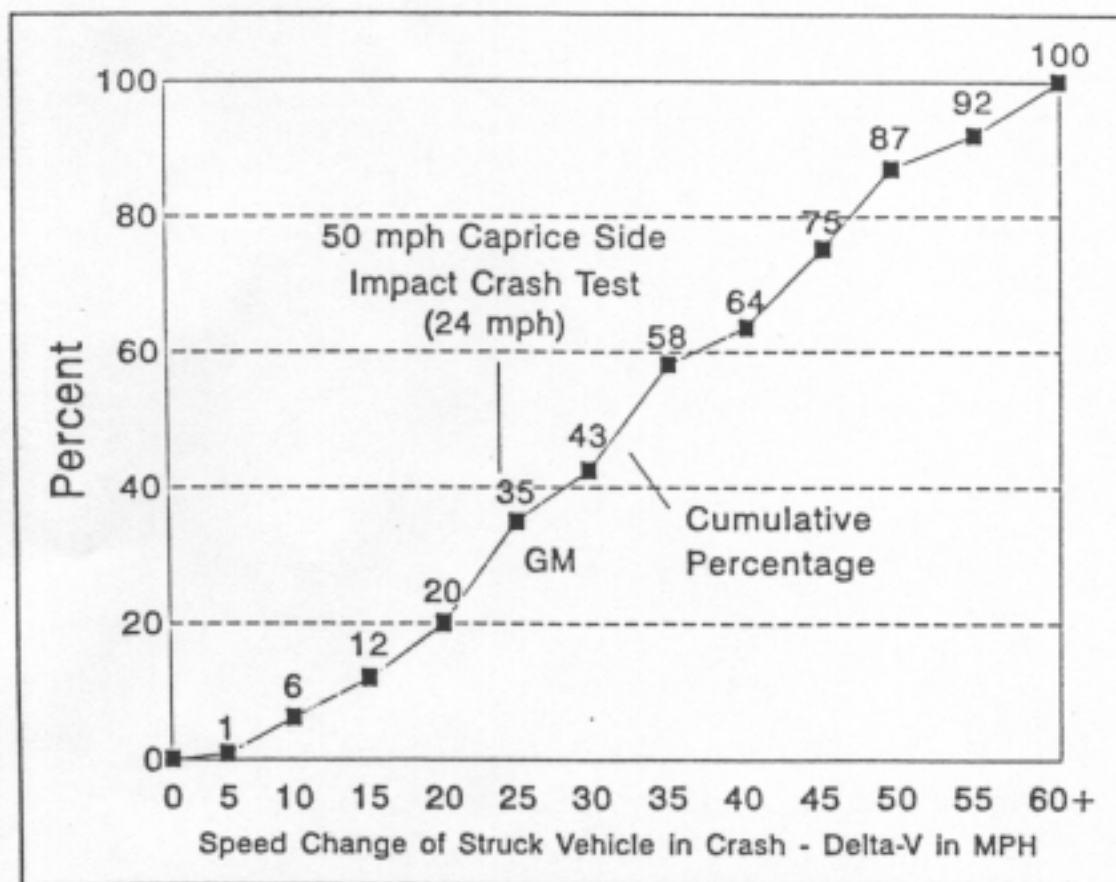
Figures 4 and 5 present the results of this analysis for GM and Ford pickups, respectively. The figures depict the percentage of fire-related, fatal side-impact crashes within five mph delta-V increments for each of these vehicles. Also shown is the 24 mph delta-V obtained in the ODI 50-mph crash test of a subject vehicle that resulted in a fuel tank leak. This indicates that a 50-mph crash is at the lower end of the range of crash severity necessary to cause a fire due to a fuel tank leak in both the subject vehicles and the Ford pickups; i.e., approximately 65 percent of the GM crashes and 94 percent of the Ford crashes analyzed by ODI had delta-V values above 24 mph.

Figure 4. Percent of GM Pickup Truck Fatal Side Crashes with Fire, by Crash Severity (Delta-V in mph).

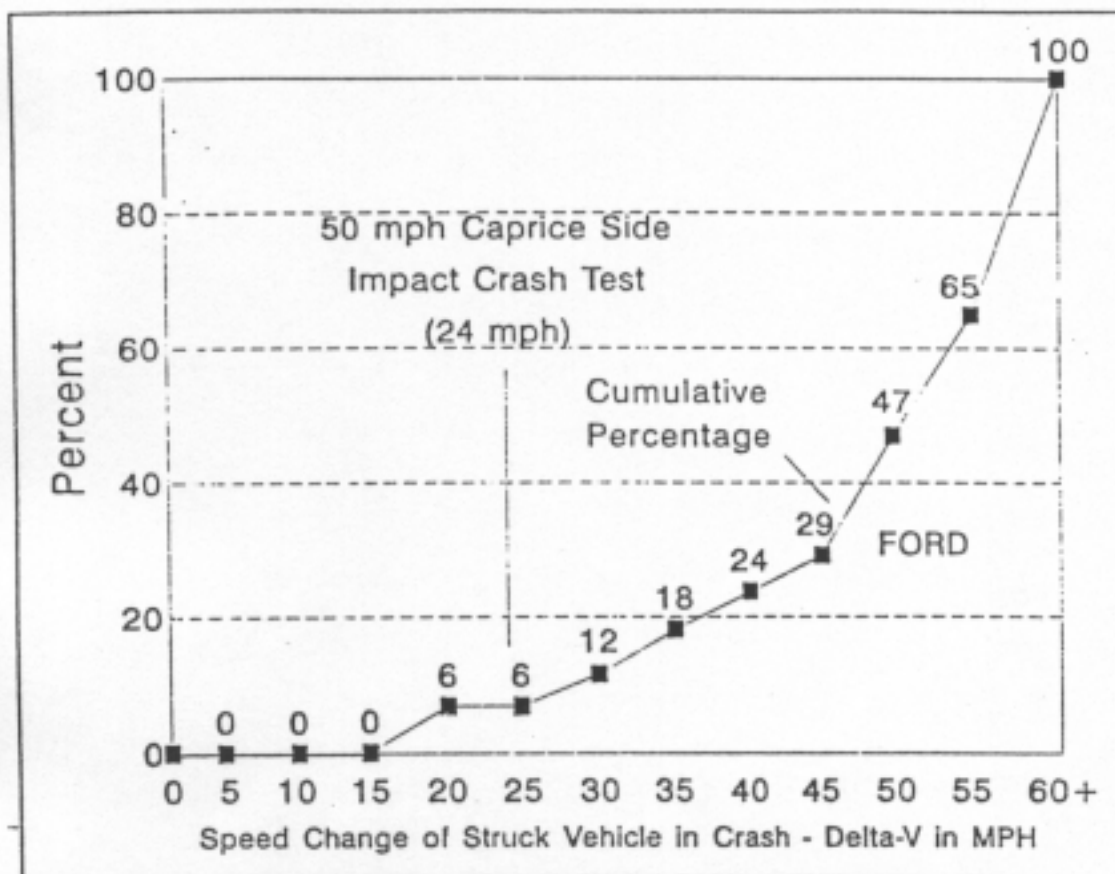
Figure 5. Percent of Ford Pickup Truck Fatal Side Crashes with Fire, by Crash Severity (Delta-V in mph).

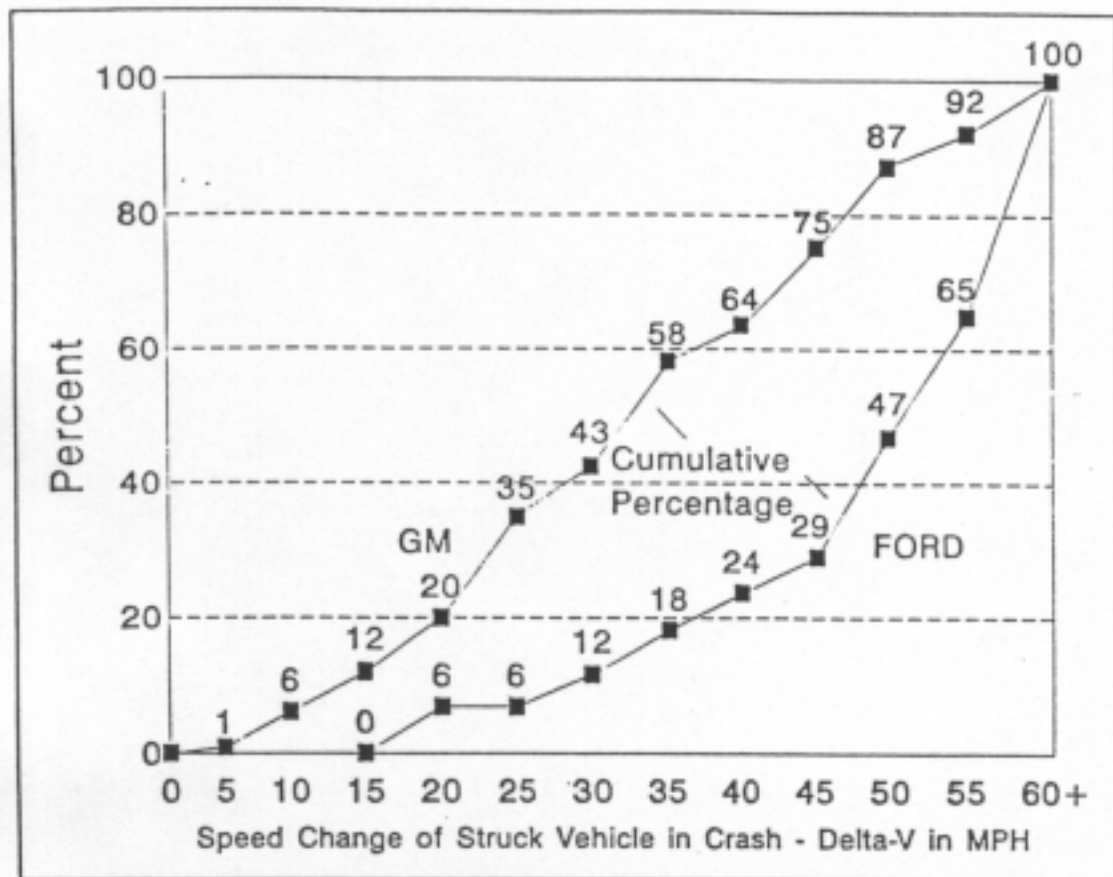
Figure 6 presents the GM and Ford data together. Because of the limited number of Ford crashes available for analysis, ODI recognizes that the graph of the Ford data may not be a precise reflection of the delta-V experienced by Ford pickups in fire-related fatal crashes. Nevertheless, ODI believes that these graphs provide a valid indication that, in general, the crash severity needed to cause a fire in a fatal side-impact crash involving a Ford pickup is greater than that needed to cause a fire in such a crash involving the subject vehicles.

Figure 6. Percent of GM and Ford Pickup Truck Fatal Side Crashes with Fire, by Crash Severity (Delta-V in mph).

These data indicate that the average crash severity for the GM truck in fatal side-impact crashes with fire is at a delta-V of 36 mph, while the Ford delta-V average is 55 mph. Thus, while fatal side-impact crashes with fire involving the subject vehicles occur at extremely high levels of crash severity, and at severity levels far in excess of that associated with a FMVSS No. 301 side-impact test, those severity levels are often below those required to create a post-crash fire in the Ford pickups.
