Service Bulletin

Bulletin No.: 03-07-30-017

Subject: Grind Noise or No Vehicle Movement when Shifting into Drive or Reverse
(Inspect Transaxle, Replace Various Transaxle Components)

Models: 1999-2002 Buick Century, LeSabre, Park Avenue
2002 Buick Rendezvous
1999-2002 Chevrolet Monte Carlo, Venture
2000-2002 Chevrolet Impala
1999-2002 Oldsmobile Intrigue, Silhouette
1999-2002 Pontiac Bonneville, Grand Prix, Montana
2001-2002 Pontiac Aztek
with Transaxle Auto 4-SPD, 4T65-E (RPO MN3)

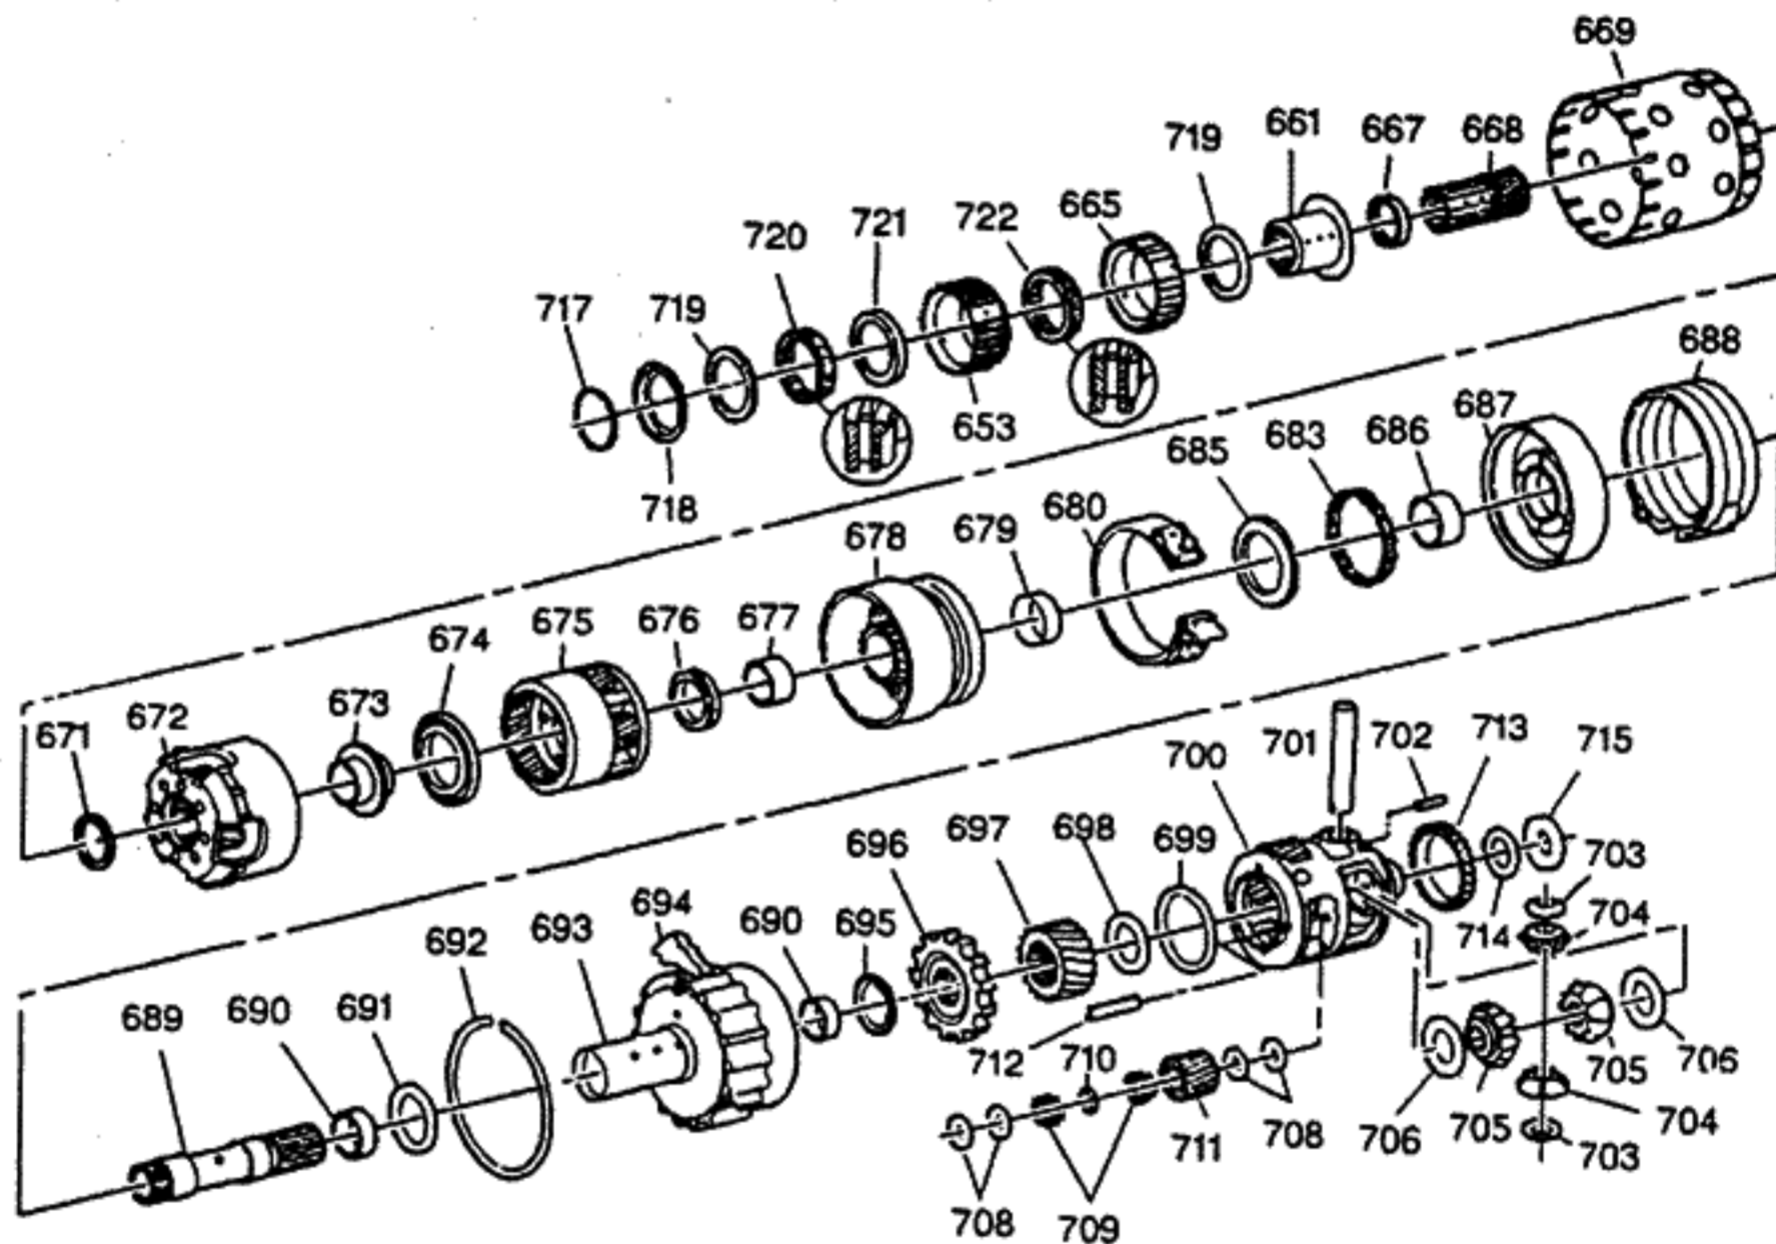
(668) Input Sun Gear, P/N 24204098

- o (672) Input Complete Carrier Assembly, P/N 24204430
- o (674) Input/Reaction Carrier Thrust Bearing Assembly, P/N 24205127
- o (675) Reaction Complete Carrier Assembly, P/N 8646504
- o (676) Reaction Carrier/Sun Gear Thrust Bearing Assembly, P/N 8649353

4. Replace the parts listed above to correct this condition. Refer to Unit Repair Manual, Transmission Overhaul procedure, SI Document ID #417561; Input and Third Sprag Clutches Disassemble, SI Document ID #38901; and Input and Third Sprag Clutches Assemble, SI Document ID #60415.
5. When servicing or replacing the transaxle resulting from this condition, the transaxle cooler MUST be flushed. Refer to informational Corporate Bulletin #02-07-30-052.
