INVESTIGATION : EA92-044 DATE OPENED: 12-17-92  
 SUBJECT : THROTTLE STICKING  
 PROMPTED BY : PE92-065  
 PRINCIPAL ENGINEER: G. PERSON DID INVESTIGATOR: J. ABBOTT

MANUFACTURER: TOYOTA  
 MODEL YEAR(S): 1987-1989 VEHICLE POPULATION: 813,879  
 MODEL(S): CAMRY, CELICA WITH 2.0L ENGINE

Subject: Throttle Sticking on 1987 Through 1989  
Toyota Camry and Celica Vehicles Equipped  
With Electronic Fuel Injection (EFI) Systems, EA92-044

**ENGINEERING ANALYSIS CLOSING REPORT**

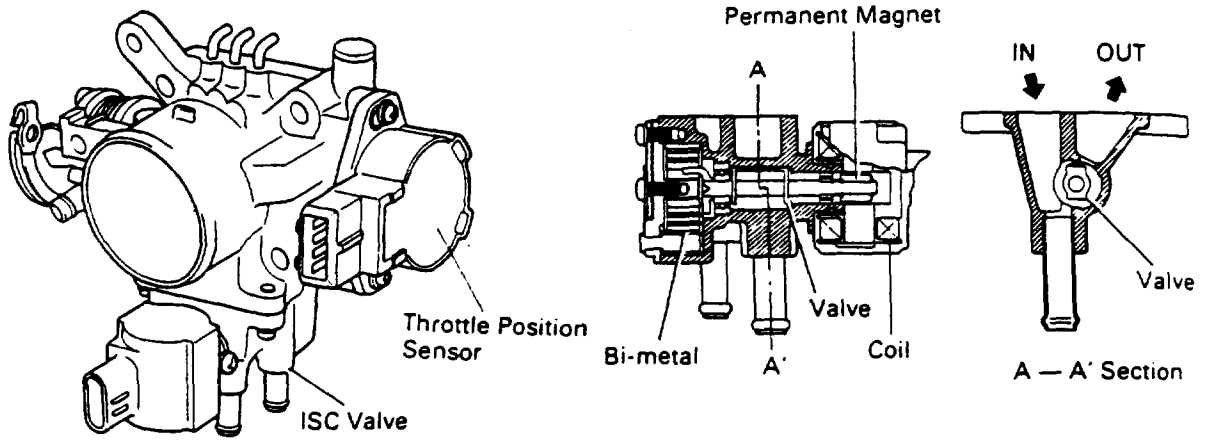
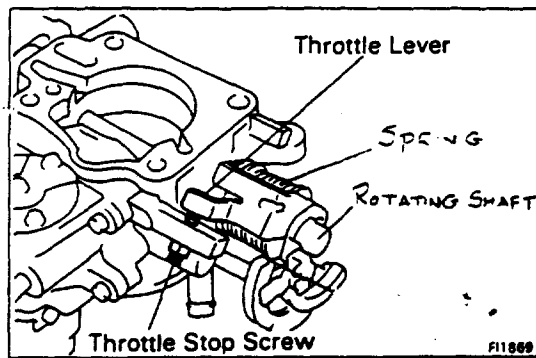
ATTACHMENT A

A drawing of the subject TBA is provided in Attachment A. The throttle plate is supported by a single rotating shaft which passes through the TBA. Springs normally keep the throttle shaft in the idle position (almost fully closed), except when the accelerator cable (activated by the driver's foot on the accelerator pedal), or the cruise control cable (on vehicles with cruise control) pull on the lever attached to the end of the throttle shaft.
