EA12-005 Reconstruction Testing for KJ Jeep Liberty and ZJ Grand Cherokee

July 2014

U.S Department of Transportation
National Highway Traffic Safety Administration

6. Performing Organization Code NVS-313	
7. Author(s) William D. Collins, NHTSA Engineer				8. Performing Organization Report No. VRTC Report DCD3208

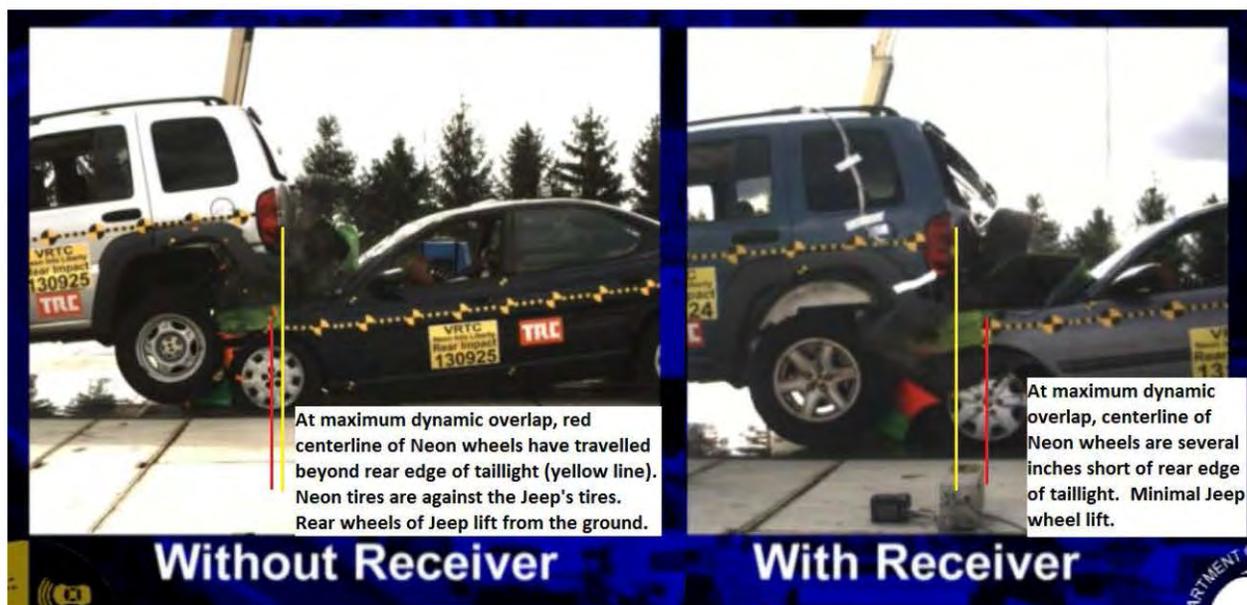
This test used a 1997 Plymouth Neon as the bullet vehicle and a 2004 Jeep Liberty without a hitch-receiver as the target vehicle. Post-test observation of the impact damage to the target vehicle was compared to and found to be consistent with the damage of the vehicle in the real-world crash. The fuel tank was directly contacted by the Neon, and most of the 68.5 liters of Stoddard in the tank spilled by the end of 30 minutes. Review of the high-speed video footage revealed the Neon passed under the Jeep and significantly lifted the back end until the front wheels of the Neon contacted the back wheels of the Jeep to move it forward, indicating significant under-ride as shown in Figure 6.

This test used a 1997 Plymouth Neon as the bullet vehicle and a 2004 Jeep Liberty equipped with an OE hitch-receiver as the target vehicle. Model years of both the bullet and target vehicles were the same as the original crash. Post-test observation of the impact damage to the target vehicle showed no rupture of the fuel tank. Review of the high speed video footage revealed the Neon directly impacted the hitch-receiver and reduced upward motion of the Jeep from the baseline test due to reduced under-ride, also shown in Figure 6. Additionally, the front wheels of the Neon did not contact the back wheels of the Liberty. Post-test observations from the baseline and comparative test, as compared to the real-world crash are shown in Figure 6. A comparison between the two front bumper reinforcements of each Neon test vehicle is shown in Figure 7. Pre and post-test photos of the target vehicle fuel tanks are shown in Figure 8, Figure 9, and Figure 10, respectively. Test #1 shows significant scraping of the tank from the under-ride of the bullet vehicle (see Figure 9). Also the orange paint from Region 2 (17 to 24 inches above the ground) can be seen on the vehicle exhaust pipe and rear differential indicating significant interaction between the bullet vehicle, the Jeep fuel tank, and other adjacent components. Figure 10 shows the post-test photo of the comparative test (Test #2) with the hitch-receiver installed. The fuel tank and exhaust pipe do not show signs of under-ride or interaction with the bullet vehicle.

Figure 6 - Difference in dynamic overlap of Neon and Jeep Liberty

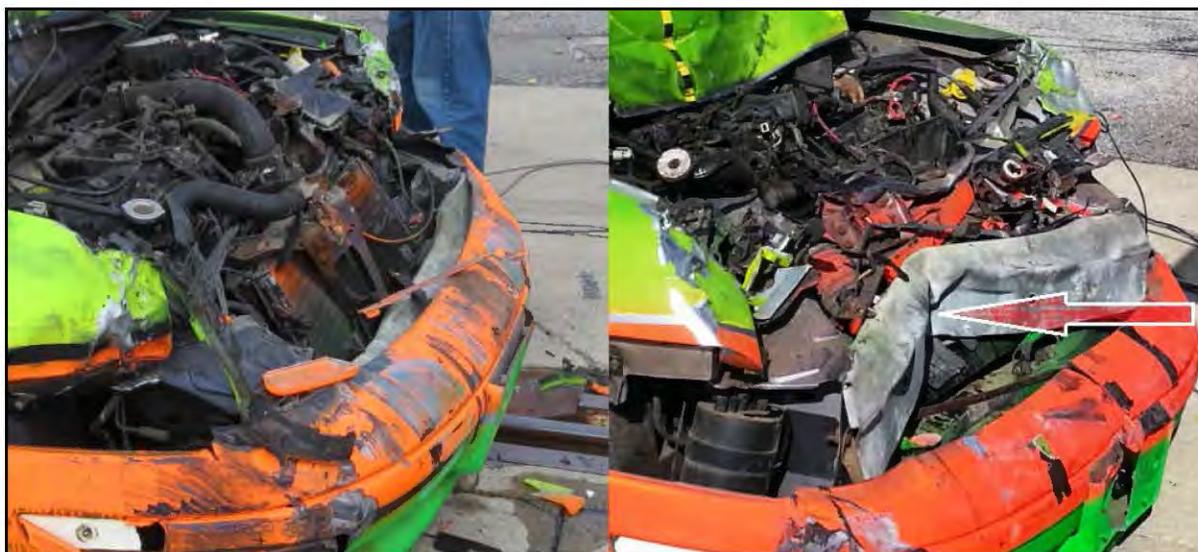
Figure 7 - Neon bumper reinforcement Test 1 vs. Test 2. Arrow at hitch-receiver contact

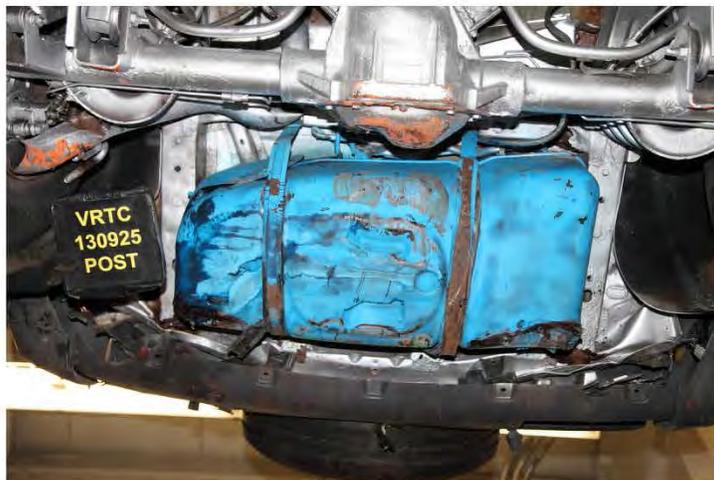
Figure 9 – Test #1 Post-test target vehicle fuel tank close-up view without hitch-receiver

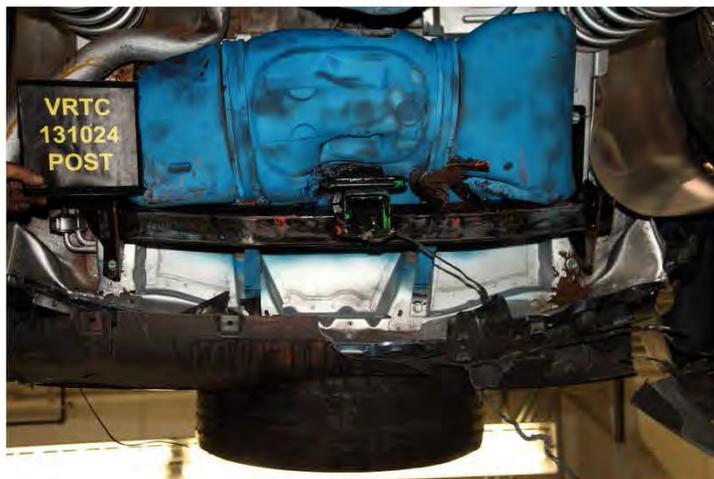
Figure 10 – Test #2 Post-test target vehicle fuel tank close-up view with hitch-receiver

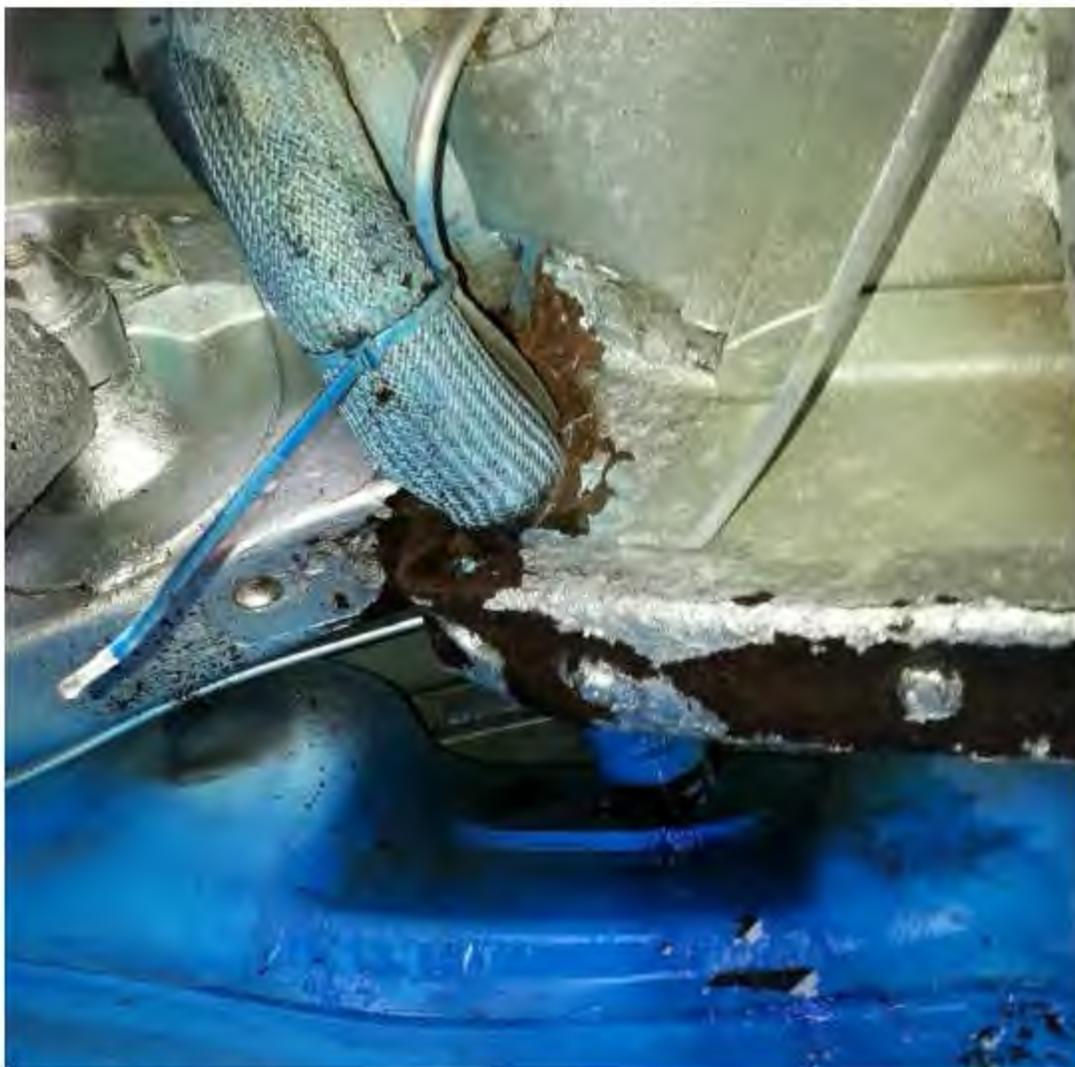
Figure 12 - Test #3 Significant rust causes collapse at relief tunnel in rail where fuel hoses pass through

Both of the Jeep Grand Cherokees tested to this point had unseen corrosion (rust) inside of the frame rails that wasn't revealed until after the tests. While this was not surprising given the number of exposure years in salt-belt states, it was reasoned that this could potentially be a variable in crash performance and may reduce the ability of the frame rail relief tunnel to resist crushing. A Jeep Grand Cherokee with limited salt exposure was procured for baseline Test #5. Although height had not been a significant factor in producing the crushed frame rail, the cut on the bottom side of tank in the real-world crash had still not been produced, so a final attempt was made to further lower the front ride height of the Cadillac, but the progressive springs limited static compression to between two and three inches, making the striking height essentially only marginally lower than in Test #4. At the conclusion of this test, there was no fuel leak. The left frame rail had bent outward, but the filler hose relief tunnel was not crushed and allowed the hoses to slide through the tunnel as it was bent by the force of the crash. Despite significant scraping between the Cadillac and the Jeep tank being produced, the cut in the bottom of the tank was not produced. It became apparent that it would be improbable to be able to control the formation and motion of sharp features from the deforming Cadillac, while also predicting whether the metal reinforcement on the Jeep would break away or just deform.

The reconstruction of the Cadillac Deville into the ZJ Jeep Grand Cherokee revealed a repeatable failure mode with the crushed and rusted frame rail pulling on the fuel filler hoses until they broke the connections from the plastic tank. It was confirmed that a vehicle with little to no rust could withstand the crash. The hitch-receiver bracket and mounting bolts provided a structural reinforcement that prevented the collapse of the moderately rusted frame rail relief tunnel in testing.

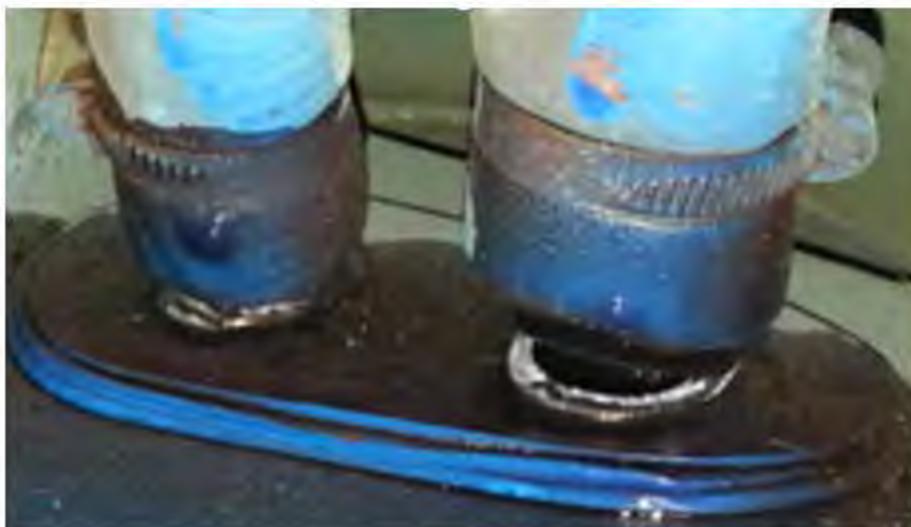
facts to support pre-impact braking. At the conclusion of the first test, it was evident that the Cadillac struck the Jeep with an impact point at least two inches higher than in the real-world crash based on intrusion patterns into the rear gate of the Jeep. At least one known source of the fuel leak in the real-world crash was a several inch long cut along the bottom of the tank. It is possible that other leak sources existed, but no other sources were documented. In the baseline crash, a fuel leak was produced; however it originated at the fuel filler hose connections. There is a relief tunnel (hole) through the left frame rail that routes the fuel filler hose along the path to the filler cap shown in Figure 11. The tunnel in the frame rail was crushed due to the force of the crash, combined with significant rust originating from the hollow, inside of the rail, and this resulted in the hoses being captured in the frame rail, shown in Figure 12. As the frame rail bent, it pulled upward on the fuel tank hose connections and broke them at their bases on the plastic tank, resulting in a significant leak, as shown in Figure 13.

Figure 13 - Test #3 Broken fuel connections on plastic fuel tank

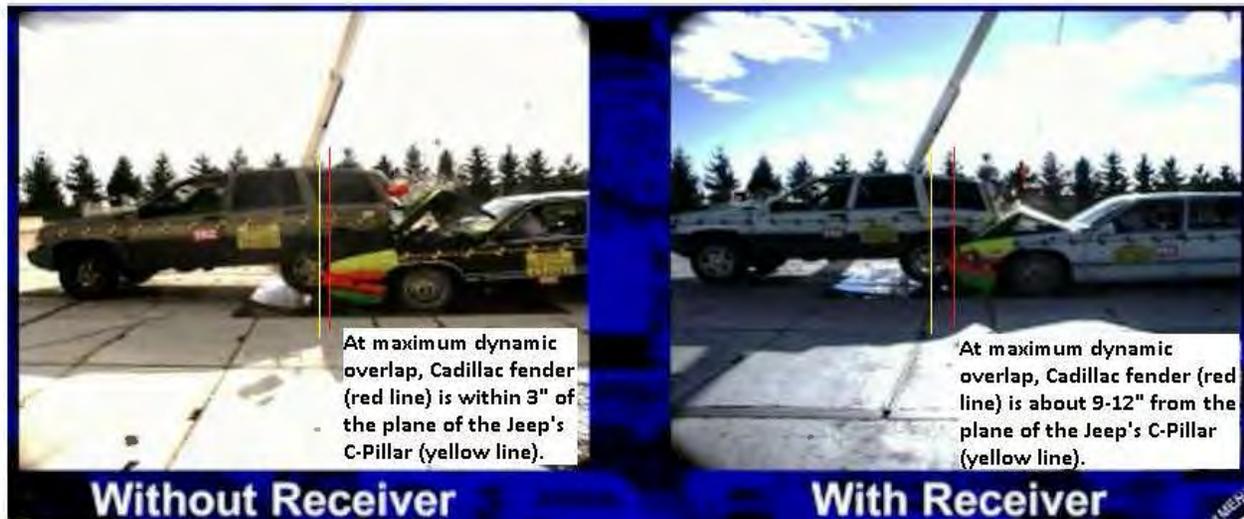
from the high speed video showed the difference in dynamic overlap, where the Cadillac did not encroach as far into the Grand Cherokee when it was equipped with the hitch-receiver (Figure 14).

Figure 14- Dynamic overlap between Cadillac and Jeep Grand Cherokee without and with a hitch-receiver

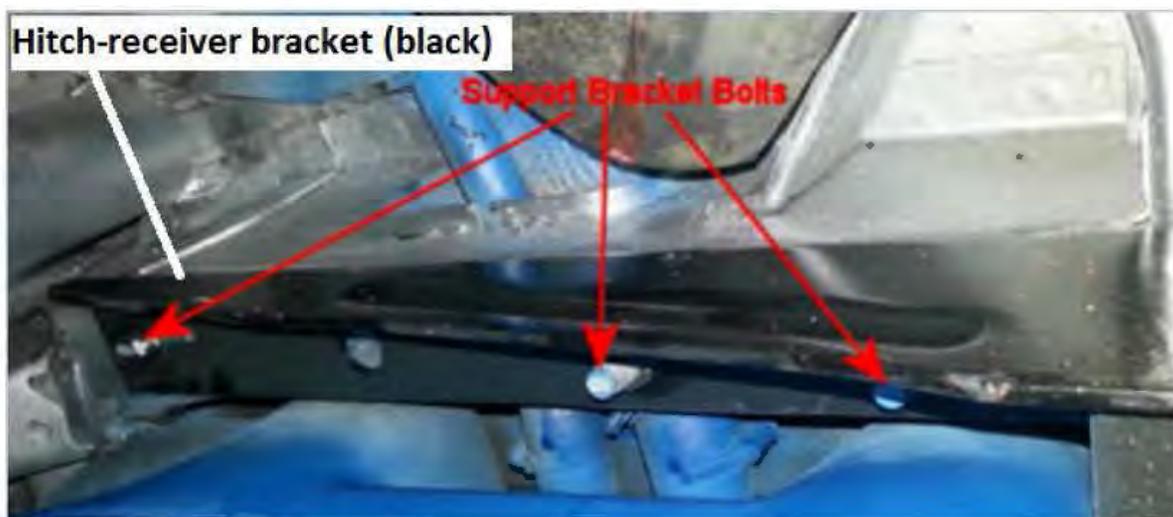
The Cadillac bumper engaged directly with the Jeep's hitch-receiver and prevented the frame rails from bending near the tank. The support brackets that attach the hitch-receiver to the body of the Jeep with three bolts on each side provided significant structural support (Figure 15). This also resulted in greatly reduced scraping between the Jeep's tank and the Cadillac.

Figure 15 - Test #6 - Hitch-receiver bracket reinforces tunnel, hose not captured - Minimal rust vehicle

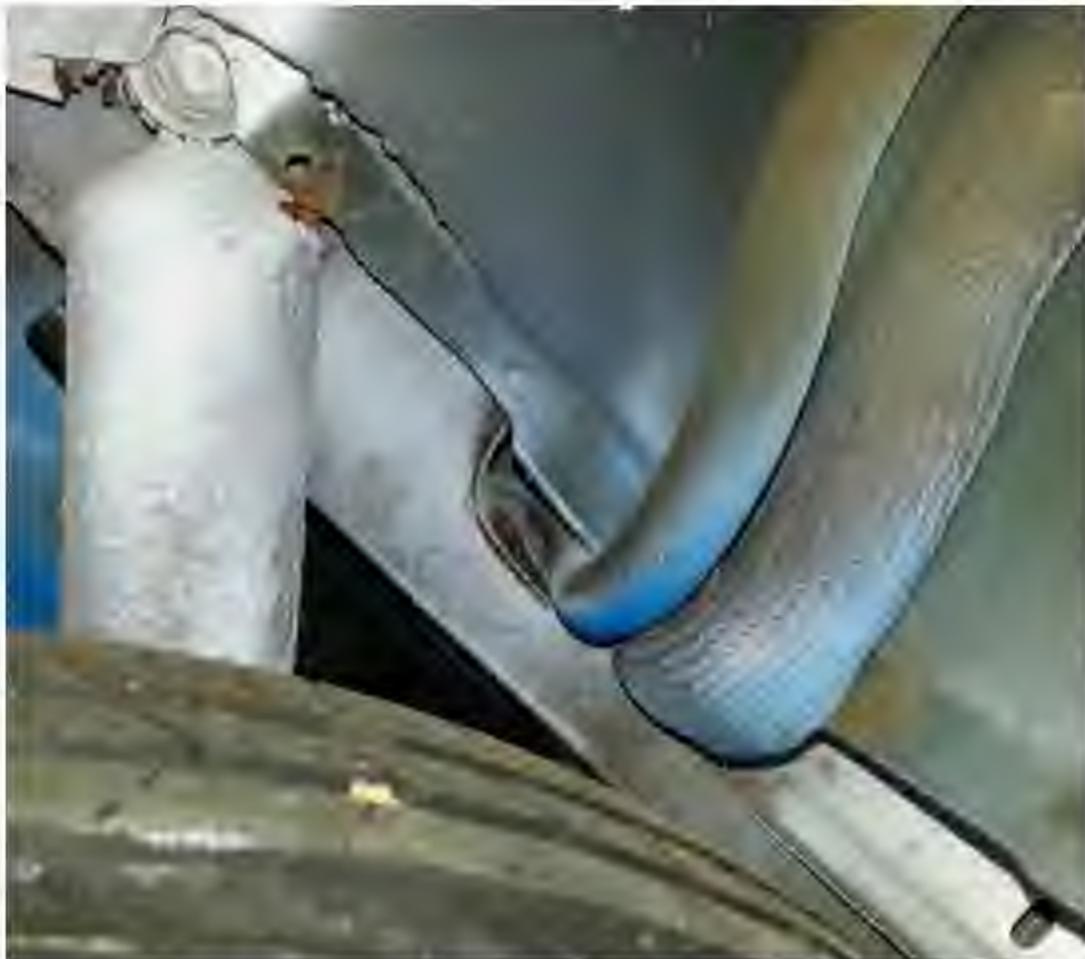
The last ZJ Grand Cherokee test was Test #7. This test was conducted to determine whether the frame rail reinforcement properties demonstrated in Test #6 would also sufficiently benefit a rusted frame rail relief tunnel. The Jeep used for Test #7 had up to 18 years of road salt exposure. The Cadillac was set to normal ride height, similar to baseline Test #3. At the conclusion of the crash, there was no fuel leak. The Cadillac again directly struck the hitch-receiver and the frame rails did not bend near the tank. The hitch support bracket bridged the frame rail relief tunnel and transferred the impact force to a forward point on the frame rail away from the tank (Figure 16). Scraping between the Cadillac and fuel tank was minimal.

Figure 16 Test#7 Rail with rust reinforced by hitch-receiver bracket, hose not captured – moderately rusted vehicle

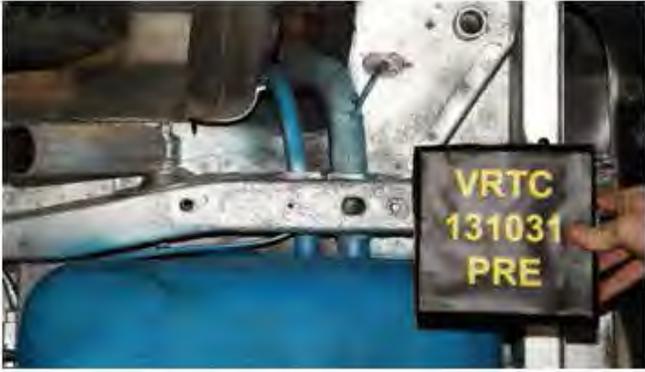
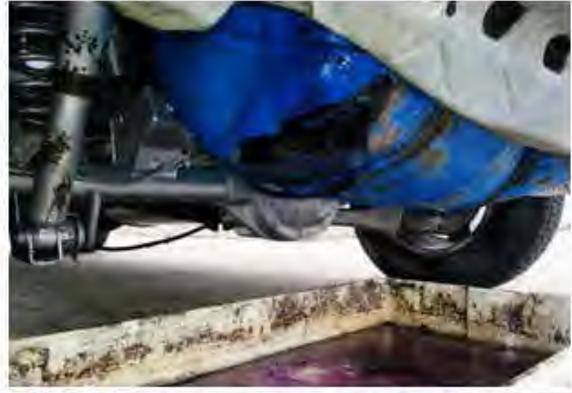
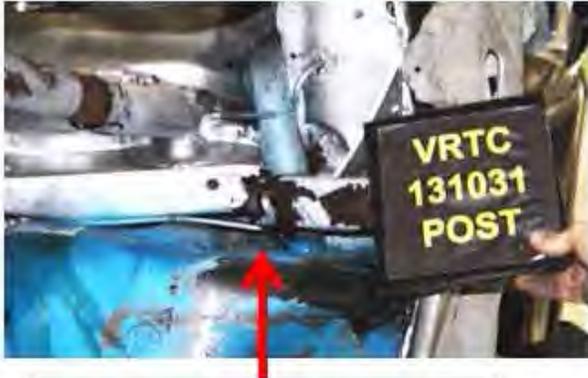
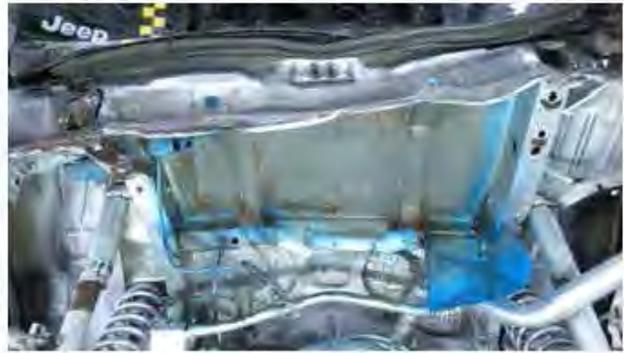
Fuel filler frame pass-through collapsed and pulled away from tank – Known source of leak from testing, Unknown if this occurred in the real-world crash

Significant sliding interaction between tank & bullet vehicle – Known source of leakage from real-world crash

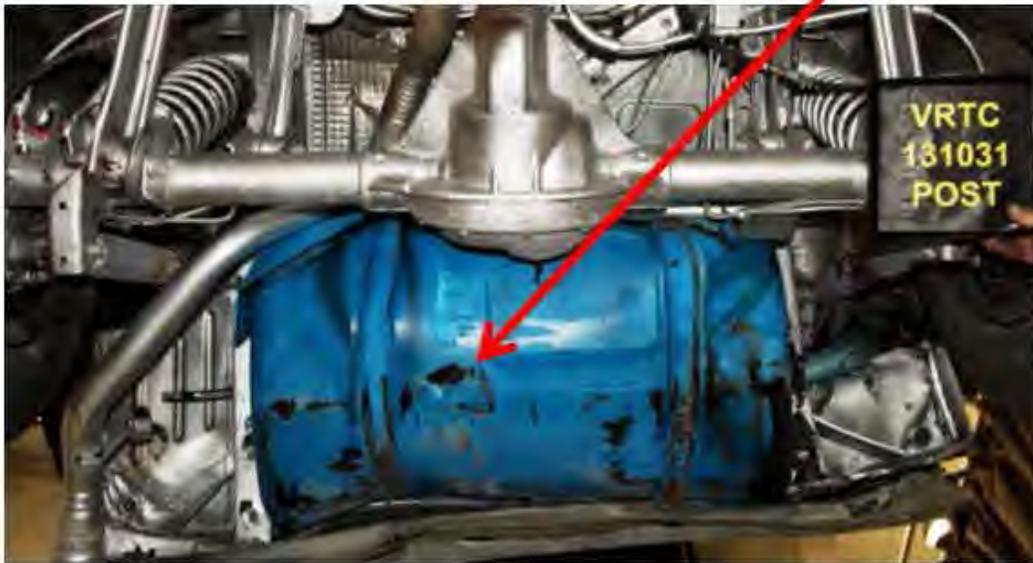
Figure 21 – Post-test damage from Test #3 – No hitch-receiver

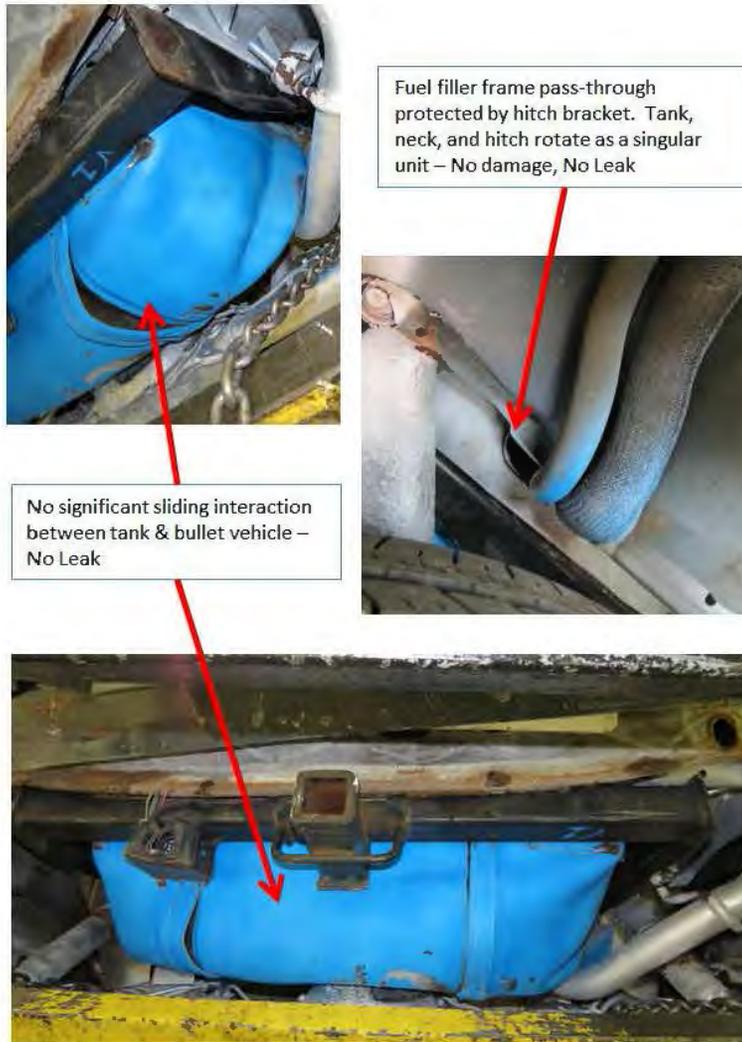
Figure 22 - Post-test damage from Test #7 - With hitch-receiver

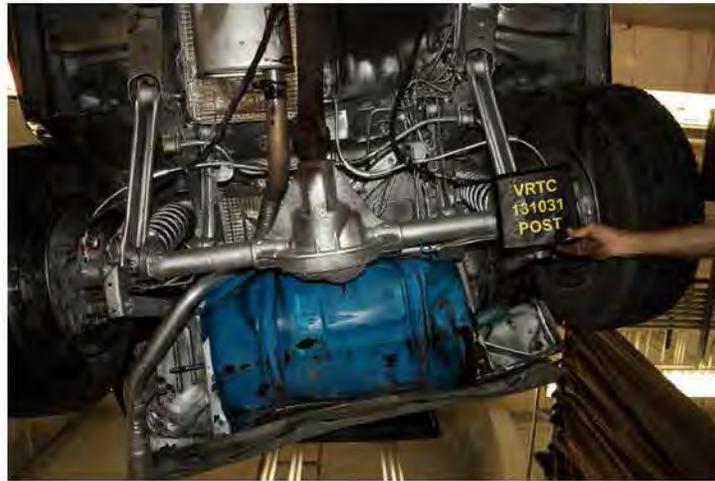
Pre-test and post-test photos of the target vehicle fuel tank from the baseline test (Test#3) are shown in Figure 23 and Figure 24, respectively. The post-test photo shows the scraping caused by the under-ride. Figure 25 shows the post-test photo of the comparative test (Test #7) with hitch-receiver installed. The fuel tank did not show signs of under-ride, but did show signs of impacting the rear differential of the Jeep.

Figure 24 - Test #3 Post-test target vehicle fuel tank close-up without hitch-receiver

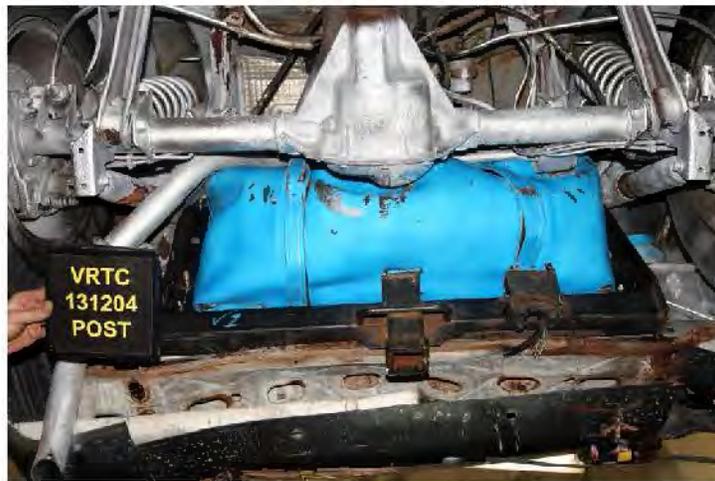
Figure 25 - Test #7 Post-test target vehicle fuel tank close-up with hitch-receiver

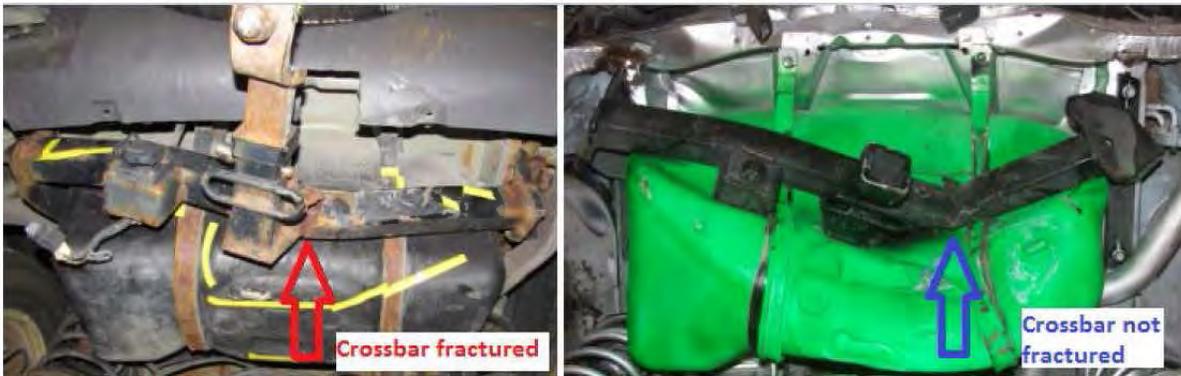
This crash scenario consisted of one test identified as Test #8 from VOQ #10512282. It used a 2008 Ford F-150 Super Cab travelling at 43 mph as the bullet vehicle and a stationary 2004 Jeep Liberty with a hitch-receiver as the target vehicle. Unlike the real-world crash, the hitch on this test vehicle did not have the consumer installed ball-mount drawbar inserted into the hitch-receiver. Upon impact, the hitch partially collapsed, but the cross-member did not fracture as it did in the real-world crash (see Figure 26 and Figure 27). The cross-member did push into the fuel tank but did not pierce it. Stoddard solvent droplets were observed immediately after the crash but ceased before they could be measured. There were no observable openings in the tank.

Figure 26 - Left: Real-world crash cross-member fracture, Right: Reconstruction deformation, no cross-member fracture

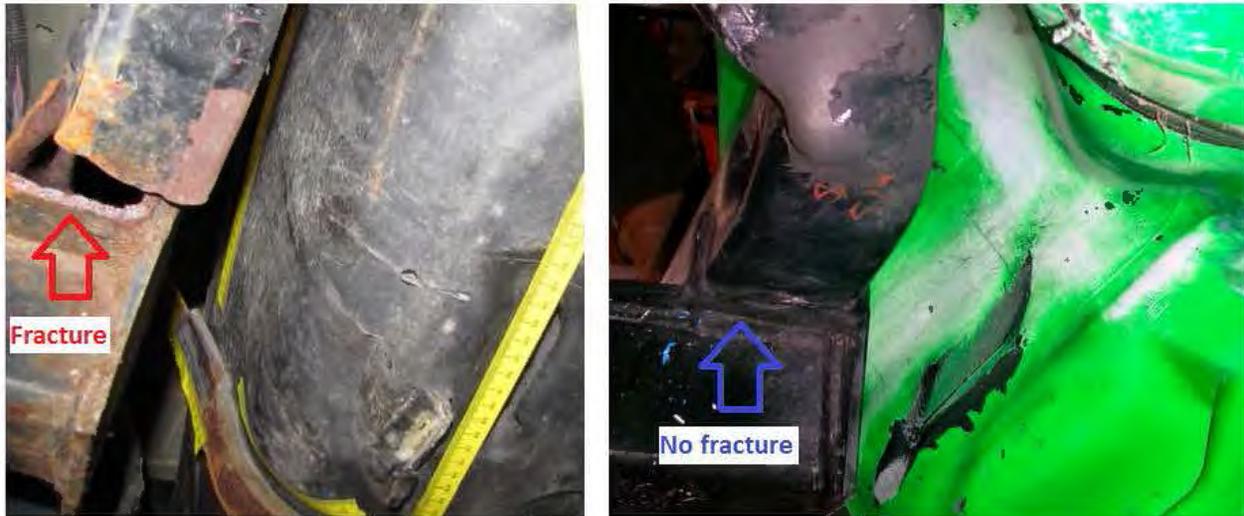
Figure 27 - Left: Real-world crash cross-member fracture (picture taken several months after crash), Right: Reconstruction deformation, no cross-member fracture

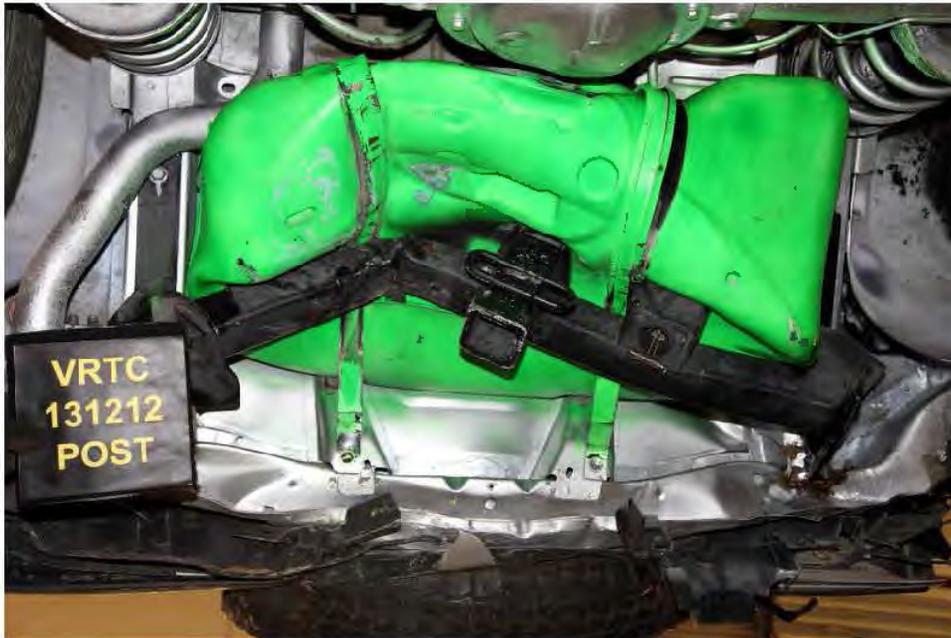
Pre-test and post-test photos of the target vehicle fuel tank from the baseline test (Test#8) are shown in Figure 28 and Figure 29, respectively. The post-test photo shows no signs of under-ride from the bullet vehicle. Post-test observations are compared to the real-world crash and shown in Table 11. Damage to the tested Jeep Liberty indicated that the energy levels were consistent with, if not in excess of that achieved in the real-world crash. In post-test observation and during the procedural longitudinal rollover test, leakage occurred when the vehicle was rolled in the rollover fixture. Upon disassembly, the source of the droplets was discovered to be the overfill vent connector and the charcoal vapor connector, which had broken off at the top of the fuel pump assembly (Figure 30). These connectors were made from a nylon material and were formed into the top of the housing. They do not carry fuel during normal operation because they function to vent vapors and prevent overfilling. A third connector of the same material, the high pressure supply connection, which does carry fuel during normal operation, remained intact. Further investigation of the fuel pump inside of the tank revealed that the bottom of the plastic pump housing assembly had been displaced forward, had shattered inside of the fuel tank, and had broken the internal supply tube to the fuel pump. This rendered the pump incapable of pressurizing the external fuel tube.

Figure 29 - Test #8 Post-test target vehicle fuel tank close-up view

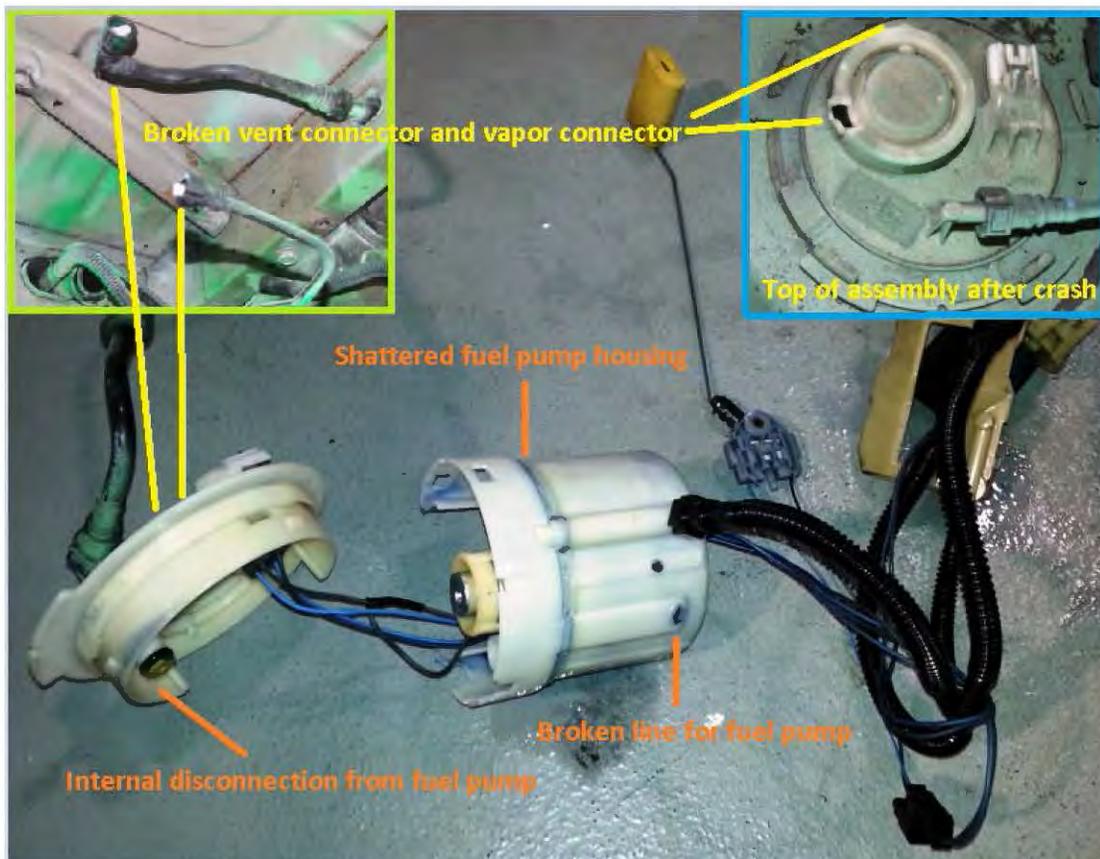
Figure 30 - Additional observation: Fuel pump assembly contained in tank rendered internally non-functional by crash. Vent and vapor tubes broken externally.
