Service Bulletin

Bulletin No.: 03-06-01-010

Subject: Engine Oil or Coolant Leak (Install New Intake Manifold Gasket)

Models: 2000-2003 Buick Century
2002-2003 Buick Rendezvous
1996 Chevrolet Lumina APV
1997-2003 Chevrolet Venture
1999-2001 Chevrolet Lumina
1999-2003 Chevrolet Malibu, Monte Carlo
2000-2003 Chevrolet Impala
1996-2003 Oldsmobile Silhouette
1999 Oldsmobile Cutlass
1999-2003 Oldsmobile Alero
1996-1999 Pontiac Trans Sport
1999-2003 Pontiac Grand Am
2000-2003 Pontiac Grand Prix, Montana
2001-2003 Pontiac Aztek
with 3.1L or 3.4L V-6 Engine (VINs J, E - RPOs LG8, LA1)

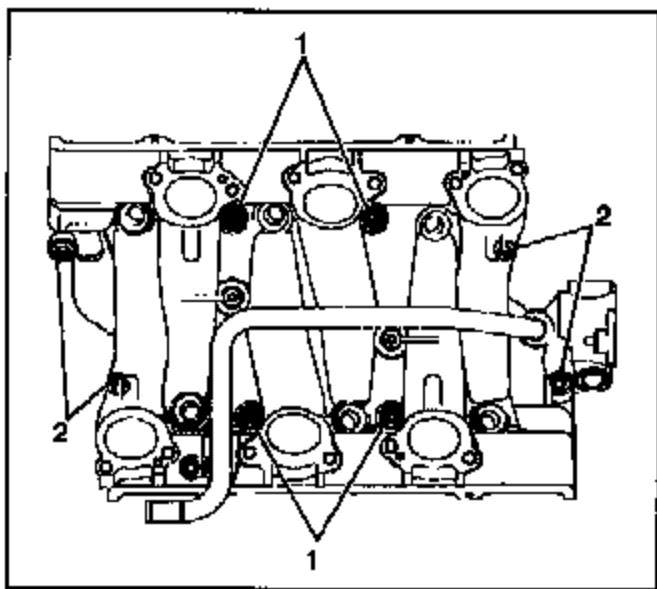
Intake manifold may be leaking allowing coolant, oil or both to leak from the engine.

Install a new design intake manifold gasket. The material used in the gasket has been changed in order to improve the sealing qualities of the gasket. When replacing the gasket, the intake manifold bolts must also be cleaned, coated with threadlocker and torqued to a revised specification.

Clean all of the intake bolts of any debris or oils.

Be sure to apply threadlocker, GM P/N 12345382 (in Canada, P/N 10953489), to the bottom 3-4 threads of each of the intake bolts before installation.

Notice: An oil leak may result if the vertical bolts are not tightened before the diagonal bolts.

1. Tighten the vertical lower intake manifold bolts (1) to 7 N·m (62 lb in).
2. Tighten the diagonal lower intake manifold bolts (2) to 7 N·m (62 lb in).
3. Tighten the vertical lower intake manifold bolts (1) to 13 N·m (115 lb in).
4. Tighten the diagonal lower intake manifold bolts (2) to 25 N·m (18 lb ft).
