# Sudden Acceleration Without an Accelerator Input

Ronald A. Belt  
Plymouth, MN 55447  
1 November 2012

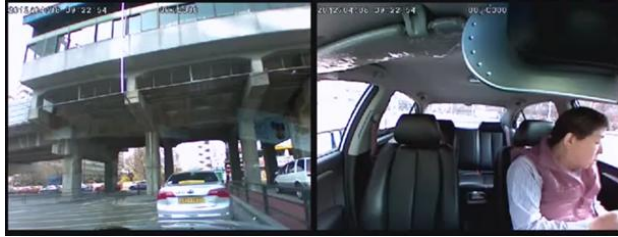
Figure 1-0:02 on page 9 shows the driver waiting in the taxi line. After about a minute and a half of waiting, the driver exits the vehicle to have a smoke. When he exits the vehicle, he leaves the vehicle running at idle with the transmission in DRIVE and the parking brake on. Figure 1-1:42 shows the driver smoking outside the vehicle. Figure 1-2:07 shows the driver becoming aware that the taxi ahead of him in line has moved forward, so he re-enters the vehicle to inch it forward. He does so by reaching inside to release the parking brake while leaving both feet outside the vehicle. Figure 1-2:08 shows the driver hearing the engine rev up suddenly to full throttle as he is releasing the brake. A passenger disembarking from a nearby taxi also hears the unusually high engine revs and looks toward the taxi in line to determine what is going on. Figure 1- 2:09 shows the taxi beginning to surge forward as the engine is heard revving at wide open throttle (WOT). Four seconds later, Figure 1-2:15 shows the taxi crashing into a bridge pillar with the driver's feet still outside the vehicle as the engine continues to rev at full throttle. The taxi rebounds from the pillar and turns to the right as the engine revs audibly. The turning is probably caused by the left wheel hitting the curbing around the pillar, causing the vehicle to turn to the left when moving forward and to the right while moving backward. Figure 1-2:16 shows the driver doing something like shifting into neutral. This might explain why the vehicle does not surge forward and hit the taxi in front. Figure 1-2:19 shows the driver doing something after which the engine revving starts to decrease. Figure

0:02 Waiting in taxi line. Driver is boored.

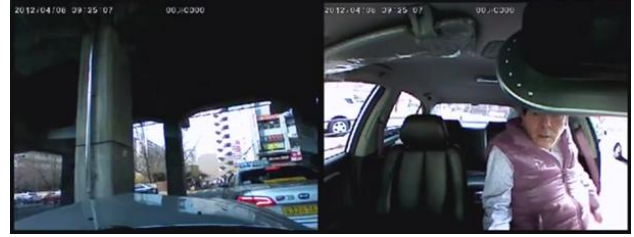
2:15 Taxi runs into pillar as WOT revs continue to be heard.

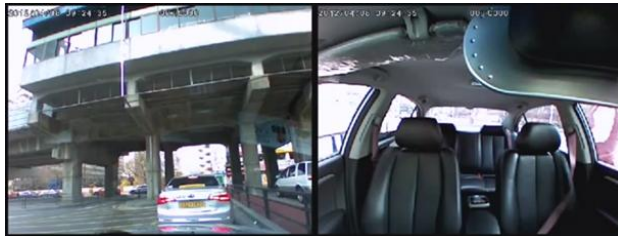
1:42 Taking a smoke break while engine idles normally.

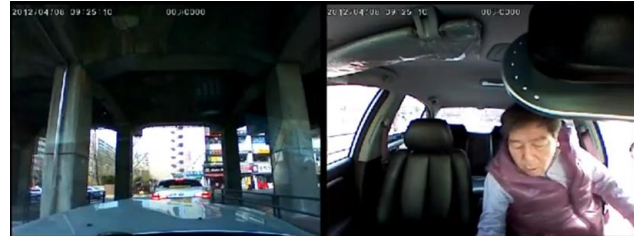
2:16 Driver shifts into neutral?

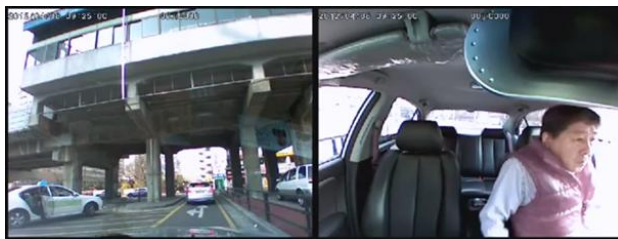
2:07 Taxi ahead moved. Gets back in cab to move it up in line. Feet are still outside the vehicle.

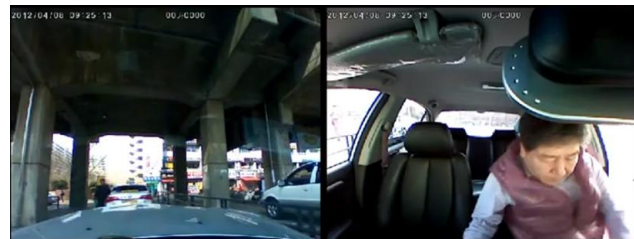
2:19 Driver does something and engine revving starts to decrease.

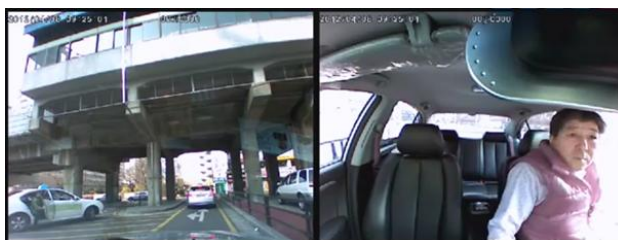
2:08 Releases hand brake to move up in line while feet are still outside the vehicle. Hears engine immediately rev to WOT. Passenger in another taxi also hears engine rev up.

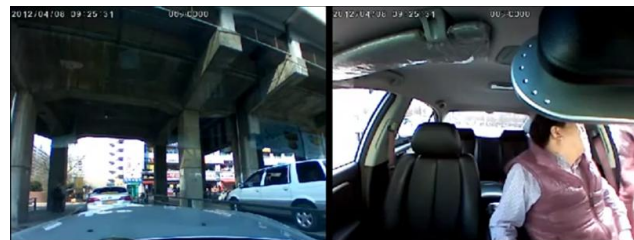
1-2:37 shows a bystander shutting off the ignition after the engine is running at normal idle. Finally, Figure 1-2:52 shows the driver talking to the bystander after his ordeal is over. Both his feet are still outside the vehicle.

2:37 Bystander shuts off ignition after engine is running at normal idle

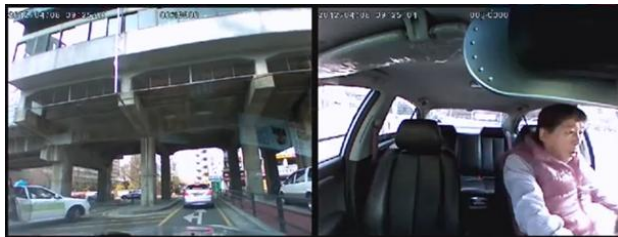
2:09 With engine revving at WOT taxi surges forward.

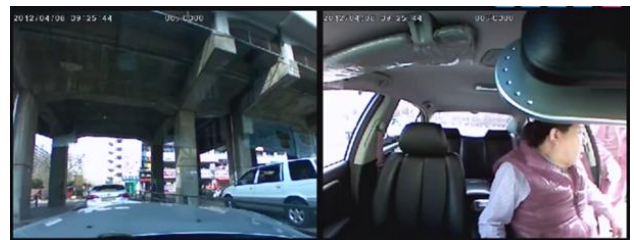
2:52 Shocked driver thanks bystander afterward. His feet are still outside the vehicle.

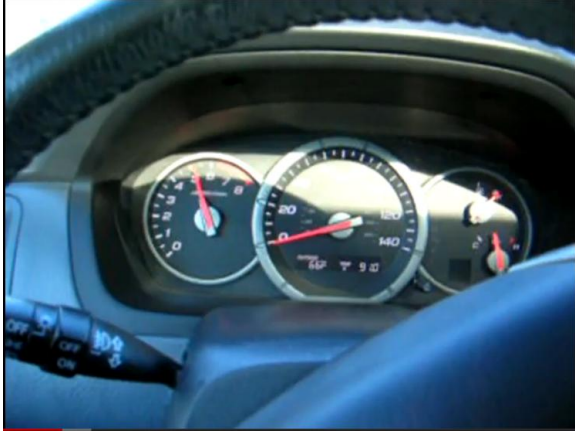
0:01 High revs continue to be heard in PARK after beginning randomly while in DRIVE.

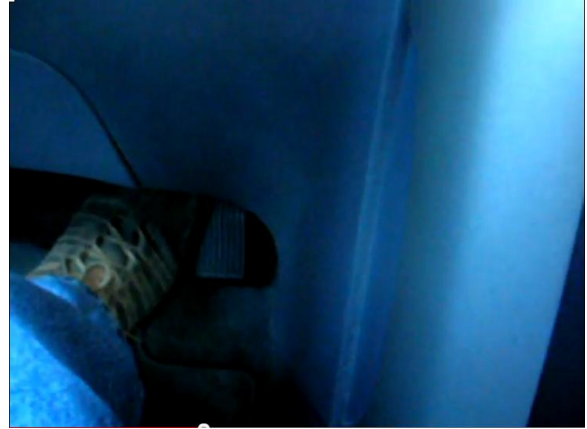
0:17 Driver shows that foot is on the brake and not on accelerator while high revving continues to be heard.

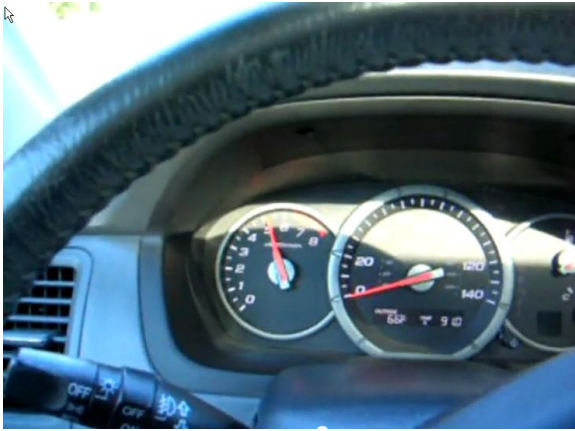
0:21 to 0:30 Revs at 5000 RPM continue to be heard.

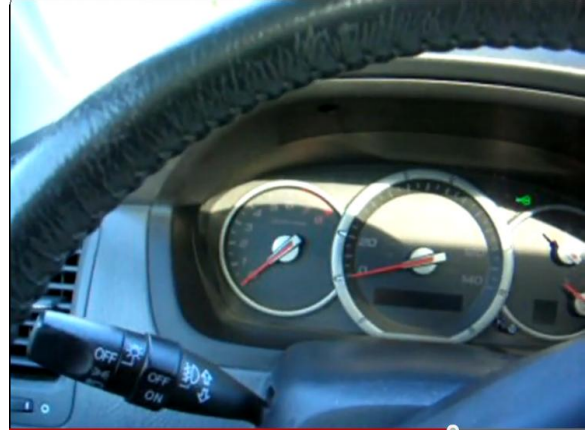
0:31 High revs cease when ignition is turned off.

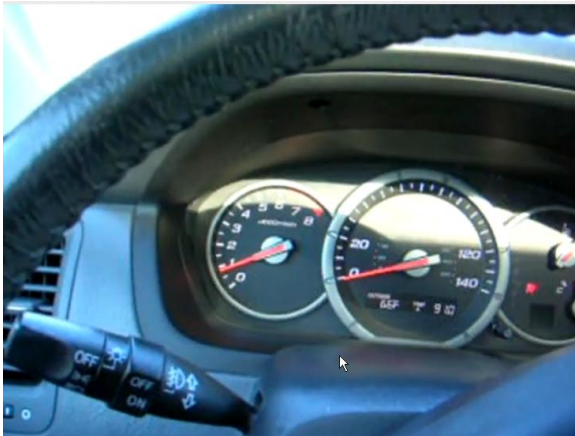
0:41 to 0:48 Normal idle operation occurs when the ignition is turned back on.

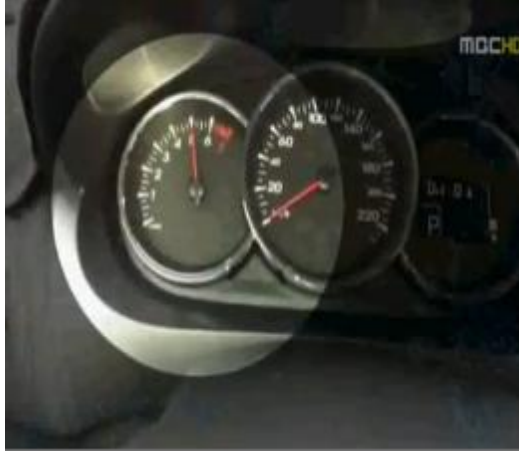
0:04 High revs continue after starting in DRIVE. "P" on right shows transmission is in PARK.

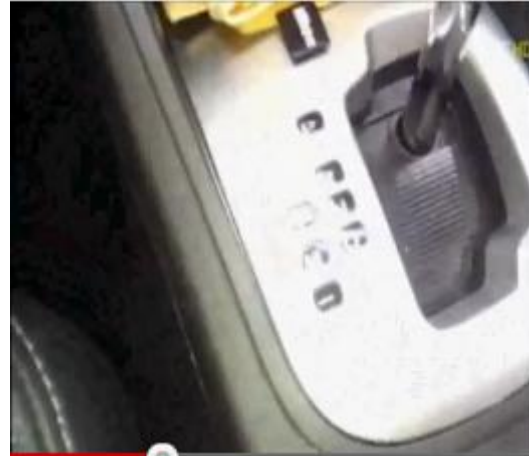
0:15 Gearshift is in PARK while high revving continues to be heard.

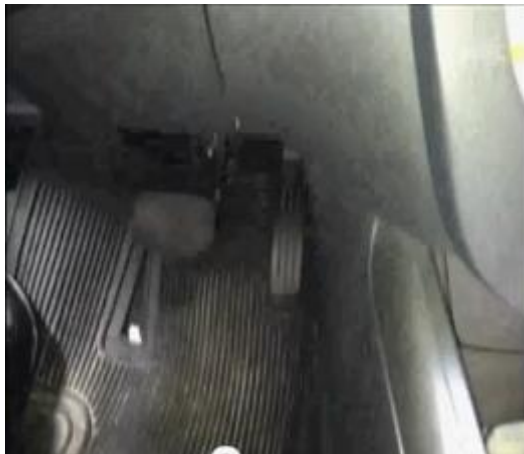
0:18 No foot on accelerator as high revs continue to be heard.

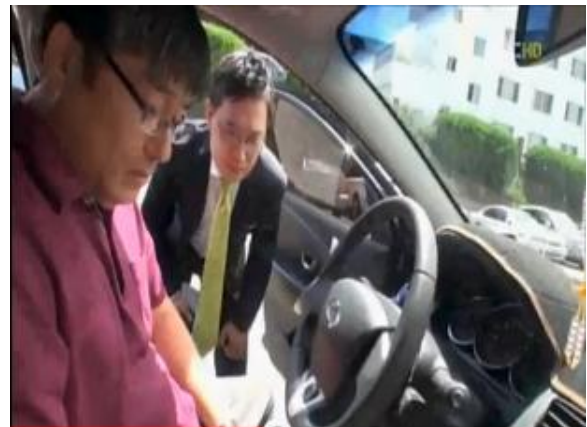
0:19-0:26 High revving continues to be heard as the driver talks to an observer.

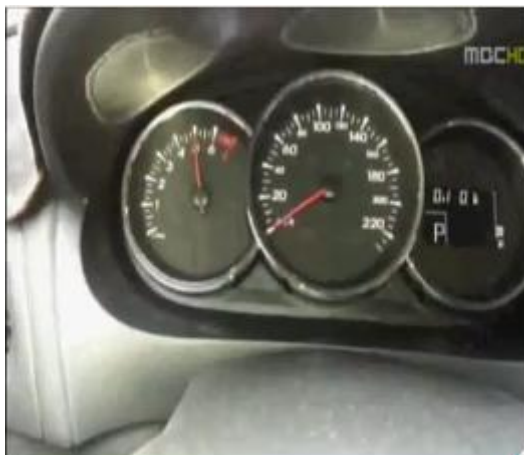
0:34-0:37 High revving continues to be heard.

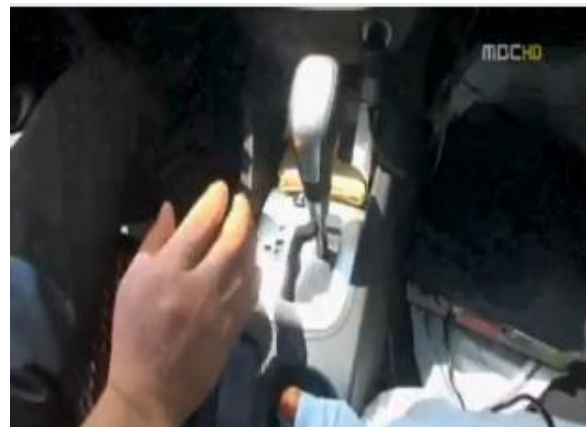
0:40 High revving continues to be heard as gearshift remains in PARK. An accessory is seen plugged into the cigarette lighter.

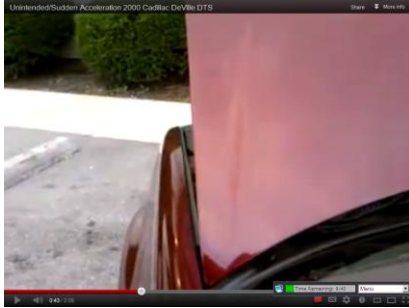
The video begins by showing the vehicle with the hood up and the engine off. The owner has opened the hood to see if the dealer's repairs might have caused some obvious problem. But the owner could find nothing to cause the high revs. Figure 4-0:42 on page 12 shows the owner restarting the engine, at which time it roars back to life at 3800 RPM. Figure 4-0:51 shows the engine continuing to roar at high RPM after the driver has exited the vehicle while leaving it in PARK. Figure 4-0:54 shows the tachometer at 3800 RPM with no pedal input. Figure 4-0:59 shows that the engine has shut off on its own within a few seconds after hitting the rev limiter at 4000 RPM. Figure 4-1:01 shows the engine being restarted, after which it goes immediately to high revs again. Figure 4-1:05 shows the tachometer oscillating between 3500 and 3900 RPM with no accelerator input. Figure 4-1:13 shows that the engine is revving at 3800 RPM with no accelerator pedal input. Figure 4-1:29 shows that the engine is shut off manually while at 3800 RPM. The next day, after the vehicle was towed to the dealership, when the dealer started it up again the vehicle exhibited the same behavior as shown in the video.

0:42 Engine restarted after just undergoing a sudden acceleration followed by putting the vehicle in PARK. Engine roars back into high revs again.

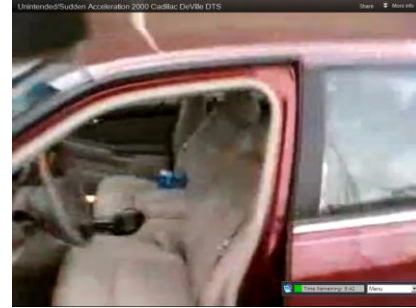
0:51 Engine continues to roar at high RPM after driver has exited the vehicle while leaving it in PARK.

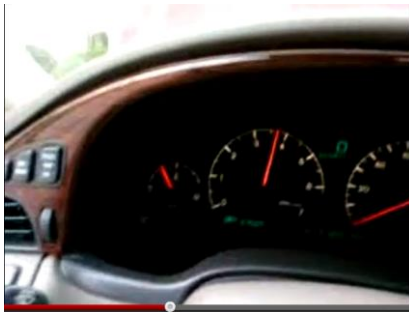
0:54 Tach shows 3800 RPM with no pedal input.

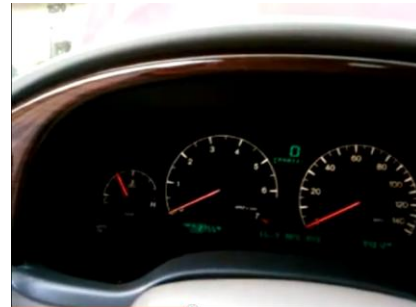
0:59 The engine shuts off after hitting the rev limit at 4000 RPM.

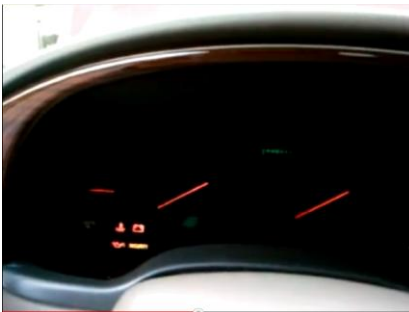
1:01 Engine is restarted and immediately goes to high revs again.

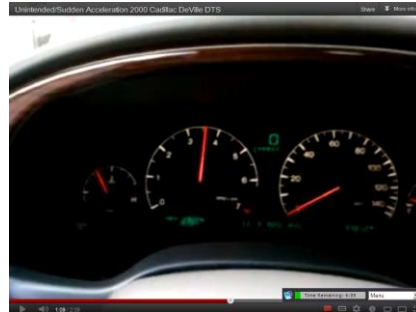
1:05 Tach oscillates between 3500 and 3900 RPM with no accelerator input.

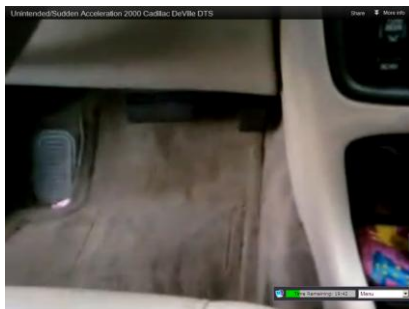
1:13 Shows engine revving at 3800 RPM with no accelerator pedal input.

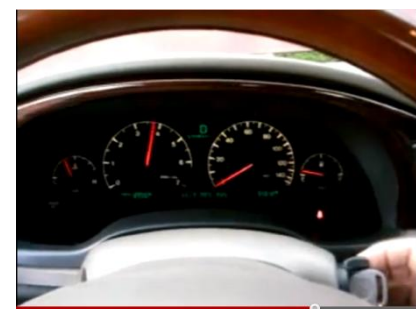
1:29 Engine is shut off manually while at 3800 RPM.
