**Technical Service  
BULLETIN**

Title:  
**EXCESSIVE SULFUR DIOXIDE ODOR**  
Models:  
**'03 – '04 Matrix (1ZZ-FE)**

**ENGINE**  
**EG017-04**

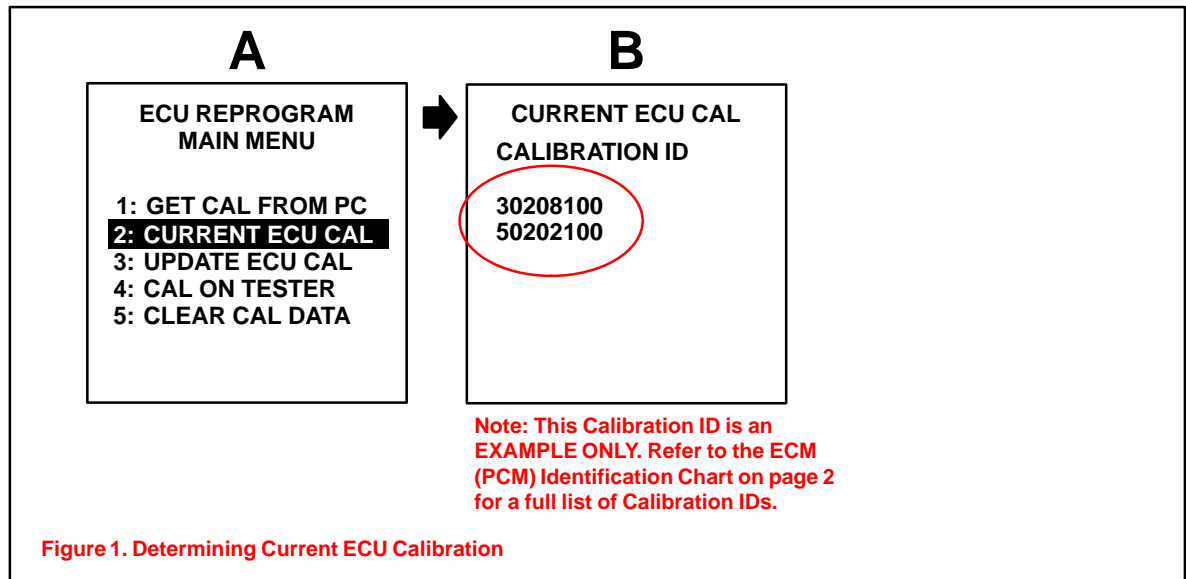
1. Check for the Authorized Modification Label affixed to the vehicle in the location shown in Figure 2 on page 5. If there is no label present, proceed to step 2.
2. Connect the Diagnostic Tester to the vehicle and select “CURRENT ECU CAL” from the “ECU REPROGRAM MAIN MENU.” To determine the vehicle’s current ECM calibration, see Figure 1 shown below.

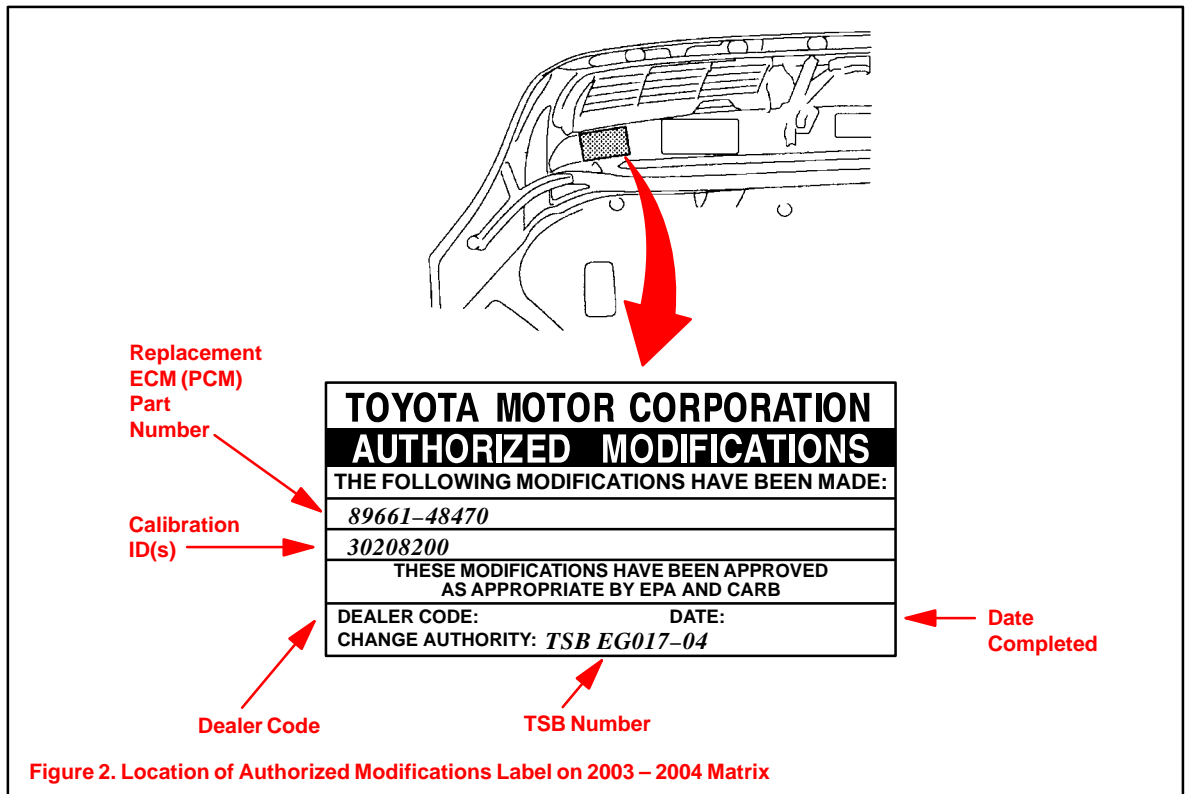
7. Enter the following information on the Authorized Modification Label shown below in Figure 2 using a permanent marker.
  - ECM (PCM) part number.
  - New ECM (PCM) calibration number.
  - Your dealer code.
  - Reprogramming date.
  - This TSB number.
