OFFICE OF DEFECTS INVESTIGATION
CALSPAN REMOTE ALLEGED SUDDEN ACCELERATION CRASH INVESTIGATION

NASS/SCI COMBO CASE NO: 2008-12-077A
VEHICLE: 2005 TOYOTA CAMRY
LOCATION: MICHIGAN
CRASH DATE: APRIL, 2008

Contract No. DTNH22-07-C-00043

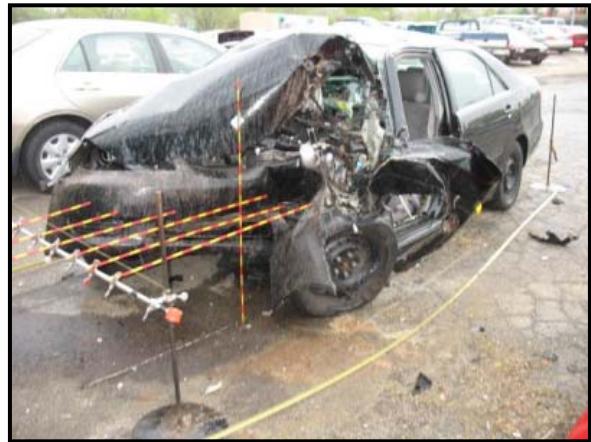
Figure 1: Left front oblique view of the Camry.

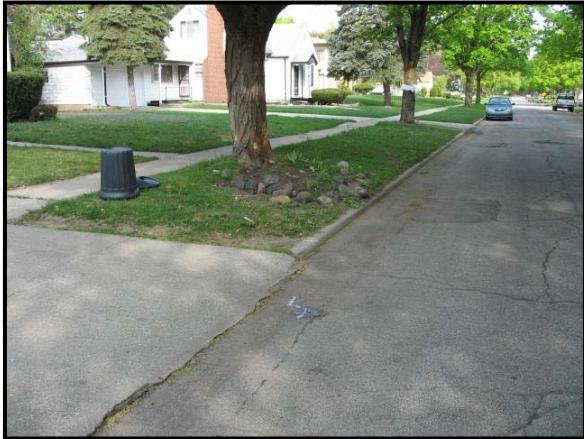
the curb. Residential driveways intersected both sides of the street. The posted speed limit was 40 km/h (25 mph). **Figure 3** is a westbound trajectory view of the Toyota at the point of the roadside departure. An area of landscape rocks was overridden by the front left wheel rim and an 80 cm (31.5 in) diameter tree was sideswiped as the Toyota left the road. A 53 cm (20.9 in) diameter tree was located 15.8 m (52 ft) downstream and was the point of the frontal impact, **Figure 4**. A section of the tree's bark was stripped and removed during the impact. This section was located 1.4 m to 2.6 m (4.5 ft to 8.5 ft) above the ground and extended approximately 40 percent around the tree's circumference. Two scrapes in the asphalt road surface oriented in the northwest direction extended beyond the second tree and evidenced the vehicle's path to final rest. The scrapes measured 5.2 m (17 ft) in length and were attributed to contact from the rear wheel rims. An area of fluid spill and run-off was noted throughout the area of final rest.

Figure 3: Trajectory view of the Toyota at the road side departure.

The Toyota departed the left side of the road at a shallow angle (estimated at 10 degrees) at the mouth of a driveway. The vehicle entered the grass area immediately outboard the curb line and the front tires overrode the rock landscape area located at the base of an 80 cm (31.5 in) diameter

tree (refer to **Figure 3** above). As the Toyota continued its southwest trajectory, the left fender and front door of the vehicle sideswiped the tree. This impact redirected the vehicle's trajectory to its right and the Toyota continued along the grass area with a trajectory nearly parallel to the road.

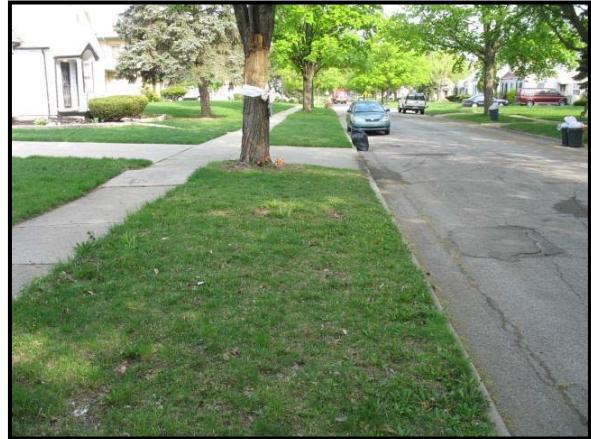
Figure 4: Trajectory view to the frontal impact.

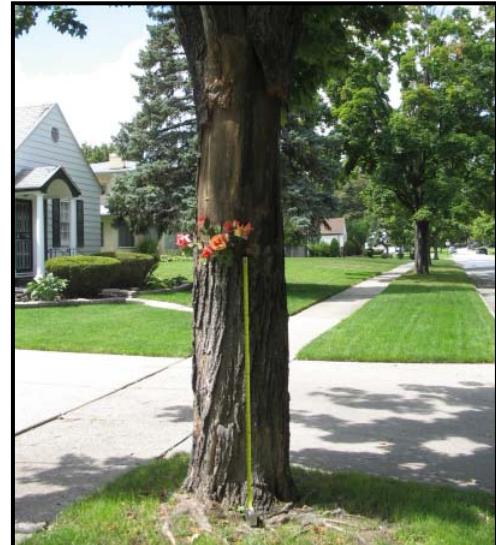
Figure 5 is a close-up view of the tree and the point of impact. The force of this impact was severe and resulted in the deployment of the vehicle's driver air bag and actuation of the safety belt pretensioner. The severity of the crash (delta V) calculated by the Damage Algorithm of the WINSMASH model was 91 km/h (57 mph). The longitudinal and lateral components delta V were -91 km/h (-57 mph) and 0, respectively.

The force of the impact resulted in a vertical buckling of the hood. The deformed hood penetrated the bark of the tree 1.4 m (4.5 ft) above the ground. As a consequence of the offset left impact, the Camry rotated counterclockwise (CCW) approximately 145 degrees as it separated from the tree. During the rapid rotation of the vehicle, the hood's contact with the bark stripped/separated a 1.2 m (4 ft) section of bark from the tree trunk. The separated section of the bark was located 1.4 m to 2.6 m (4.5 ft to 8.5 ft) above the ground. The Camry came to rest on the roadway facing southeast. The post-impact trajectory of the Toyota was evidenced by multiple scratch/gouge marks and an area of fluid spills at the scene. A schematic of the crash is included at the end of this report as **Figure 11**.

Figure 5: Close-up view of the point of impact.

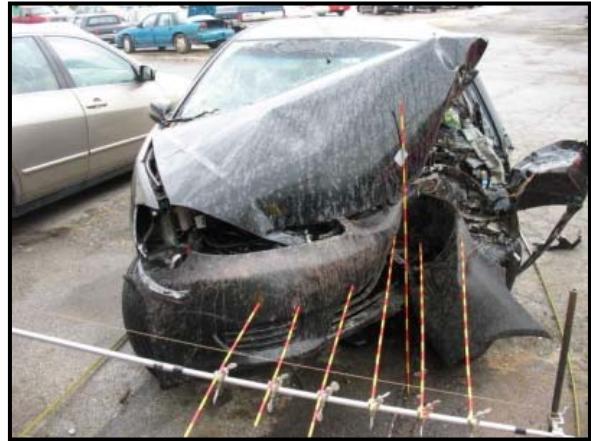
Figure 6 is a front view of the damaged Toyota Camry. The Camry sustained severe damage as a result of the road side impact sequence. The Toyota sideswiped an 80 cm (31.5 in) diameter tree immediately after departing the road. Although partially masked by the overlapping frontal damage, this swiping contact was observed on the left fender and left front door. The contact measured 112 cm (44.0 in) in length. The lateral extent zone was unknown. The Collision Deformation Classification of this impact was 12-LYES9.

Figure 6: Front view of the Camry.

The Camry continued along the road side to the frontal engagement with the 53 cm (20.9 in) diameter tree. The direct contact to the front bumper began 16 cm (6.2 in) left of center and extended 26 cm (10.2 in) to the left front corner. The impact was biased to the left side of the front structure and as the front left structures crushed rearward into the engine compartment, the front right bumper corner was pulled inboard. This resulted in a Field L of 67 cm (26.3 in) across the front plane. The residual crush measured along the front bumper was as follows: C1 = 90 cm (35.4 in), C2 = 126 cm (49.6 in), C3 = 116 cm (45.7 in), C4 = 56 cm (22.0 in), C5 = 27 cm (10.6 in), C6 = 7 cm (2.8 in). The left wheelbase was reduced 29 cm (11.4 in). The right wheelbase was unchanged. The left front door was jammed shut and removed by the first responders. The left rear, right front and right rear doors were operational. The CDC of the frontal tree impact was 12-FYEN6.

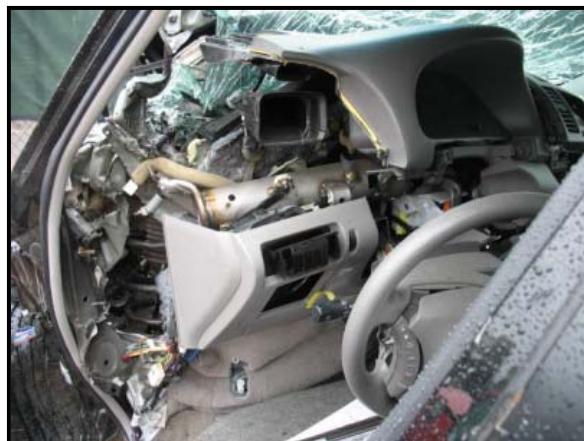
The interior Camry sustained severe intrusion into the driver's interior space as a result of the frontal impact. **Figures 7-9** are interior views depicting the magnitude and severity of the intrusion. The deformed steering wheel rim was in close proximity to the driver seat back. The left floor pan deformed in an inverted V-pattern and was intruded to the forward edge of the driver seat cushion. Floor mats were not installed in the left floor pan.

Figure 7: Left front interior intrusion.

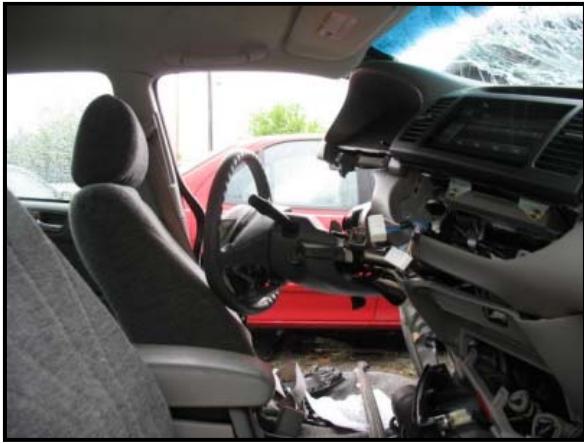
Figure 8: Right lateral view of the intruded steering wheel.

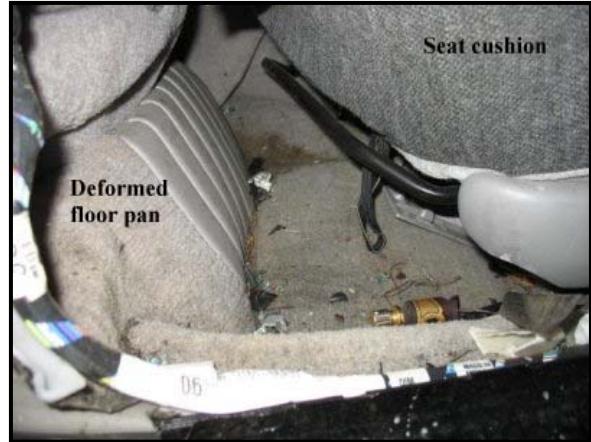
Figure 9: Floor pan intrusion. Floor mats were not present.

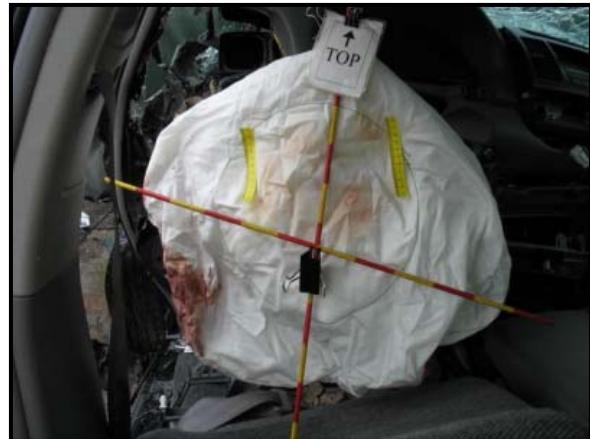
The driver air bag (**Figure 10**) deployed from an H-configuration module located in the center of the steering wheel rim. The module cover flaps opened as designed. There was no occupant contact to the flaps. The air bag was tethered and was vented by two ports located on the back side of the bag in the 11/1 o'clock sectors. A 20 cm x 14 cm (8 in x 5.5 in) red/yellow make-up transfer was noted to the central face of the bag. A large area of post-crash blood evidence was observed on the back side of the air bag in the 6 to 9 o'clock sectors. A smaller area of post-crash blood evidence was observed on the back side of the bag in the 12 o'clock sector.

Figure 10: Driver air bag contact evidence.
