| <ul style="list-style-type: none"> <li>• <b>BODY—PARTS AND PROCEDURE TO REDUCE THE POTENTIAL OF FUEL TANK PUNCTURES DURING RARE AND EXTREMELY HIGH-SPEED REAR IMPACTS</b></li> <li>• <b>FUEL— PARTS AND PROCEDURE TO REDUCE THE POTENTIAL OF FUEL TANK PUNCTURES DURING RARE AND EXTREMELY HIGH-SPEED REAR IMPACTS</b></li> </ul> | <b>Article No.</b><br><b>01-21-14</b> |

**FORD:** 1992-2001 CROWN VICTORIA

**LINCOLN:** 1992-2001 TOWN CAR

**MERCURY:** 1992-2001 GRAND MARQUIS

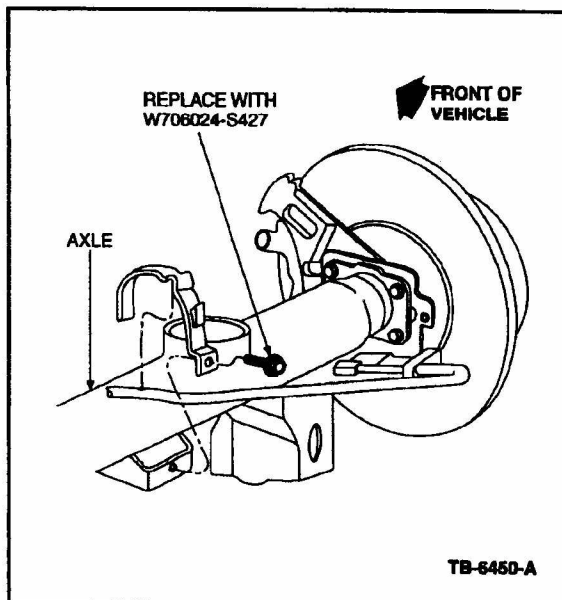
Figure 1 - Article 01-21-14

Ford corporate guideline tests, at speeds 20 mph above government requirements, demonstrate excellent fuel tank integrity in these vehicles. Because of the nature of their use, some Police vehicles in certain applications may be exposed to extremely high-speed rear impacts with closing speeds above 80 mph. Investigation of several police vehicles involved in extreme high-speed rear impacts has identified a potential cause of the fuel tank puncture in at least one of these impacts.

1. On 1992-1997 vehicles, replace Park Brake Cable to Axle attaching hex head bolt part N806900-S2 with round-headed fastener part W706024-S427. Model year 1998 and later vehicles are of a different design and do not use this bolt (Figure 1).
