Service Action Circular

Code: WG

June 2004

Subject: 2001–2003 Model Year Volkswagen Vehicles Replace Ignition Coils

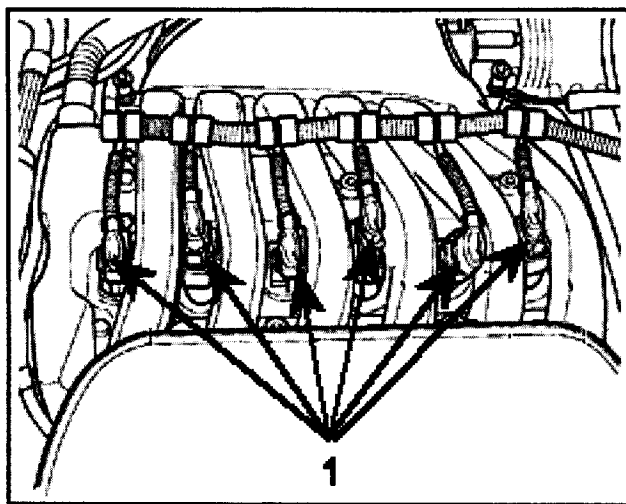
⇐ Disconnect connector from all ignition coils -1-

- Using **Puller T10095**, remove ignition coils

CAUTION: USE OF TOOL T10095 IS REQUIRED TO AVOID DAMAGING THESE SENSITIVE COMPONENTS

- Install new ignition coils (022 905 100 D/G/K) by pressing into cylinder head by hand only

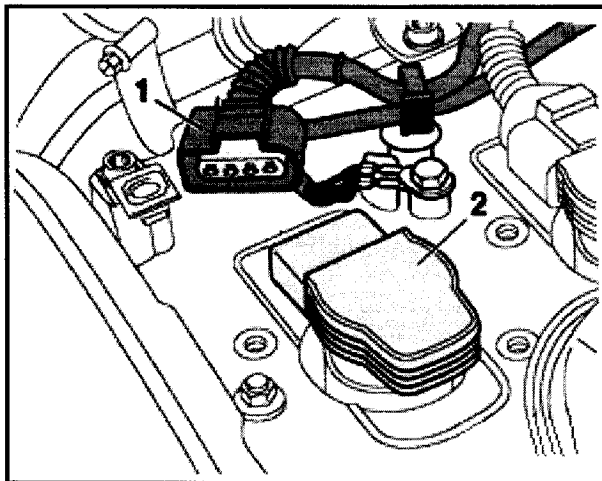
⇐ Disconnect connectors -1- from all ignition coils -2-

- Using **Puller T40039**, remove ignition coils

CAUTION: Use of tool T40039 is required to avoid damaging these sensitive components

- Install new ignition coils (06B 905 115J/L) by pressing into cylinder head with hand only

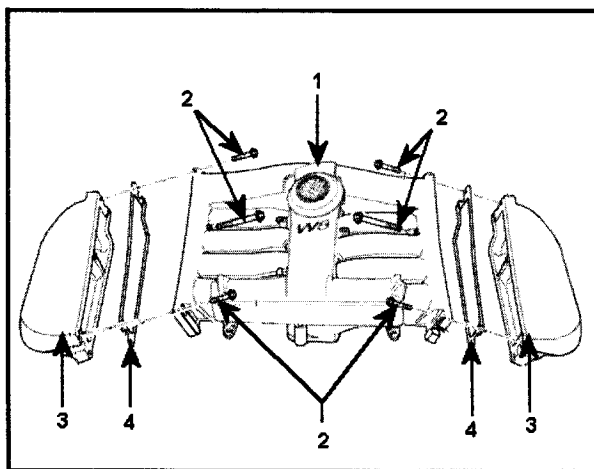
- If applicable, connect VAS5051 and check DTCs
- ⇐ Open hood and remove center manifold cover -1-
- ⇐ Remove bolts -2- securing left and right intake manifold side parts -3- and remove side part with gaskets -4-
- Disconnect connectors on all ignition coils

- Using **Puller T10094**, remove ignition coils on left and right banks of engine

- Install new ignition coils (07C 905 115C/D) by pressing into cylinder head by hand only

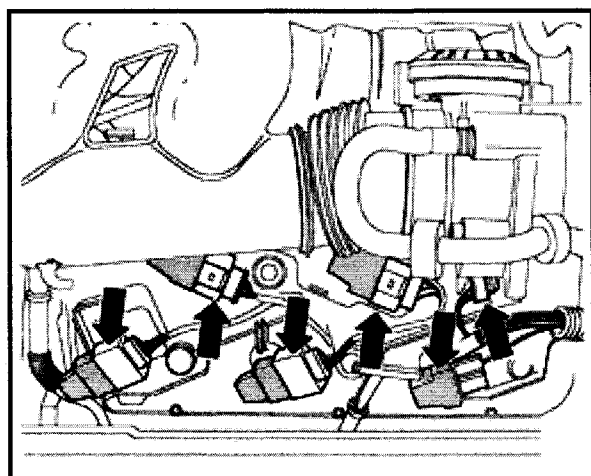
⇐ Disconnect connectors -arrows- from all ignition coils

⇐ Using Puller T10095, remove ignition coils

- Install new ignition coils (022 905 100C/F/J) by pressing into cylinder head by hand only
