NHTSA_58 SUA Cases Report ASA Preliminary Analysis

FORENSIC ANALYSIS OF ELECTRONIC AND COMPUTER VEHICLE CONTROLS

A Forensic Engineering Approach to SUA Investigations

ASA Provisional Observations

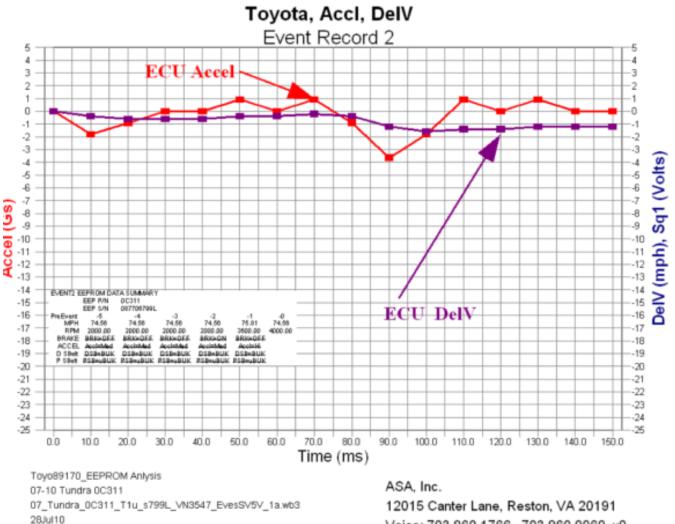
Exhibit C.11.5 shows the subject SRS ECU ASA translated acceleration and Deltadata and the translated Pre-event data [data window on data chart].

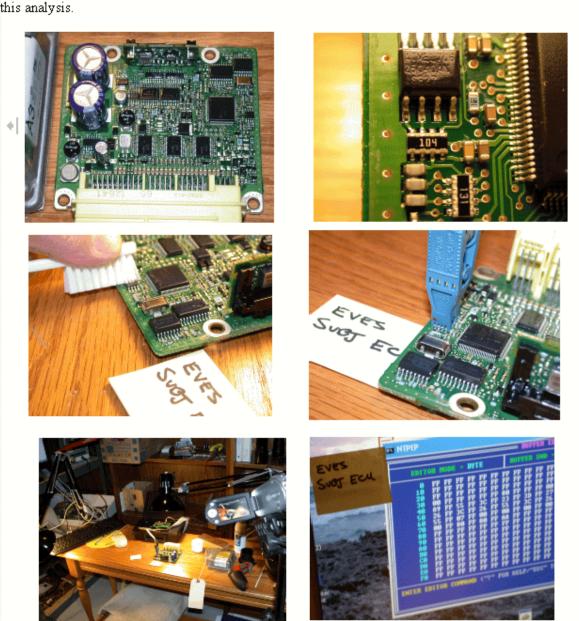
Exhibit C.11.11 shows the methodology used to accomplish the EEPROM direct-read employed for this analysis.

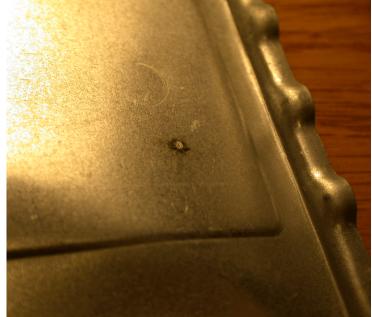
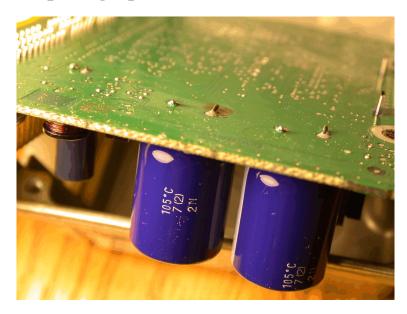
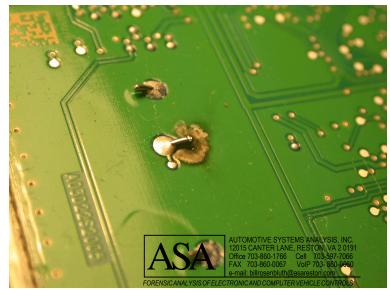
One reason for non-meaningful acceleration data (after a known crash and deploy event) can be an electronic anomaly preventing RAM data (volatile) from being written to EEPROM after the crash event.

Such an electronic anomaly was physically observed in the subject SRS ECU. In the subject ECU, the backing plate was deformed such that a short circuit, with arcing, existed between an energy storage capacitor positive lead and the backing plate (an electrical ground). These arcing artifacts were photographed.

The crash event record, as properly translated, contains non-meaningful acceleration data. With non-meaningful acceleration data, no crash-event Delta-V can be derived. The non-meaningful data was probably a residue from a prior non-deployment event.

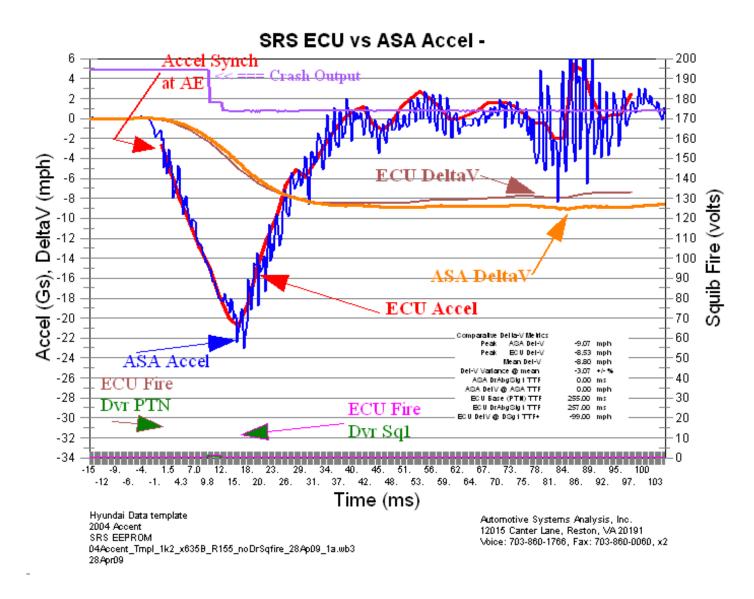
Example of Impinged-Acceleration SLOT Calibration Results

"SLOT" information is defined by the Society of Automotive Engineers (SAE) Recommended Practice J2178-2 (SAE J2178-2) to be Scaling, Limit, Offset and Transfer Function specifications that allow hexadecimal encoded engineering data to be interpreted into engineering units such as psi, seconds, volts, amps, Gs, etc.

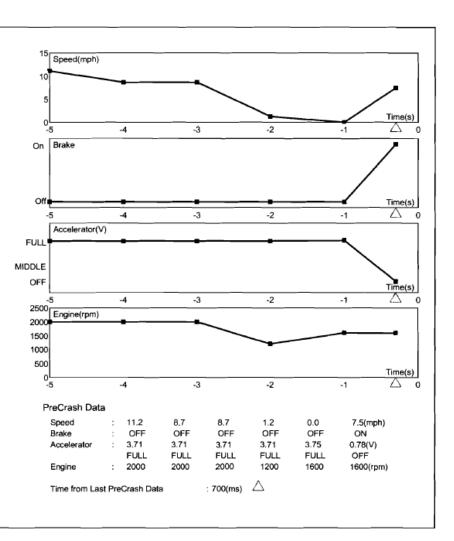
Case 4 Complete EDR Image

Contradictions in record:

- Speed decreasing w/accel WOT
 Speed increasing w/accel off
 Speed decreasing w/brake off
 Speed increasing w/brake on

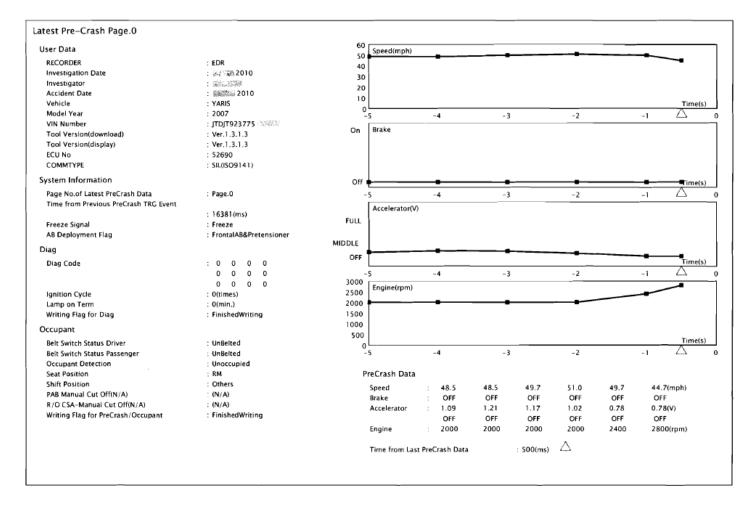
Case 38 Complete EDR Image

Contradictions in record:

1. RPM increasing (+800RPM) w/Accel released to Idle (0.78V)

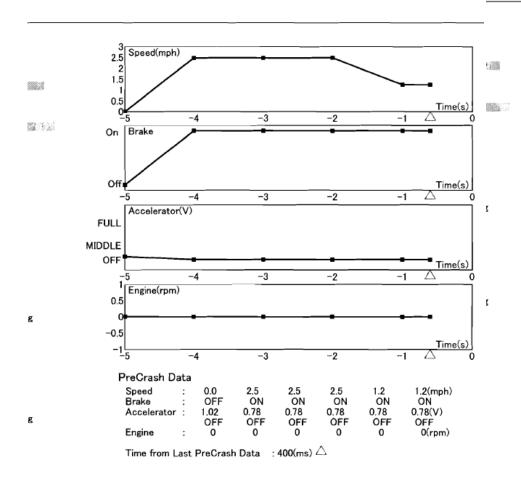
Case 19 Complete EDR Image

Contradictions in record: ENTRY SPD =1.2 DEL-V 7.8 FOR PG 0 = Next Most Recent = Contradictory

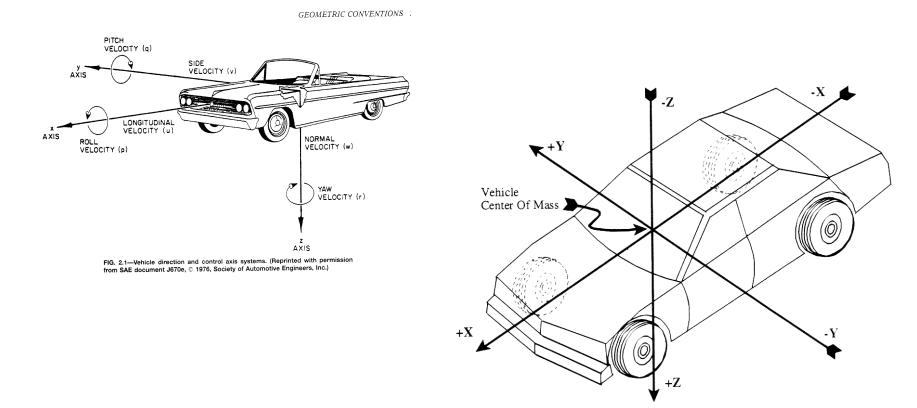
Exhibit A Standard SAE J211, J670e, J1733 signing convention

Base Vehicle with SAE J211/J670e Axes Superimposed

FIG. 2.2—Vehicle axis system with signed SAE J211/J670e directions and labels.

14. Why does Toyota show Longitudinal Delta-V with a sign opposite to the standard SAE J211, J670e, J1733 signing convention? (See Exhibit A)
