CENTER FOR AUTO SAFETY

PETITION

The Center for Auto Safety (CAS) petitions the National Highway Traffic Safety Administration (NHTSA) to initiate a defect investigation into and recall all 1993-2004 Jeep Grand Cherokee with a fuel tank located behind the rear axle. Unlike the earlier Jeep Cherokee, the fuel tank of the Grand Cherokee is plastic and extends below the rear bumper so there is nothing to protect the tank from a direct hit in a rollover or by a vehicle with a low front profile or one lowered by pre-impact braking.

ALLEGED FUEL TANK AND FILLER NECK DAMAGE IN REAR-END
COLLISION OF SUBCOMPACT PASSENGER CARS

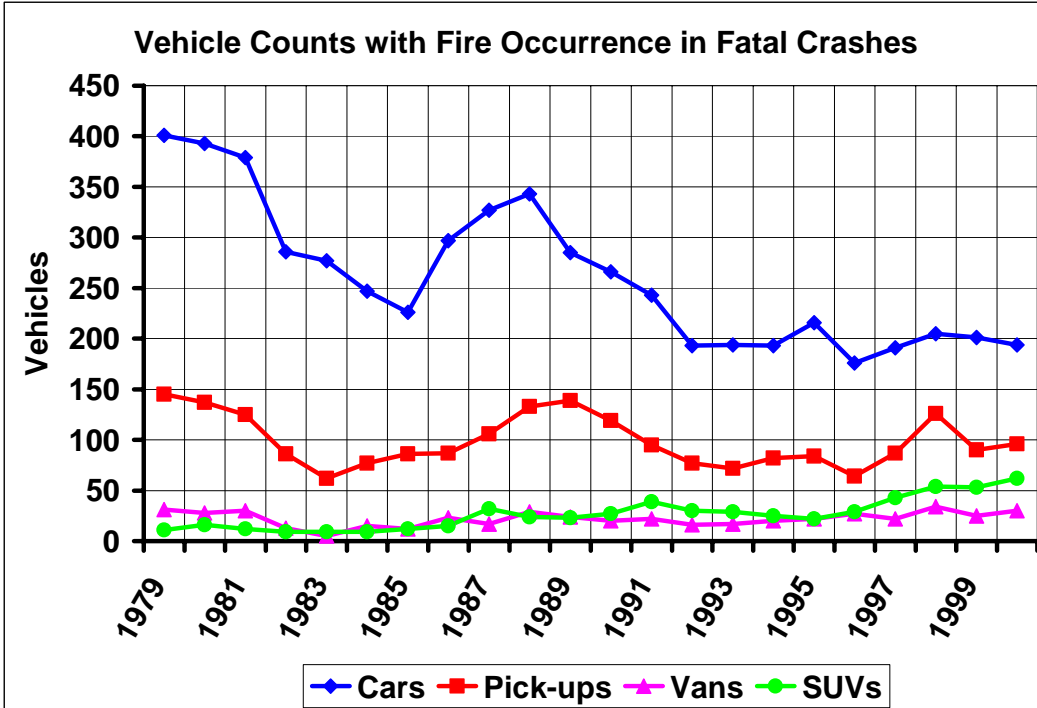
Figure 1 shows the fire occurrence for vehicles 0 to 4 years old at the time they were involved in fatal accidents. To be counted, a fire had to occur in the vehicle after the crash and a fatality had to occur in the crash. The fatality may or may not have been in that particular vehicle or caused by the fire. Figure 2 displays the same data adjusted for vehicle exposure. The exposure metric used in the figure is the number of registered vehicle years by vehicle class, given as million vehicle years or MVY.

Figure 1. Frequency counts of vehicles involved in fatal crashes where a fire occurred in that particular vehicle (fatality did not necessarily occur in the vehicle with the fire). Data is from FARS 1979-2000, vehicle age is 0-4 years, and distributions are by vehicle type.

This study looks at vehicles of age 0-4 years; therefore, FARS year 2000 includes models years 1996-2000. A significant occurrence took place during model year 1976 with the introduction of the FMVSS 301 standard for fuel system integrity. Based on data in these figures, FARS year 1981 would be the first year with all vehicles FMVSS 301 compliant.

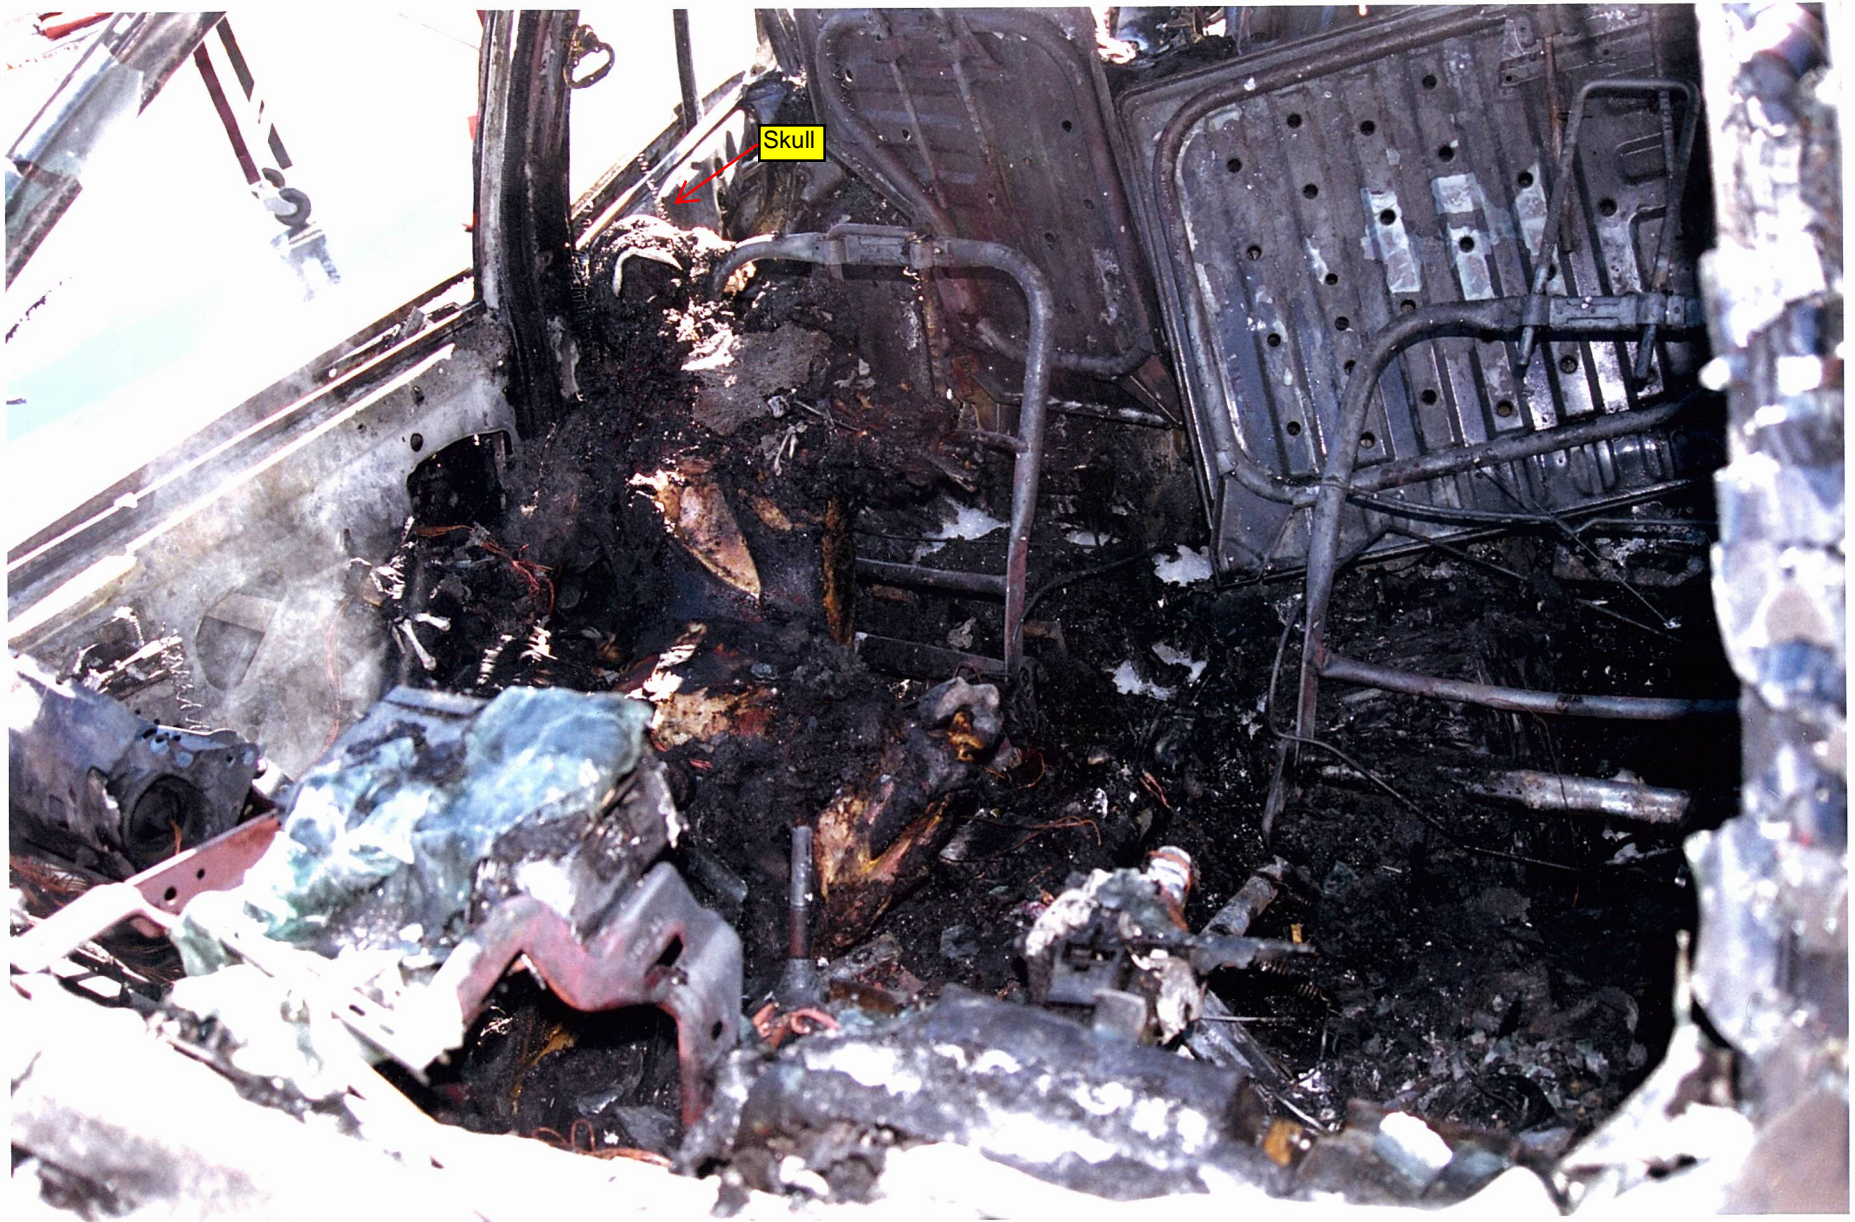
Mrs. Susan Kline (death victim).
Post fuel-fed fire caused by defective fuel system/tank
design in Jeep Grand Cherokee SUVs
