Milwaukee Ford Windstar Rear Axle Beam Corrosion Failure

Presentation to ODI
Management and
NCC 07/27/2010

PE10-016

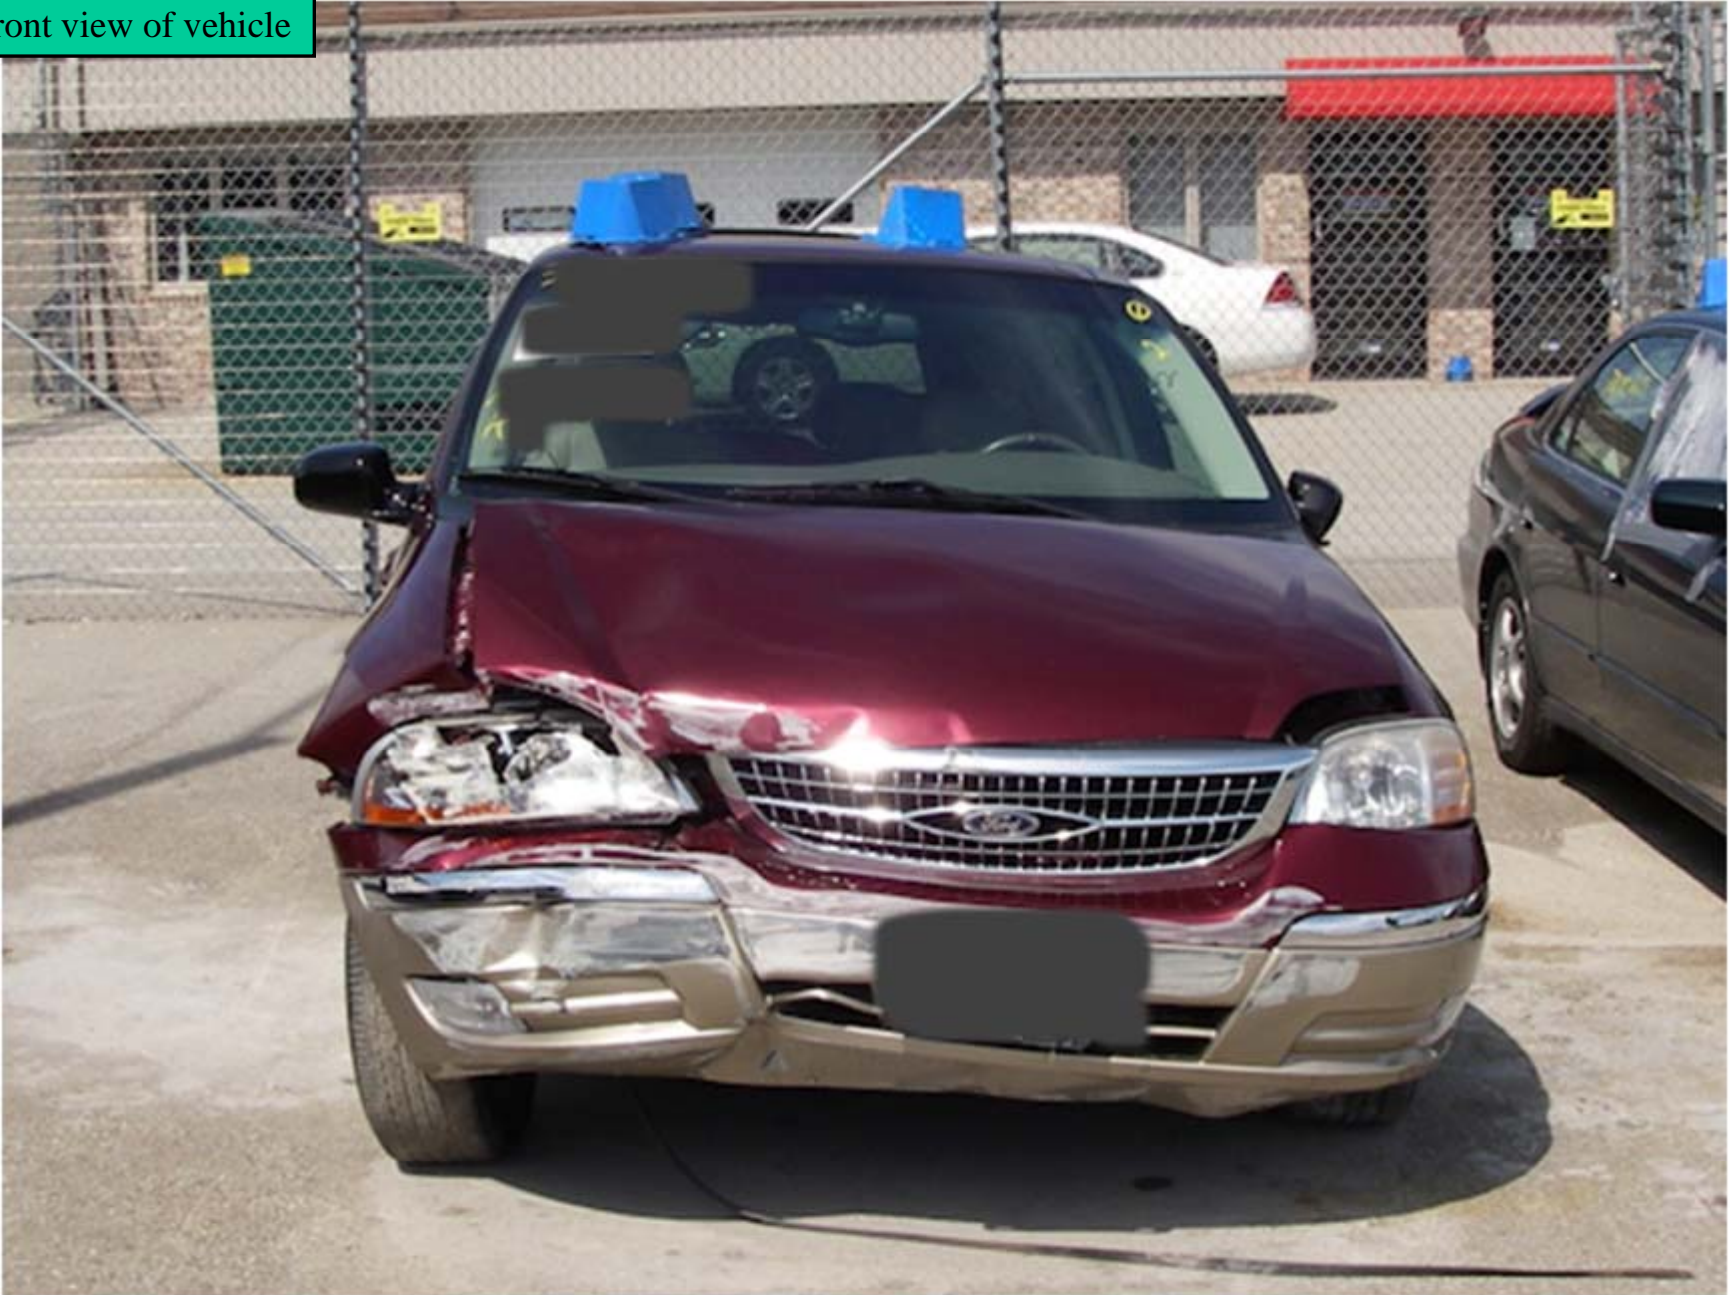
Front view of vehicle

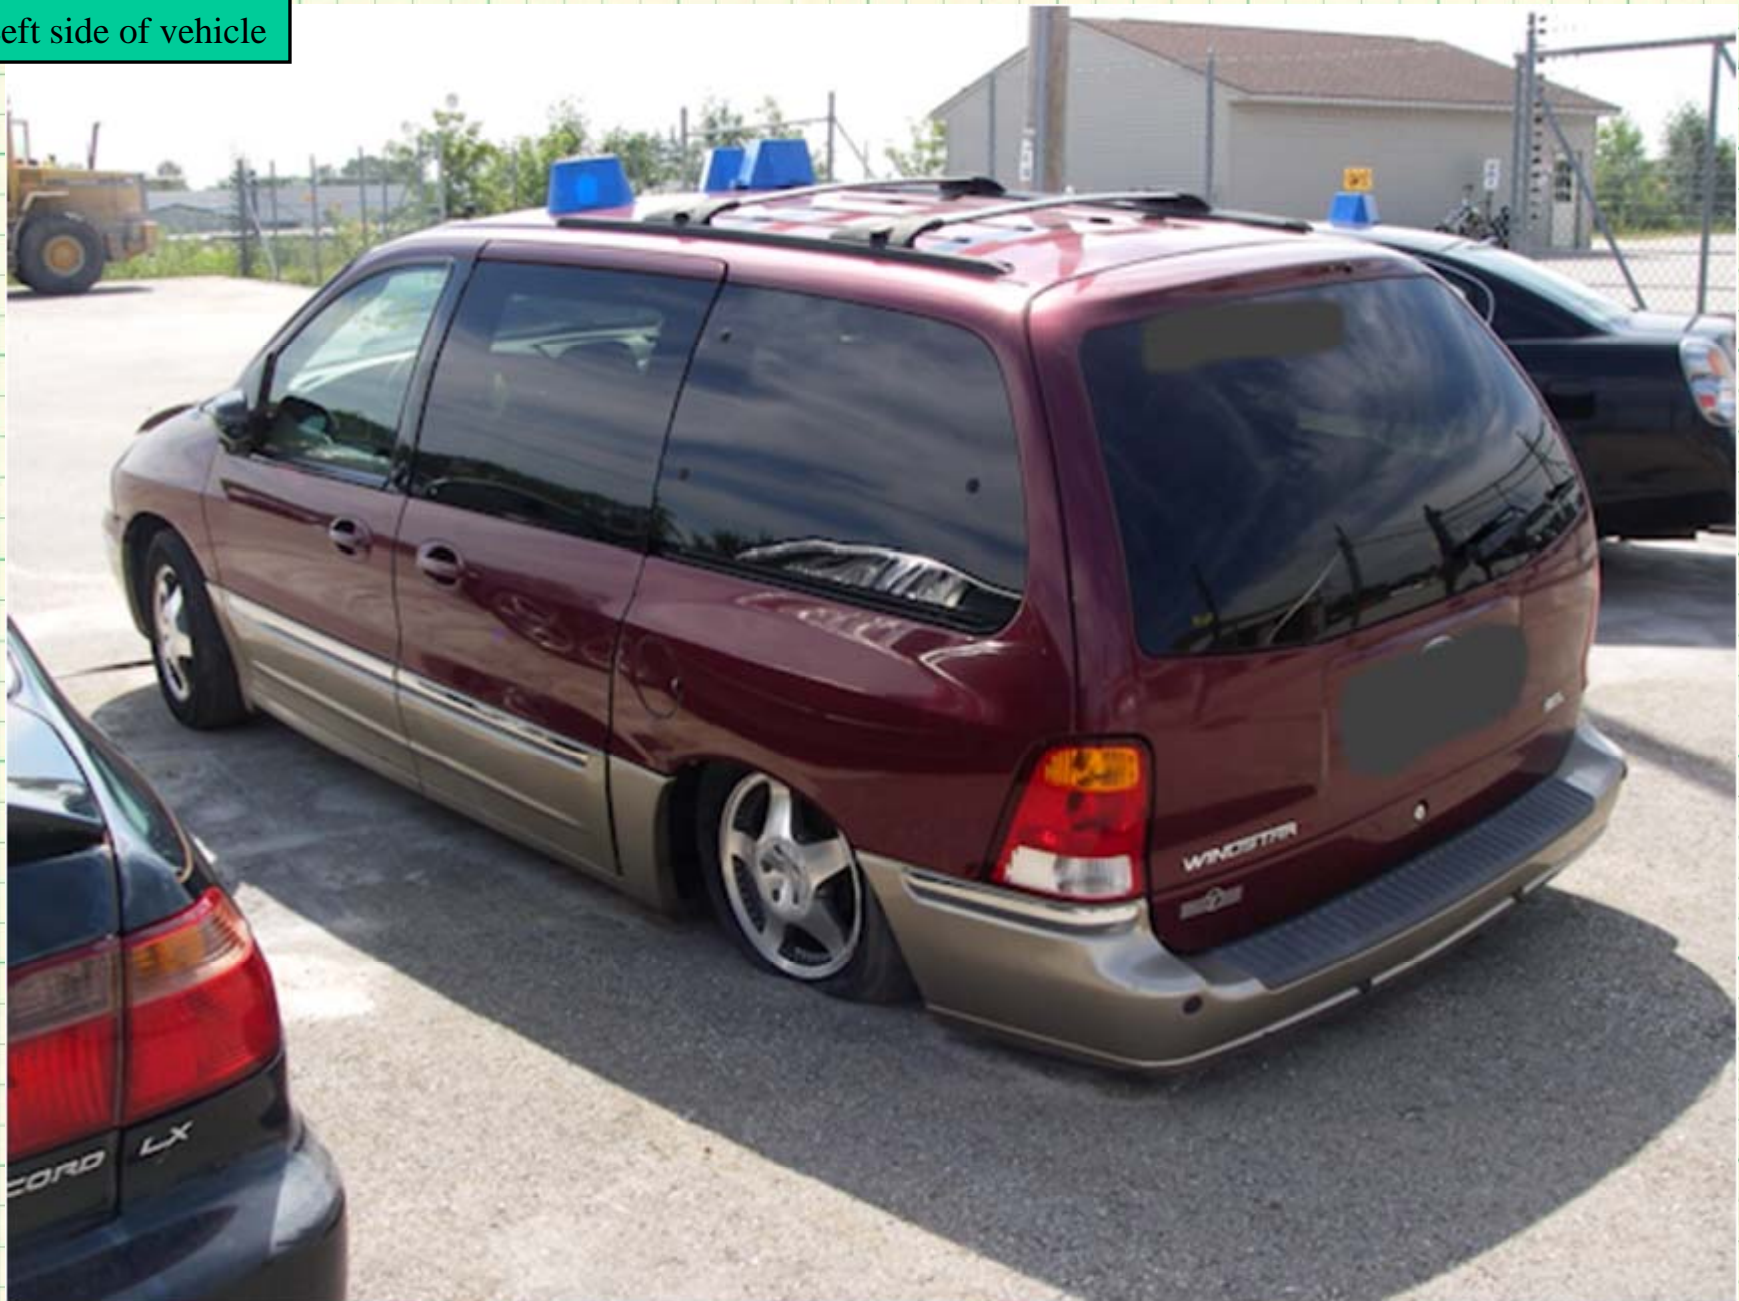
Left side of vehicle

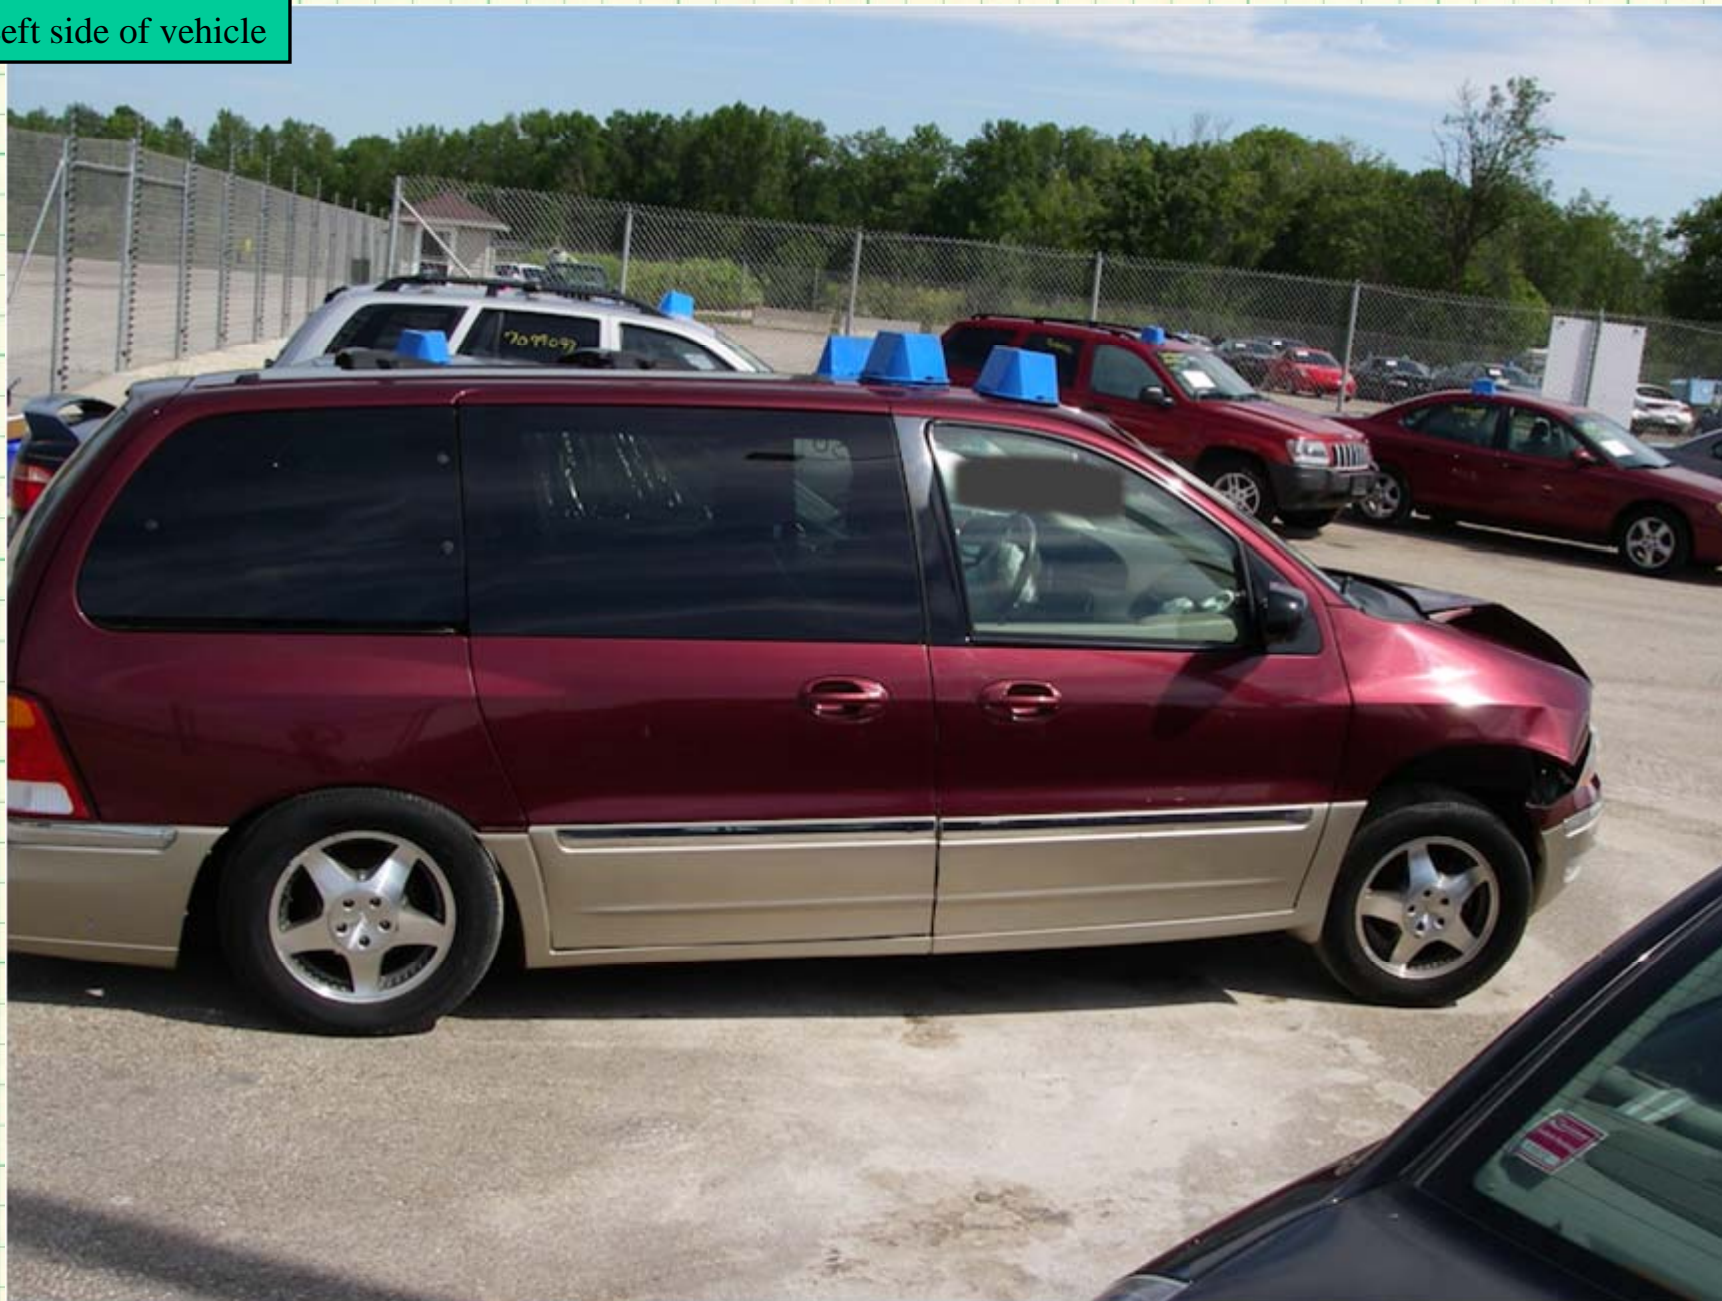
Left side of vehicle

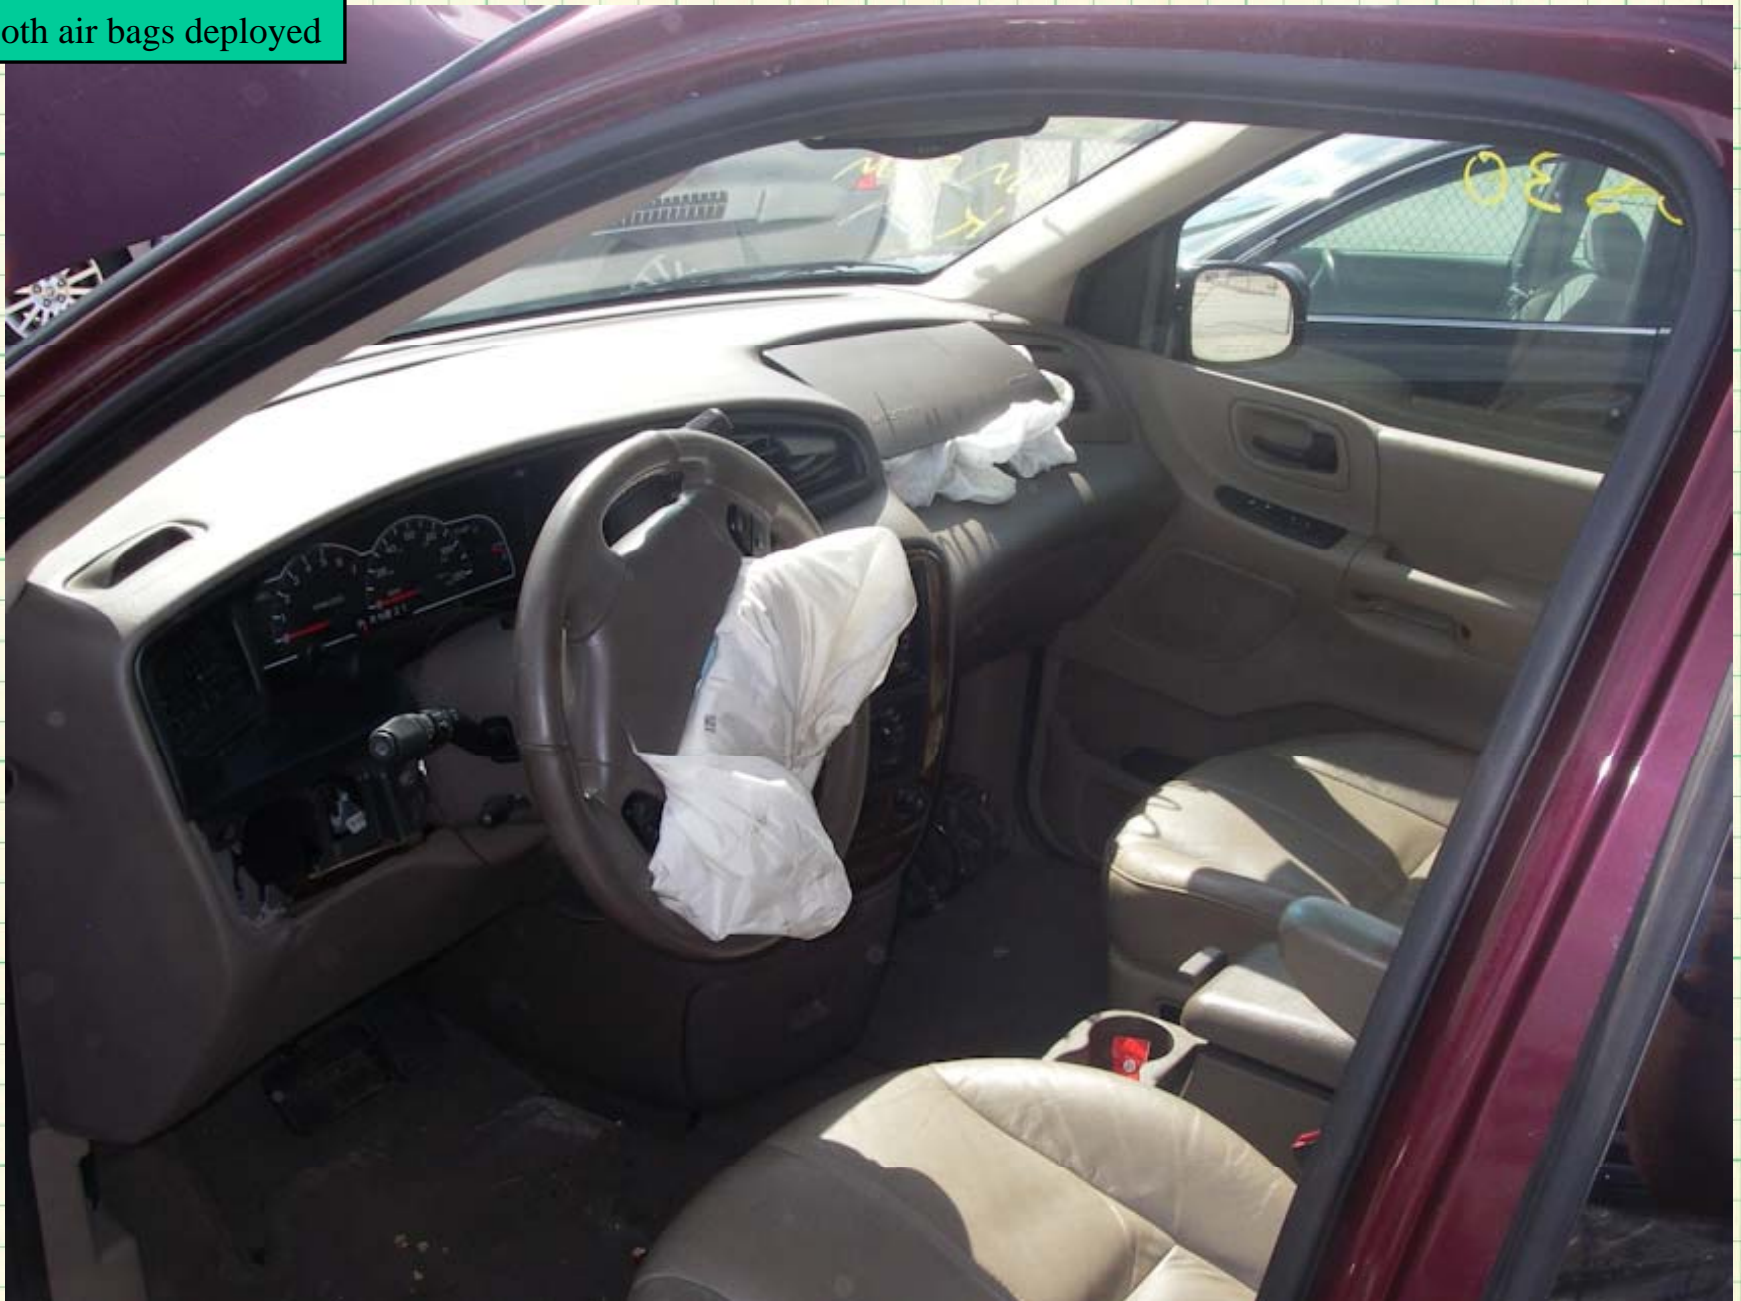
Both air bags deployed

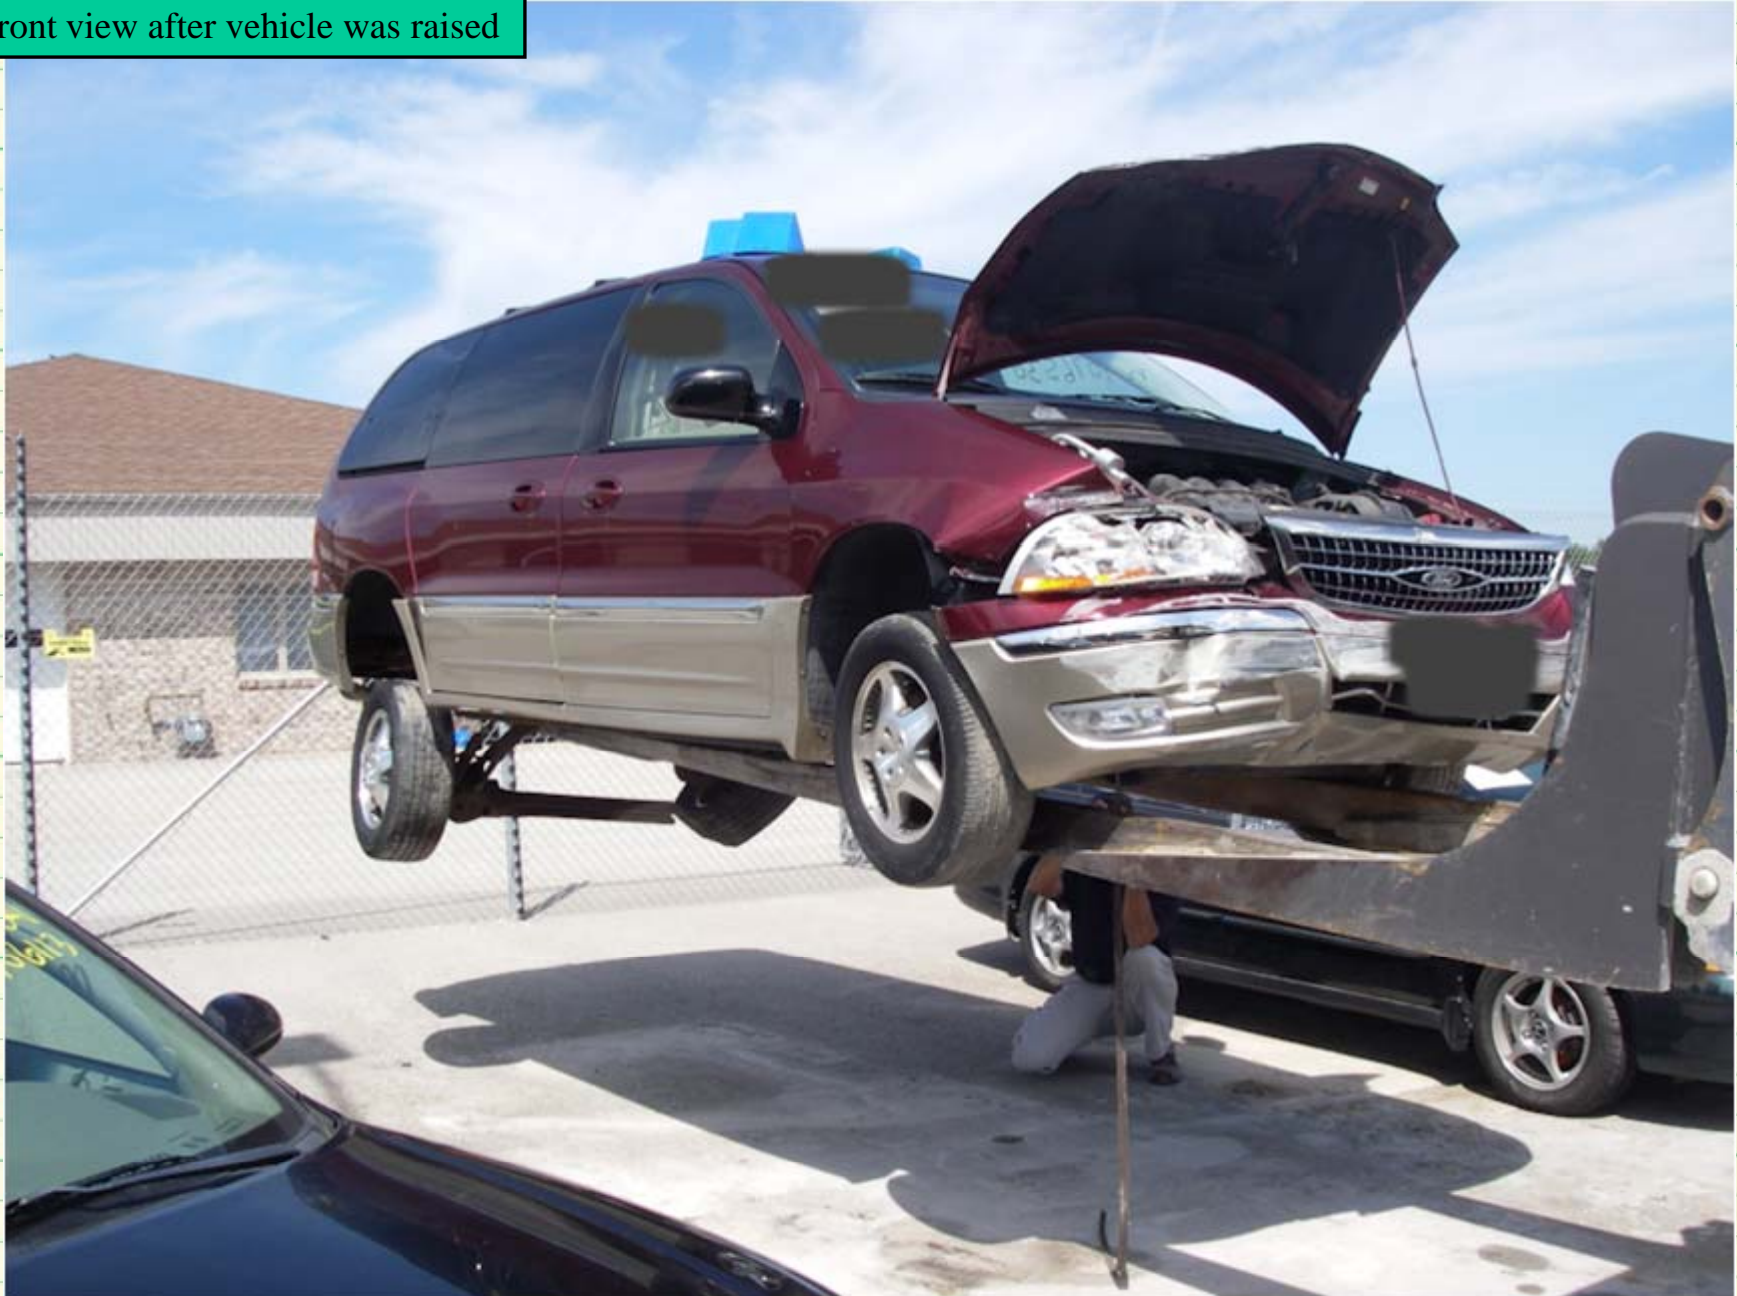
Front view after vehicle was raised

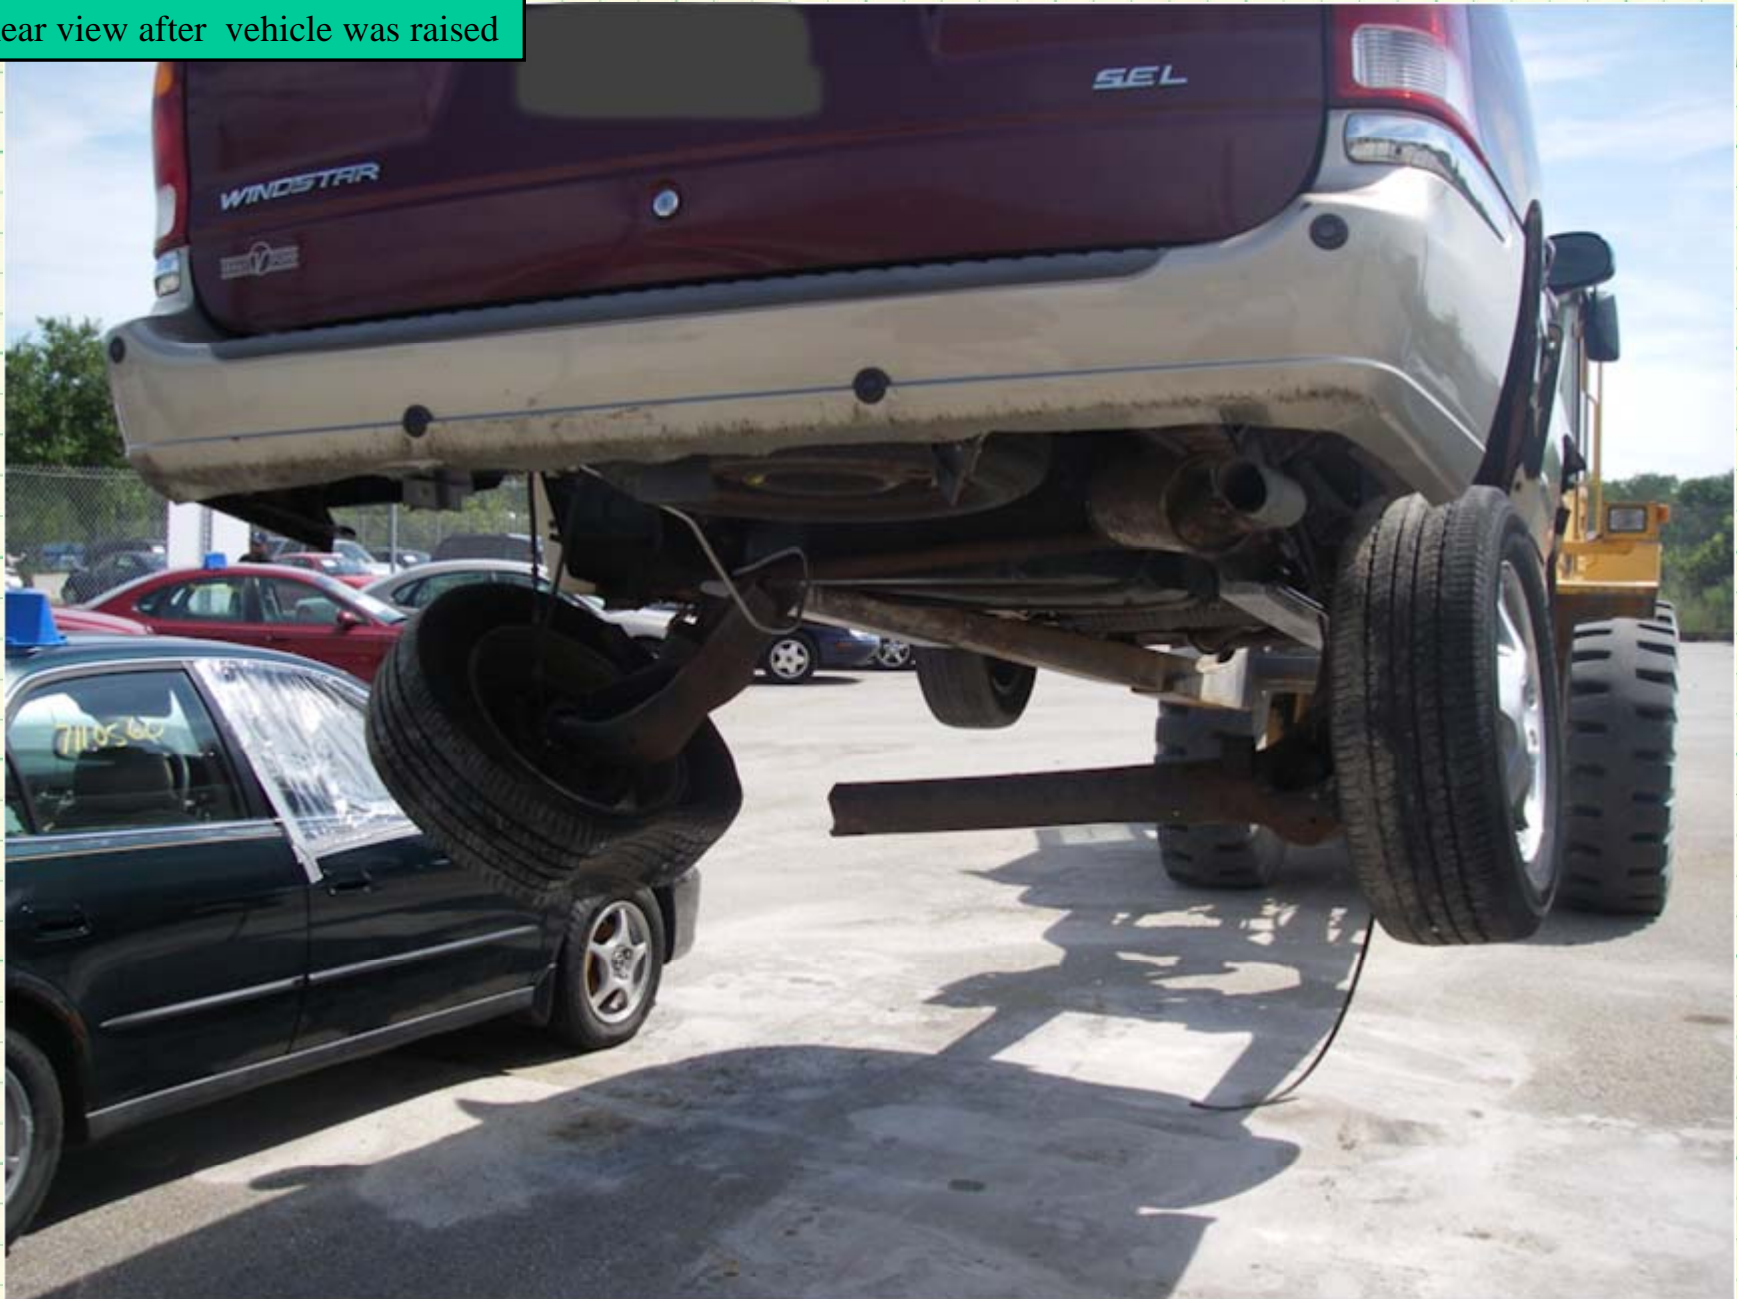
Rear view after vehicle was raised

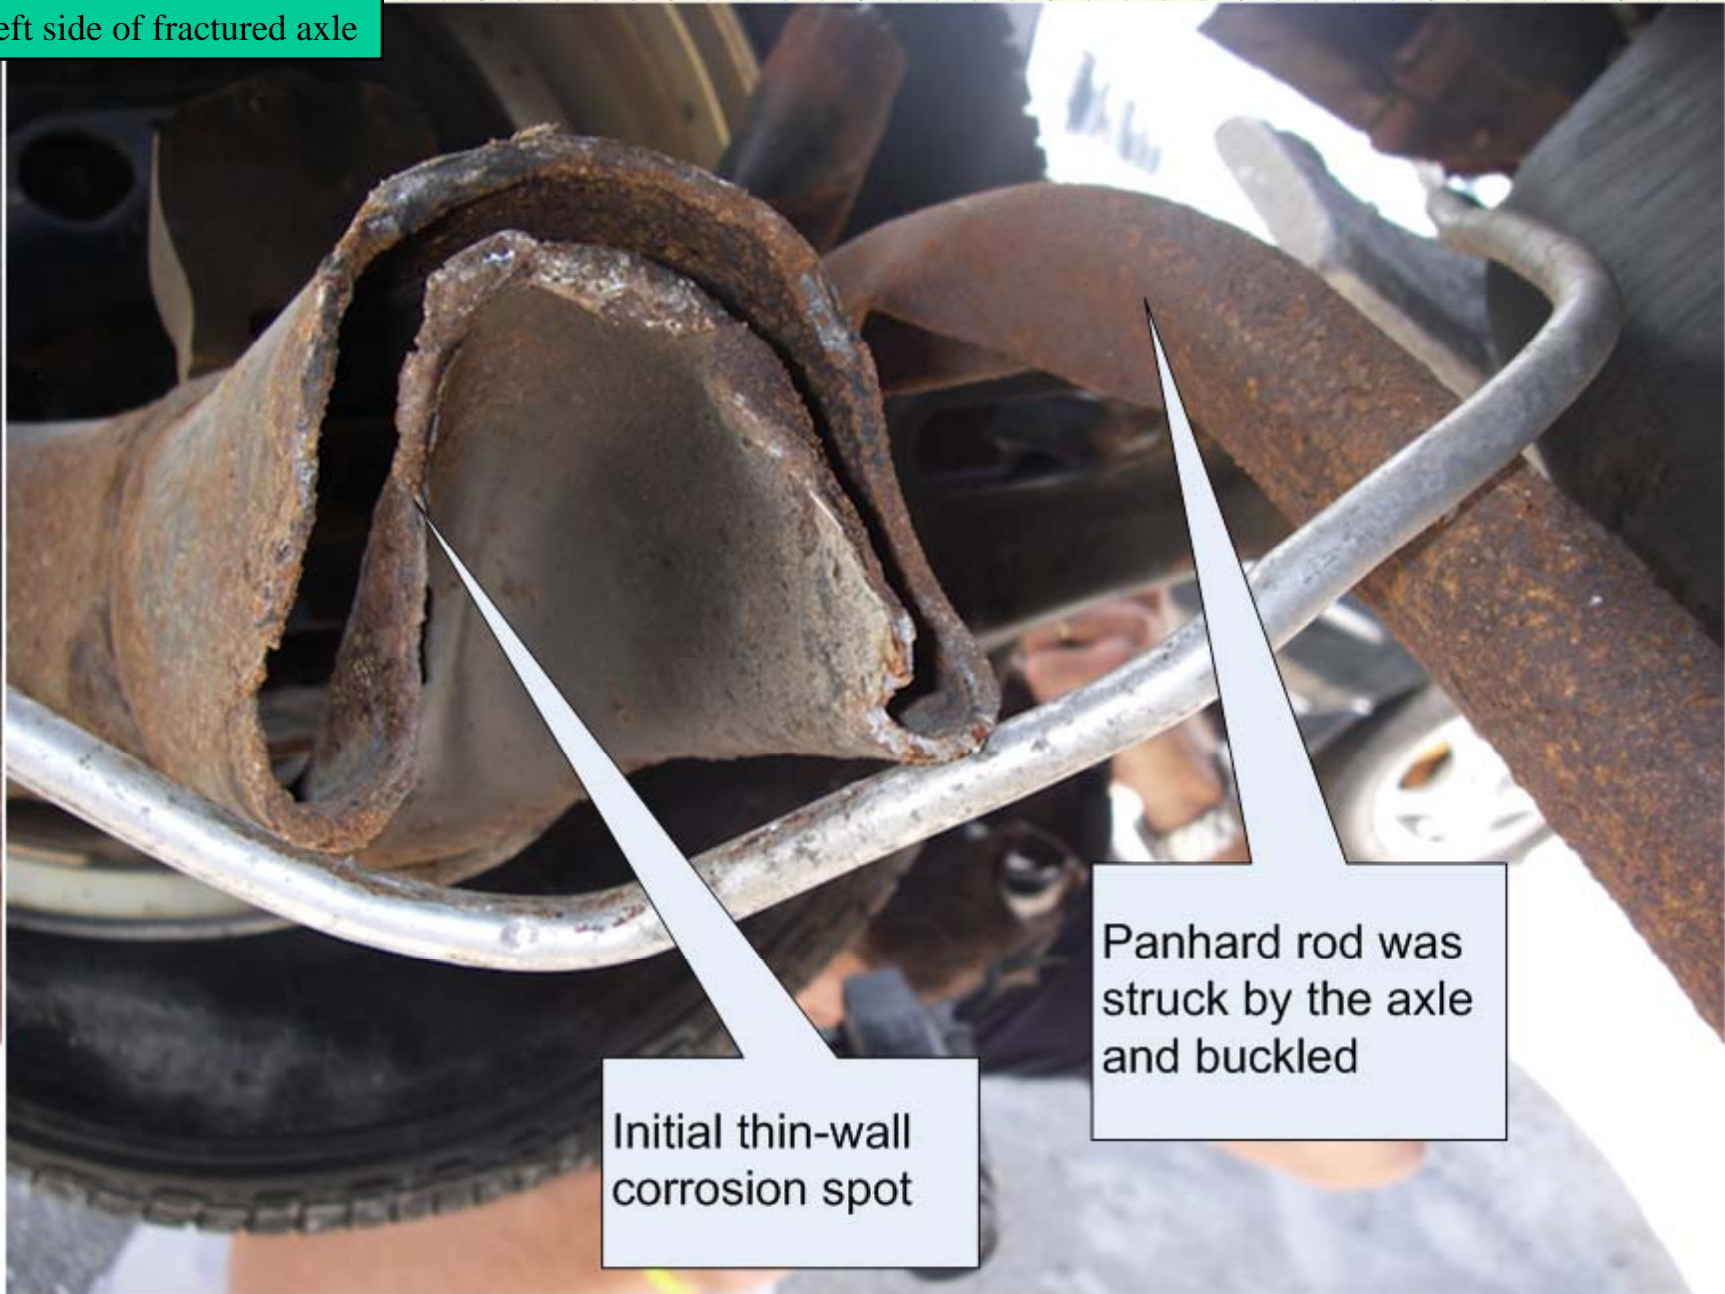
Left side of fractured axle

Initial thin-wall
corrosion spot

Panhard rod was
struck by the axle
and buckled

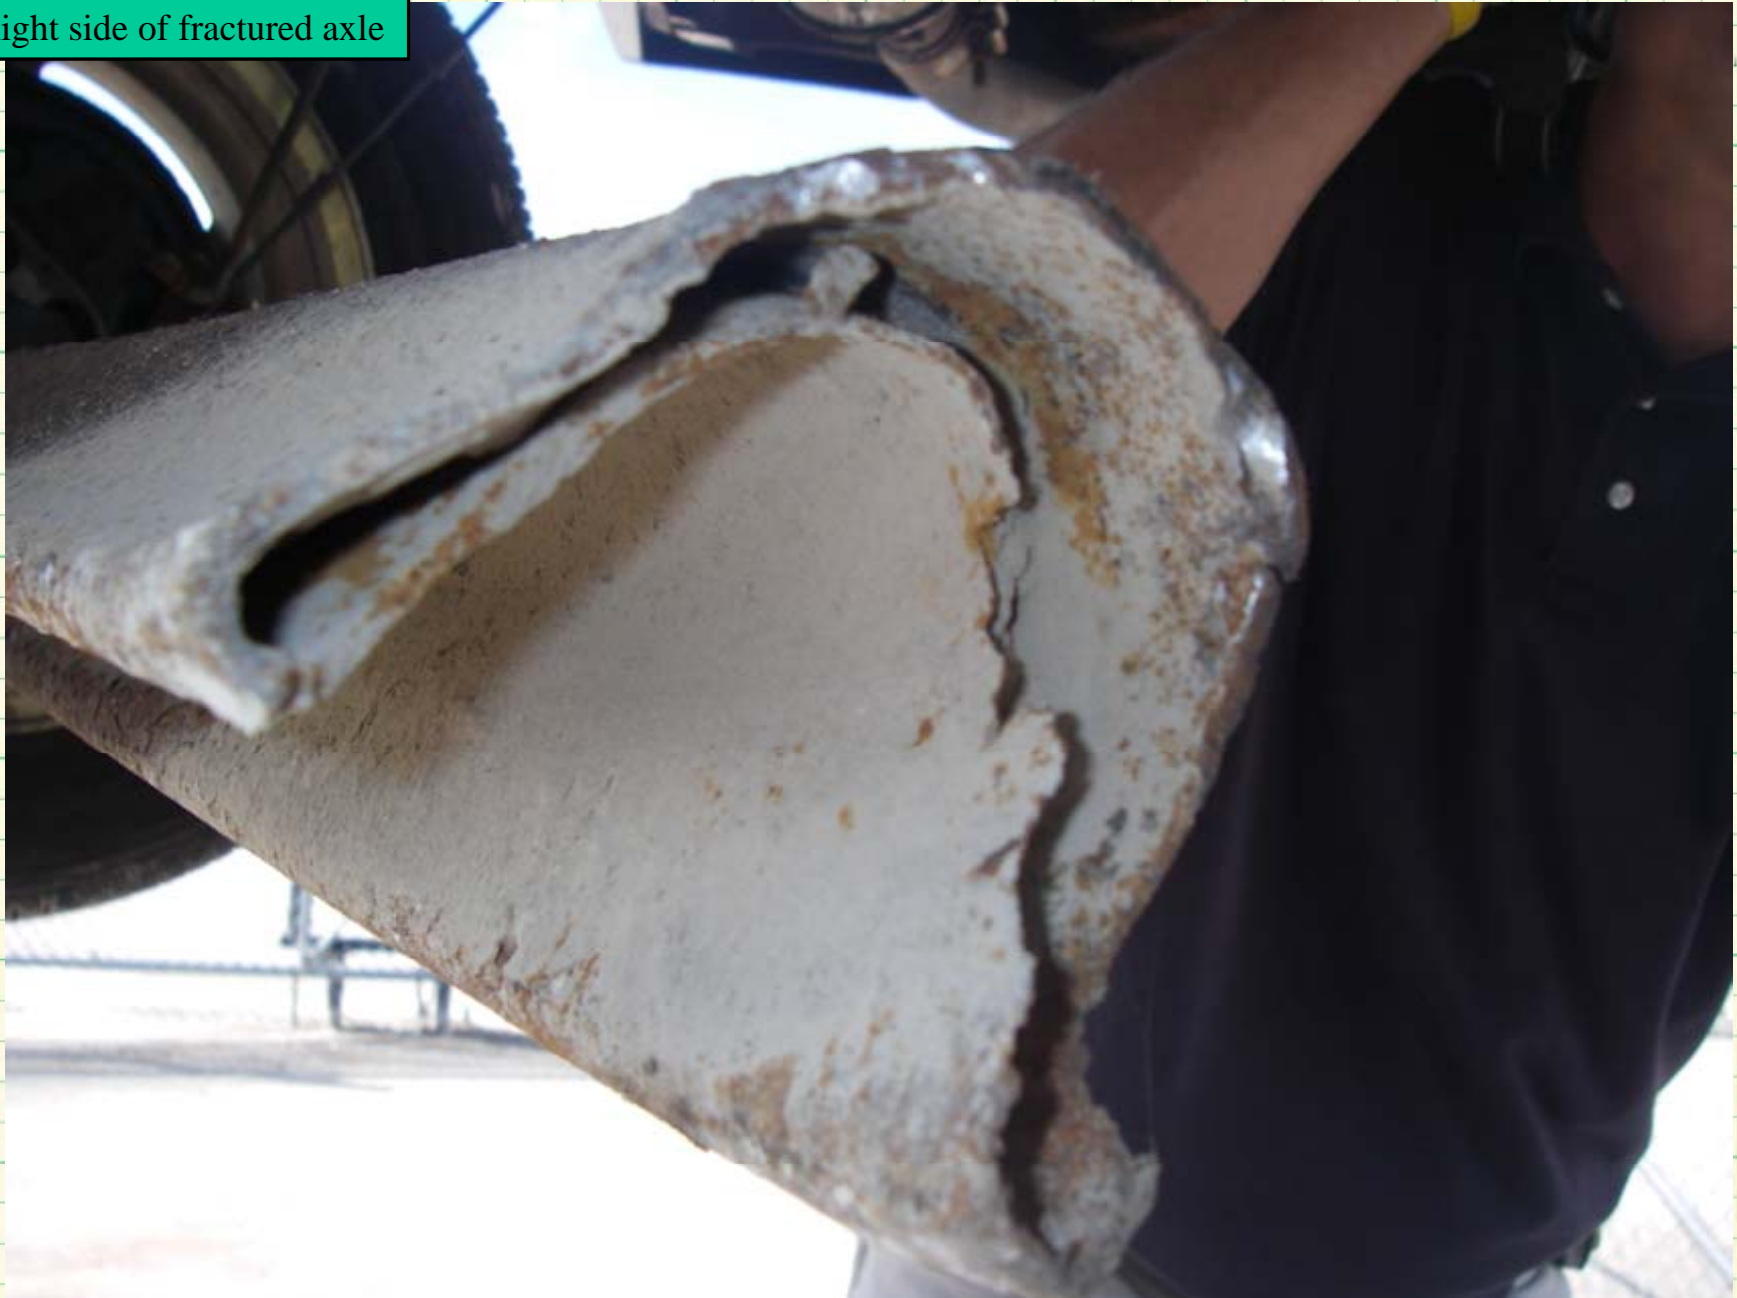
Right side of fractured axle

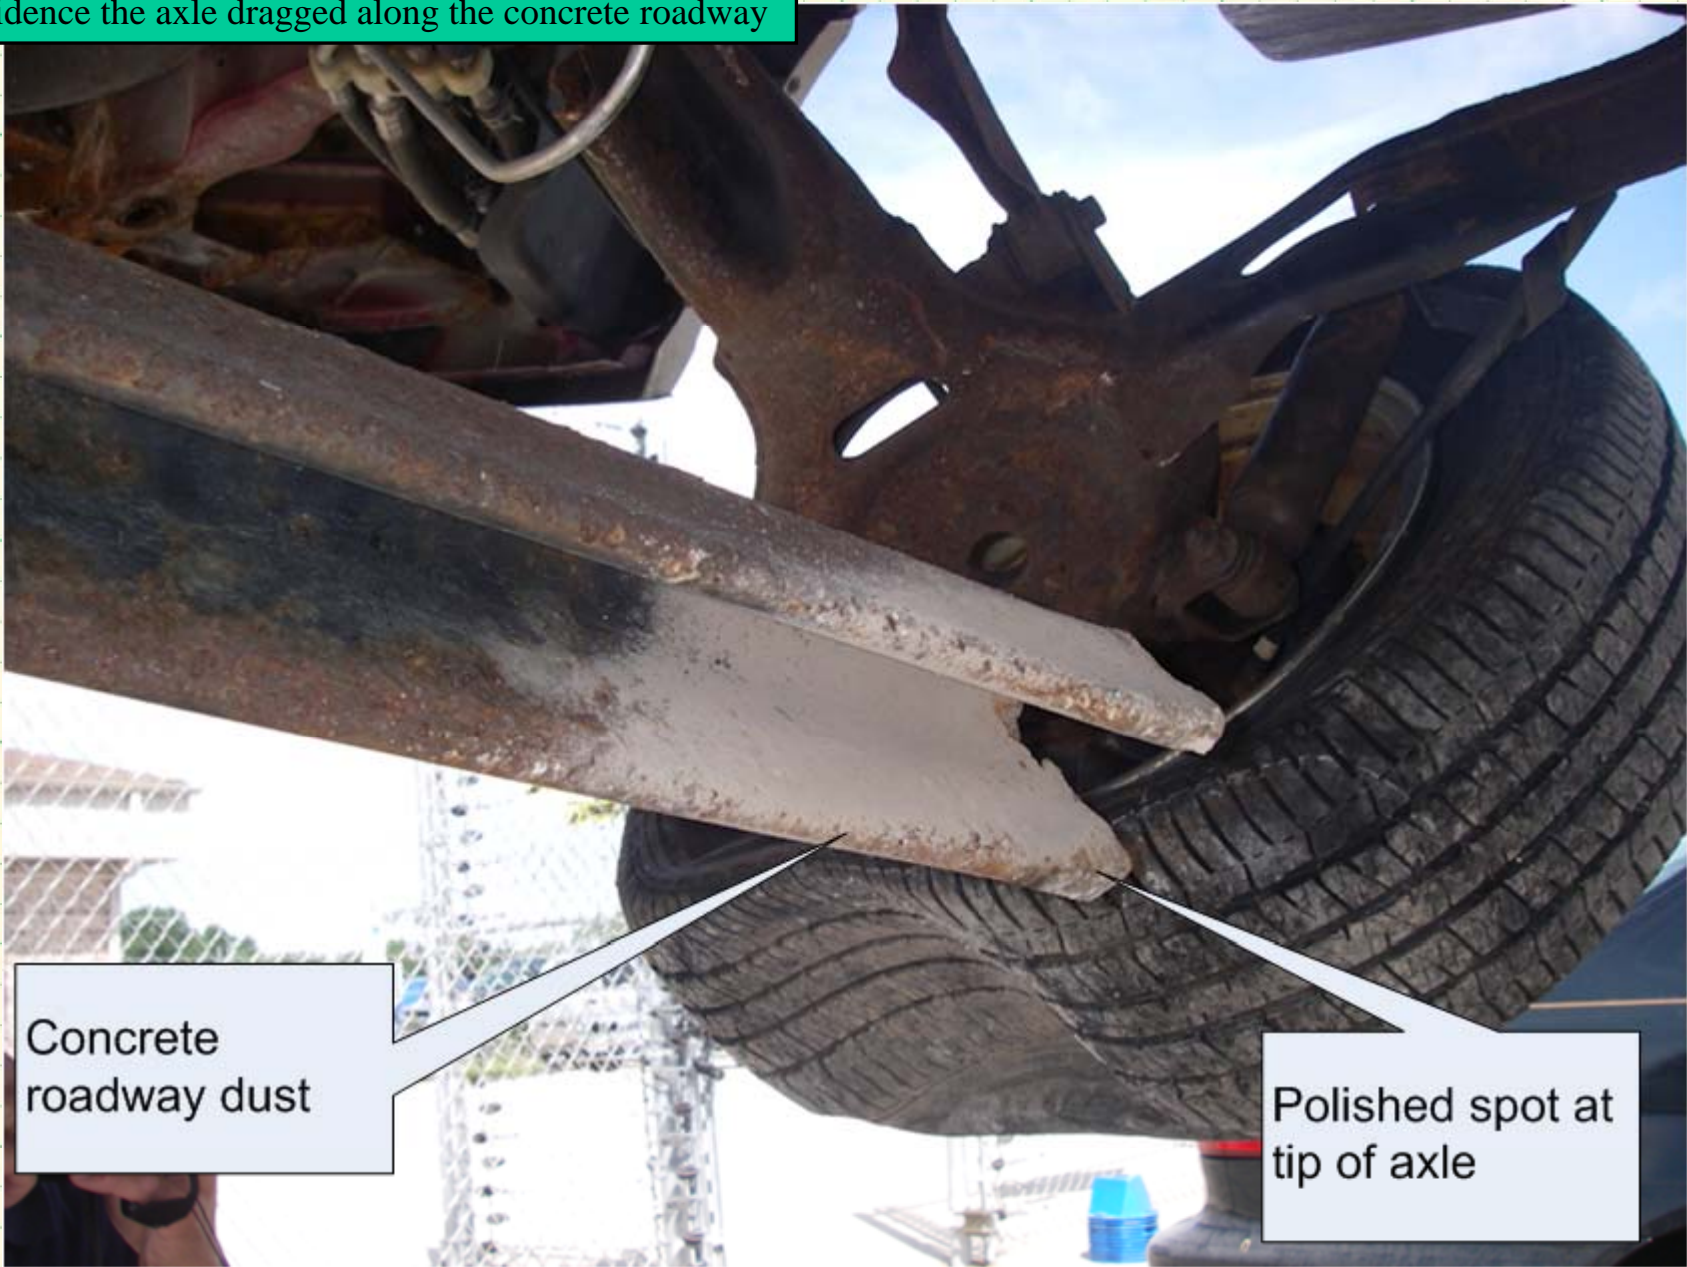
Evidence the axle dragged along the concrete roadway

Concrete roadway dust

Polished spot at tip of axle

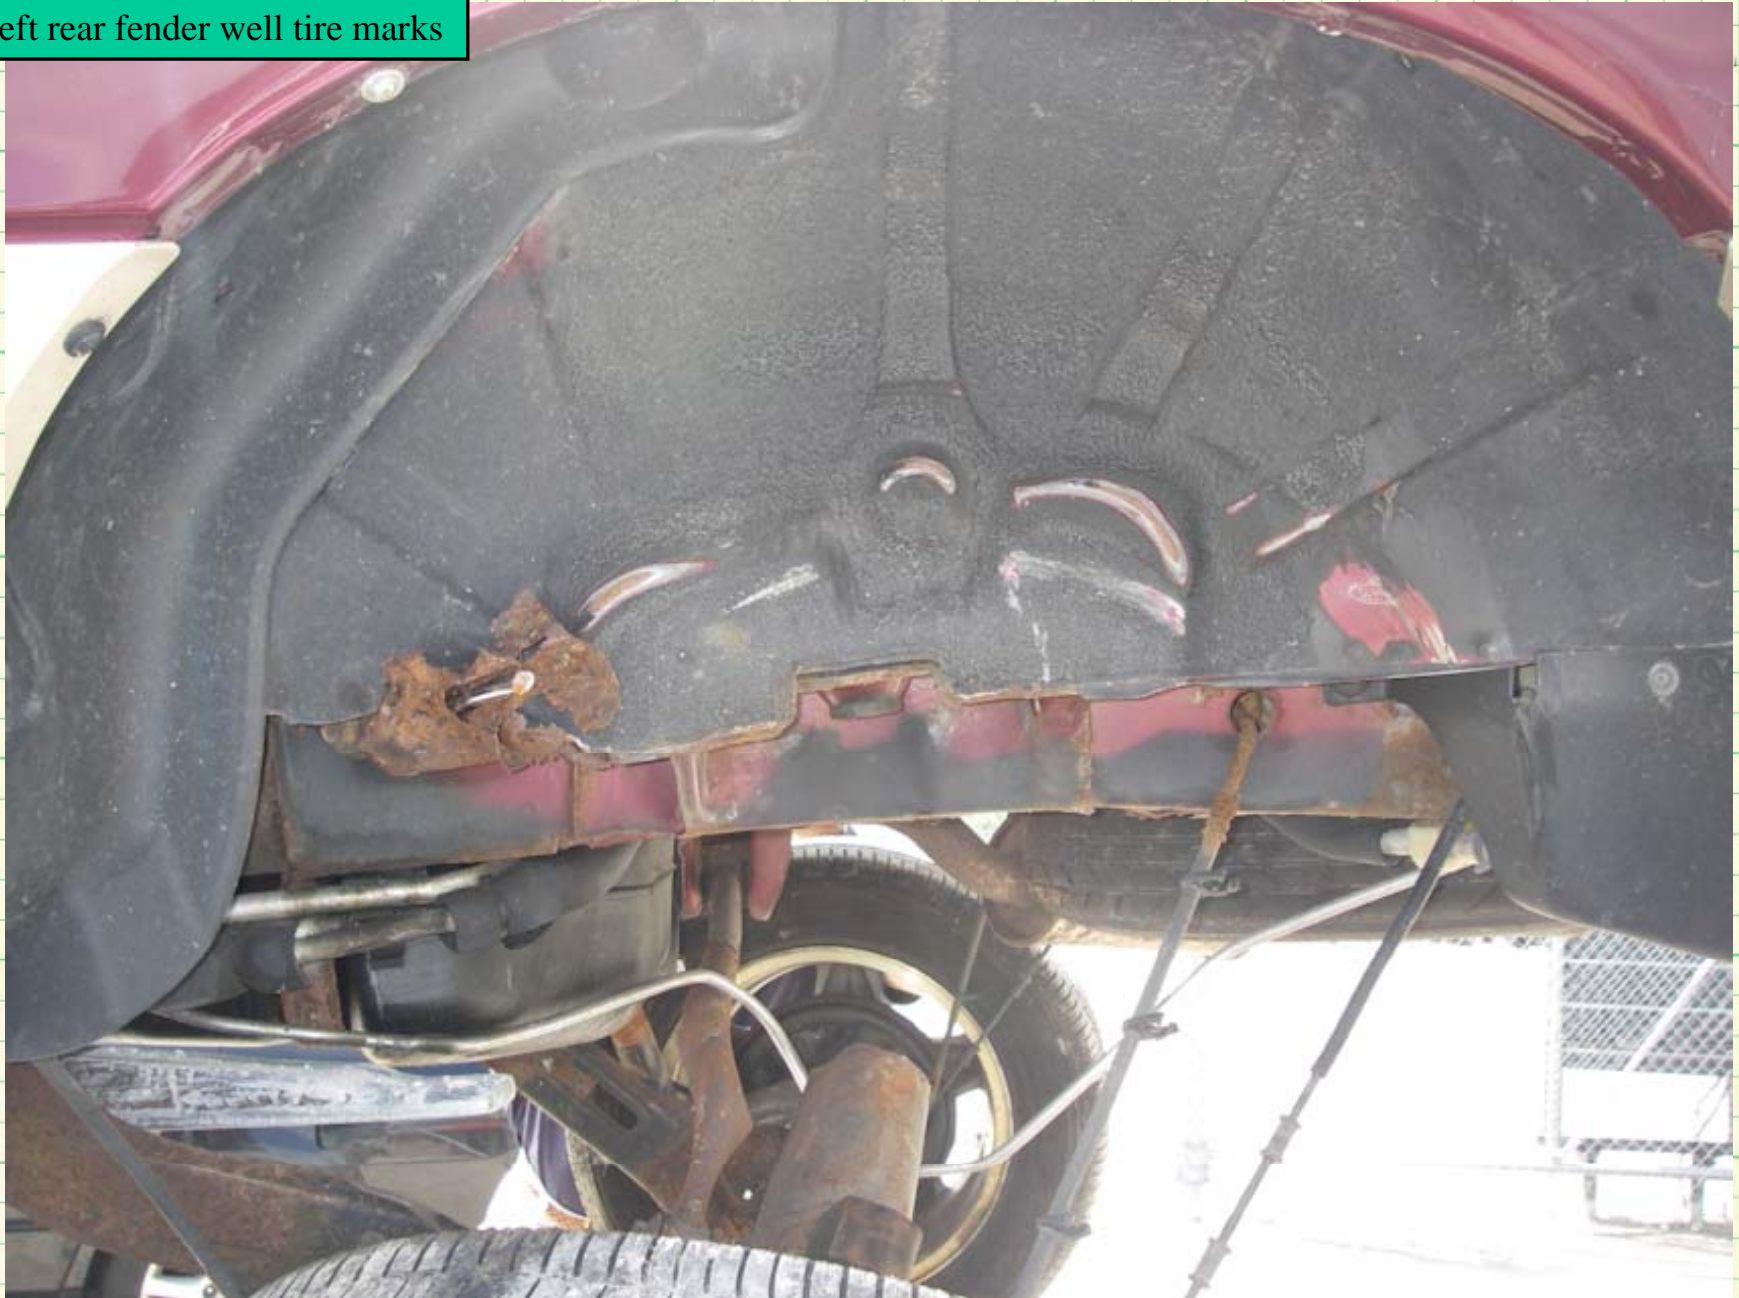
Left rear fender well tire marks
