Milwaukee Ford Windstar Rear Axle Beam Corrosion Failure

Presentation to ODI
Management and
NCC 07/27/2010

PE10-016

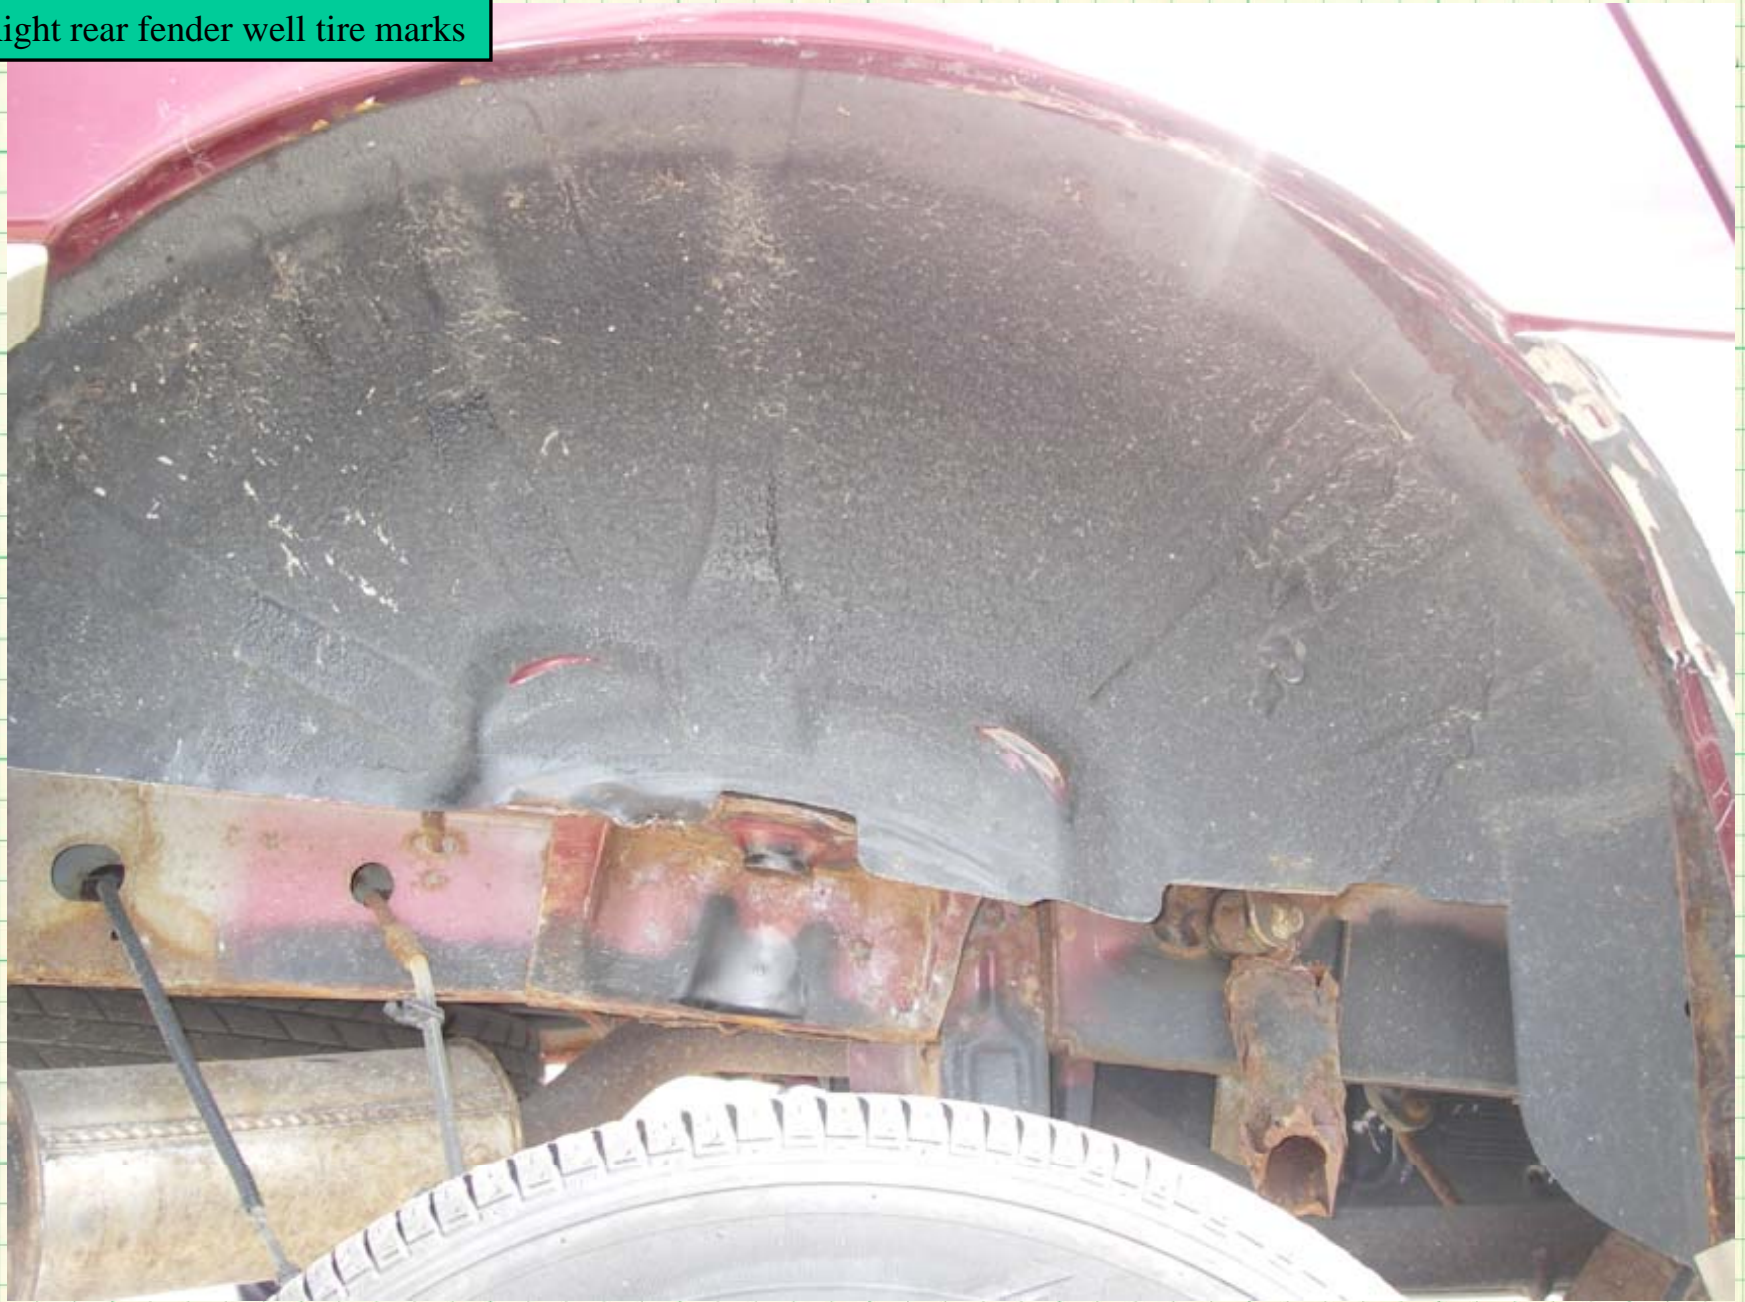
Right rear fender well tire marks

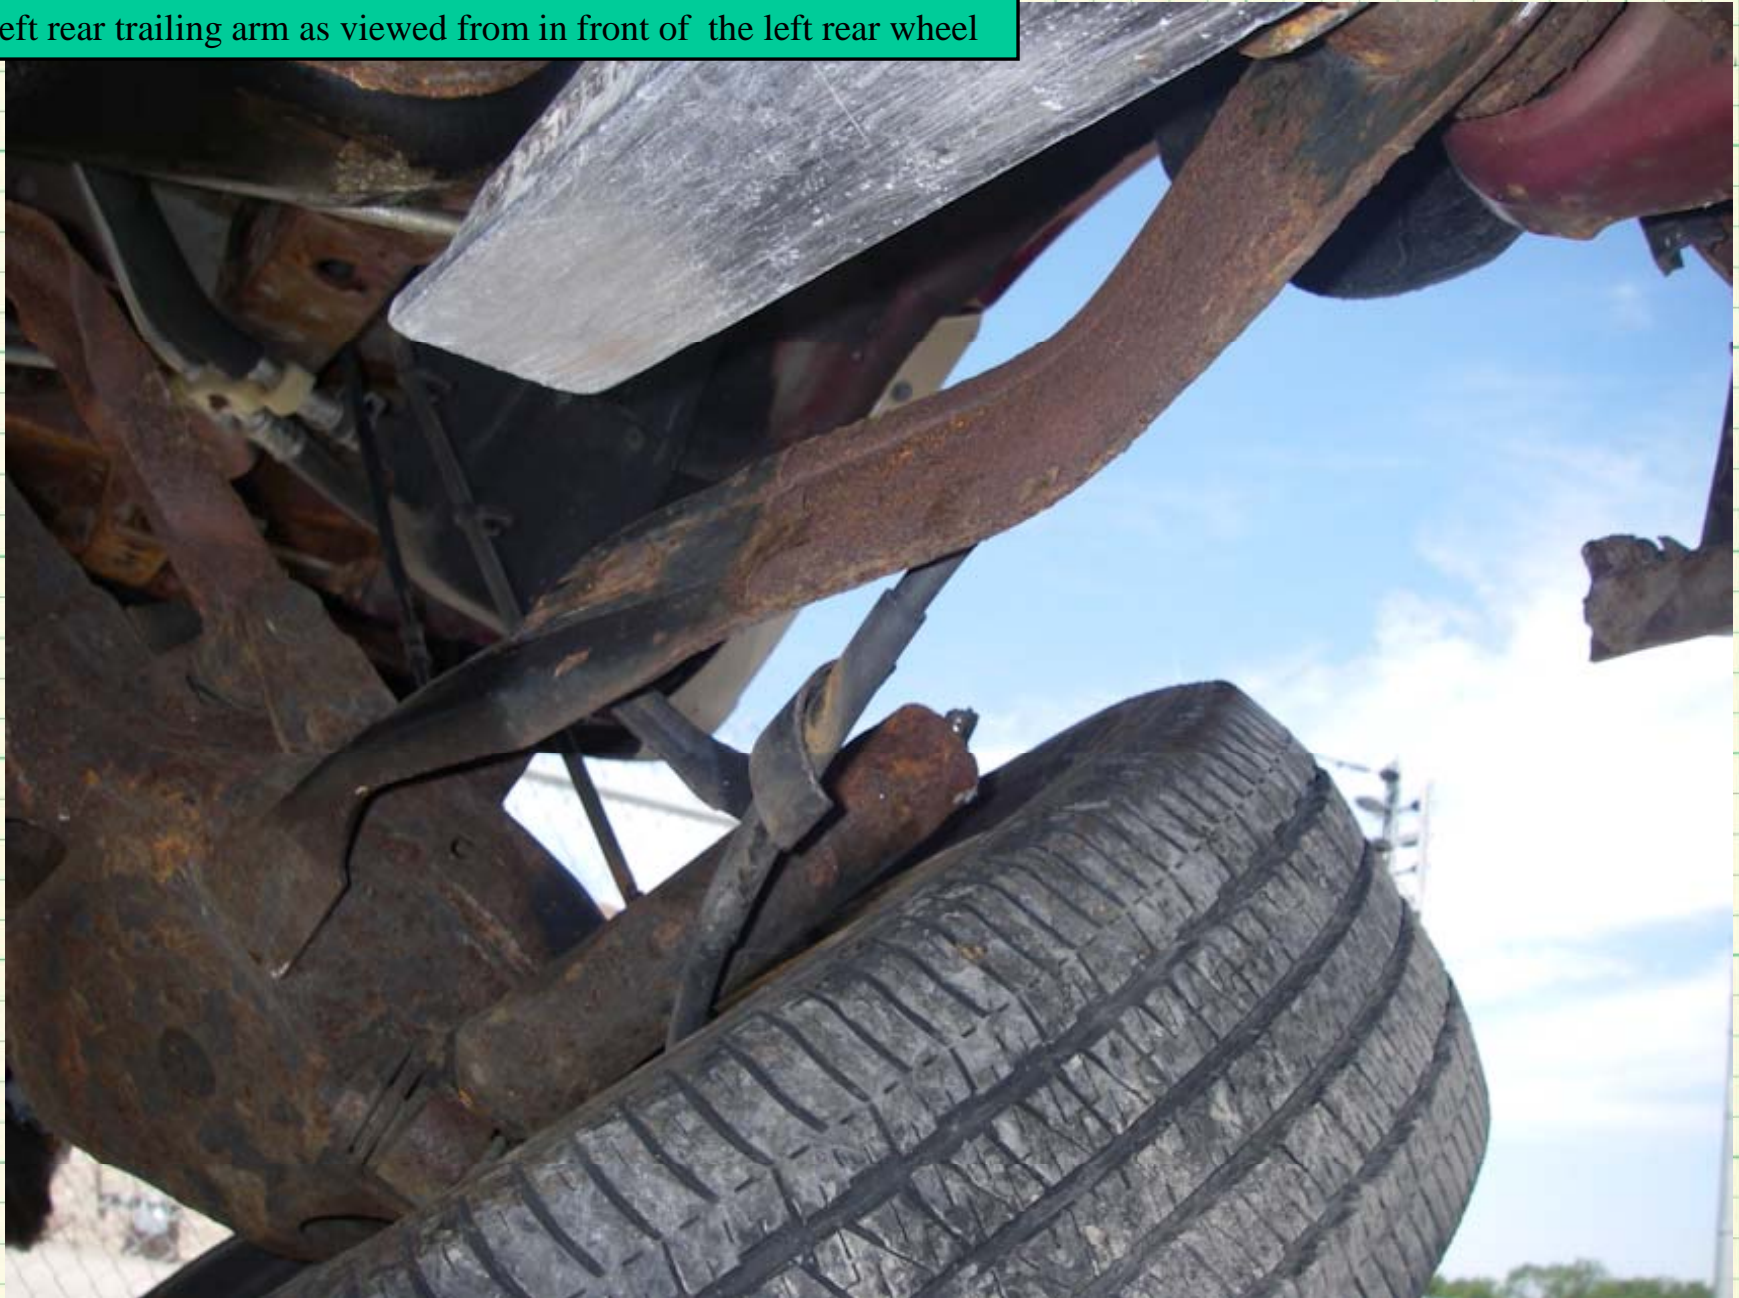
Left rear trailing arm as viewed from in front of the left rear wheel

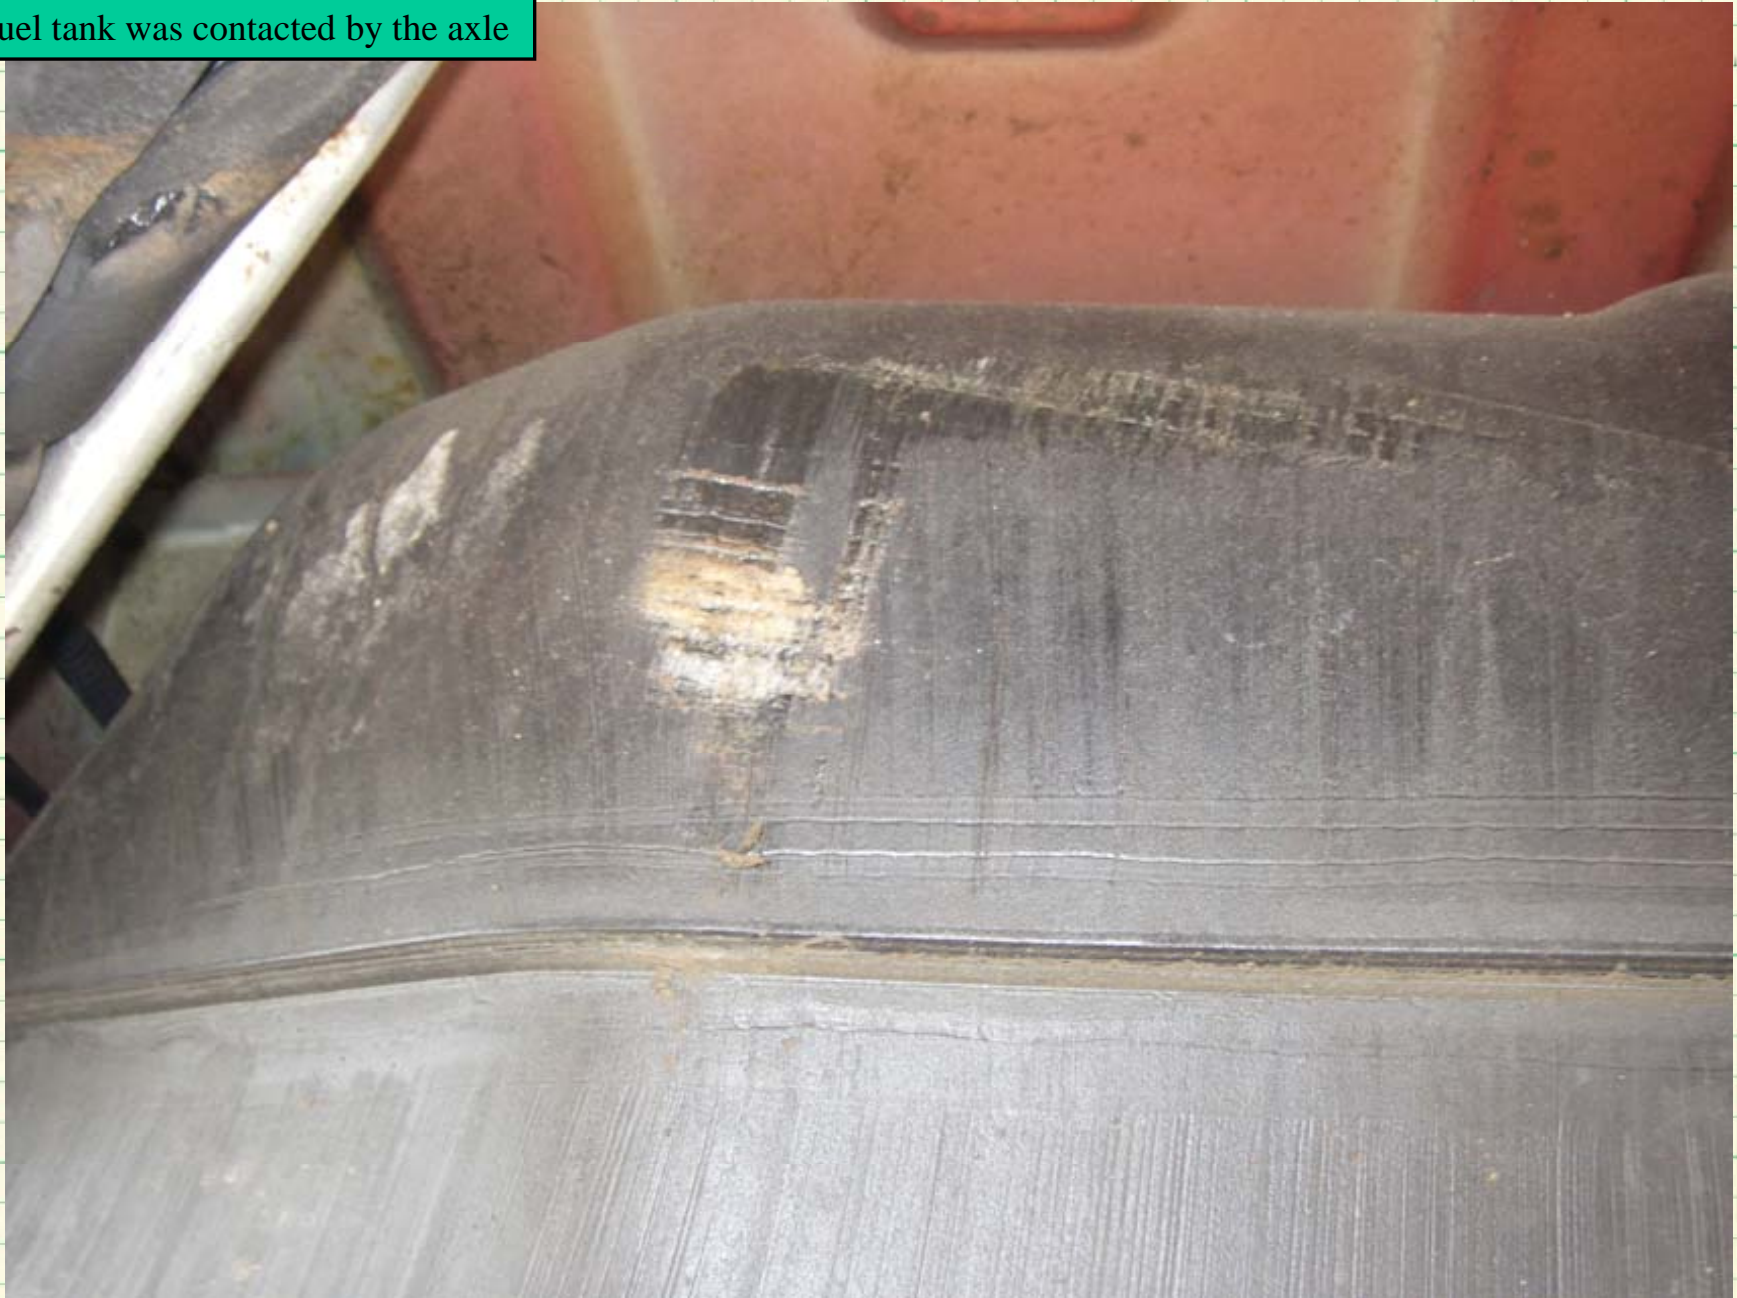
Fuel tank was contacted by the axle

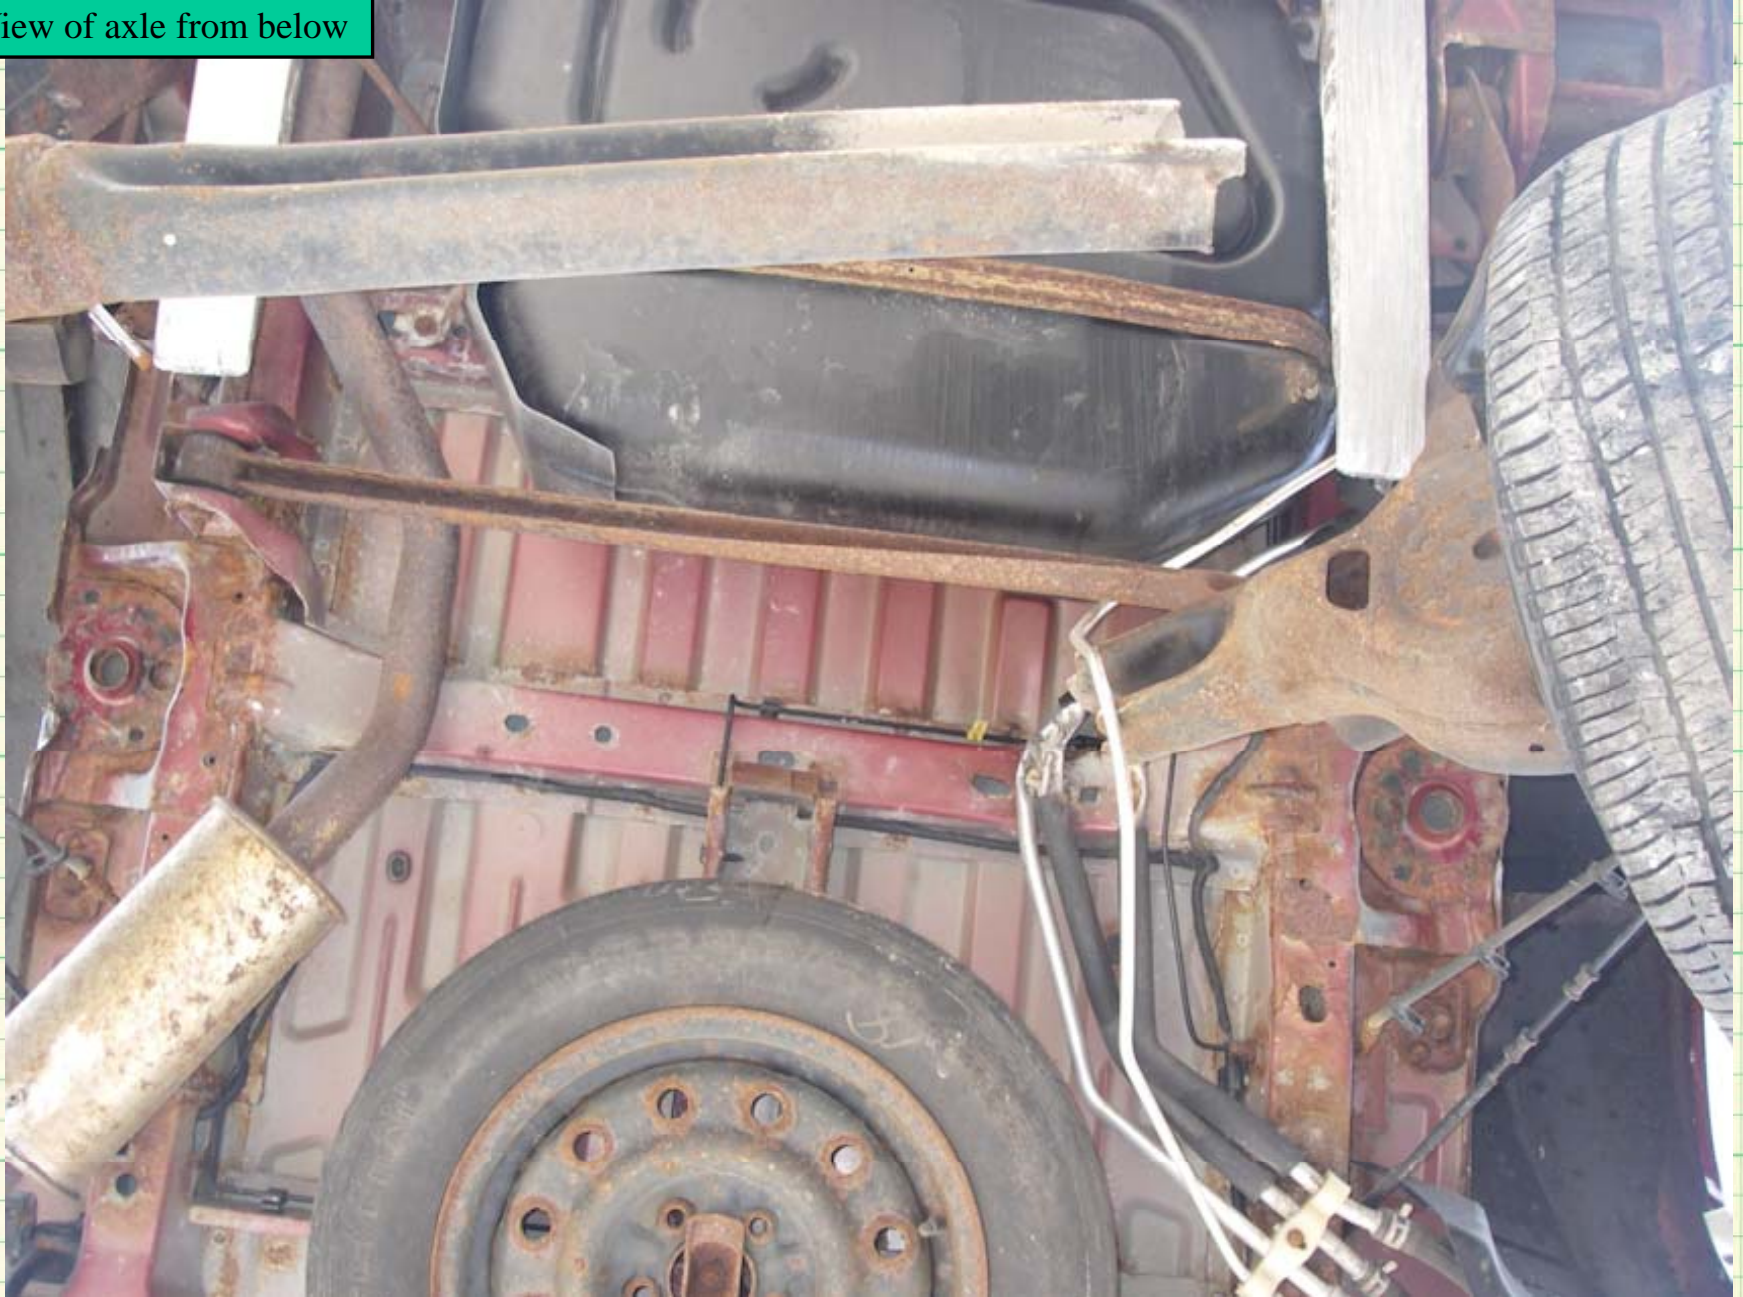
View of axle from below

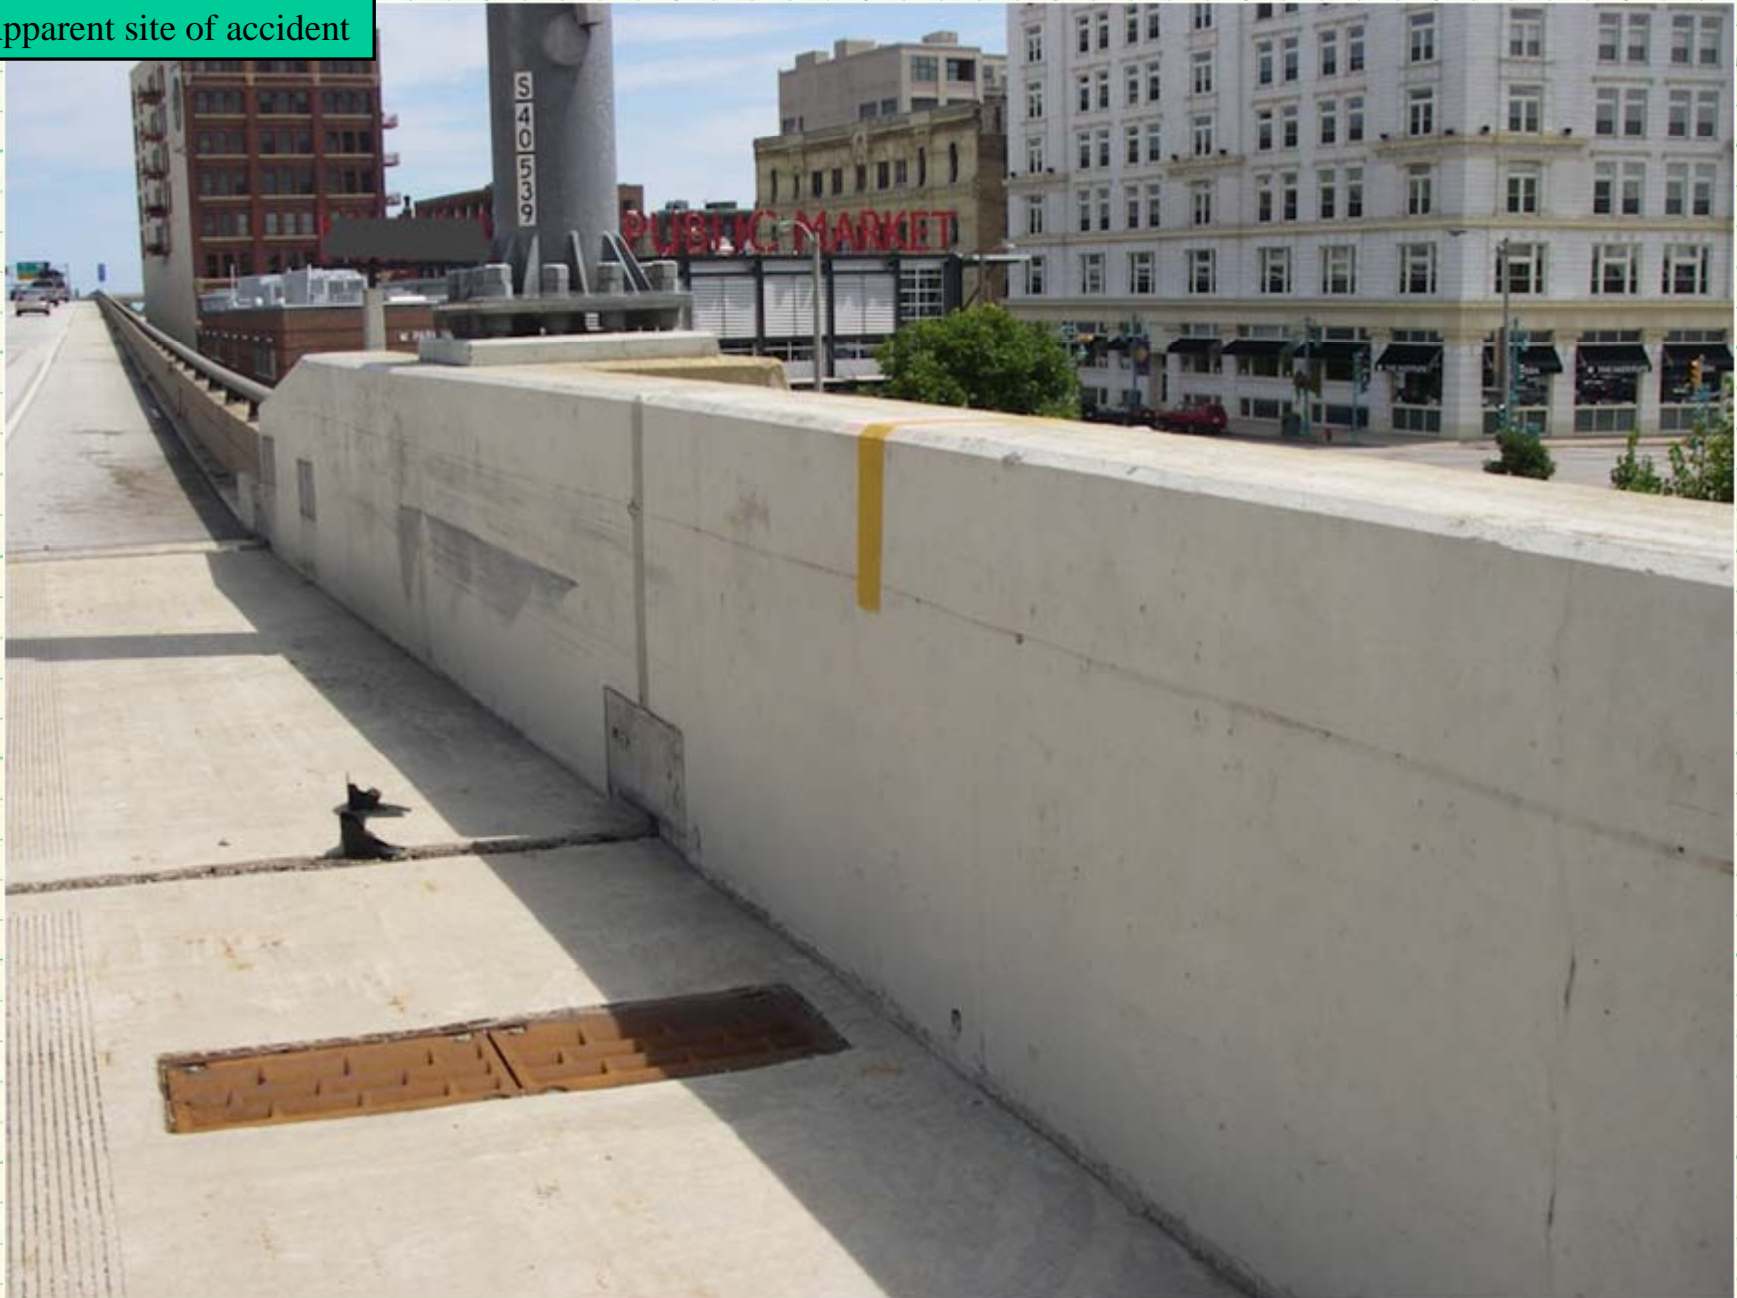
Note: no gouges could be located along the roadway surface

Apparent site of accident
