**Center for Auto Safety  
1346 Connecticut Ave., NW  
Washington, D.C. 20009  
(202) 328-7700**

December 12, 2006

This letter is to report recent findings from our research and testing that demonstrate the high level of rollover occupant protection currently offered in at least one production vehicle; and the availability of a highly repeatable, controlled dynamic test to objectively demonstrate such performance.

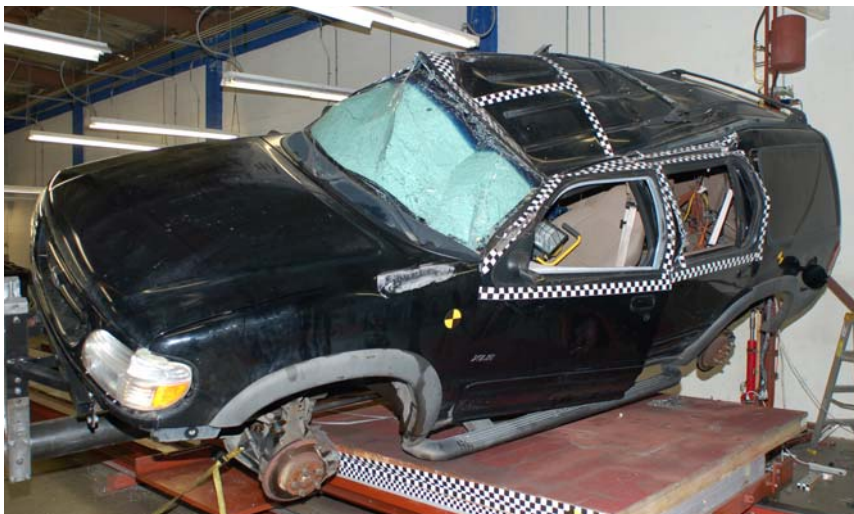
Figure 2. A 1995-2001 Ford Explorer following the second JRS test.

There were no structural failures in these tests, so that the vehicle would have been capable of sustaining further rollover roof impacts while protecting the occupants. Figure 1 shows the XC90 following the second JRS test while Figure 2 shows a Ford Explorer following the same tests.

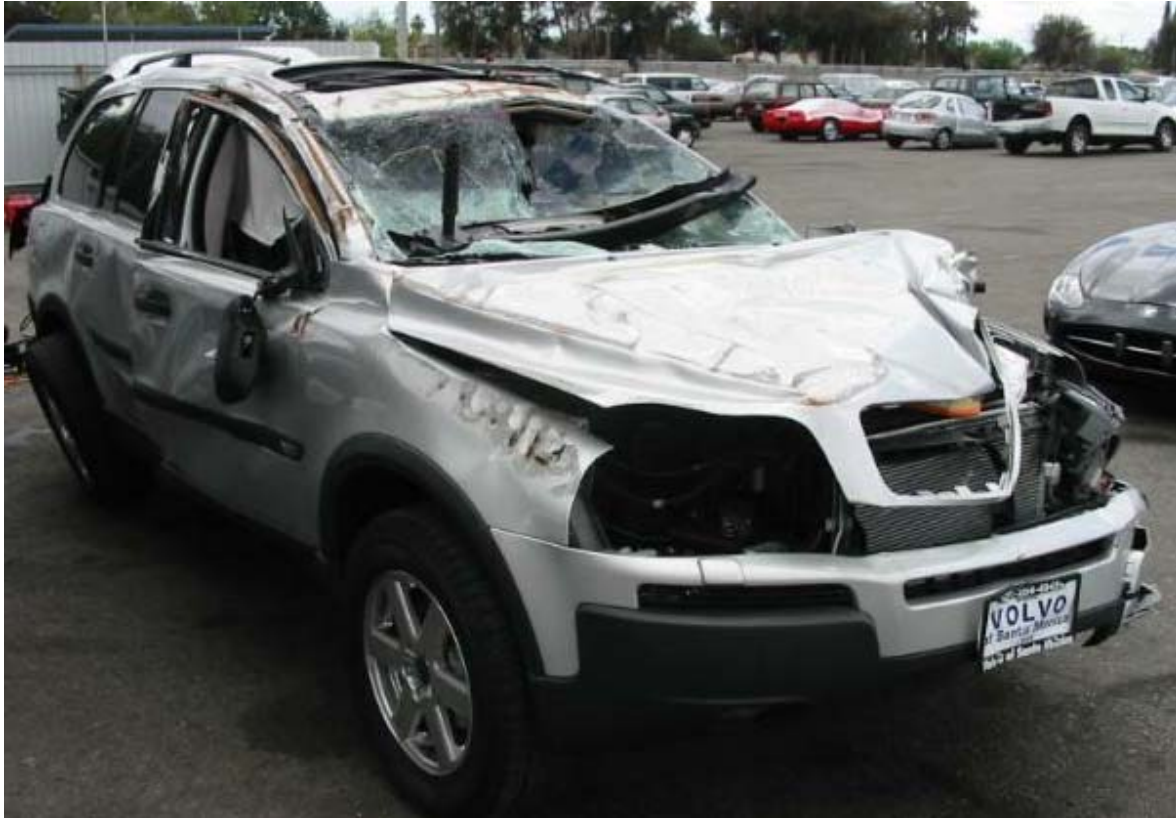
Figure 3. A Volvo XC90 involved in a rollover of 1½ rolls (NASS Case 2003-79-57).

There has been only one spontaneous rollover of a Volvo XC90 that has been fully investigated: NASS Case 2003-79-57 (see Figure 3, below; and Attachment 2). In that case, the rollover occurred because an initial collision sent the Volvo out of control so

that it subsequently rolled one and a half rolls landing on its roof. The vehicle in question did not have the optional laminated side glazing. The two women front seat passengers were uninjured except for some glass cuts from the failed side windows. Although the roof sustained substantial superficial damage, its structure protected the occupant survival space very well. This is similar to the results we obtained in our JRS tests of this vehicle.

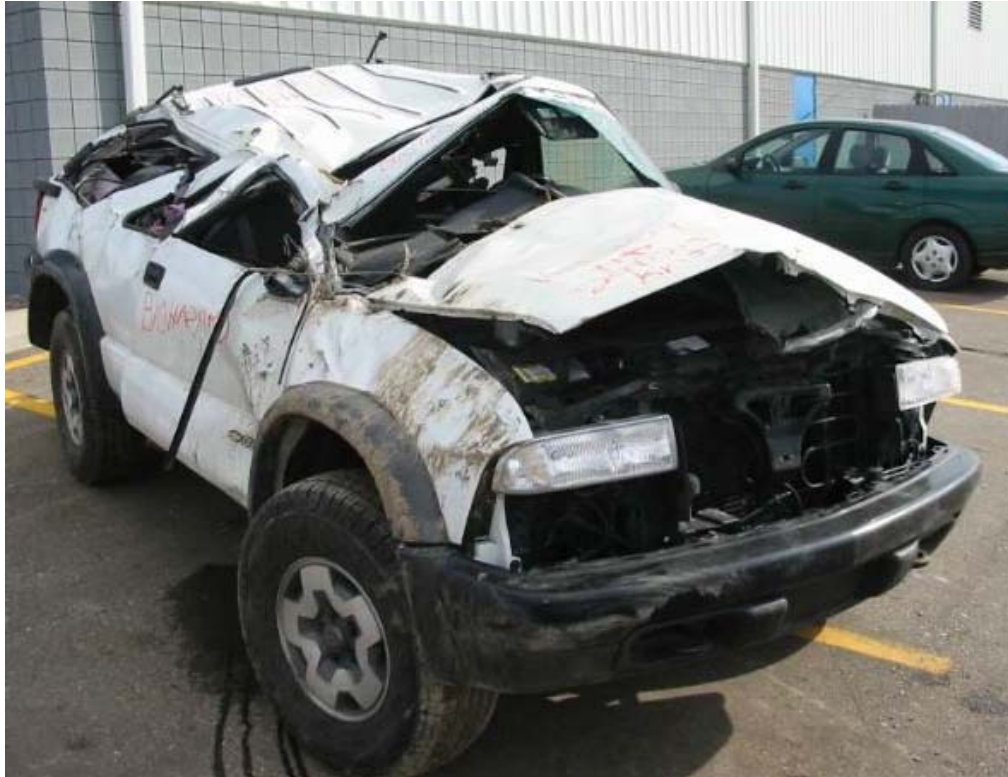
Figure 4. A 2001 Chevrolet Blazer following a one roll rollover. The right front passenger, who was wearing a lap/shoulder belt, suffered a serious cervical spine injury.

We looked for examples of flat ground rollovers of these vehicles in recent NASS files and found several. In all cases there was serious structural buckling and roof intrusion into the occupant survival space where there was a restrained occupant who suffered serious to fatal head or neck injury. These cases are shown in the attachments and in the photographs (Figures 4 through 7).

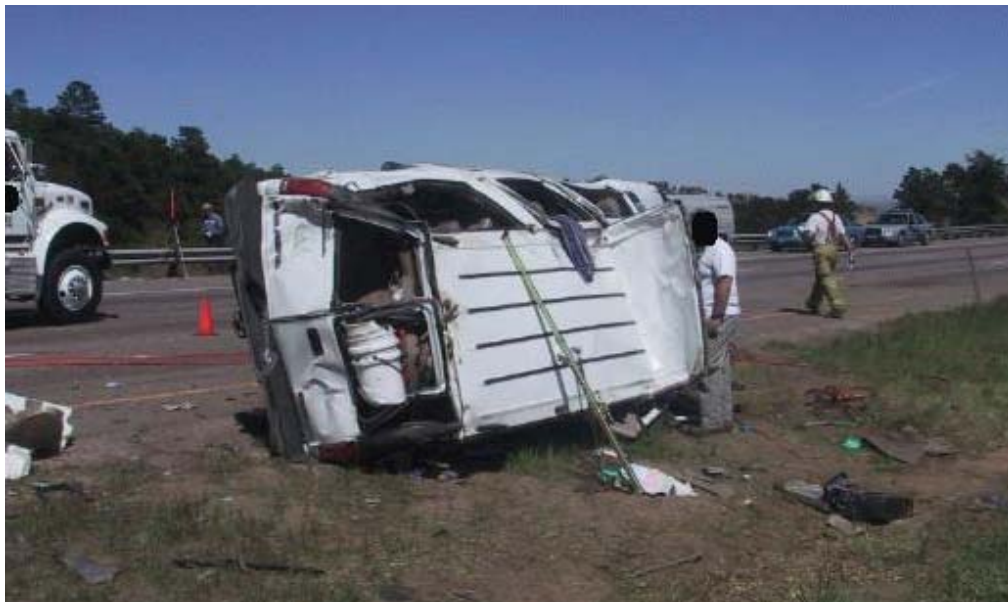
Figure 5. A 1997 Chevrolet Suburban that rolled over. The lap/shoulder belted driver suffered fatal head injuries.

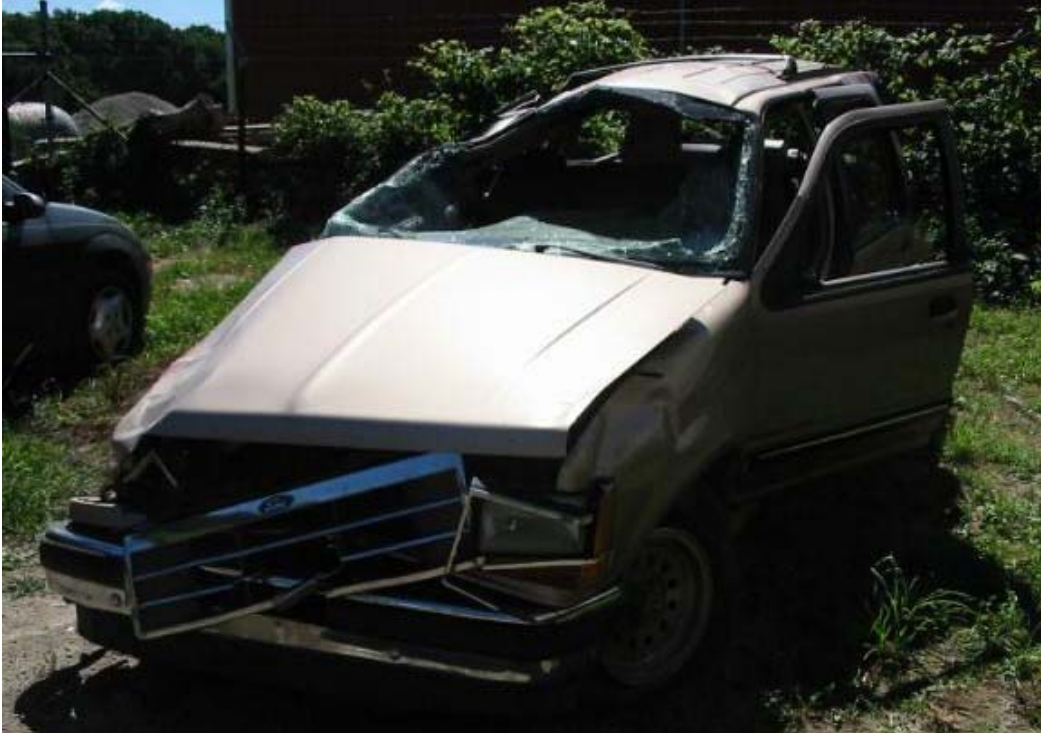
Figure 6. A 1993 Ford Explorer after a three roll rollover. The right front passenger died of brainstem injuries.

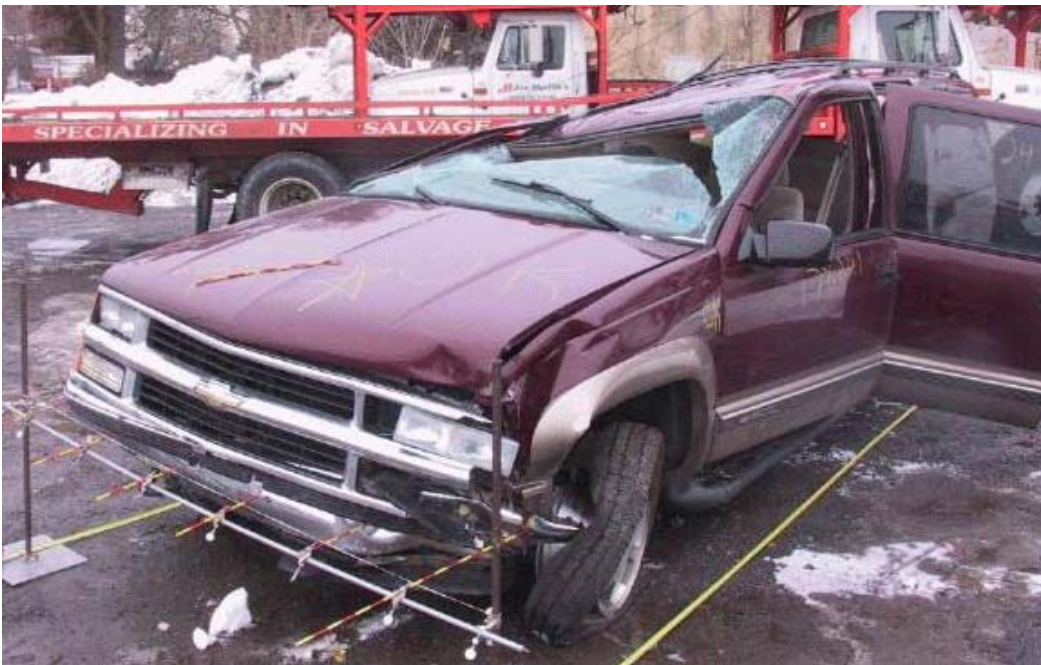
Figure 7. A 1999 Chevrolet Suburban that rolled over. The right front passenger died of critical head injuries.

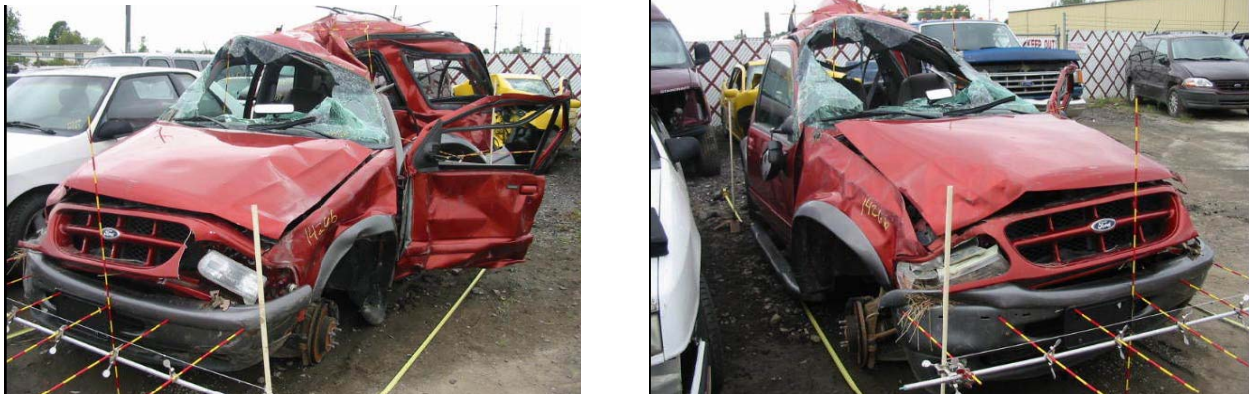
Figure 1. An example of a Class 4 NASS case where an initial collision (with a large tree) was the most serious event.

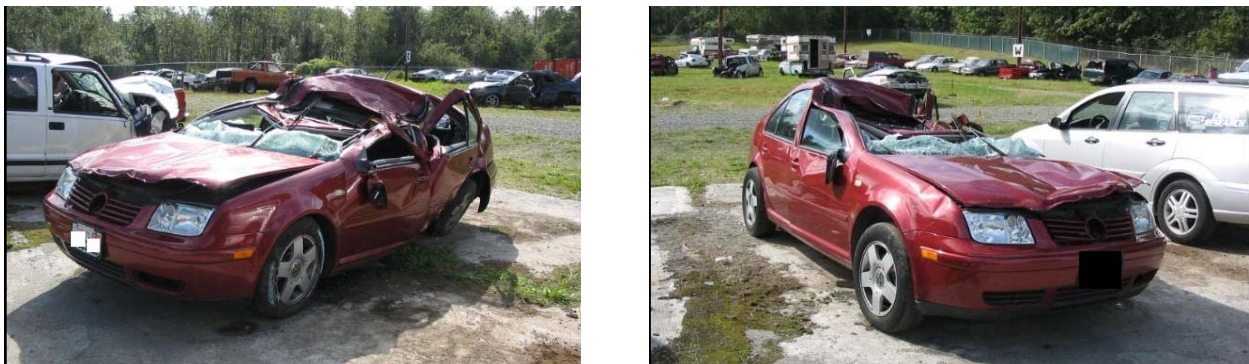
Figure 2. An example of a Class 5 NASS case where a collision (with a large tree) during a rollover was the most serious event.

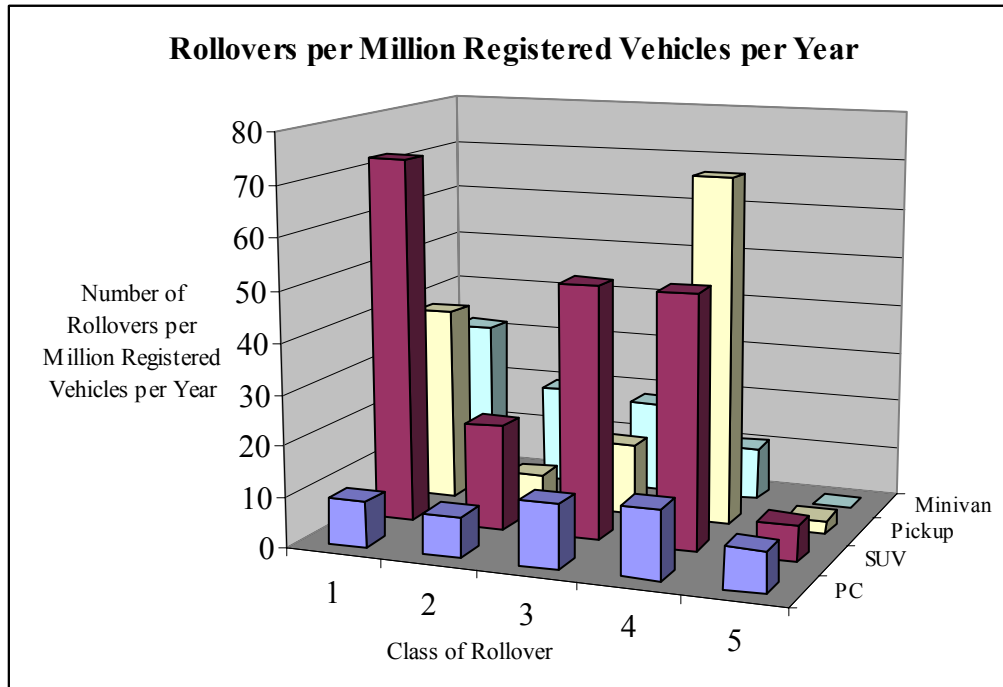
Figure 3. Estimated annual number of rollovers with AIS 3+ injuries by class and vehicle type.

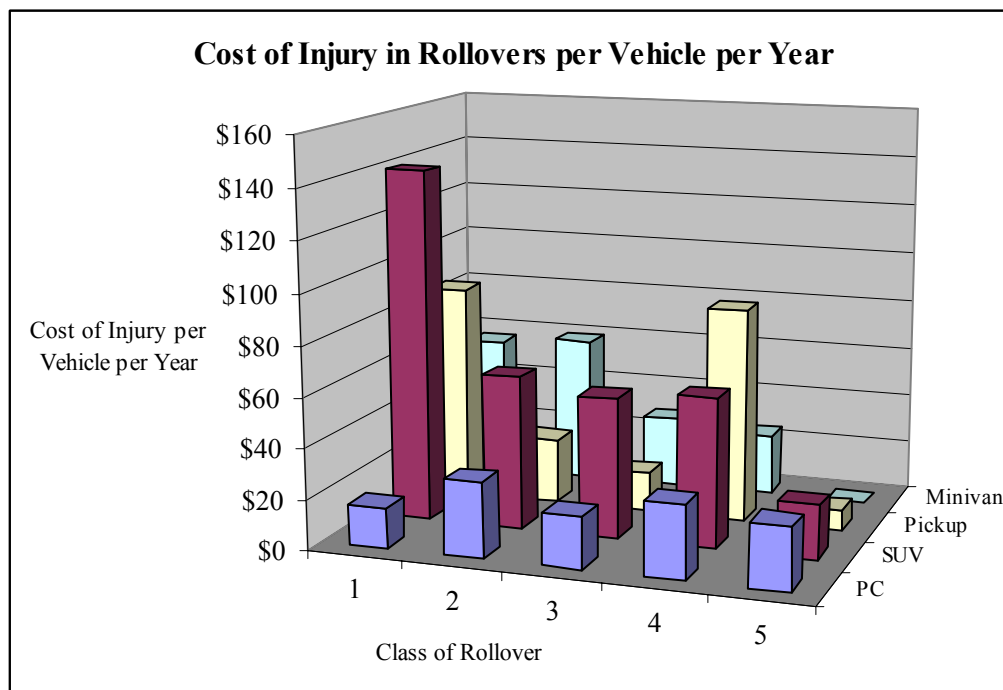
Figure 4. Cost of injury per registered vehicle by type of vehicle and type of injury.

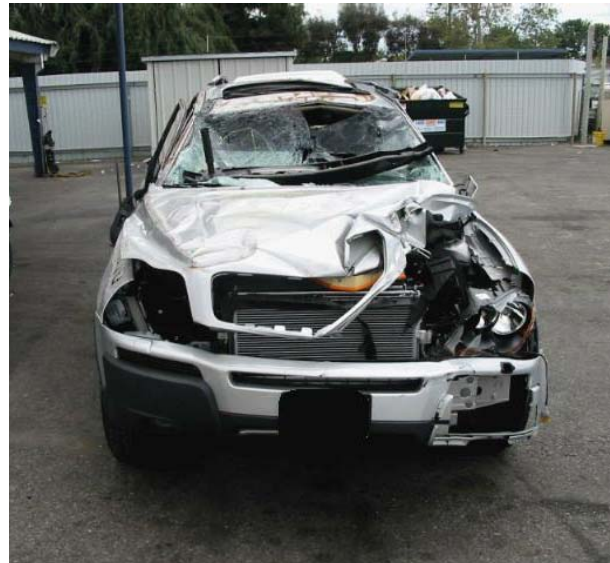
Figure 6. A Volvo XC90 with a strong roof after a rollover (NASS Case 2003-79-57).

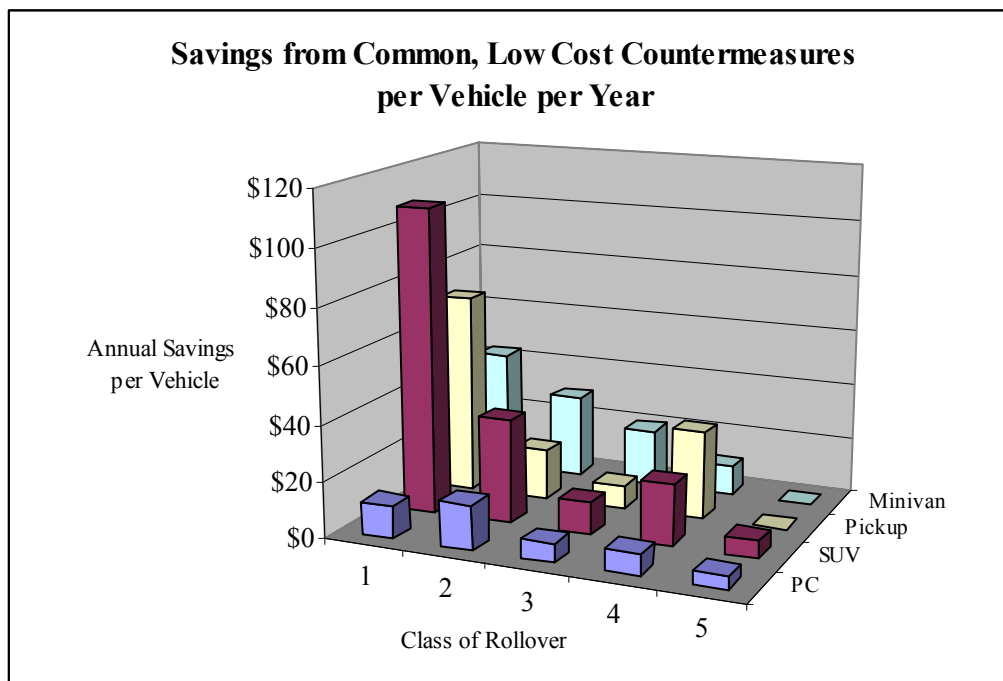
Figure 7. Benefits of basic countermeasures – a strong roof, side glazing designed to contain occupants, and effective safety belt use reminders – from the reduction of rollover AIS 3 or greater injuries. These results should be compared with Figure 4 showing the total economic consequences of AIS 3+ injuries rollovers. It does not include reductions in AIS 1 and 2 injuries.

The results, which are a total saving of half of the comprehensive cost of rollover AIS 3+ injuries, are shown in Figure 5.
