CENTER FOR AUTO SAFETY

March 27, 2008

Re: Docket No. NHTSA-2008-0015

Jordan Rollover System Test Results

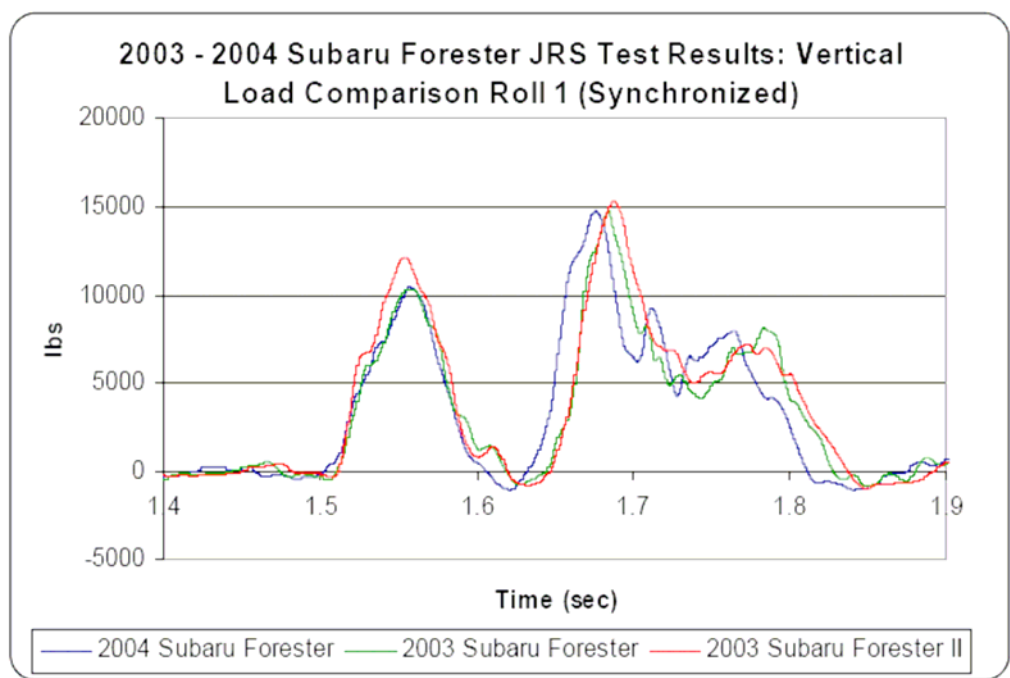
Figure 2. Comparison of roof to road force loads in three initial tests of Subaru Foresters using the JRS.

First JRS Test Series. The first test of each Forester was conducted with a road speed of 18 mph, a vehicle roll rate of $240^{\circ}/\text{sec.}$, 10 degrees pitch and yaw, and a 4" drop height to the leading side of the roof.³ Photographs of the three vehicles following the first tests are shown in Figure 1. Traces of the road load in the three first tests are shown in Figure 2.

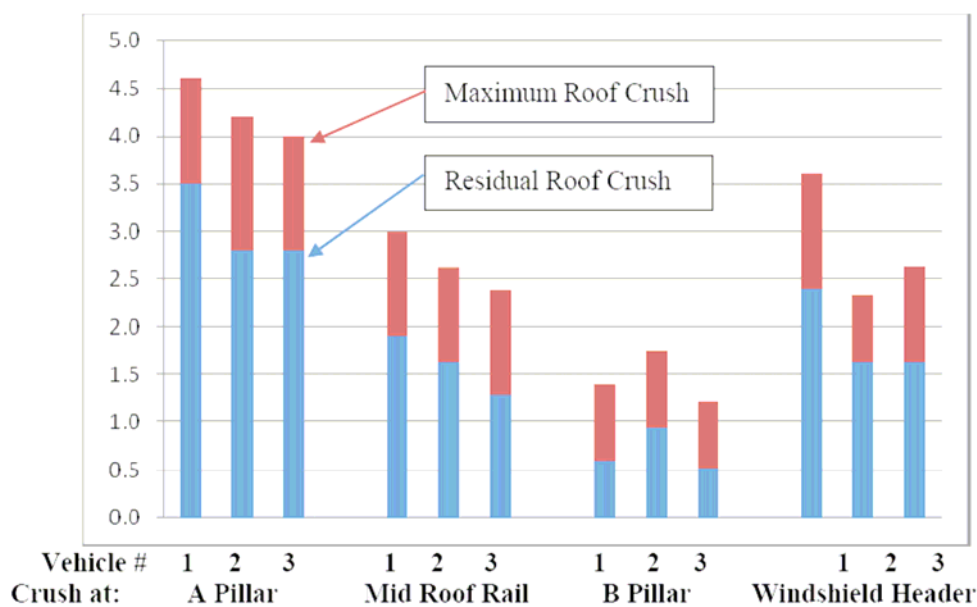
We use string potentiometers inside the vehicle to measure roof intrusion at key points in the roof area.⁴ The maximum dynamic roof crush and residual crush are shown in Figure 3. The standard deviation of the maximum dynamic crush at the A pillar was 0.31 inches and the standard deviation was only 7 percent of the average and only 6 percent of the generally accepted maximum acceptable roof crush (5 inches in the FMVSS 216 test).

Figure 3. Maximum and residual roof crush, in inches, following the first test of the three Subaru Foresters.

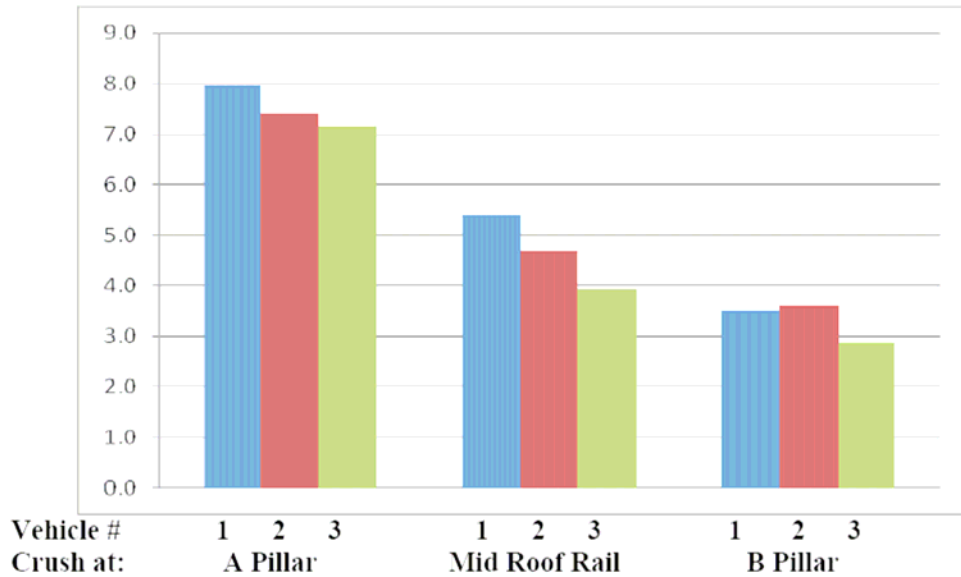
Roof intrusion speed, shown in Figure 4, provides a better measure than gross intrusion of the potential for head or neck injury. Again, the A pillar crush speed is more than twice that of the B pillar. The standard deviation of the maximum dynamic crush at the A pillar was 0.41 ft/sec and the standard deviation was only 5 percent of the average.

Figure 4. Maximum roof intrusion speed, in ft/sec, in the first test of the three Subaru Foresters.

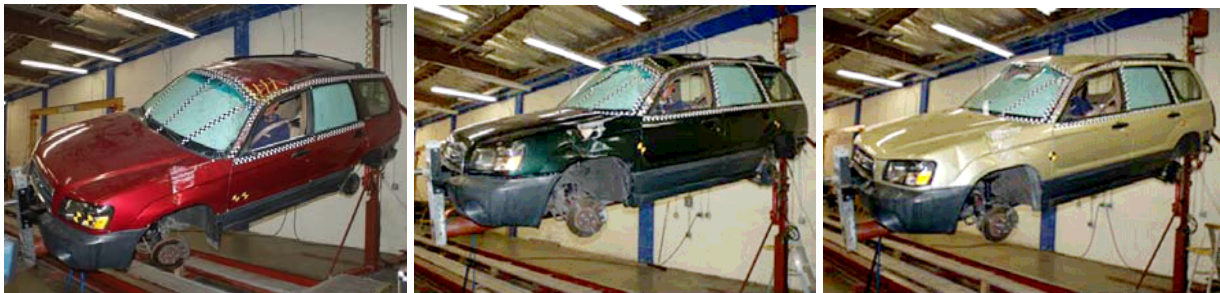
Photographs of the three vehicles following the second tests are shown in Figure 5.

Figure 5. Photographs of the three Foresters following the second JRS tests.

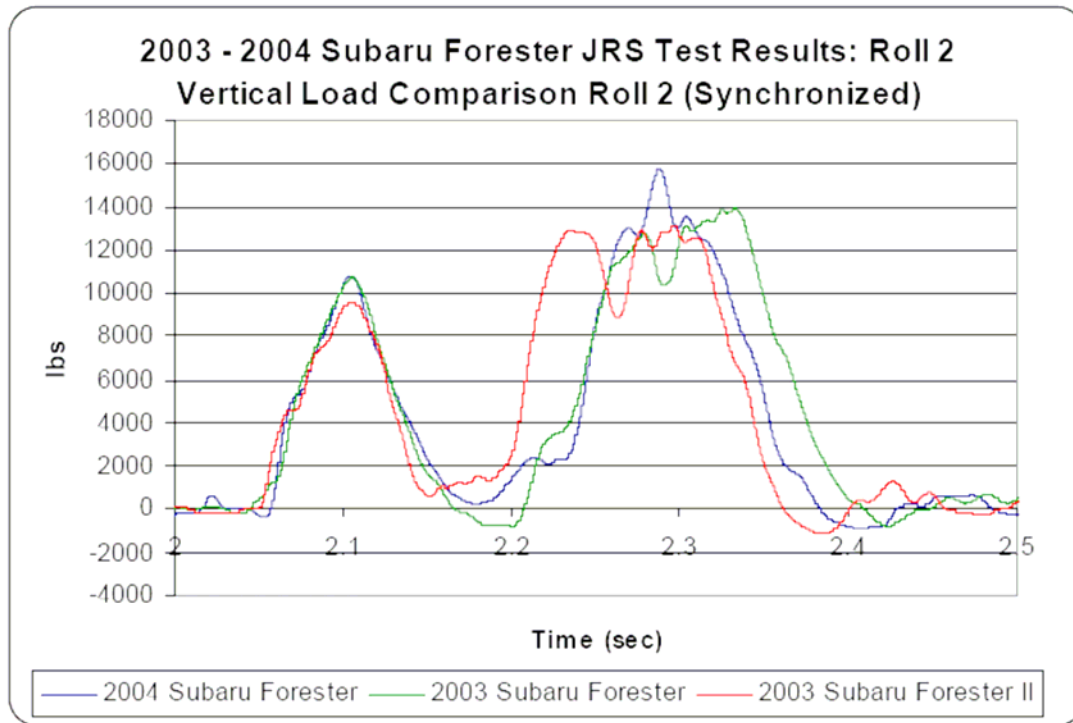
Traces of the road loads in the three second roll tests are shown in Figure 6. The roof to road force loads show more variations than the first test results after 2.15 seconds, probably due to detailed difference in the vehicles following the first test.

Figure 6. Comparison of roof to road force loads in three subsequent tests of Subaru Foresters (vehicles already damaged in first JRS test) with dummies using the JRS.

In our JRS tests, the curves of vertical road load and the maxima were very well coordinated in the first set of tests. There was somewhat more variation in the second tests which is probably the result of minor differences in roof damage from the first tests.

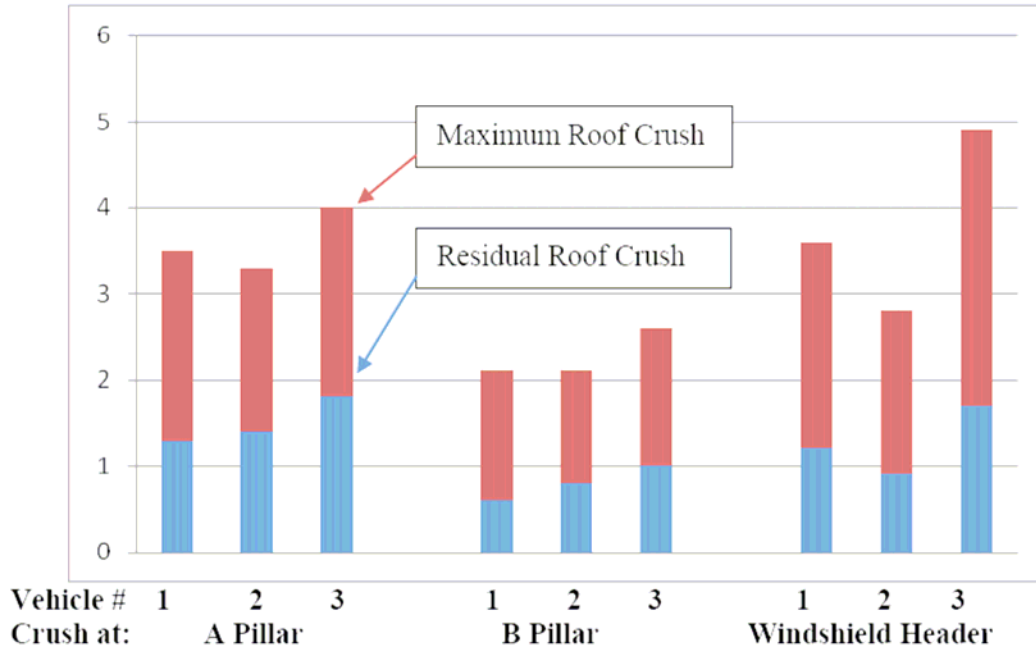
Figures 7 and 8 show the intrusion and intrusion rates in the second series. The standard deviation for maximum roof crush at the A pillar divided by the average is 11%.

Figure 7. Maximum and residual intrusion roof crush, in inches, following the second test of the three Subaru Foresters. (Because of the presence of the dummy, no measurement could be taken from the midpoint of the roof rail. }

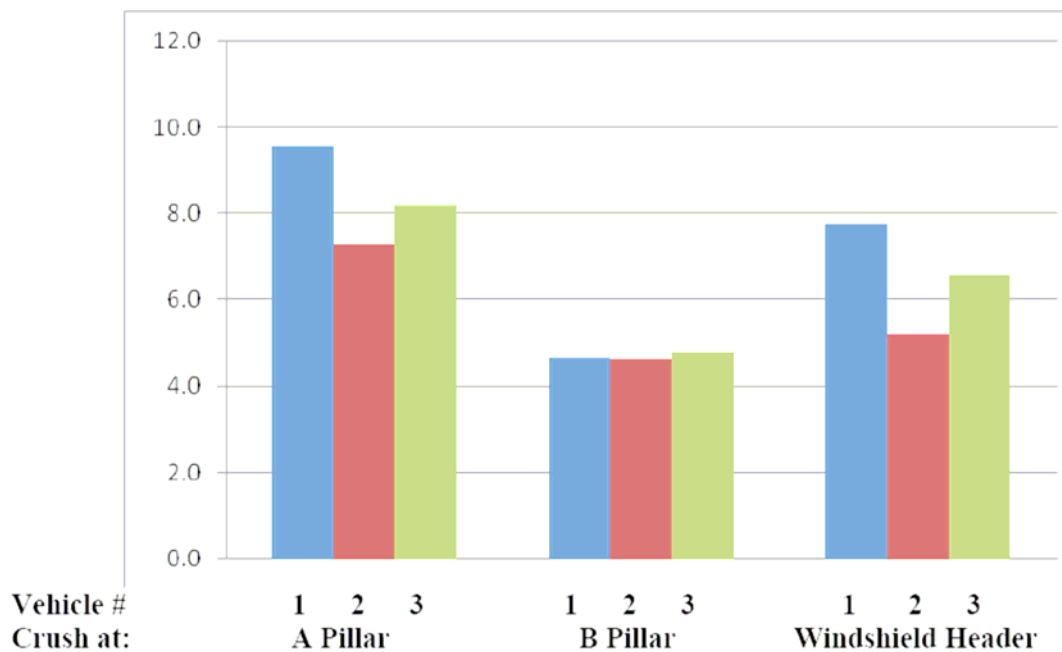
Figure 8. Maximum roof intrusion speed, in ft/sec, in the second test of the three Subaru Foresters.

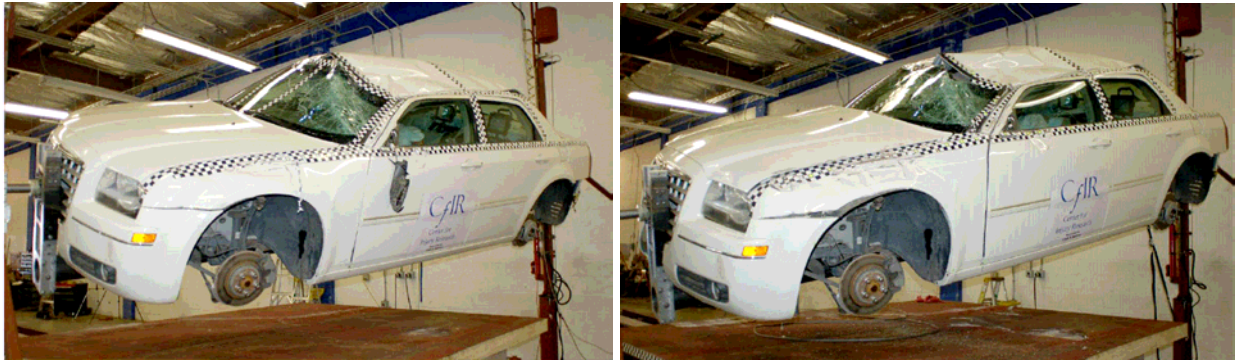
Figure 10. The 2007 Chrysler 300 after the first JRS roll test (left) and second roll.

The Chrysler 300 barely met the 2.5 SWR roof crush resistance value proposed by NHTSA in 2005, and did so in its two-sided test. However, the roof showed serious performance deficiencies in our dynamic testing. The rollover occupant protection capability of this vehicle as poor based on the amount and speed of roof intrusion, and on the high peak neck load and neck injury criterion in the first roll test. If this were a FMVSS 208 compliance test, the Nij levels would fail the vehicle.

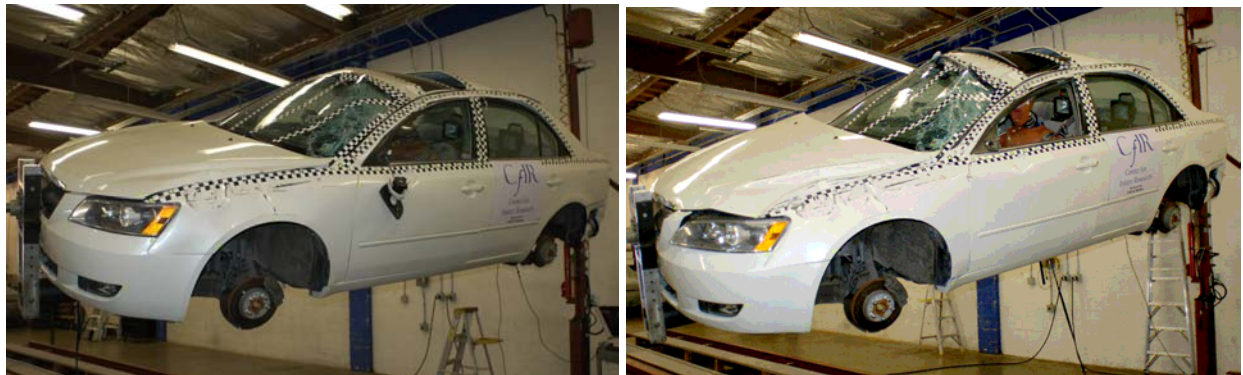
Hyundai Sonata. Figure 11 shows the 2006 Hyundai Sonata after the first and second rolls. The damage to the initially leading side of the roof increased substantially in the second roll, which is somewhat unusual in both JRS tests and actual rollovers, and indicates that the damage to the second side in the first test substantially weakened the roof overall.

Figure 11. The 2006 Hyundai Sonata after the first JRS roll test (left) and second roll.

The Sonata's curb weight is 3,266 pounds and its test weight was 3,501 pounds. It registered a maximum road impact load with the second side of the roof of 17,711 pounds during the first roll and 31,380 during the second. Belt loads were nominal during the test. The residual roof intrusion at the A pillar was 2.6 inches after the first roll and could not be measured after the second because of interference between the dummy and the string potentiometer. Although the intrusion over the driver position was reasonable, the tenting of the windshield

header and damage to the roof on the passenger side indicate problems with the overall structural integrity of the roof of this vehicle.

The 3.2 SWR Sonata would meet NHTSA's proposed 2.5 SWR roof crush resistance criteria in the FMVSS 216 test, but its performance showed serious structural weakness in the JRS test and a significant probability of injury to the driver in these rollover tests. The rollover occupant protection performance of the Hyundai Sonata is only marginal based on the peak neck load and neck injury criterion in the first roll test, the peak roof intrusion speed in the second roll, and the excessive intrusion of the passenger side roof. If this were a FMVSS 208 compliance test, the Nij levels would fail the vehicle.

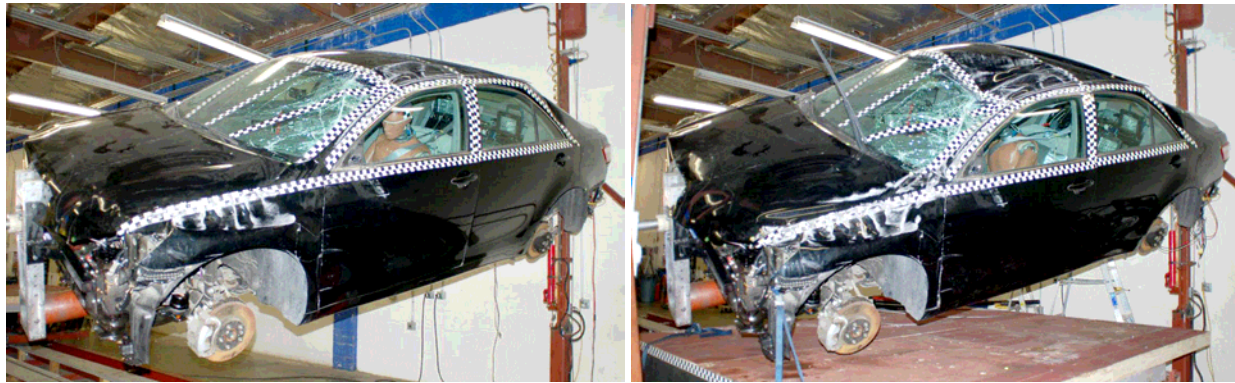
Toyota Camry. Figure 12 shows the 2007 Toyota Camry after the first and second roll tests on the JRS.¹⁵ The vehicle looked fairly good after the first roll test (although there was incipient damage at the left end of the windshield header), but developed significant buckles in the windshield header in the second roll. Toyota uses high strength steel in the pillars and roof rails at the side of the roof of its Camry and Corolla models, but they have weak windshield headers as demonstrated in this test.

Figure 12. The 2007 Toyota Camry after the first roll JRS test (left) and the second.

The Toyota's curb weight is 3,260 pounds and its test weight was 3,176 pounds. It registered a maximum road impact load with the second side of the roof of 19,242 pounds on the first roll test and 25,038 pounds on the second. Belt loads were nominal during the test. The residual roof intrusion at the A pillar was 1.6 inches after the first roll and 4.7 inches after the second. The intrusion at the roof buckle was somewhat greater. This vehicle had only marginal headroom after the second roll test according to NHTSA's headroom criterion.

The Toyota Camry substantially exceeded NHTSA's proposed roof crush resistance criterion of a SWR of 2.5. However, the performance of the windshield header shows that performing well in the FMVSS 216 test is not a sufficient condition for good roof crush resistance. The attached paper by Nash shows that this weakness affects the performance of Toyota sedans in actual rollovers captured by the National Accident Sampling System (NASS).

The rollover occupant protection of the Camry is fair. The good side structure of the roof is compromised by the weak windshield header which permitted high roof intrusion speed in the second roll test. The real world performance of the Camry gives little confidence that the Camry's rollover performance is much better than average. These test results show why the conditions of the current FMVSS 216 test, even if repeated on the second side, are not adequate to ensure good roof crush resistance.

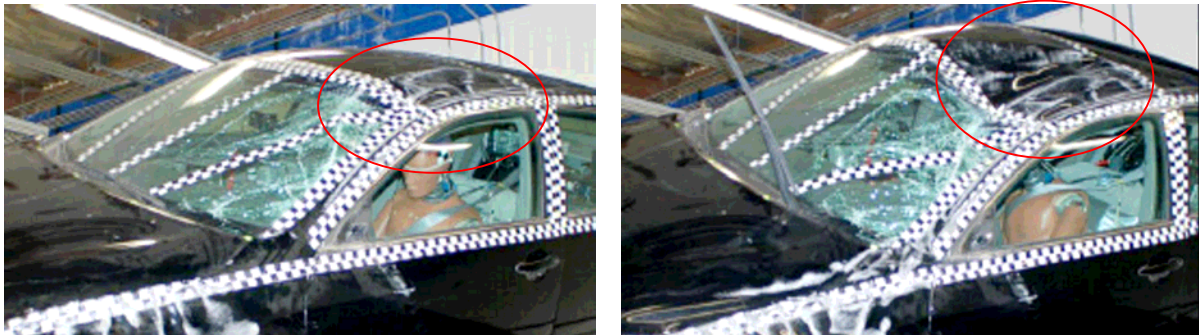
The Center for Injury Research has tested two Toyota passenger cars, the Corolla and the Camry, on the dynamic Jordan Rollover System (JRS). In those tests, a weakness in the structure of the tested vehicles became obvious: the windshield header is weak and likely to buckle under dynamic loading (see Figure 1).

Figure 1. Photographs of a 2007 Toyota Camry roof after one roll and after two rolls in a JRS test showing the buckling of the windshield header in this vehicle. The Toyota Corolla showed similar buckling in a JRS test.

Except for a couple of cases, we found that Toyota roofs generally looked good after a rollover except that in many cases the windshield header buckled. This behavior mirrors the results of the JRS tests.
