REVISED HONDA VALIDATION TEST REPORT

Revised Report – 1st Copy
November 06, 2000
Document Number ERL-0164
Thomas Sheridan

Product: P-SDI Inflator

To: Bill Martin / Kevin Fitzgerald
From: Tom Sheridan
Subject: Corrected Honda Test data

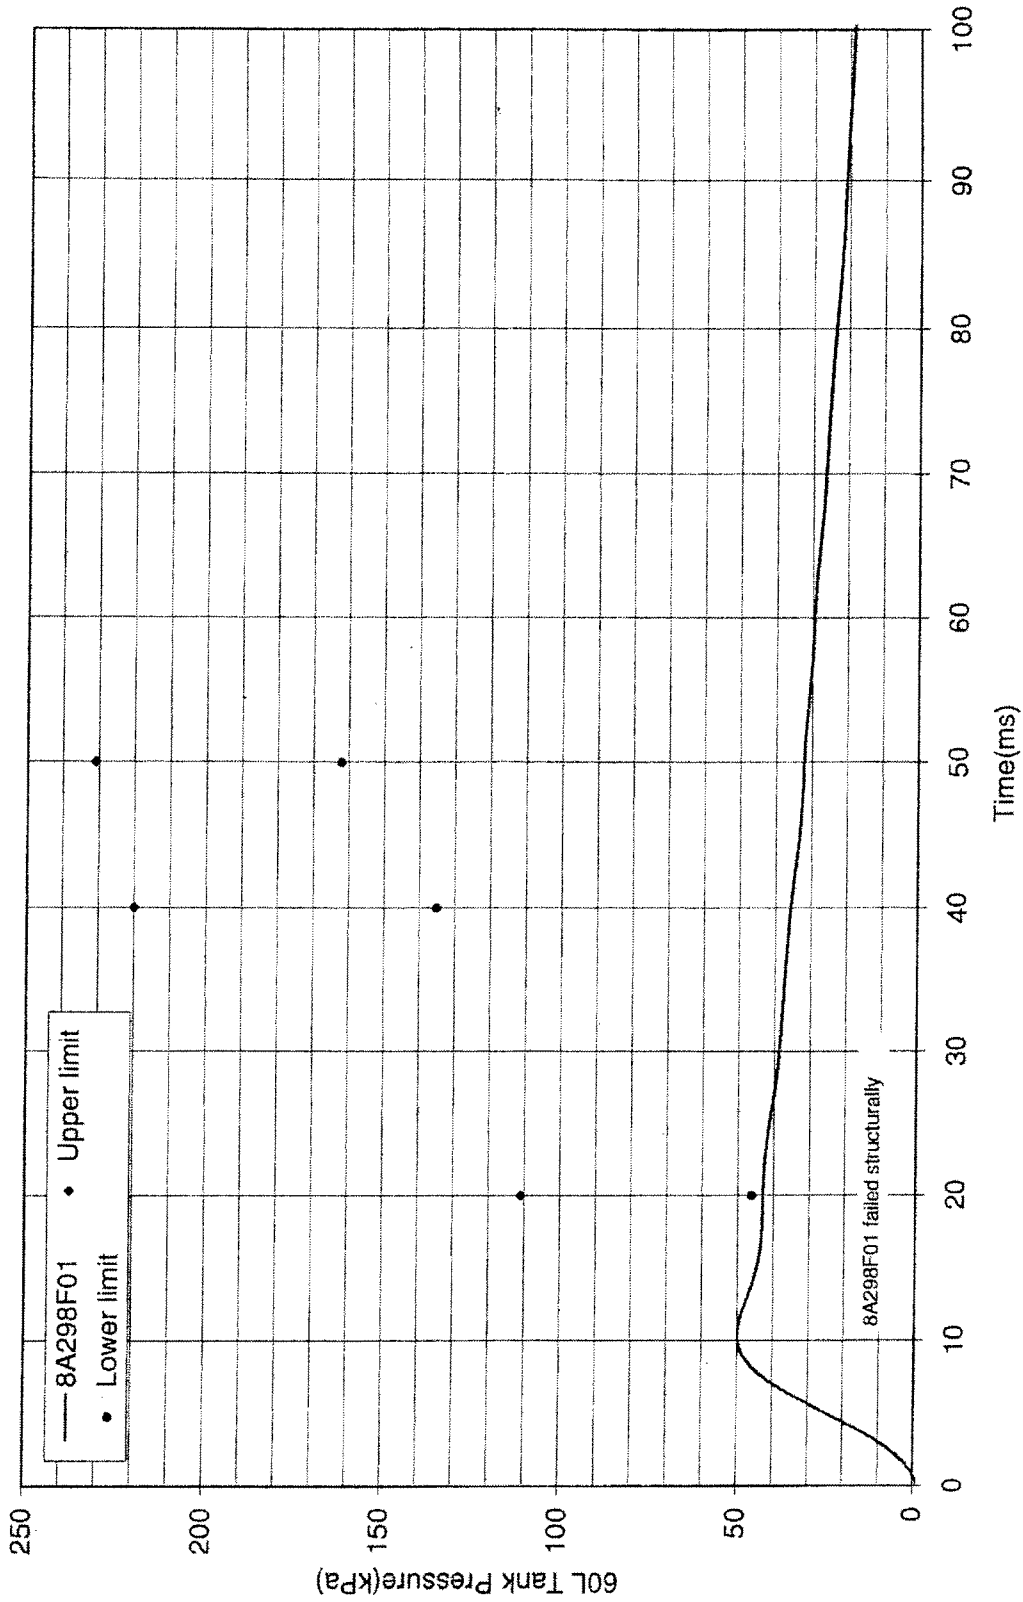
Vibration/Moisture/Thermal Cycle Group 8
EAR 8A298 Group F

Corrected chart and data for
8A298 Group F.

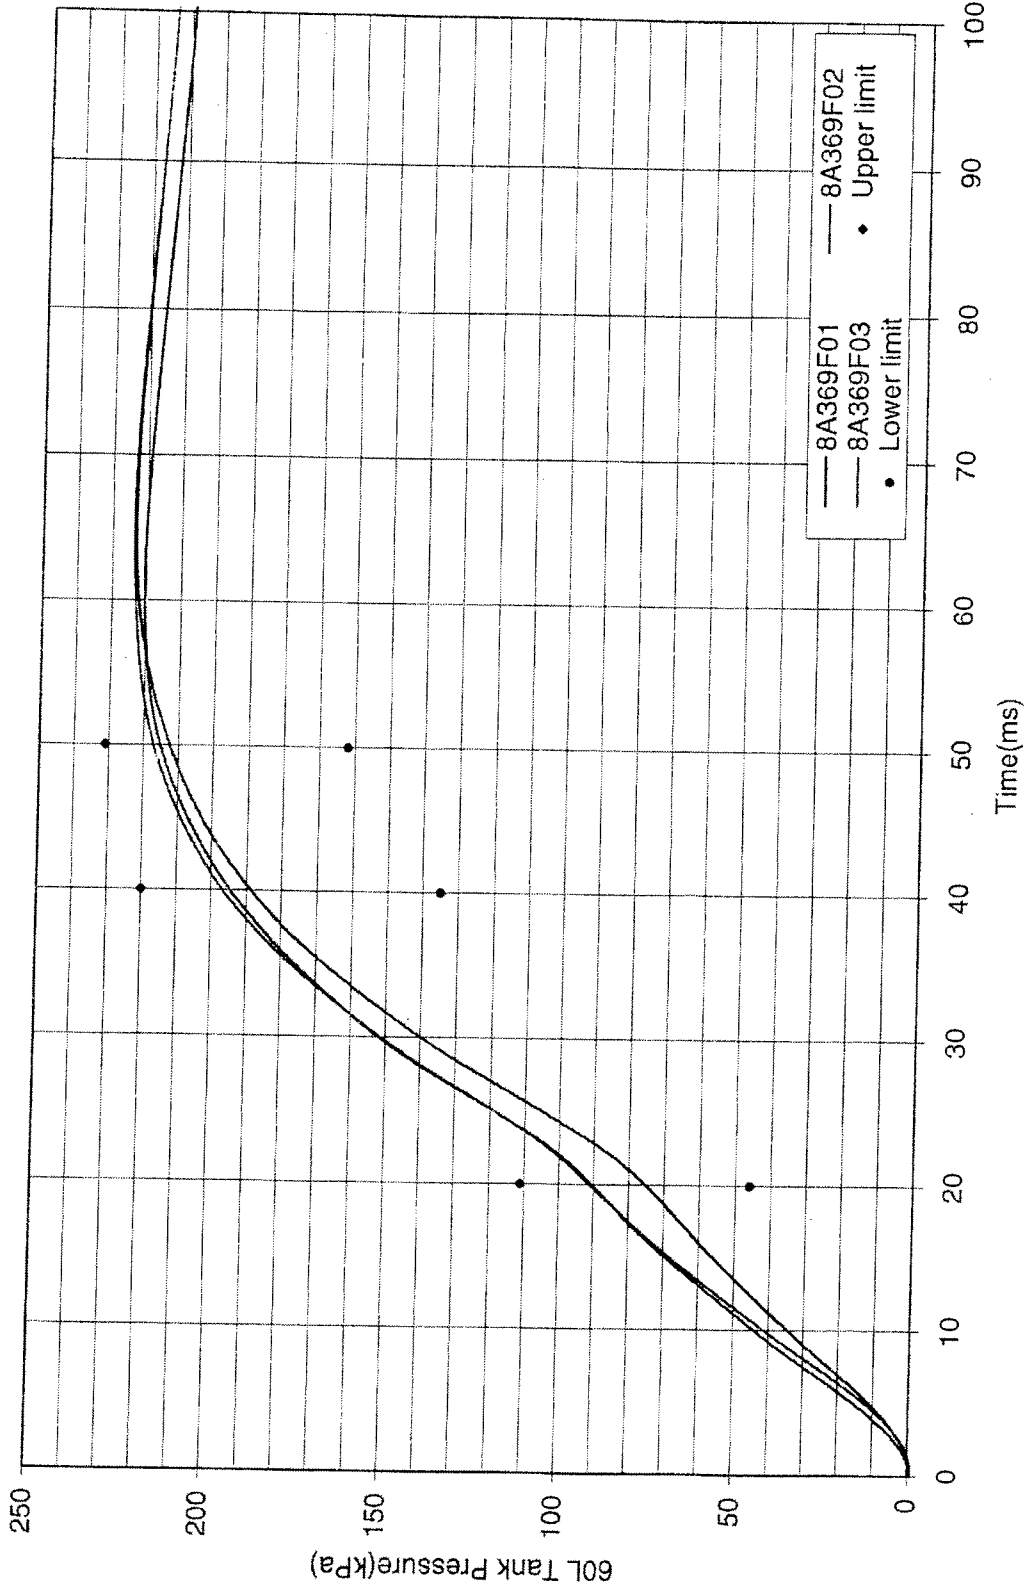
Drop Test Group 10
EAR 8A369 Group F

Corrected chart and data for
8A369 Group F.
