Center for Auto Safety

Dynamic Roof Crush Tests of Ten 2005-07 Passenger Vehicles

Dynamic rollover roof crush tests have been conducted for the Center for Auto Safety (CAS) by the Center for Injury Research (CfIR) using the Jordan Rollover System (JRS). This work was funded by the Santo Family Foundation on the following ten 2005-07 vehicles that were donated by State Farm Insurance. The results were.

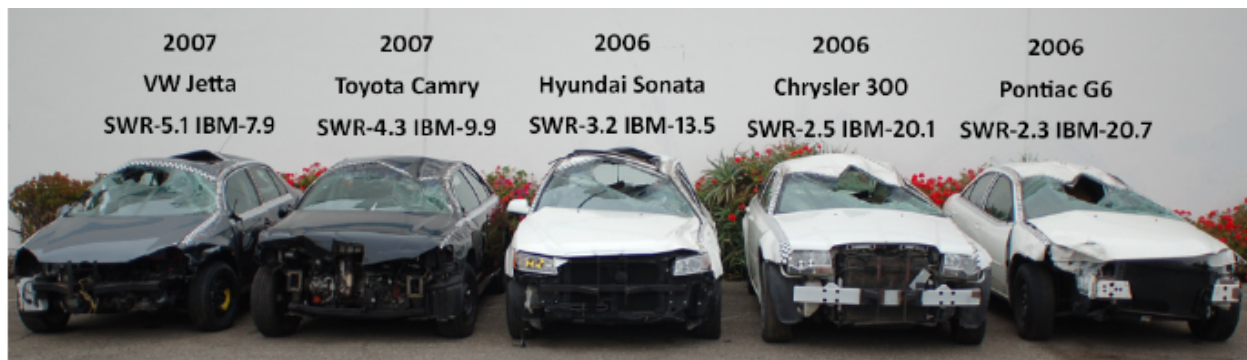
The following figures show the detailed results of JRS testing of the five passenger cars and five light trucks.

2007 VW Jetta		2007 Toyota Camry		2006 Hyundai Sonata		2006 Chrysler 300		2006 Pontiac G6	
	Roll 1	Roll 2	Roll 1	Roll 2	Roll 1	Roll 2	Roll 1	Roll 2	Roll 1	Roll 2
Roof FMVSS 216 SWR	5.1	5.1	4.3	4.3	3.2	3.2	2.5	2.5	2.3	2.3
Road Speed (kph)	24	24	24	24	24	24	24	24	24	24
Pitch Angle at Impact (deg)	5	10	5	10	5	10	5	10	5	10
A-Pillar										
Peak Dynamic Crush (cm)	6.9	16.0	8.6	18.3	11.9	17.5	21.3	26.4	18.0	25.4
Cumulative Residual Crush (cm)	2.5	8.6	4.1	10.9	6.6		14.2	18.8	12.4	17.8
Maximum Crush Speed (kph)	9.2	11.4	8.0	13.2	8.0	--	12.07	17.06	12.07	21.08
B-Pillar										
Peak Dynamic Crush (cm)	3.8	6.1	4.6	10.7	--	6.6	11.2	13.5	9.1	15.0
Cumulative Residual Crush (cm)	1.5	3.3	1.8	5.3	--	2.0	6.9	8.6	6.4	8.6
Maximum Crush Speed (kph)	6.1	5.6	5.1	8.0	--	6.6	8.7	12.23	10.14	14.32
Compressive Neck Load, Fz	5158	5394	4211	2669	4835	3457	5598	1979	2399	1916
Peak Upper, Flexion Moment (N m)	279	318	--	--	--	--	414	155	198	155

Upper Neck, Nij*	0.96	1.08	0.78	0.76	1.63	1.15	1.80	0.40	0.66	0.54
Lower Neck, Nij**	1.17	1.28	--	--	--	--	1.44	0.57	0.68	0.54
*Based on by NHTSA: Compression 6160 N, Flexion 310 Nm, Extension 135 Nm

Year, Make and Model	FMVSS 216 SWR	JRS Results
2007 Pontiac G6	2.3	Extensive windshield header and roof panel buckling, intrusion of roof panel over driver position, poor seat belt performance, and side window failure. Generally poor performance.
2006 Chrysler 300	2.5	Extensive windshield header buckling and intrusion of roof panel over driver position. No side window failures. Generally fair to poor performance.
2006 Hyundai Sonata	3.4	Moderate intrusion of passenger side roof, side window failure, and sunroof intrusion. Generally fair to poor performance
2007 Toyota Camry	4.3	Poor windshield header performance but otherwise good roof performance. No side window failures.
2007 VW Jetta	5.1	Moderate windshield header buckling and roof intrusion above dummy's head. No side window failures. Generally good performance.
2006 Honda Ridgeline	2.4	Roof structure failed catastrophically. The top of the A-pillar was forced below the belt line of vehicle. Side window failures. Performance considered unacceptable.

The VW Jetta and the Camry showed substantially better dynamic roof crush performance than typical vehicles now on the road. Nevertheless, in the JRS tests these two vehicles both showed structural failures in their windshield headers that were not revealed by NHTSA's static roof crush test.

The differences in the injury potential performance of these two vehicles demonstrate why a dynamic test is critical to accurately and efficiently measuring the rollover occupant protection capability of vehicles. The Sonata has a sunroof with internal structure that collapses inward in a dynamic rollover but not in a static test. Except for the CR-V, all of the vehicles that had FMVSS 216 SWR below 3 performed poorly in the JRS tests.

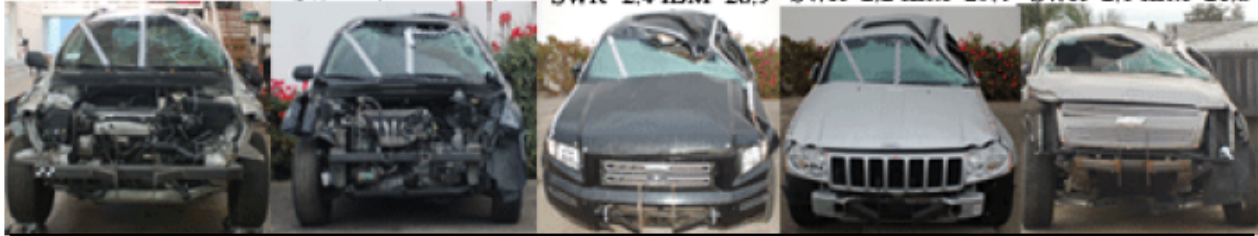
Volvo XC90
SWR=4.6 IBM=11.3

Honda CRV
SWR=2.6 IBM=18.7

Honda Ridgeline
SWR=2.4 IBM=28.9

Jeep Grand Cherokee
SWR=2.2 IBM=29.4

Chevrolet Tahoe
SWR=2.1 IBM=21.8

2005 Volvo XC90		2007 Honda CRV		2006 Honda Ridgeline		2007 Jeep Grand Cherokee		2007 Chevrolet Tahoe	
	Roll 1	Roll 2	Roll 1	Roll 2	Roll 1	Roll 2	Roll 1	Roll 2	Roll 1	Roll 2
Roof FMVSS 216 SWR	4.6	4.6	2.6	2.6	2.4	2.4	2.2	2.2	2.1	2.1
Road Speed (kph)	24	24	24	24	24	24	24	24	24	24
Pitch Angle at Impact (deg)	5	10	5	10	5	10	5	10	5	10
A-Pillar		***								
Peak Dynamic Crush (cm)	4.3	8.1	8.6	16.5	19.8	36.6	21.3	30.0	20.1	35.6
Cumulative Residual Crush (cm)	1.3	2.5	4.6	9.1	12.7	27.7	16.5	23.1	14.7	27.7
Maximum Crush Speed (kph)	3.1	5.1	6.4	8.5	13.2	24.1	11.75	13.84	9.8	18.67
B-Pillar										
Peak Dynamic Crush (cm)	3.0	5.3	5.1	8.6	15.2	28.2	18.5	25.7	13.2	24.9
Cumulative Residual Crush (cm)	0.5	1.8	2.0	3.6	8.6	18.8	14.2	19.8	8.9	17.5
Maximum Crush Speed (kph)	2.7	3.5	4.2	5.5	9.0	11.1	12.71	10.46	6.8	11.27
Compressive Neck Load, Fz	2889	3628	5583	3687	10006	4685	9757	6781	6101	3318
Peak Upper, Flexion Moment (N m)	128	259	255	328	492	324	470	396	304	247

Upper Neck, Nij*	0.52	1.05	1.02	1.30	1.64	1.19	1.75	2.07	1.09	0.81
Lower Neck, Nij**	0.62	0.87	1.20	1.10	2.10	1.06	2.00	1.59	1.02	0.87
*Based on by NHTSA: Compression 6160 N, Flexion 310 Nm, Extension 135 Nm

2005 Volvo XC90	4.6+	Best performing vehicle with little roof damage. Side windows remaining intact.
2007 Honda CR-V	2.6	Modest damage to trailing roof edge at top of A pillar. Driver window broke on second roll. Generally good performance.
2007 Chevrolet Tahoe	2.1	Roof had substantial crush, windshield header buckled, and side windows failed. Generally poor performance.
2007 Jeep Grand Cherokee	2.2	Major damage and intrusion of roof panel with substantial inward buckling of roof header over driver position. Side window failures. Generally very poor performance.

Out of the ten tested vehicles only the Volvo XC90 showed a high degree of rollover occupant protection. The Honda CR-V was nearly as good as the Volvo XC90 despite having a strength-to-weight ratio of only 2.6, and thus would not meet the amended Federal roof crush resistance standard.

Two of the tested vehicles from the same manufacturer, the Honda CR-V and the Ridgeline, had similar SWRs in the FMVSS 216 test; but showed radically different performance on the JRS. While the CR-V was one of the best performers on the JRS (except for the failure of the driver's side window on the second roll test), the Ridgeline suffered severe windshield header buckling, forming a pointed wedge that intruded rapidly and dramatically into the driver's survival space.
