**CALSPAN ON-SITE ADVANCED OCCUPANT PROTECTION SYSTEM
CRASH INVESTIGATION**

SCI CASE NO: CA04-014

**VEHICLE: 2004 SATURN ION
LOCATION: PENNSYLVANIA
CRASH DATE: FEBRUARY, 2004**

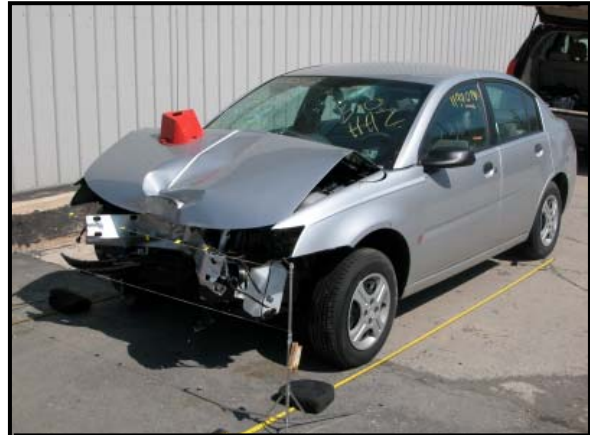
Figure 1: 2004 Saturn Ion.

This on-site investigative effort focused on the performance of the Advanced Occupant Protection System (AOPS) in a 2004 Saturn Ion, **Figure 1**. The Saturn was involved in a fixed object frontal impact with a tree. The Saturn was equipped with an AOPS that consisted of dual-stage frontal air bags and retractor pretensioners for the front safety belts. The AOPS was not commanded to deploy in the moderate severity frontal crash. Additionally, the vehicle was equipped with an Event Data Recorder (EDR) that had the capabilities to record both pre-crash vehicle systems and crash related data. That data was downloaded during the inspection as a supplement to the investigation. The 23 year old

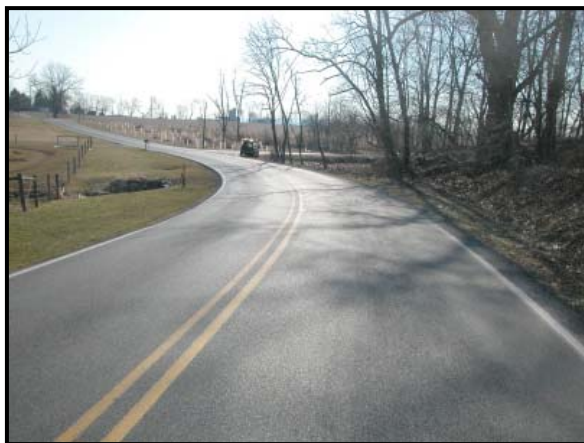
Figure 3: Eastbound trajectory view 55 m (180 ft) from impact.

This single vehicle run-off-road/fixed object crash occurred during the daylight hours in February 2004. At the time of the crash, weather was snow/sleet and rain. The asphalt road pavement was police reported as icy. The crash occurred on a two-lane east/west rural road at the exit of a small radius left curve for eastbound traffic. The radius of the curve measured 85 m (280 ft). A stand of small diameter trees located 3 m (10 ft) from the edge of the travel lane bordered the road. A 36 cm (14 in) diameter tree located at the end of the tree stand was the point of impact. At the beginning of the curve, the road had a negative grade (estimated greater than 2 percent) in the eastbound direction. The grade transitioned to level in the area of the impact. A north/south two lane road located 23 m (75 ft) east of the point of impact intersected the primary road from the south forming a three leg intersection. The speed limit in the area of the crash was 56 km/h (35 mph). **Figure 2** is an eastbound trajectory view approaching the crash site. **Figure 3** is a view of the point of impact.

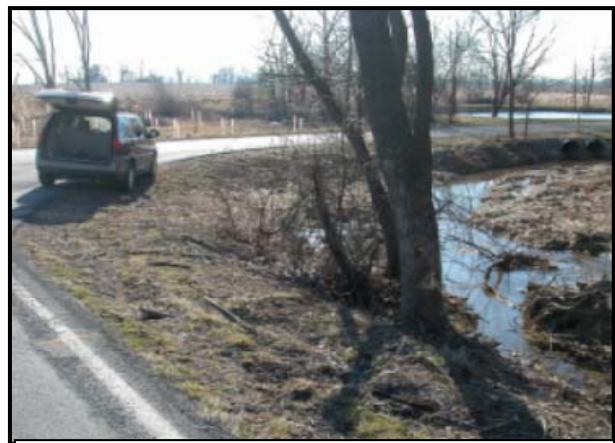
Figure 2: View of the point of impact.

The crash occurred when the center aspect of the vehicle's front plane impacted the 36 cm (14 in) diameter tree. The eastward momentum of the Saturn was stopped by the tree and resulted in 58 cm (23 in) of longitudinal crush at the center line. The vehicle rotated approximately 20 degrees clockwise and came to rest facing southeast in close proximity to the tree. The delta V of the crash calculated by the Barrier Algorithm of the WINSMASH model was 35 km/h (21.7 mph).

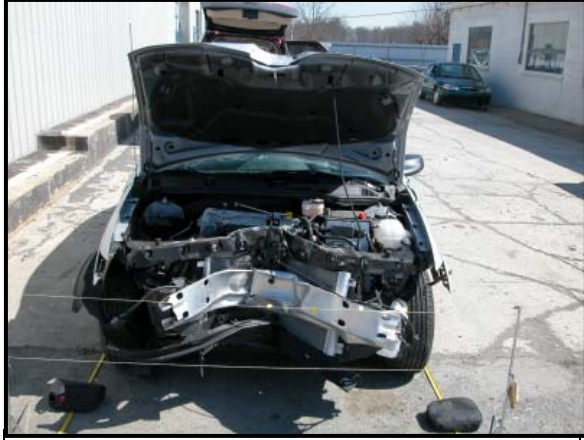
Figure 4: Front view of the Saturn.

Figures 3 and 4 are the front and overhead views of the Saturn. The frontal plane of the vehicle sustained 28 cm (11.0 in) of direct contact damage as a result of the tree impact. The direct damage started 14 cm (5.5 in) left of center and ended 14 cm (5.5 in) right of center. The combined width of the direct and induced frontal damage extended across the entire 145 cm (57 in) frontal width of the vehicle. The components damaged in the impact included the front bumper fascia and reinforcement bar, center grille, hood, radiator, air conditioner condenser, upper radiator support and headlamp assemblies. The right forward uni-body frame end deformed 15 cm (6 in) inboard during the impact phase, as the bumper reinforcement bar crushed into a U-pattern. The residual crush profile measured along the reinforcement bar was as follows: C1 = 1 cm (2.5 in), C2 = 21 cm (8.3 in), C3 = 49 cm (19.3 in), C4 = 58 cm (22.8 in), C5 = 50 cm (19.7 in), C6 = 1 cm (2.5 in). The right wheelbase reduction measured 6 cm (2.5 in). The left wheelbase was unchanged. All four doors remained closed during the impact and were operational at the time of the SCI inspection. The Collision Deformation Classification (CDC) was 12-FCEN-3. The delta V of the crash calculated by the Barrier Algorithm of the WINSMASH model was 35 km/h (21.7 mph). The longitudinal and lateral components were -35 km/h (-21.7 mph) and 0, respectively.

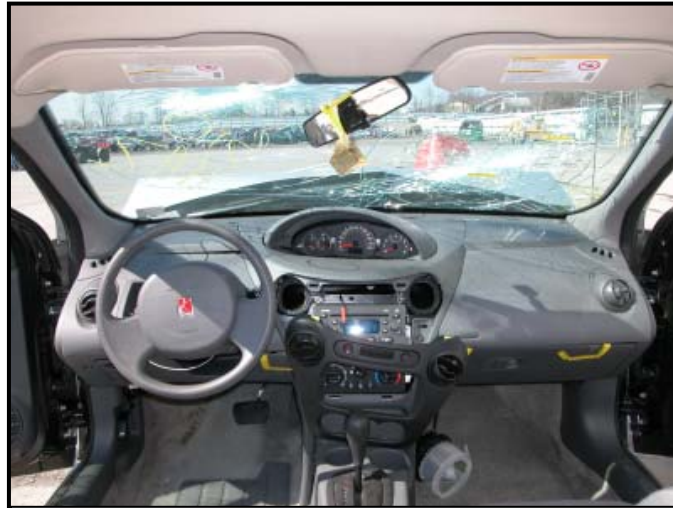
Figure 6: Interior view.

Figure 6 is an interior view of the Saturn. The vehicle's interior damage consisted of the identified (unrestrained) occupant interior contacts. There was no intrusion or damage related to the exterior force of the impact. There was no deployment of the vehicle's frontal air bags.

The driver seat was adjusted to a full rear track position. The total seat track travel measured 25 cm (10 in). The seat back was reclined 30 degrees aft of vertical, measured 36 cm (14 in) above the seat bight. The horizontal distance from the seat back to the steering wheel hub measured 76 cm (30 in). The tilt steering wheel was in the full up position. There was no evidence of loading or deformation to the steering wheel rim. There was no displacement of the steering column's shear capsules. The control stalk for the turn signals was fractured from a probable left hand contact.

The windshield was fractured forward of the driver's position from the driver's head contact. The fracture site was located 41 cm (16 in) right of the left A-pillar and 10 cm (3.8 in) below the windshield header. The center mirror was fractured and rotated from probable contact with the driver's right hand. The driver's knee bolster exhibited a scuff from the driver's right lower extremity. The scuff measured 5 cm x 6 cm (1.8 in x 2.5 in); it was located 16 cm (6.3 in) right of the steering column centerline and 46 cm (18 in) above the floor.

The windshield forward of the front right position was fractured. Two fracture sites were identified from contact by the passenger head and right hand, respectively. The fracture site from the head strike was located 34 cm (13.5 in) left of the right A-pillar and 50 cm (19.5 in) below the header. Several hair strands were embedded in the fracture. The fracture associated with the passenger's right hand was located 20 cm (7.8 in) left of the right A-pillar and 28 cm (11 in) below the header. Two scuffs were identified on the lower instrument panel resultant to contact from the passenger's lower extremities. A 5 cm x 5 cm (2 in x 2 in) scuff attributed to the right lower extremity was located 46 cm (18 in) above the floor on the left upper corner of the glove box door. A 6 cm x 4 cm (2.5 in x 1.5 in) left lower extremity scuff was located 46 cm (18 in) above the floor and 18 cm (7 in) inboard of the right outer edge of the instrument panel.
