IMECE2002-33517

**STUDY OF SEAT SYSTEM PERFORMANCE RELATED TO INJURY
OF REAR SEATED CHILDREN & INFANTS IN REAR IMPACTS**

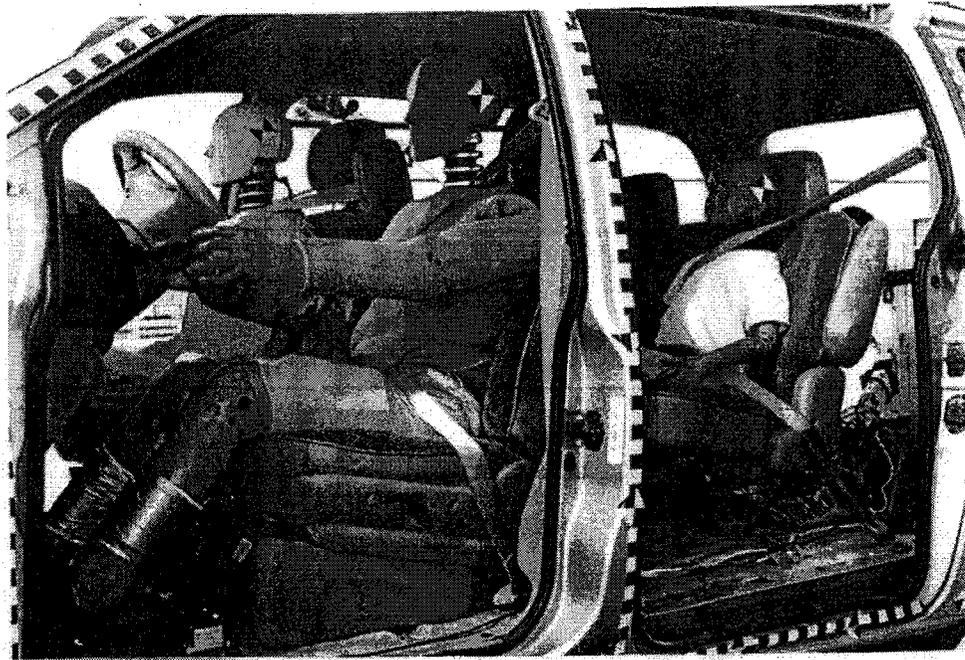
Figure 1. Surrogate Pre-test Setup for Sled-Buck Test 1

During the sled-buck dynamic tests the entire front and rear compartment areas of the vehicle were included on the sled-buck arrangement so as to more properly evaluate the benefits of seat designs within real world geometric constraints of the occupant compartment interior, and floor attachment structures. In addition, a restrained child surrogate weighing 21kg, and having a seated height of 61 cm, was placed in the left-rear seat position (i.e. position 4) directly behind the driver to simulate the size of the child in Case 1A. The front

seat surrogates for these sled-buck tests were restrained Hybrid III male surrogates ballasted up to about 125 kg to simulate the size of the driver in the Case 1A. The original right front weak collapsing "OEM" seat was replaced with a much stronger 1996 Sebring belt-integrated seat. Also, the Hybrid III driver surrogate, seated in the collapsing "OEM" seat design, had a standing "pedestrian" type pelvis so as to more closely replicate the kinematics of a human subject when rotating rearward during the front seat collapse. Figure 1 illustrates the surrogate pre-test positions described above for the first sled-buck test. In these tests the driver seat was positioned rearward as per the location indicated by the actual driver of Case 1A. The stronger right front replacement seat was matched in position with the "OEM" driver seat.

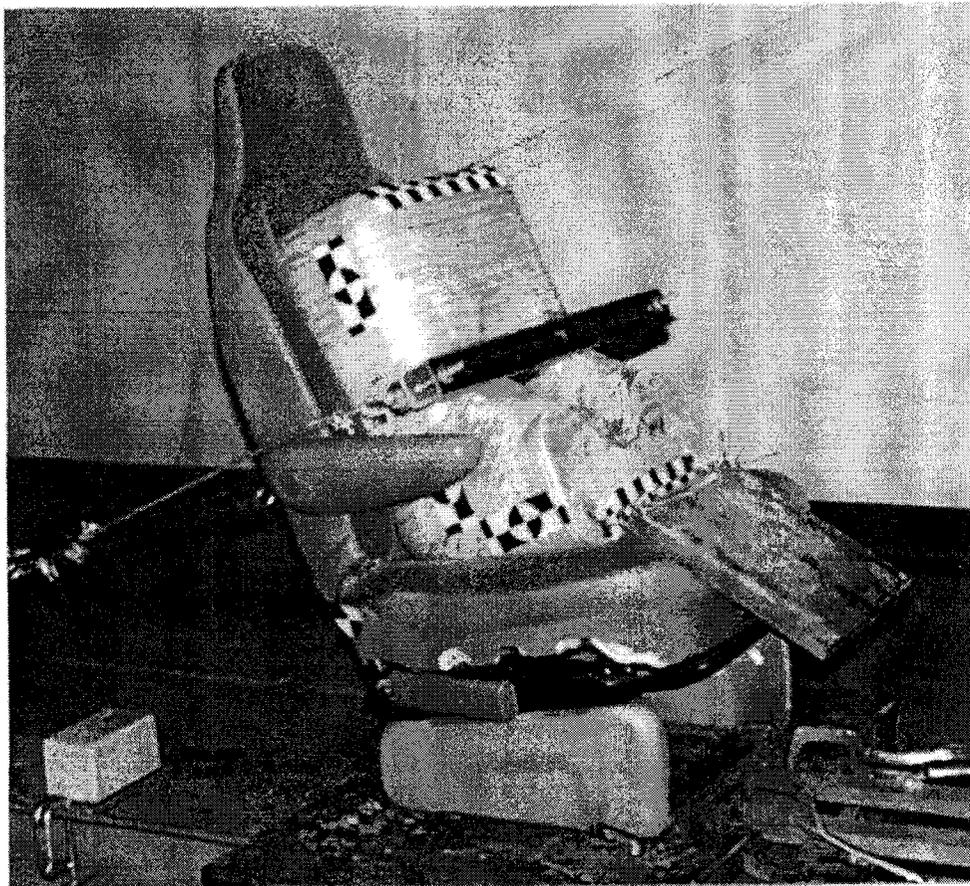
Figure 2. Quasi-static "Torso Body-Block" Seat Strength Test Set-Up

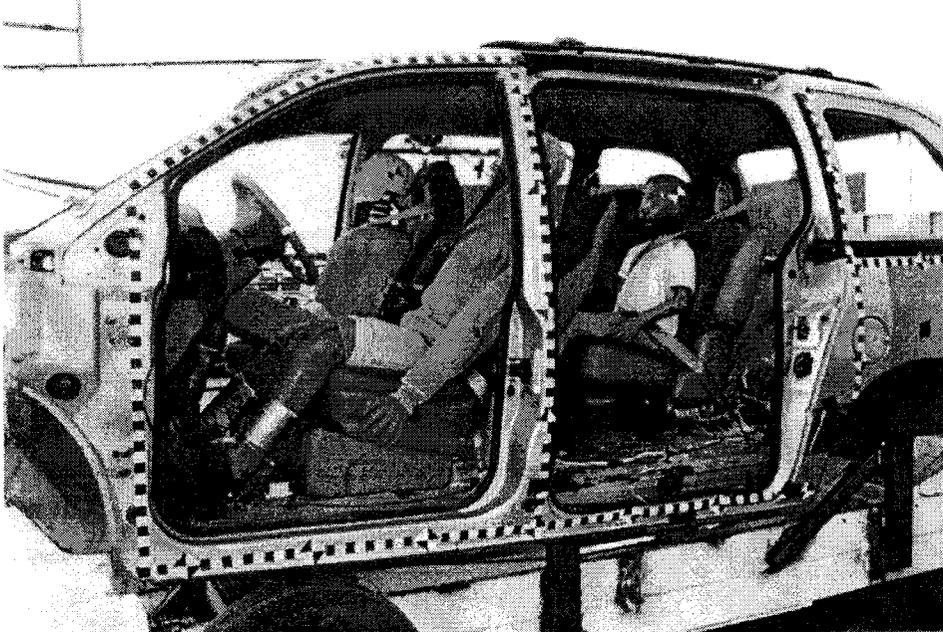
Figure 6. Post Test Surrogate Positions for Test 1 Set-up

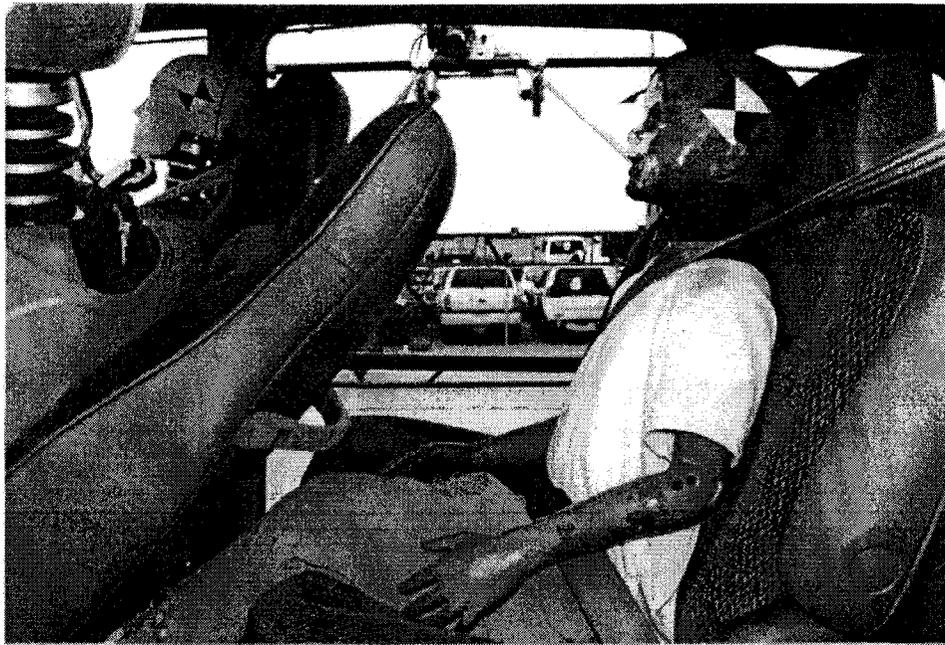
Figure 7. Close Up Showing Head Strike and Leg Impact Chalk Marks on Rear Child

During this first test, the 125kg surrogate in the weaker "OEM" driver seat collapsed rearward such that the head of the driver surrogate struck the head of the child surrogate seated directly behind the driver seat. Figure 5 is a photograph taken at about 150 ms into the crash event and this shows the head-to-head contact of the driver head with the child's head. Figure 6 shows the post-test positions of the surrogates. Figure 7 shows a closer view of the rear seated child surrogate showing the "yellow" and "blue" chalk transfers from the head of the front dummy imprinted on the face of the child, and it's legs, due to the front seat collapse.

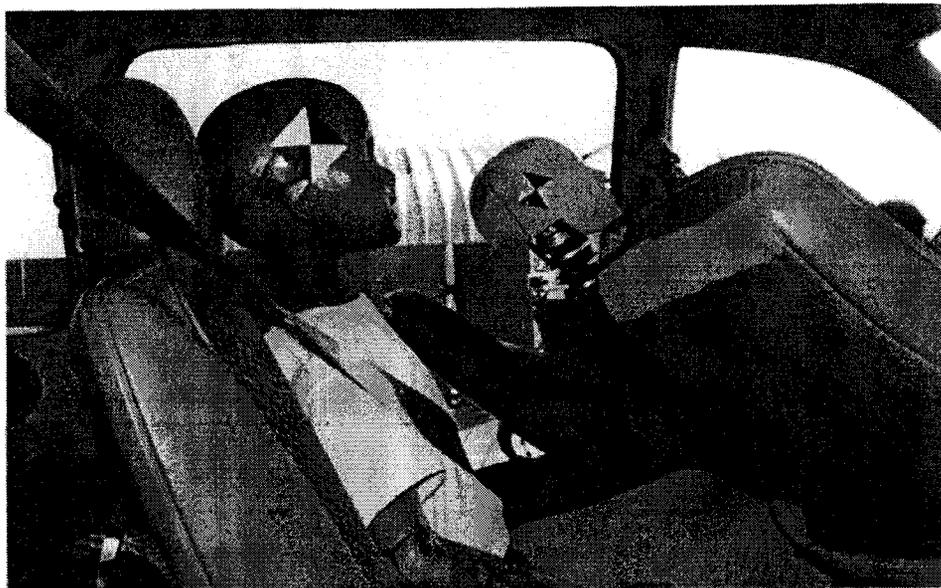
Figure 14. Collapsing Seat OOP Dummy Head Chalk Marks on Rear Seated Child

As a result of the "inboard" leaning OOP orientation of the right front surrogate in the collapsing seat, the more centered rear seated child was struck in the right chest and shoulder, and also received a glancing blow to the side of the head, from the impact of the head of the rearward collapsing right front OOP occupant. This is shown in Figure 14 by the yellow chalk transfer marks on the chest, shoulder, and side of head of the child surrogate. The driver dummy, which was also seated in a collapsing type "OEM" seat, also collapsed rearward into the empty position 4 of the rear mid-bench seat. Neither of the front seat

surrogates received injurious head or neck loads from impact with the child dummy or the empty rear seat position. Most importantly, however, as noted by the yellow chalk marks imprinted from the head of the right front OOP surrogate collapsing onto the rear seated child, even center rear seat positions are not likely to be safe for children and infants if the front seat occupants are leaning "out-of-position" and the front seats tend to collapse rearward, especially at rear impact severity levels as low as in this case (i.e. 23 kph speed change and 9 G loads).

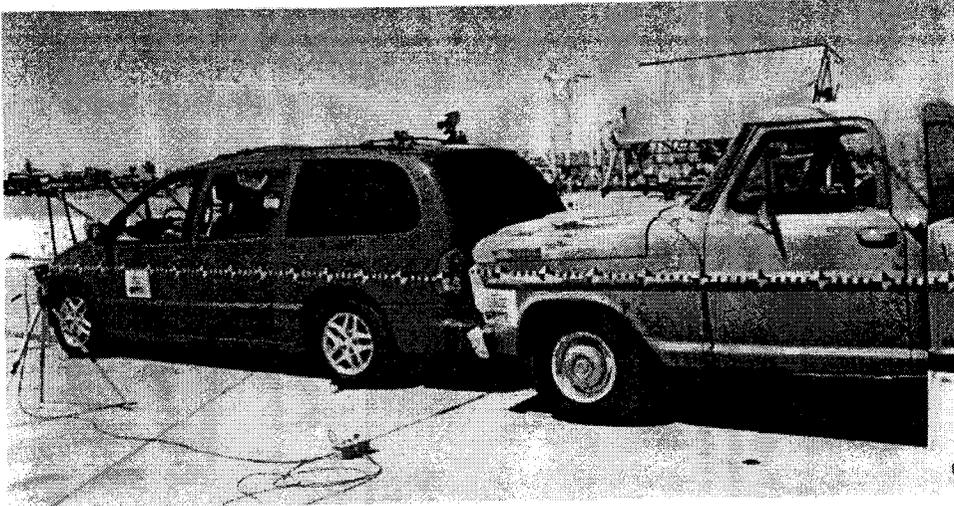
Figure 15. Vehicle-to-Vehicle Test Set-up Just Prior to Impact

In this test a stationary late model minivan vehicle, identical to the body style used in the previous sled-buck series, is rear impacted by a half-ton pickup truck traveling at 54 kph. The centerline of the impacting vehicle is aligned with, but offset by about 28 cm to the left of, the minivan centerline. Figure 15 illustrates both vehicles just prior to impact. Figure 16 shows

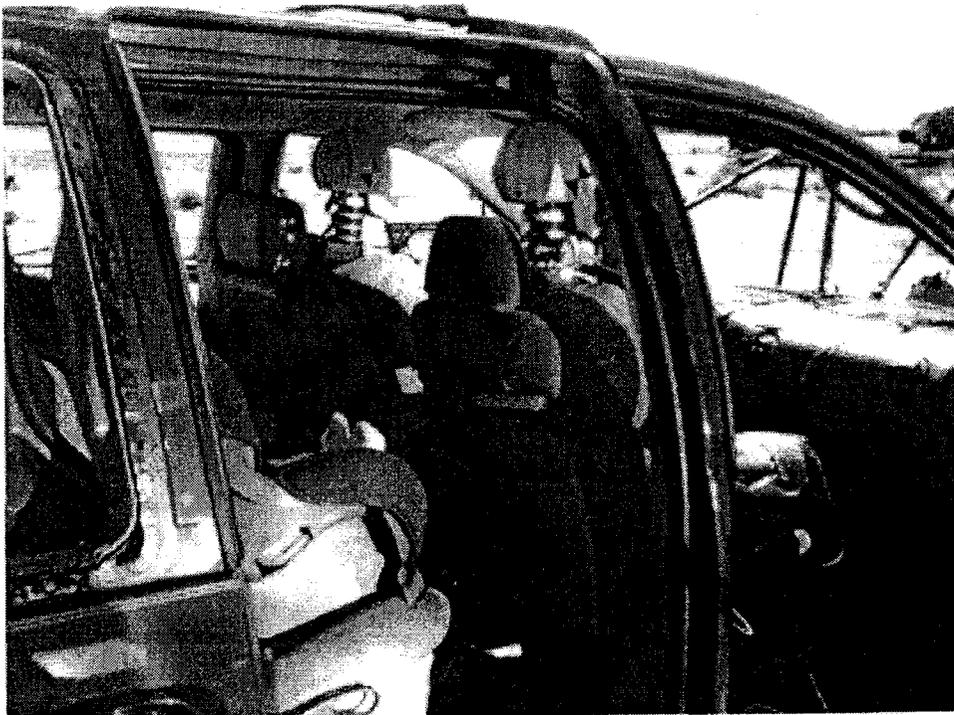
Figure 17. Lowered Front Seat Headrests in Vehicle-to-Vehicle Test

The front seat contained restrained and instrumented (i.e. head, neck, and chest) Hybrid III males ballasted to 87.3 kg. Both were seated upright on a pad so that the "head-to-roof" clearance matched that of a 185.5 cm tall male. A stronger 1996 Sebring "belt-integrated" seat replaced the "OEM" weaker driver seat. The right front seat was the standard minivan "OEM" collapsing type seat. The dummy in the weaker right front seat had a "pedestrian" standing pelvis (rather than the standard molded "seated" pelvis) so as to more realistically replicate the kinematics of a human when this seat (i.e. right front) collapsed rearward. The headrests of both front seats were placed in the lowest positions so as to allow for the study of alleged "whiplash" dangers to "out-of-position" (OOP) occupants seated in strong seats. This side-by-side arrangement of strong and weak seats, with the tops of the headrest set below the base of the head, enabled a quantitative comparison of surrogate head and neck response for the same level of impact severity with two distinctly different levels of seat strength (i.e. 3,070 Newtons vs. 14,670 Newtons). Figure 17 shows the front seat headrest positions for this test. All other headrests of (i.e. rear seats) were adjusted properly upward.

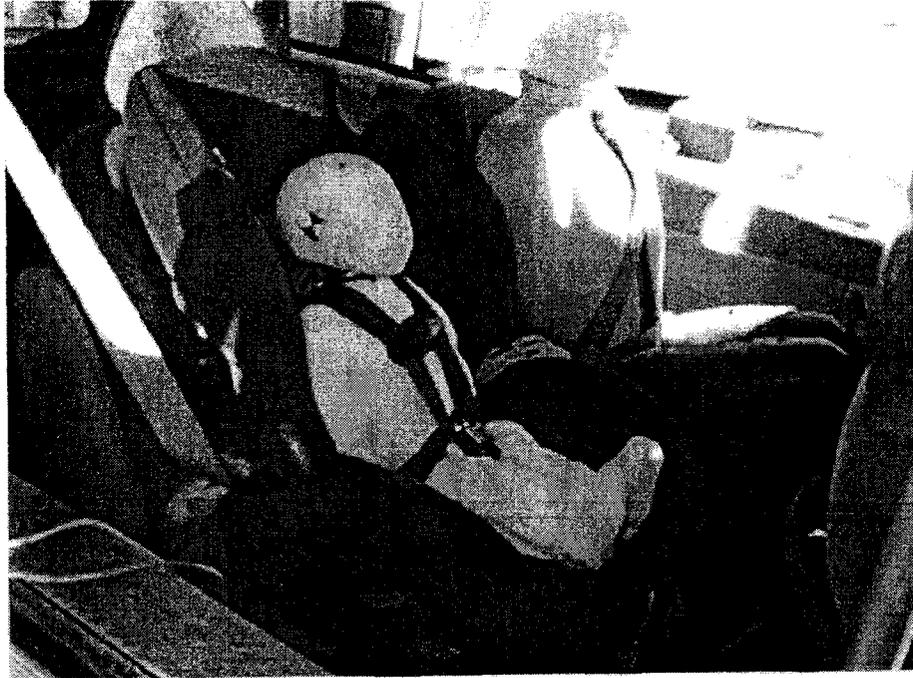
Figure 18. Mid-Left Adult Surrogate and Mid-Right Forward Facing Infant Surrogate

The mid-row seats were each standard "OEM" captain seats located in the outboard positions 4 and 6. Seated on the left-mid seat was an uninstrumented side impact surrogate weighing 71 kg. Seated on the right side of this row, behind the weaker right front seat, was a 6 month-old CRABI surrogate ballasted to 10 kg. The CRABI was instrumented with tri-axial head and chest accelerometers. The CRABI was restrained in a "forward-facing" child restraint seat that was in turn secured to the right-mid seat as shown in Figure 18. Figure 19 shows a restrained 5th percentile Hybrid III female, and a 6-year old, in the rear bench seat.

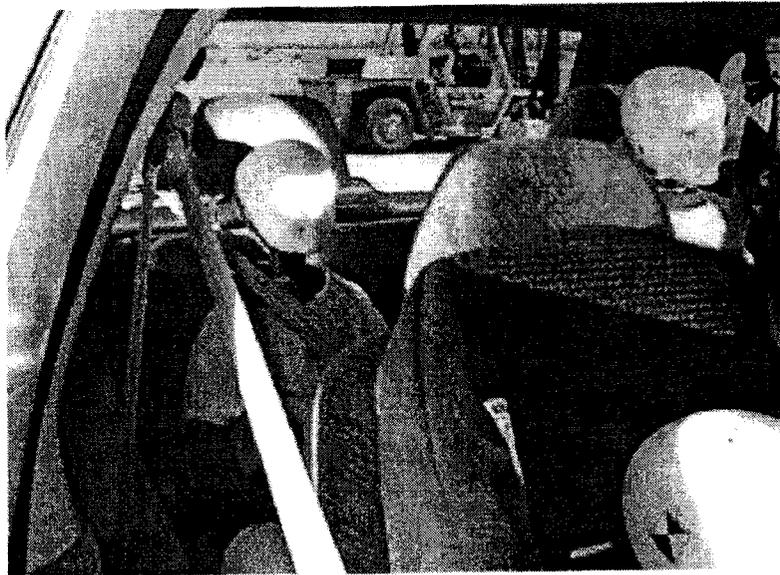
Figure 19. Rear Bench 6-Year-Old (right rear) & LR 5th Percentile Female Hybrid III

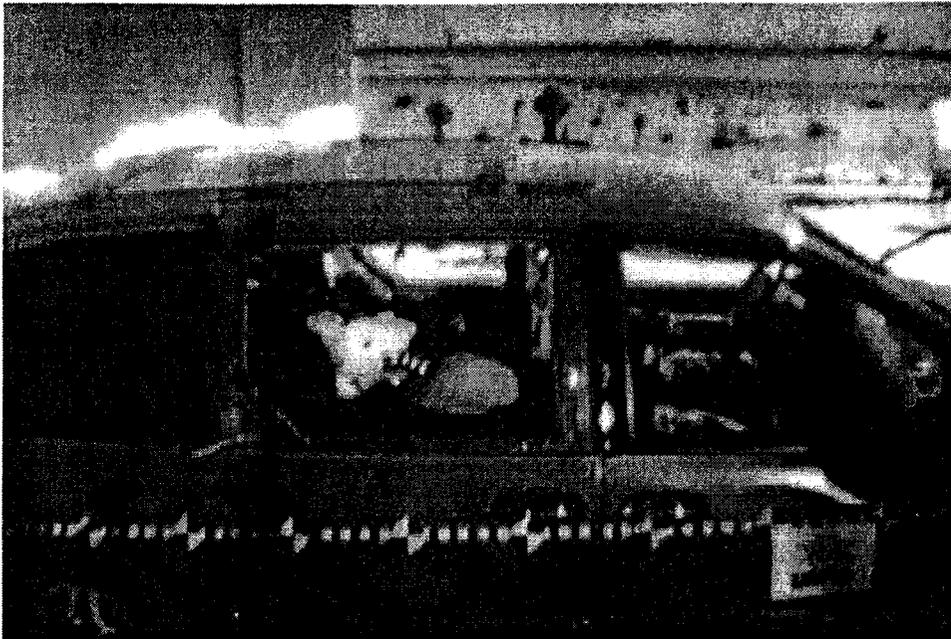
Figure 20. Head & Chest Impact to the Infant at 156 ms Into the Crash

Figure 20 is a film clip, taken from the hi-speed films at 156 ms, for the passenger side view which shows the right front surrogate, in the weaker "OEM" seat, collapsing into the head and chest of the infant seated behind. Figure 21 shows the head and chest impact accelerations imparted to the infant behind the collapsing seat.
