**National Highway
Traffic Safety
Administration**

DOT-HS-807-367
DOT-TSC-NHTSA-89-1
Final Report

An Examination of Sudden Acceleration

John Pollard
E. Donald Sussman

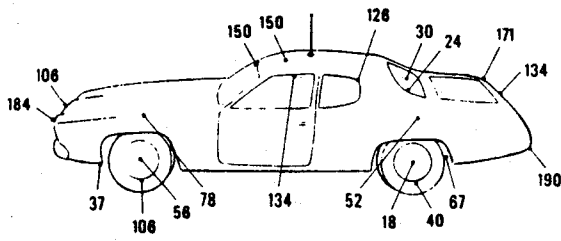
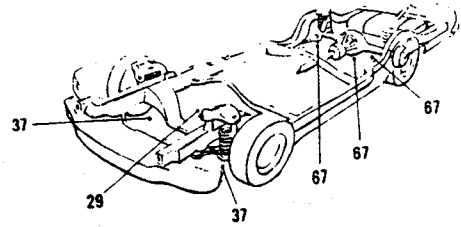
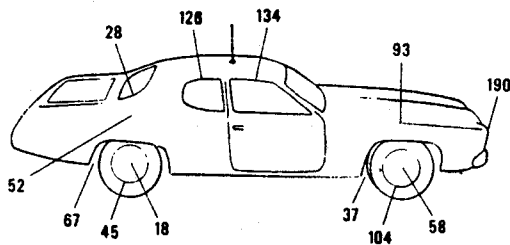
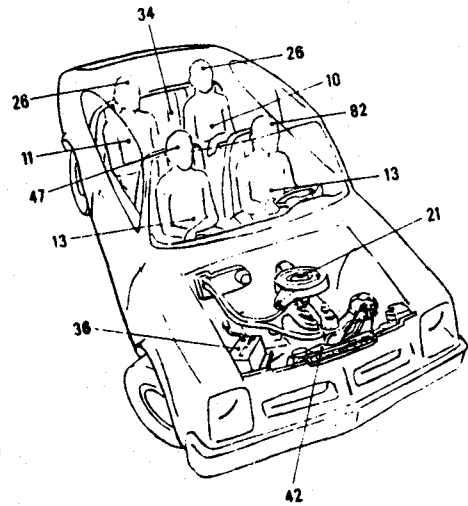
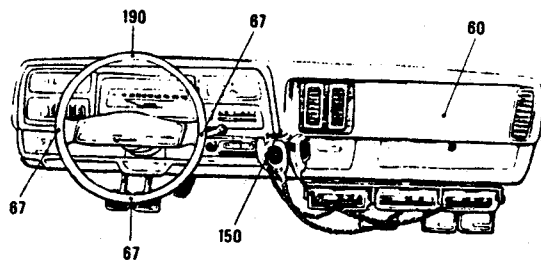
Figure 3.2.2-1 shows field strengths, expressed in Volts per meter on a typical full-size car with 100 watt amateur radio transmitter operating. Figure 3.2.2-2 shows the means of the worst-case E-field measurements for three types of vehicles. For this series of tests, the strongest fields affecting motor vehicles were associated with long-wave (most commonly, AM broadcast) and CB transmitters. The very high values shown for CB resulted from the use of illegal, 100-Watt amplifiers. Legal CB units are limited to 5 Watts.

Figure 3.2.2-1: Field strength measurements on a typical full-size car. The numbers are field strengths expressed in volts per meter. Source: Reference 36.

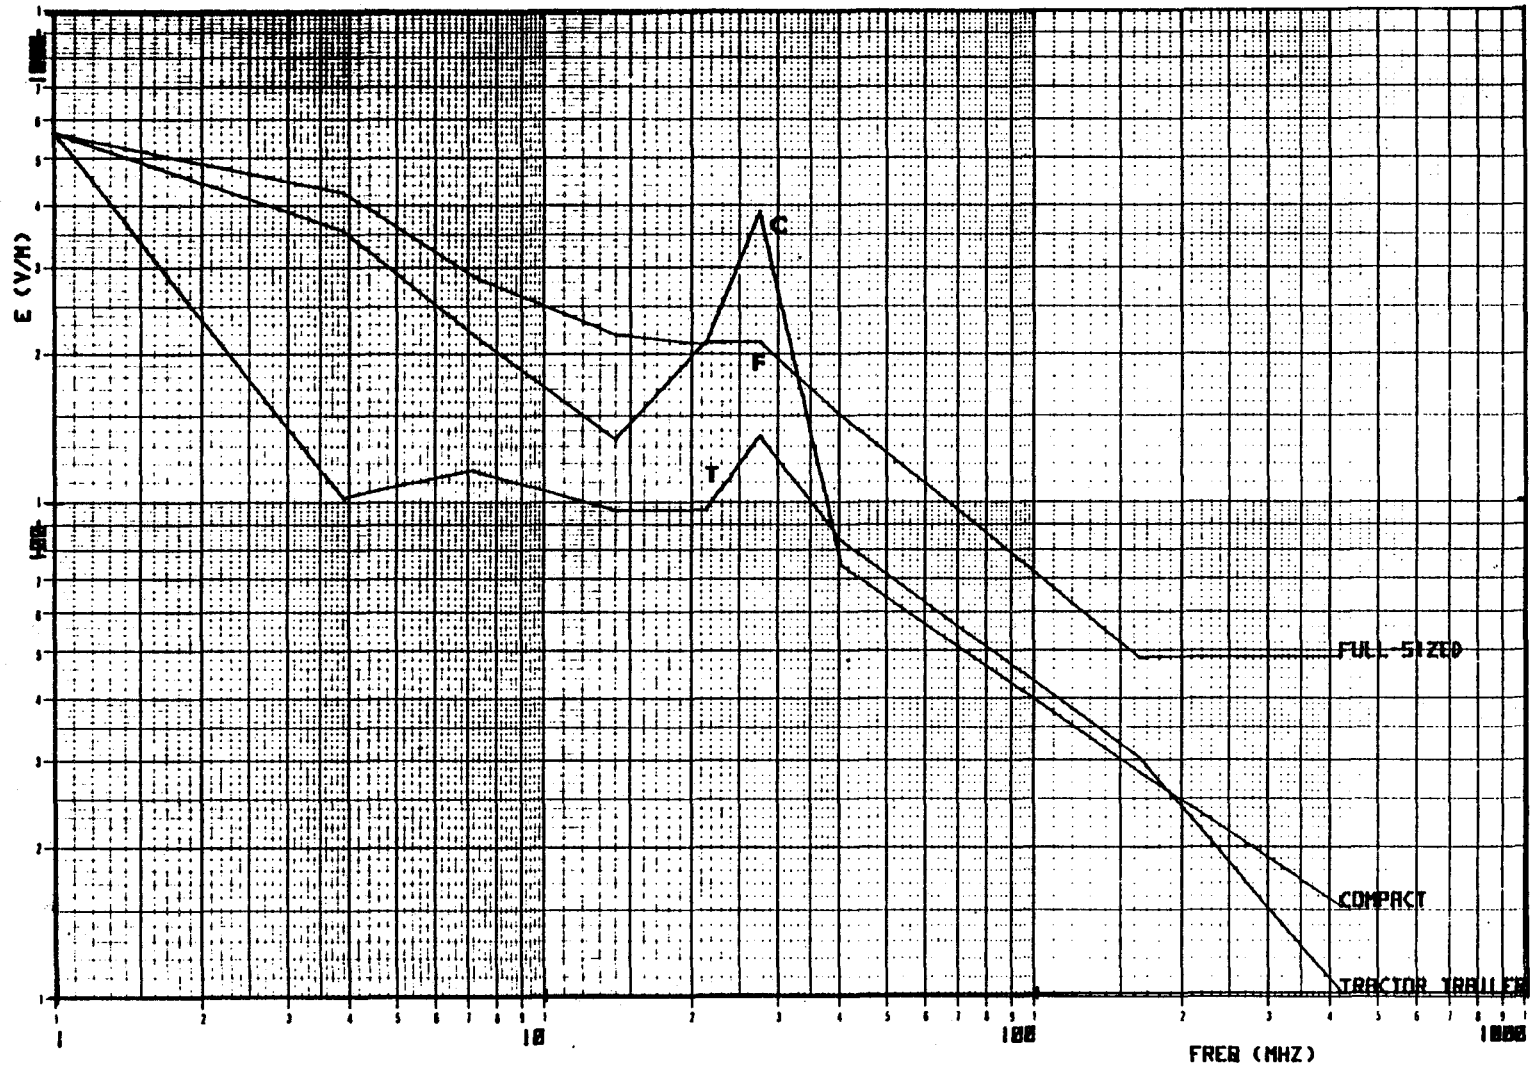
FIG. 39 - E FIELD, WORST CASE, NORMALIZED, 50 PERCENTILE

Figure 3.2.2-2: E field measurements, normalized 50th percentile values plotted against frequency. Maxima occur in the AM broadcast and CB (illegal) tests. Source: Reference 36.

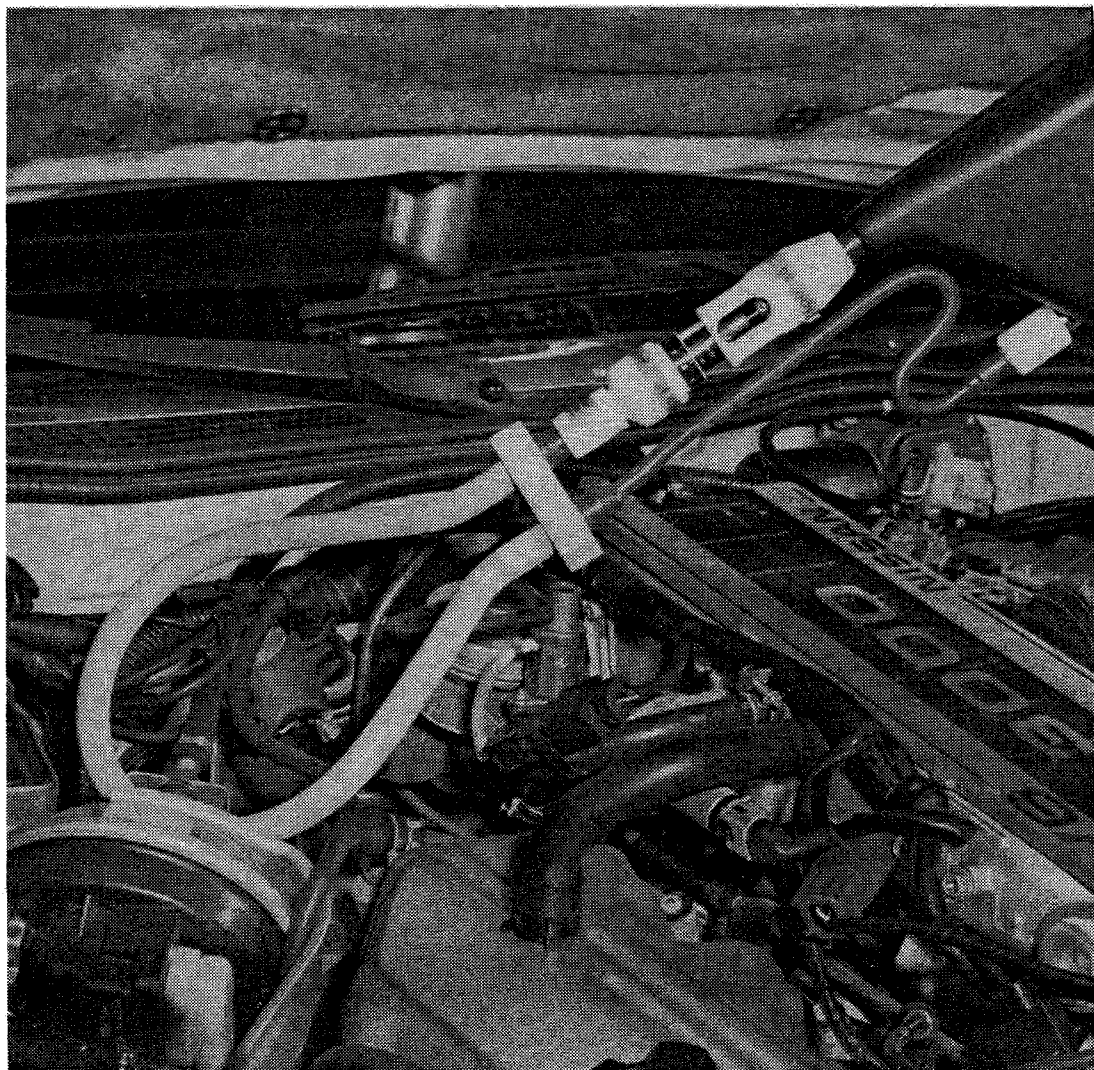
During the course of tests at VRTC, each of the vehicles was exposed to several hundred spark discharges at various points in its engine compartment and under its dashboard. The discharges were concentrated in the vicinity of the cruise control, its actuator and its wiring harness. Hundreds of magnetic pulses were also applied to the same areas. Figure 3.2.3-1 shows a close-up of a spark about an inch long impinging on the cruise actuator of one of the test vehicles, while Figure 3.2.3-2 shows the magnetic pulse attachment in use.

None of the tested vehicles showed any sign of throttle opening at any time. One of the cruise controls ceased functioning when 25 kV sparks were applied directly to its case and wiring. As a result of these tests, it may be concluded that engine controls of recent design, and cruise controls in particular, are not likely to experience throttle-opening failure modes as a result of exposure to very strong electric or magnetic fields.

Figure 3.2.3-2: Application of magnetic pulses to cruise-control wiring harness.
(Photo: VRTC)

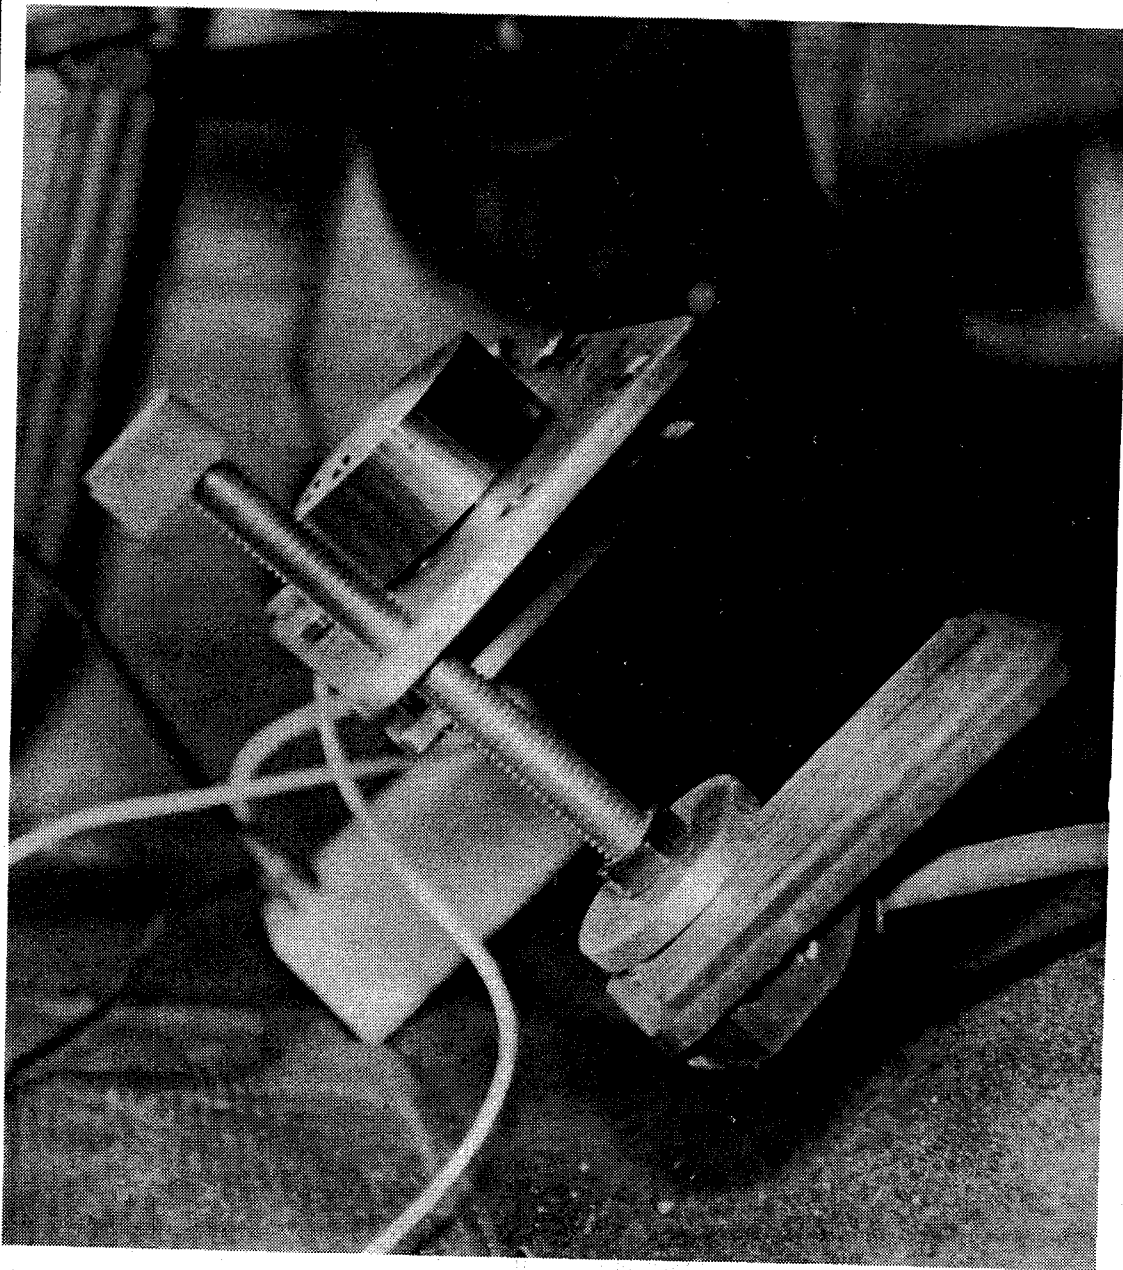
Figure 3.3.1-1: Apparatus used to measure vertical offset shown in close-up. Vertical offset is the distance from the bottom of the plate clamped to the brake pedal to the bottom of the disc pressing the accelerator and is adjusted by turning the pointer knob at the top of the screw. It is shown here installed in a Plymouth Voyager, which has a relatively high offset. The readout display for applied force is placed on the dashboard, out of view in this photograph.

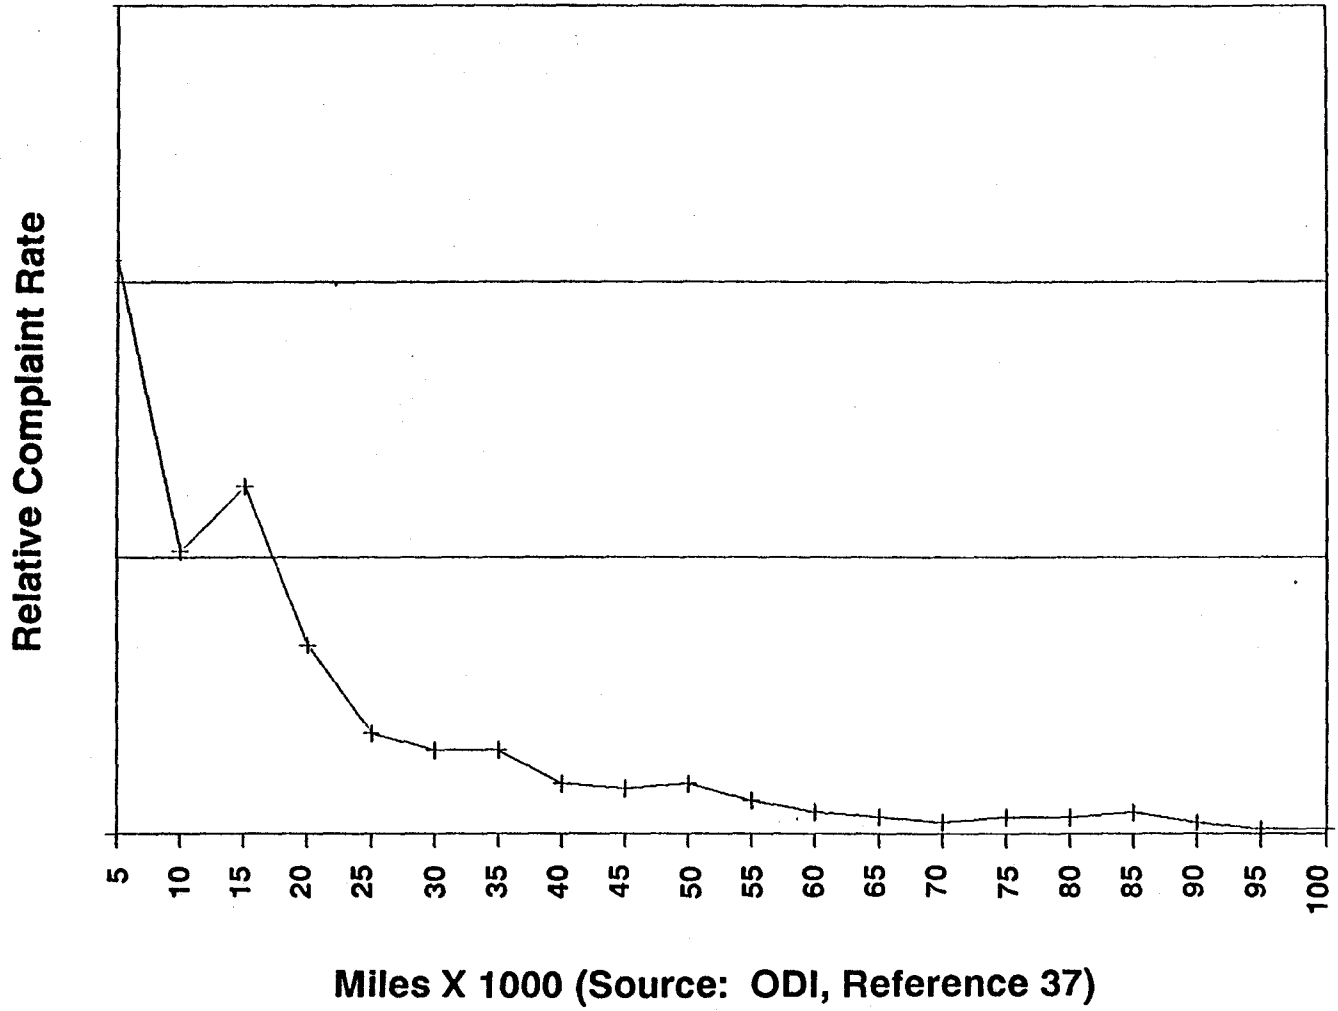
The exception to this is driver familiarity with the vehicle, which can usually be estimated from the odometer readings found in the complaint data. Review of the data recently gathered by NHTSA reveals that the rate of complaints about unwanted engine power falls off precipitously with vehicle mileage, suggesting familiarity is strongly related to complaint rate. Figure 3.3.1-3 shows complaint rates as a function of the odometer reading at the time of the incident. (The vehicles included in Figure 3.3.1-3 were selected because they have recently been under investigation by ODI in response to high RSAI rates, which resulted in the generation of a database containing the odometer data.) The extremely steep fall off in complaints with mileage can be taken to indicate that drivers are less likely to misapply pedals as they become increasingly familiar with these cars. This is consistent with the studies cited in Appendix H, Chapter 7, which establish the relationship between driver familiarity and rates for all accidents.

Figure 3.3.1-3: Unwanted engine-power relative complaint rates (by mileage) for selected vehicles. See footnote.

Note: This figure was generated by summing the rates for complaints with odometer readings for the following vehicles: Acura Legends, Audi 5000s, Honda Accords, Nissan ZXs and Mercedes-Benz (all models). Since the curves for the individual models were similar and often overlapping, a confusing figure would result if they were plotted separately. This summation presents a valid measure of the effect of familiarity on complaint rate, but the numeric value of the sum of individual complaint rates is not meaningful. Hence, numbers are not used on the vertical axis.
