CALSPAN ON-SITE AIR BAG NON-DEPLOYMENT INVESTIGATION

CASE NO: CA05-049

VEHICLE: 2005 CHEVROLET COBALT

CRASH DATE: JULY 2005

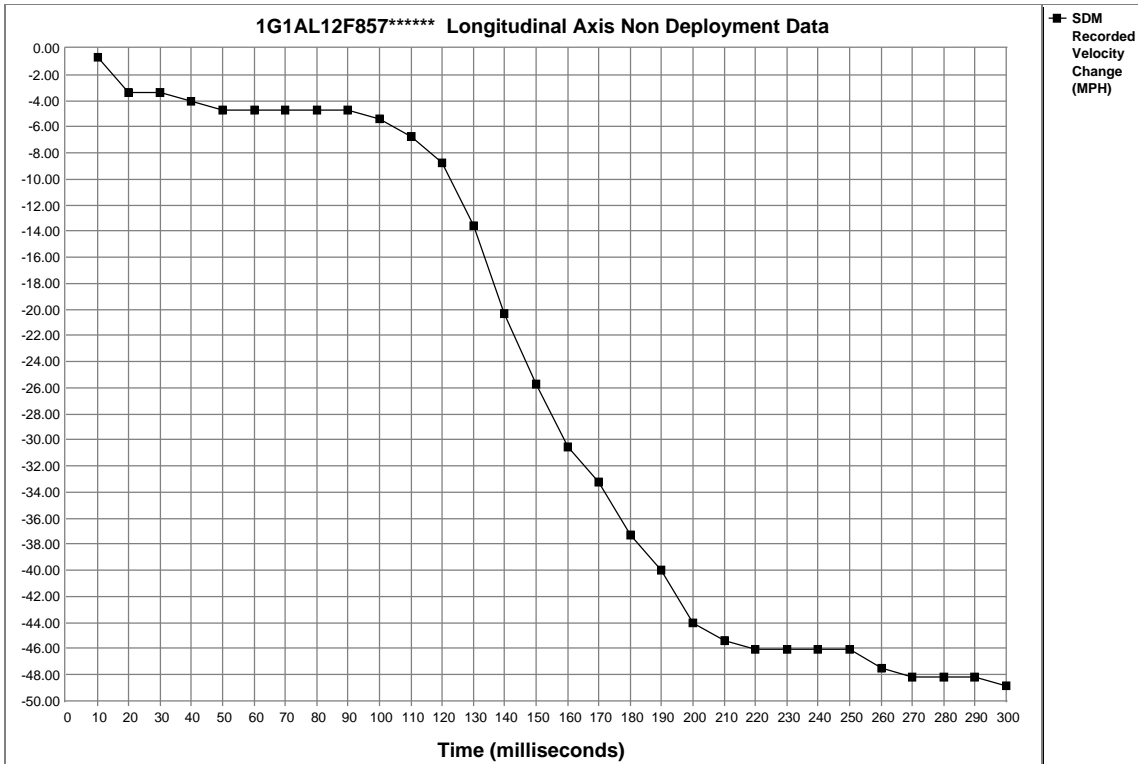
Time (milliseconds)	10	20	30	40	50	60	70	80	90	100	110	120	130	140	150
Longitudinal Axis Recorded Velocity	-0.68	-3.39	-3.39	-4.07	-4.74	-4.74	-4.74	-4.74	-4.74	-5.42	-6.78	-8.81	-13.56	-20.34	-25.76
Time (milliseconds)	160	170	180	190	200	210	220	230	240	250	260	270	280	290	300
Longitudinal Axis Recorded Velocity	-30.50	-33.21	-37.28	-39.99	-44.06	-45.42	-46.09	-46.09	-46.09	-46.09	-47.45	-48.13	-48.13	-48.13	-48.80

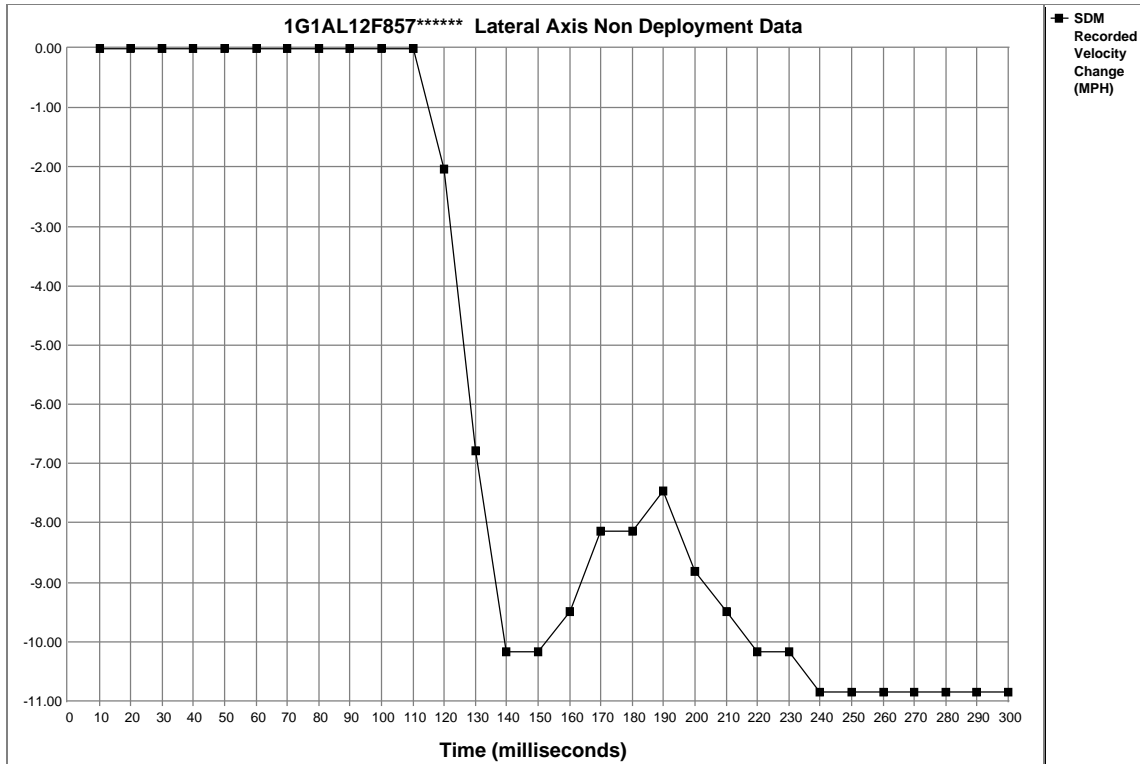
Time (milliseconds)	10	20	30	40	50	60	70	80	90	100	110	120	130	140	150
Lateral Axis Recorded Velocity Change (MPH)	0.00	0.00	0.00	0.00	0.00	0.00	0.00	0.00	0.00	0.00	0.00	-2.03	-6.78	-10.17	-10.17
Time (milliseconds)	160	170	180	190	200	210	220	230	240	250	260	270	280	290	300
Lateral Axis Recorded Velocity Change (MPH)	-9.49	-8.13	-8.13	-7.46	-8.81	-9.49	-10.17	-10.17	-10.85	-10.85	-10.85	-10.85	-10.85	-10.85	-10.85
