# CENTER FOR AUTO SAFETY

**Massachusetts State Police**  
**Collision Analysis and Reconstruction Section**  
**Collision Reconstruction Report**

<b>CASE #</b>	2013-CAR-000404
<b>Related Case#</b>	2013-0B3-006595

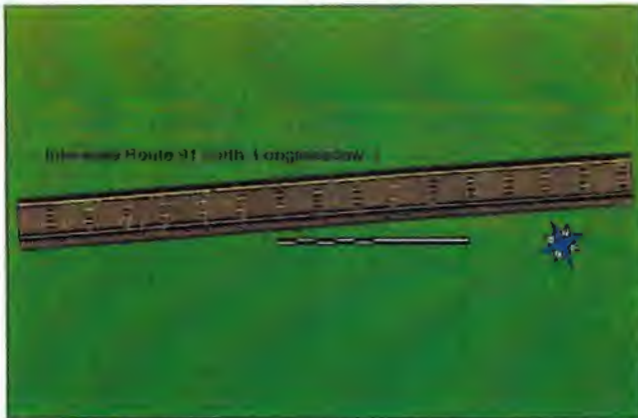
*Exhibit One*

5. A preliminary joint investigation was begun with the investigating officer. As part of this preliminary investigation physical evidence about the roadway was recorded. Trooper Christopher Kennedy of the Massachusetts State Police Collision Analysis Reconstruction Section assisted me in conducting a forensic survey of the collision location. Infrared technology via a TopCon transit and FC-100 Data acquisition system was utilized. Employing polar coordinates, the physical evidence was located and recorded. Physical evidence was noted as depicted in *Exhibit Two* and documented as follows:
